WORCESTER COLLEGE CHAPEL, OXFORD MOSAIC PAVEMENT DESIGNED BY WILLIAM BURGESS

T
W
O
M
O
S
A
I
C
S
F
R
O
M
E
N
G
L
A
N
D

HORNIMAN MUSEUM FACADE, LONDON HUMANITY IN THE HOUSE OF CIRCUMSTANCE A MOSAIC MURAL BY ROBERT ANNING BELL

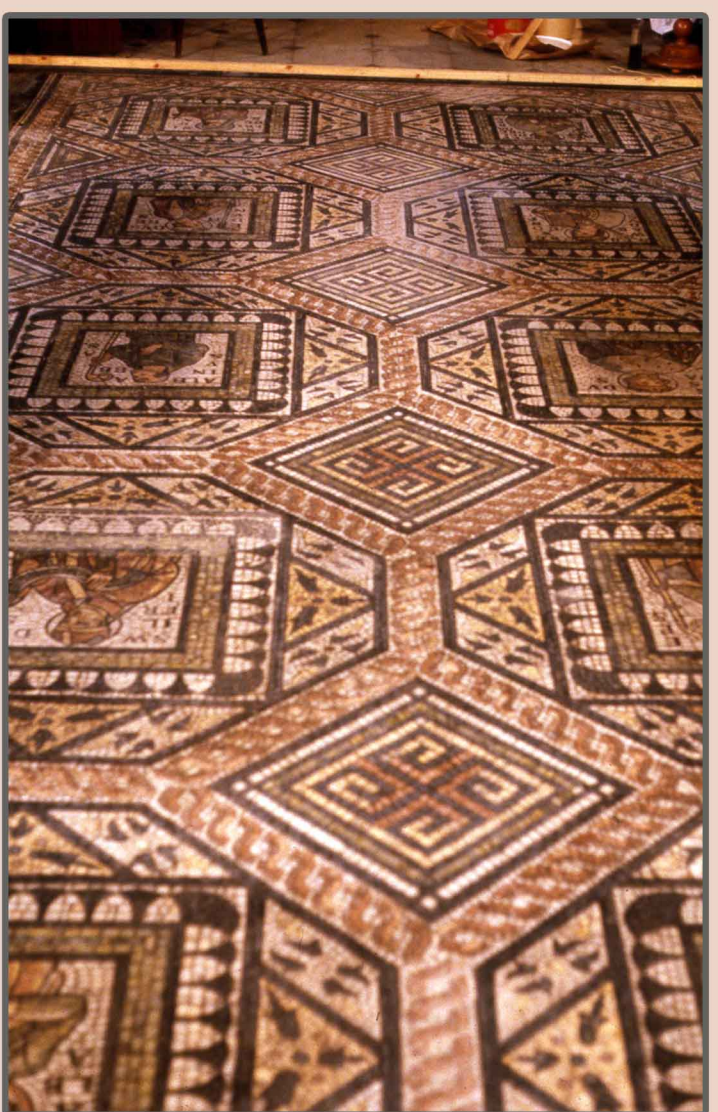
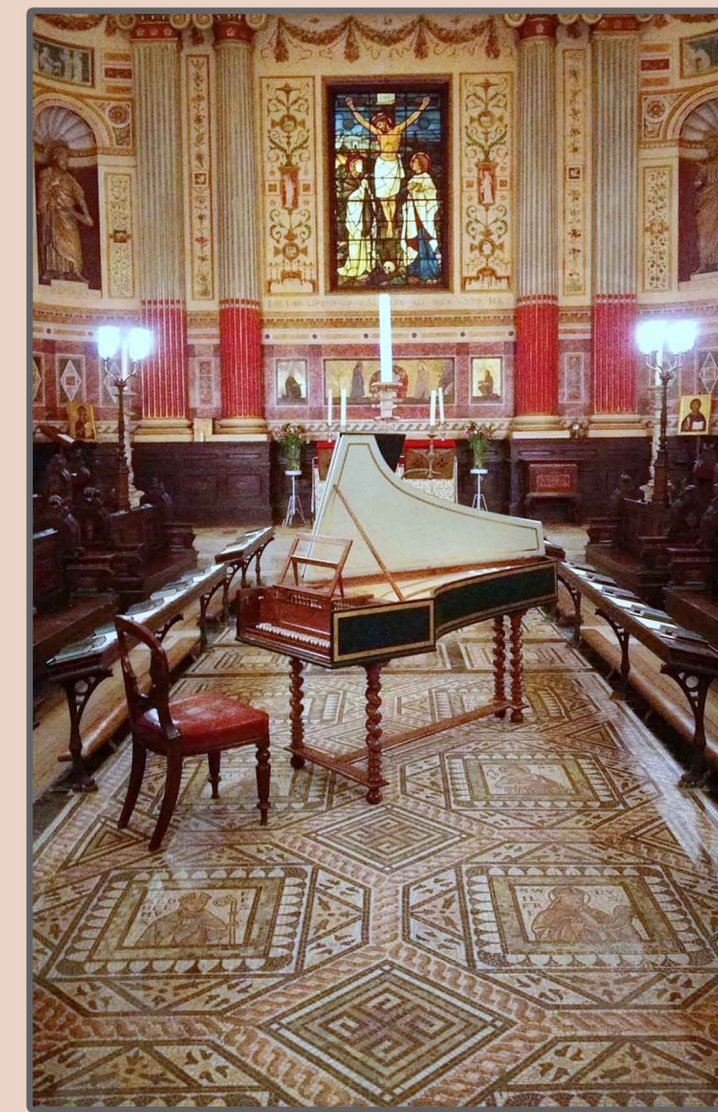
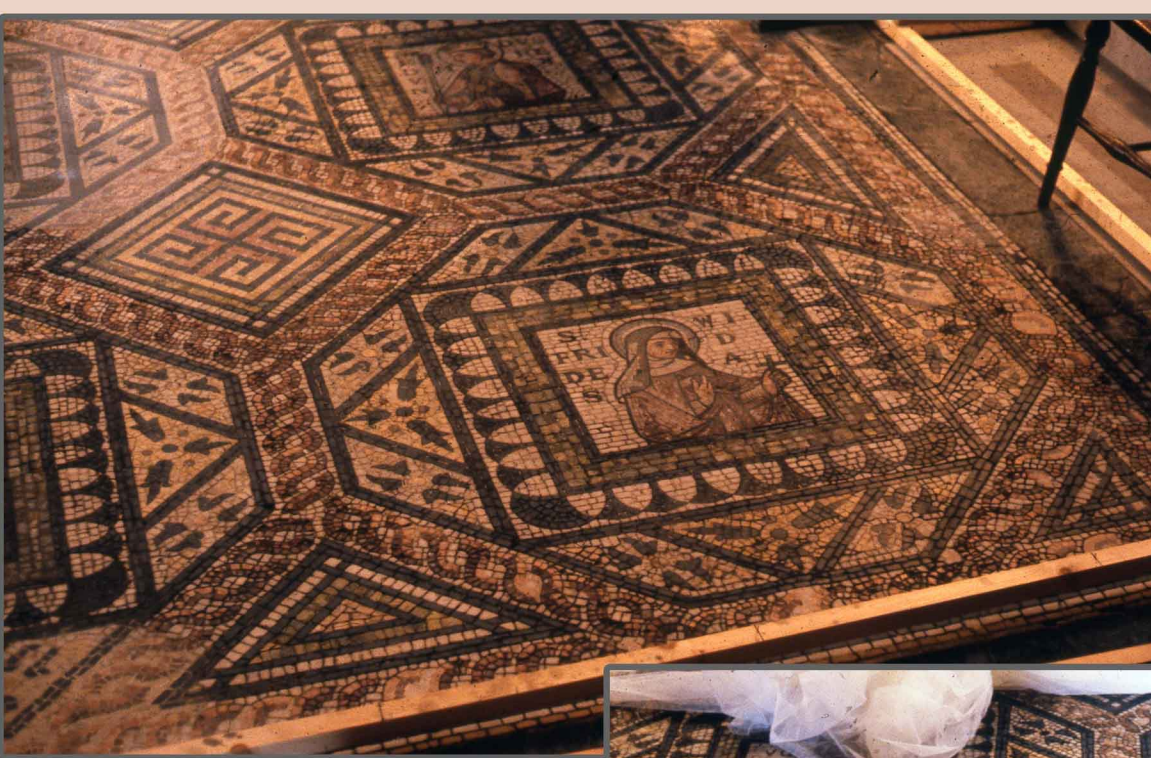
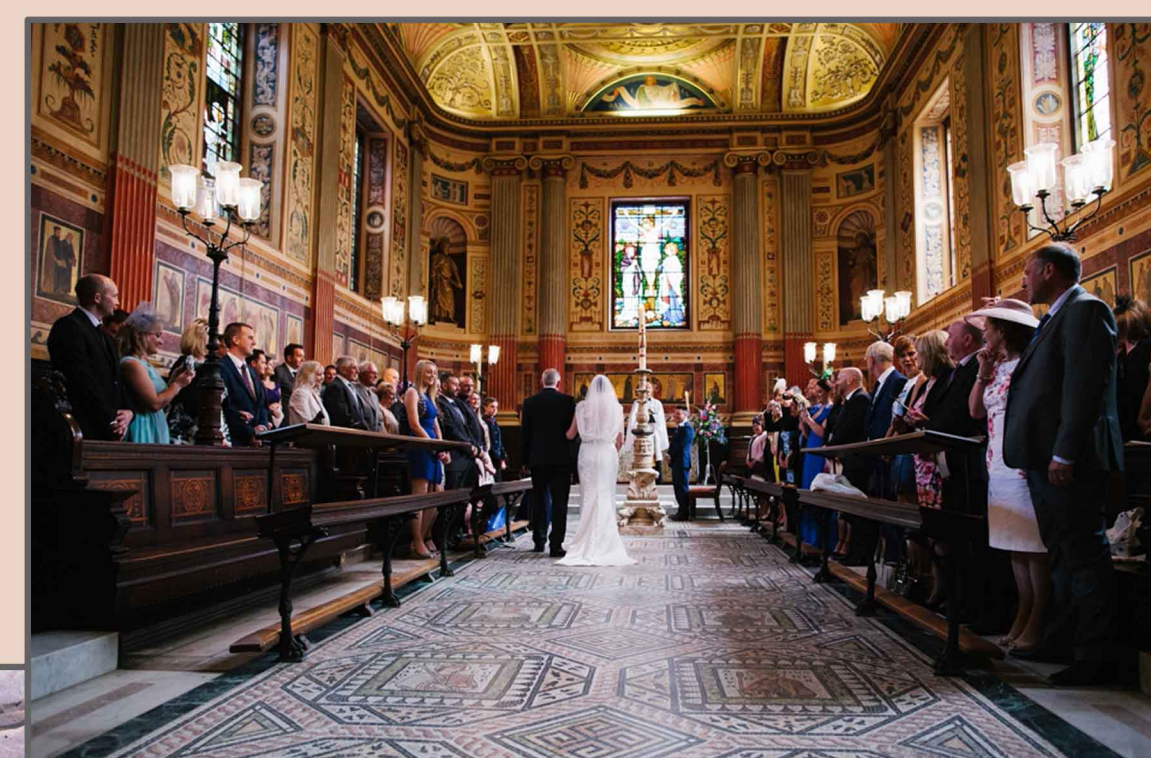
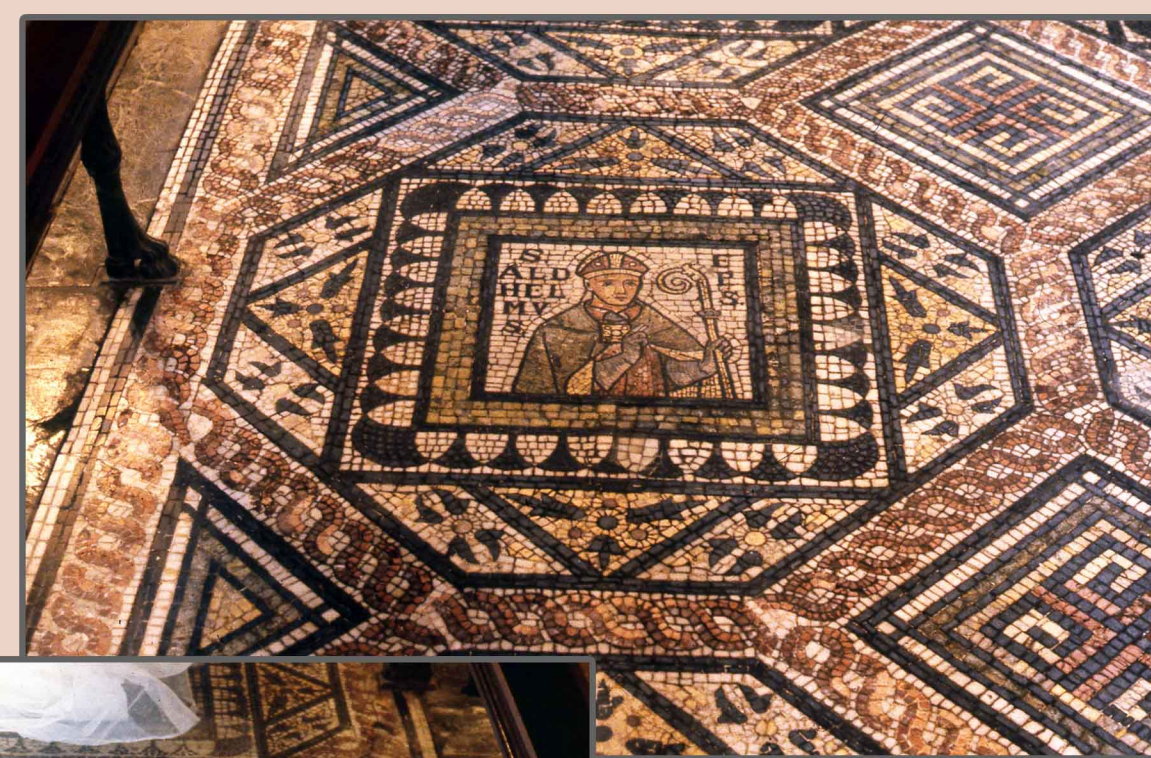
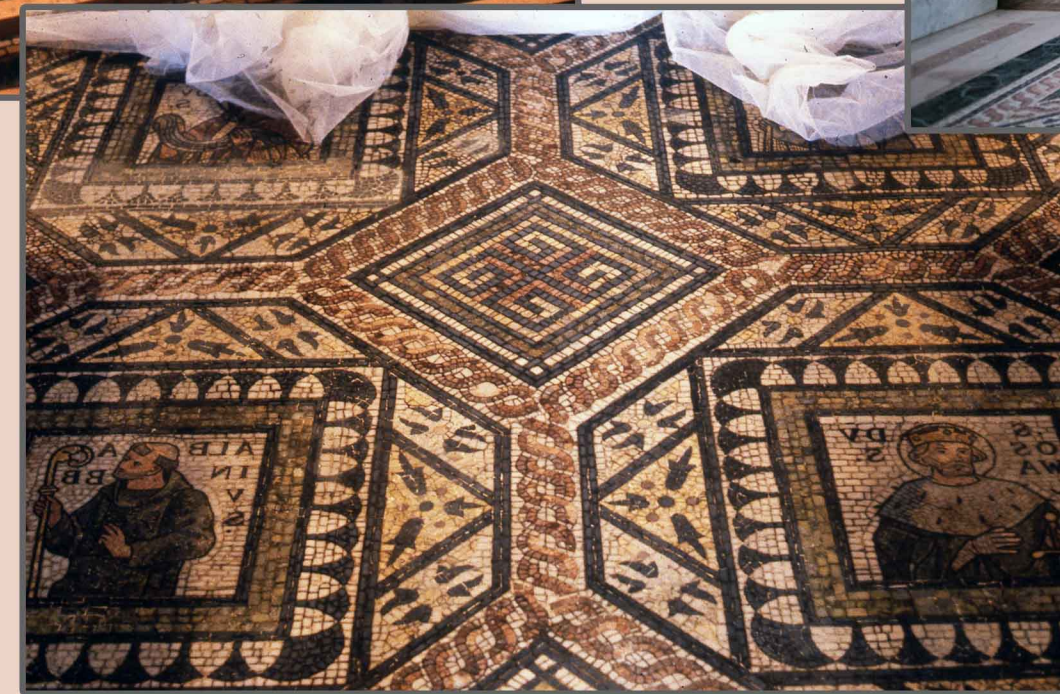
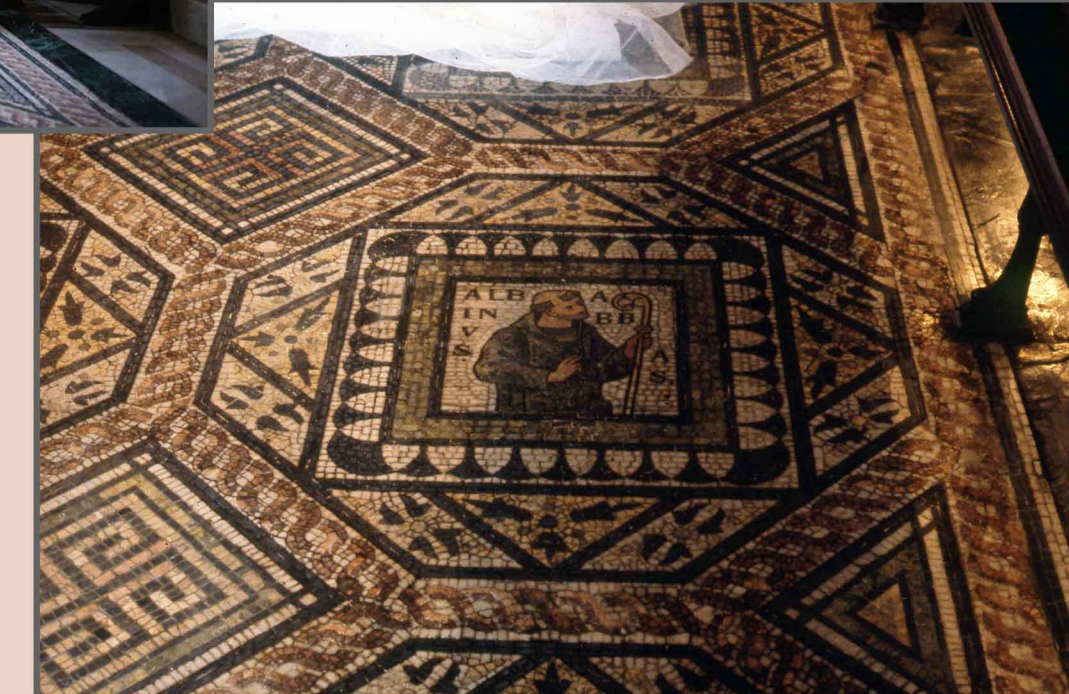
THE FIRST SECTION OF THE FLOOR, BY THE ENTRANCE SHOWED THE HEAVIEST WEAR, WITH SECTIONS BREAKING AWAY INTO LACUNAE WHICH HAD BEEN REPAIRED IN THE PAST. THE MOST WORKING PROBLEM WAS THAT THE TWELVE EMBLEMA DESIGNED TO HAVE BEEN MADE INTO PRE-FABRICATED PANELS WHICH HAD SETTLED AT DIFFERENT ANGLES TO THE GEOMETRIC INFILL WHICH APPEARED TO HAVE BEEN INSTALLED USING THE "REVERSE" METHOD. ALSO, DAMP WAS RISING AND WEAKENING THE MORTAR, UNDER THE GUILLOCHE AND GEOMETRIC AREAS. THE OTHER TWO PANELS WERE IN A MUCH BETTER CONDITION AND SEEMED TO SHOW THAT THEY WERE FIXED BY THE "REVERSE" METHOD ONLY.

THE MOSAIC WAS THEN LIFTED IN SECTIONS, INDIVIDUALLY MARKED AND PLOTTED ONTO THE MASTER PLAN. IT WAS CONFIRMED THAT THE EMBLEMA WERE MOUNTED ON PANELS OF BOTH SLATE AND LIMESTONE.

AS THE CHAPEL WAS IN CONTINUOUS USE AND BECAUSE OF THE CLEAR DETERIORATION OVER TIME, IT WAS DECIDED TO LIFT THE WESTERN PANEL AND RELAY INTO A LIME-BASED HOMOGENEOUS MORTAR, ONTO A NEW BASE; THE BASE WAS CONSTRUCTED OF 100MM OF STAINLESS STEEL REINFORCED CONCRETE SCREED LAID ONTO A DAMP-PROOF MEMBRANE.

FIRST THE FLOOR WAS CLEANED THOROUGHLY AND THEN A HEXAGONAL WEAVE COTTON MESH WAS GLUED TO THE SURFACE USING A SPECIAL PVA ADHESIVE WHICH WOULD RE-EMULSIFY AND SOFTEN EASILY WHEN WATER IS APPLIED DURING THE RELAYING PROCESS.

A REGISTRATION GRID WAS SET OUT ON SEASONED WOODEN BATTENING, (THE SAME BATTENING TO BE REASSEMBLED FOR THE RELAY TO MINIMISE ERROR), AND TRANSFERRED TO THE DRIED SCRIM BEFORE LIFTING. A DRAWING IS MADE AND RECORD PHOTOGRAPHS ARE TAKEN BEFORE AND AFTER "SCRIMMING."

CONSOLIDATION WORK AND A SUB-FLOOR WAS INSTALLED READY FOR THE RELAY. THE MIX USED FOR THE RECEIVING BED WAS COMPRISED OF LIME, WHITE CEMENT, PORTLAND CEMENT AND SHARP WASHED SAND IN THE FOLLOWING PROPORTIONS: 4:1:1:1. THE GROUT WAS MIXED IN THE RATIO OF 4:1:1 WITH NO SAND ADDED. THE COST OF THE WORK WAS ABOUT £20,000.

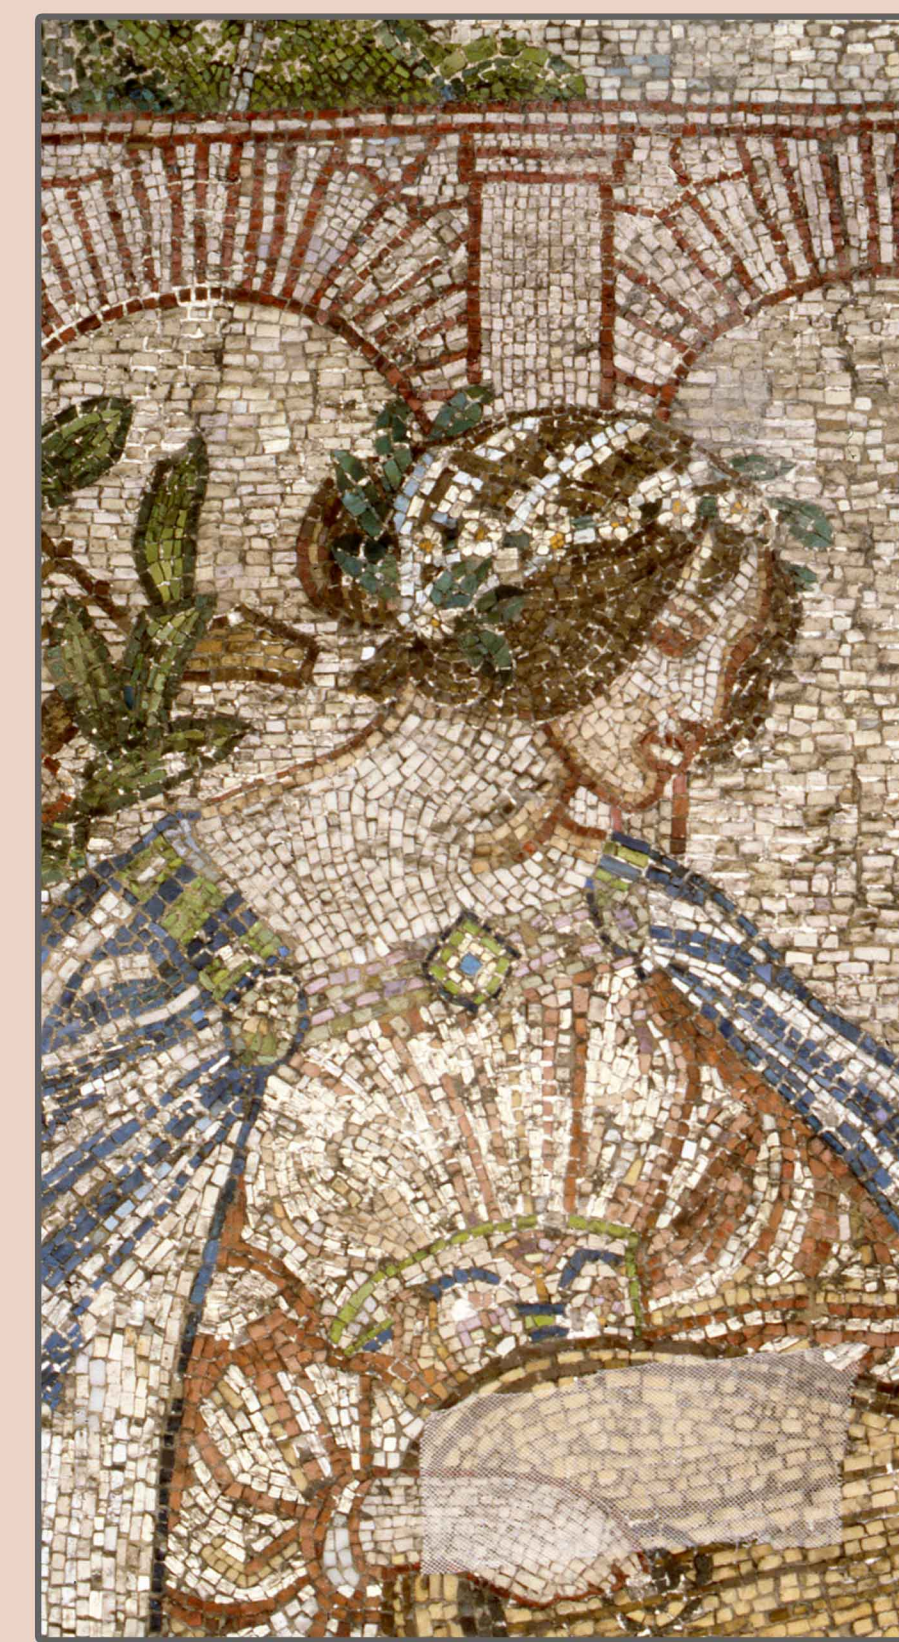
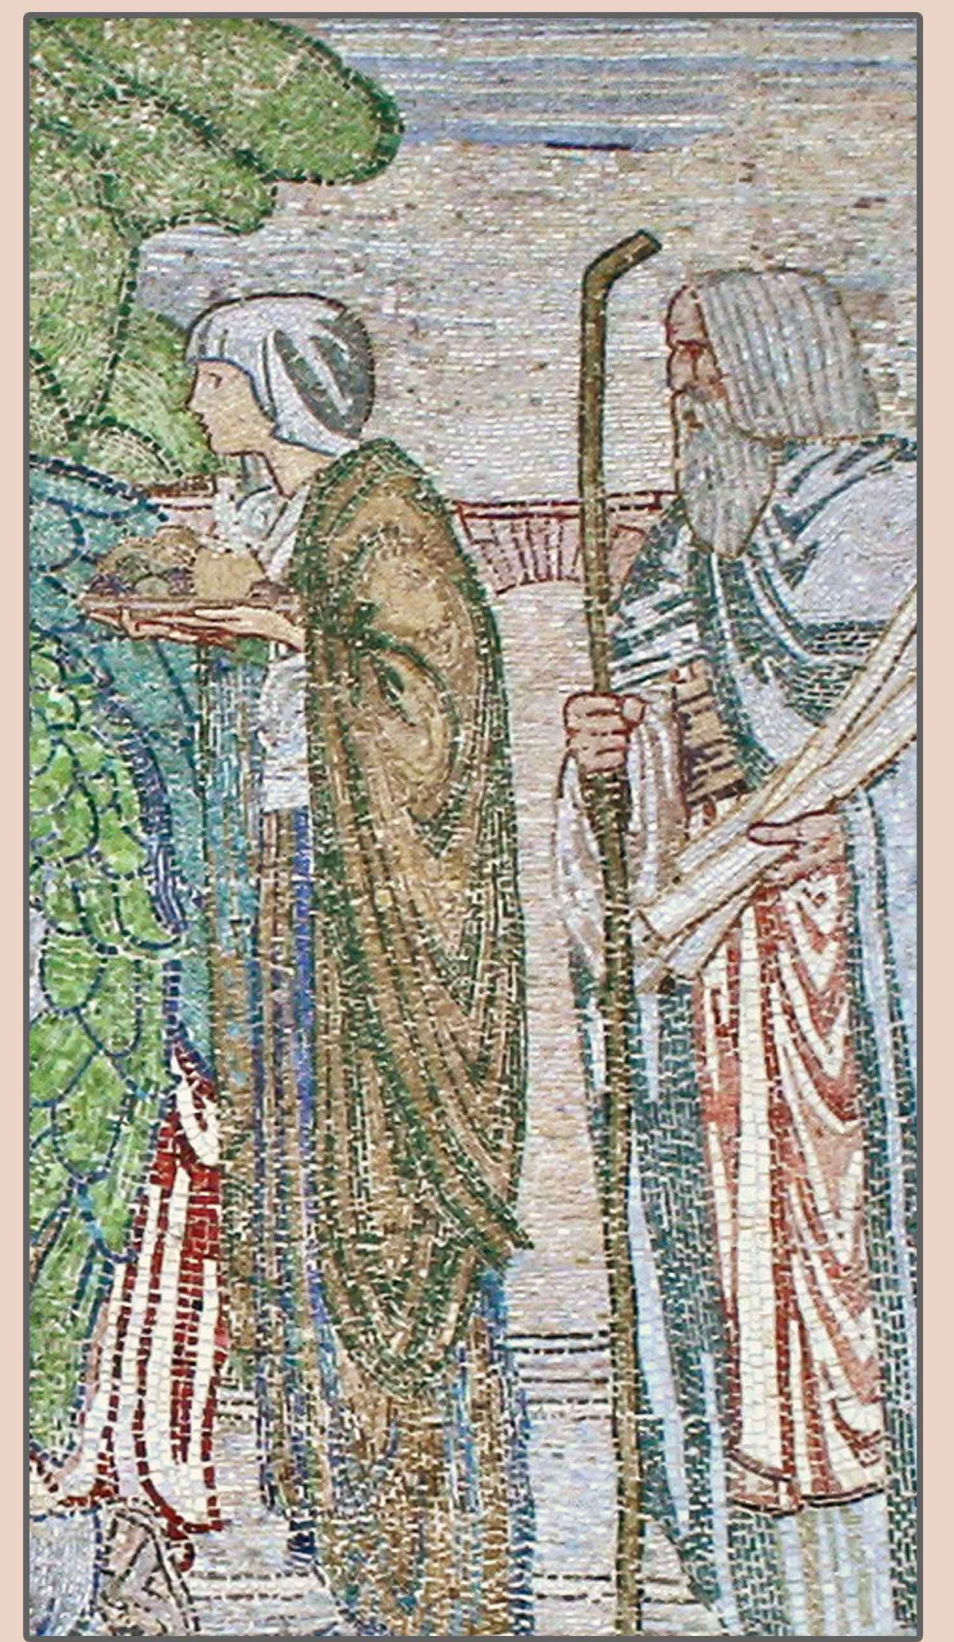
ORIGINALLY THE TESSERAE HAD BEEN FIXED BY PRESSING THEM INTO A MIX CONTAINING LIME AND BOILED LINSEED OIL; THE OIL WAS IN A HIGH PROPORTION, PERHAPS WITH THE INTENTION OF INCREASING WATER RESISTANCE IN DEFENCE OF ITS EXPOSED EXTERIOR SITING.

UNFORTUNATELY, AS THE MUSEUM BUILDING IS MADE OF POROUS STONE, AND MORE PROBABLY OWING TO PERIODS OF ILL-MAINTAINED DRAINAGE, WATER, BUILT UP BEHIND THE PUTTY/OIL MIX AND WAS PREVENTED FROM DISSIPATING BY THE OIL CONTENT. THIS MEANT THAT IN PERIODS OF FREEZING WEATHER, OWING TO ICE CRYSTAL EXPANSION, THE BEDDING BECAME DETACHED FROM THE BUILDING IN PARTS, LOOSENING TESSERAE, AND THREATENING TO FALL IN LARGER SHEETS WITH PUTTY ATTACHED.

A) THE REPAIRS ANCHORED PARTS OF THE MOSAIC, WHICH HAD PREVIOUSLY MOVED THROUGH EXPANSION AND CONTRACTION EVENLY WHEN OF ONE BEDDING, CAUSING TEARS AND RUPTURES TO THE MOSAIC BORDERING THE REPAIRS BY OWING TO THE ABSORPTION OF OIL FROM THE LIME PUTTY; THE REPAIRS HAD FAILED TO ADHERE TO THE RENDER BEHIND, AND WERE HANGING ONTO ENLARGING BLISTERS OF THE ALREADY FAILING ORIGINAL MOSAIC.

IT WAS CLEAR THAT THE ORIGINAL BEDDING HAD FAILED AND THAT REPAIRS ONLY EXACERBATED THE CONDITION AFTER TIME. IT WAS DETERMINED THAT THE BEST COURSE WAS TO TAKE DOWN THE MOSAIC AND RE-FIX INTO A LIME-BASED HOMOGENEOUS MORTAR. THE ORIGINAL RENDER SHOULD BE TAKEN DOWN AND REPLACED WITH A STAINLESS STEEL REINFORCED RENDER, FIXED TO THE BUILDING BY MECHANICAL MEANS. AN EXPANSION JOINT RAN AROUND THE PERIMETER, TO CARRY TO THE FACE.

THE PROPORTIONS OF THE MIX FOR THE SECONDARY RENDER TO RECEIVE THE TESSERAE WERE 2:1:9 IN LIME, PORTLAND CEMENT, AND SHARP WASHED SAND. THE PROPORTIONS FOR THE GROUT WERE 2:1:2 IN LIME, WHITE CEMENT AND SILVER SAND. THE SILVER SAND WAS USED TO STIFFEN THE GROUT AS THE JOINTS BETWEEN THE TESSERAE WERE WIDE.

THE MOSAIC WAS THOROUGHLY CLEANED AND A HEXAGONAL WEAVE COTTON SCRIM WAS ADHERED TO THE SURFACE UTILISING A SPECIAL PVA EMULSION; THEN A REGISTRATION GRID WAS PLACED OVER THE SURFACE. RECORD PHOTOGRAPHS WERE TAKEN BEFORE AND AFTER THE "SCRIMMING."

THE MOSAIC WAS THEN TAKEN DOWN IN MANAGEABLE SECTIONS WHICH WERE RECORDED TO A KEY-PLAN. AFTERWARDS THE BACKS OF THE TESSERAE WERE CLEANED AND TREATED TO REMOVE OIL RESIDUE AND THUS PROMOTE GOOD ADHESION FOR THE RE-FIX.
