## DOCUMENTATION AND PROJECT OF PRESENTATION OF BLACK&WHITE MOSAIC FROM ROMAN VILLA RUSTICA NEAR MOŠNJE (SLOVENIA)

Judita Lux\*, Sabina Kramar\*\*, Manlio Titomanlio\*\*\*, Asparuh Mihailov\*\*  
\* Institute for the Protection of Cultural Heritage of Slovenia, Preventive Archaeology department, Regional Office Kranj, Tomšičeva 7, 4000 Kranj, Slovenia  
\*\* Institute for the Protection of Cultural Heritage of Slovenia, Restoration Centre, Poljanska 40, 1000 Ljubljana, Slovenia  
\*\*\* private restorer, Via Posillipo 203, Naples, Italy

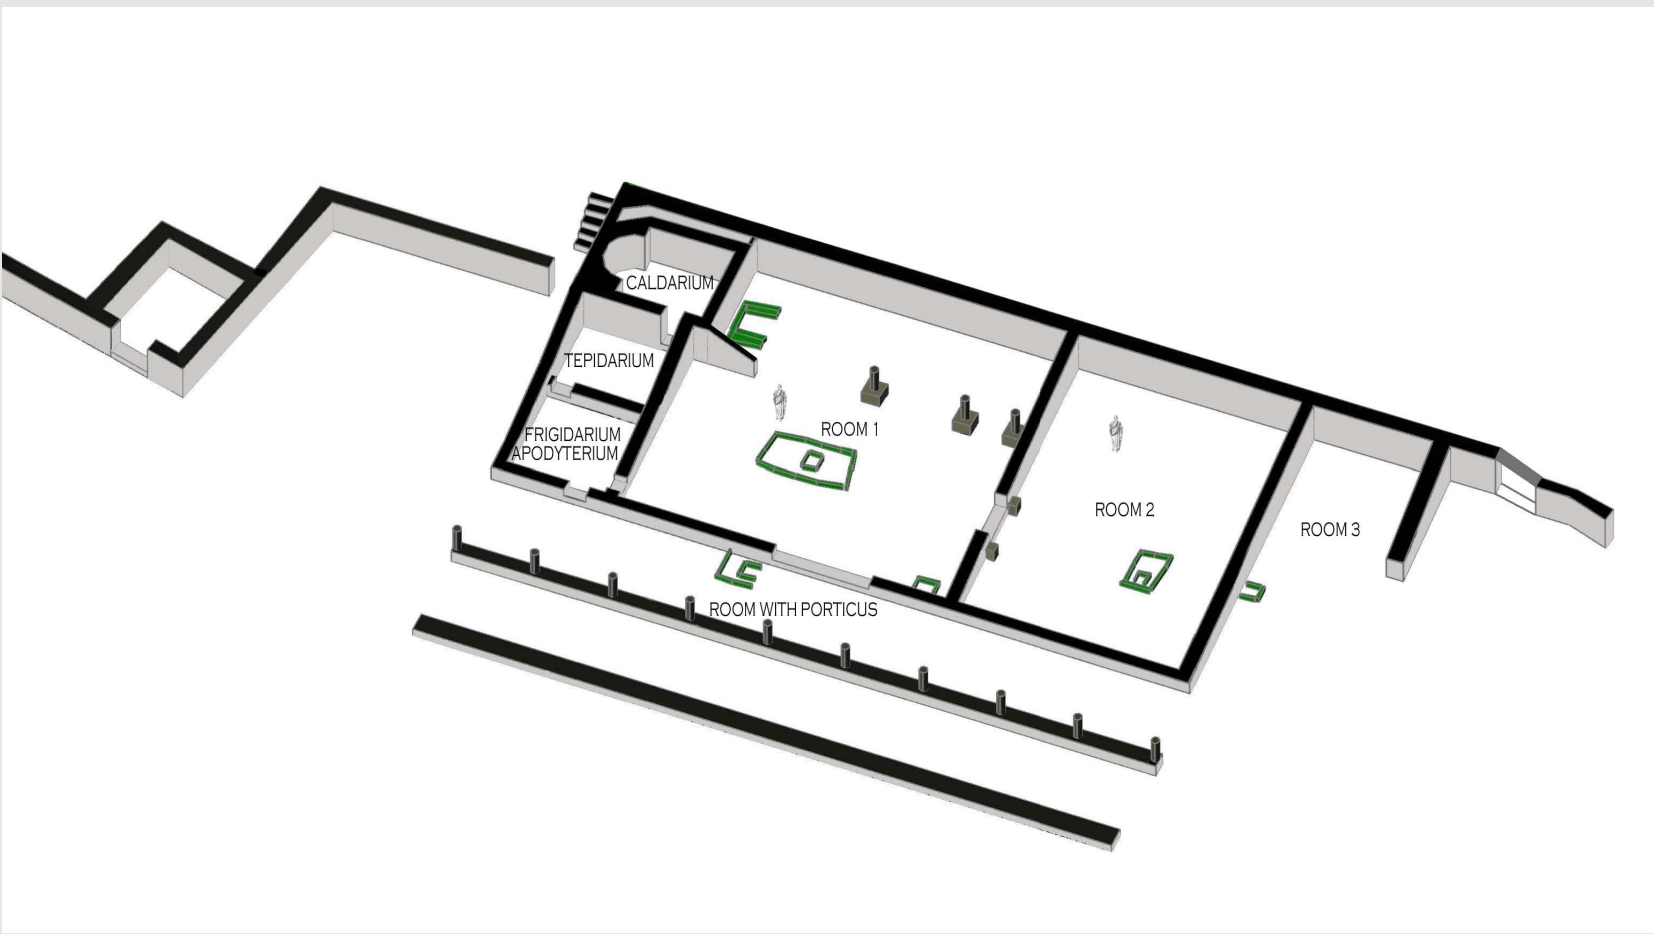
Mosaic was found in caldarium (part of balneum) in the object 2.

Mosaic found in the rubble layer of caldarium was completely destroyed, when the hypocaust collapsed. Only some pieces of mosaic are relatively large (around  $0.50 \times 0.50$  m), while about 400 fragments are of smaller dimensions (size from  $2 \times 2$  cm to  $40 \times 40$  cm). In addition, high quantities of tesserae were found. Fragments of mosaic were in the rubble layer without any significant order. The documentation of fragments is based on use of total station combined with photography.

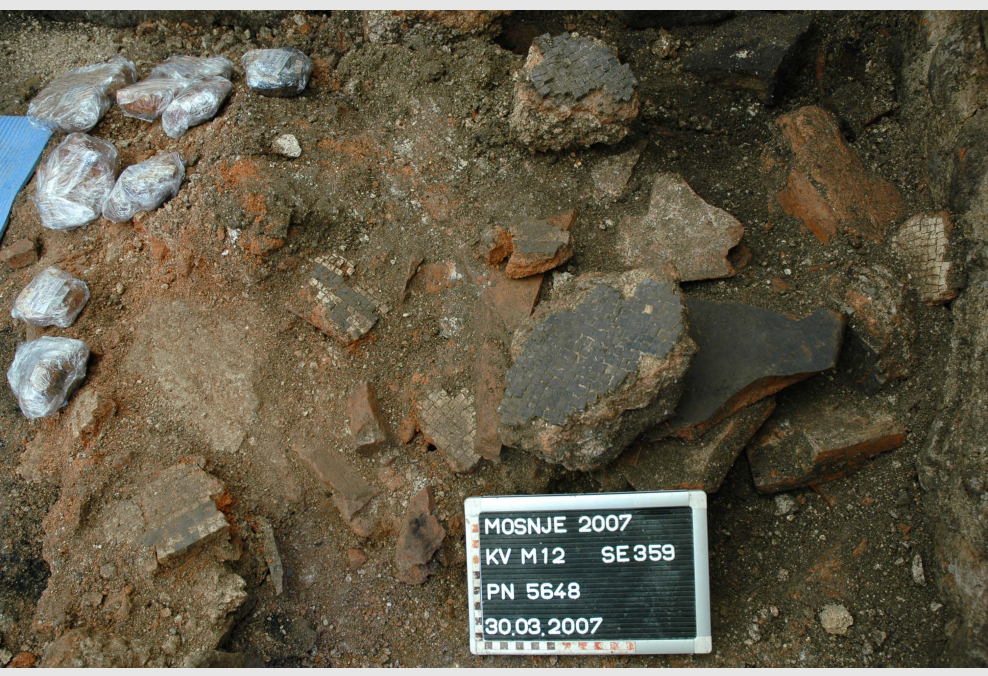
The mineralogical-petrographic investigation revealed that black and white tesserae were made of limestone; the black tesserae are made of laminated micritic limestone containing quartz grains and fossil radiolaria, whereas the white tesserae are made of bioparite limestone containing numerous fossil foraminifera. Aggregate of mortar layers consisted of local fluvioglacial deposits with predominant carbonate grains and addition of crushed brick. Brick powder into a mortar mixture conducted a pozzolanic reaction with lime and water. The floor mosaic discovered in the caldarium consists of several layers, which we marked with letters and analysed independently:

a – tessellatum with white and black mosaic cubes  $1 \times 1 \times 0.5$  cm in size and lime mortar filling the space between them. The black cubes are made of laminated micritic limestone containing quartz grains and fossil radiolaria. The white cubes are made of bioparite limestone containing numerous fossil foraminifera.

b – the bedding layer is 1–2 mm thick. It consists of lime binder, lime aggregate and individual quartz grains. The fragments range from 0.06 to 0.39 mm in size. This mortar was also present between the mosaic cubes;

c – nucleus is 1.5 cm thick. Grains of ground brick predominate, i.e. the grains are sharp edged. The fine fraction of the aggregate is mainly represented by brick powder. Aggregate represent also rounded limestone grains and individual grains of quartz (monocrystalline and polycrystalline). The grains are medium sorted, and the binder is not cracked. In addition, individual clumps of lime are present. The individual areas with brick powder are very compact. The grains are between 0.05 to 6 mm in size, averaging about 2–3 mm. Porosity: 49.72 %, average pore diameter 66.4 nm, specific surface area:  $51.14 \pm 0.20$  m<sup>2</sup>/g

d – rudus. The exact thickness of this layer is hard to determine as the mosaic was discovered in a layer of ruins. The thickness of the preserved layer is  $> 5$  cm. The aggregate is poorly sorted, the grains are large, ranging from 0.13 to 2.5 cm. The ratio of carbonate component to crushed brick is about 1 to 1. The carbonate component is represented by limestone and dolomite. Individual grains of magmatic rocks appear in places. The binder is lime and is a little cracked. A fine brick fraction is not present in this layer. Porosity: 41.76 %, average pore diameter 71.0 nm, specific surface area:  $17.82 \pm 0.09$  m<sup>2</sup>/g

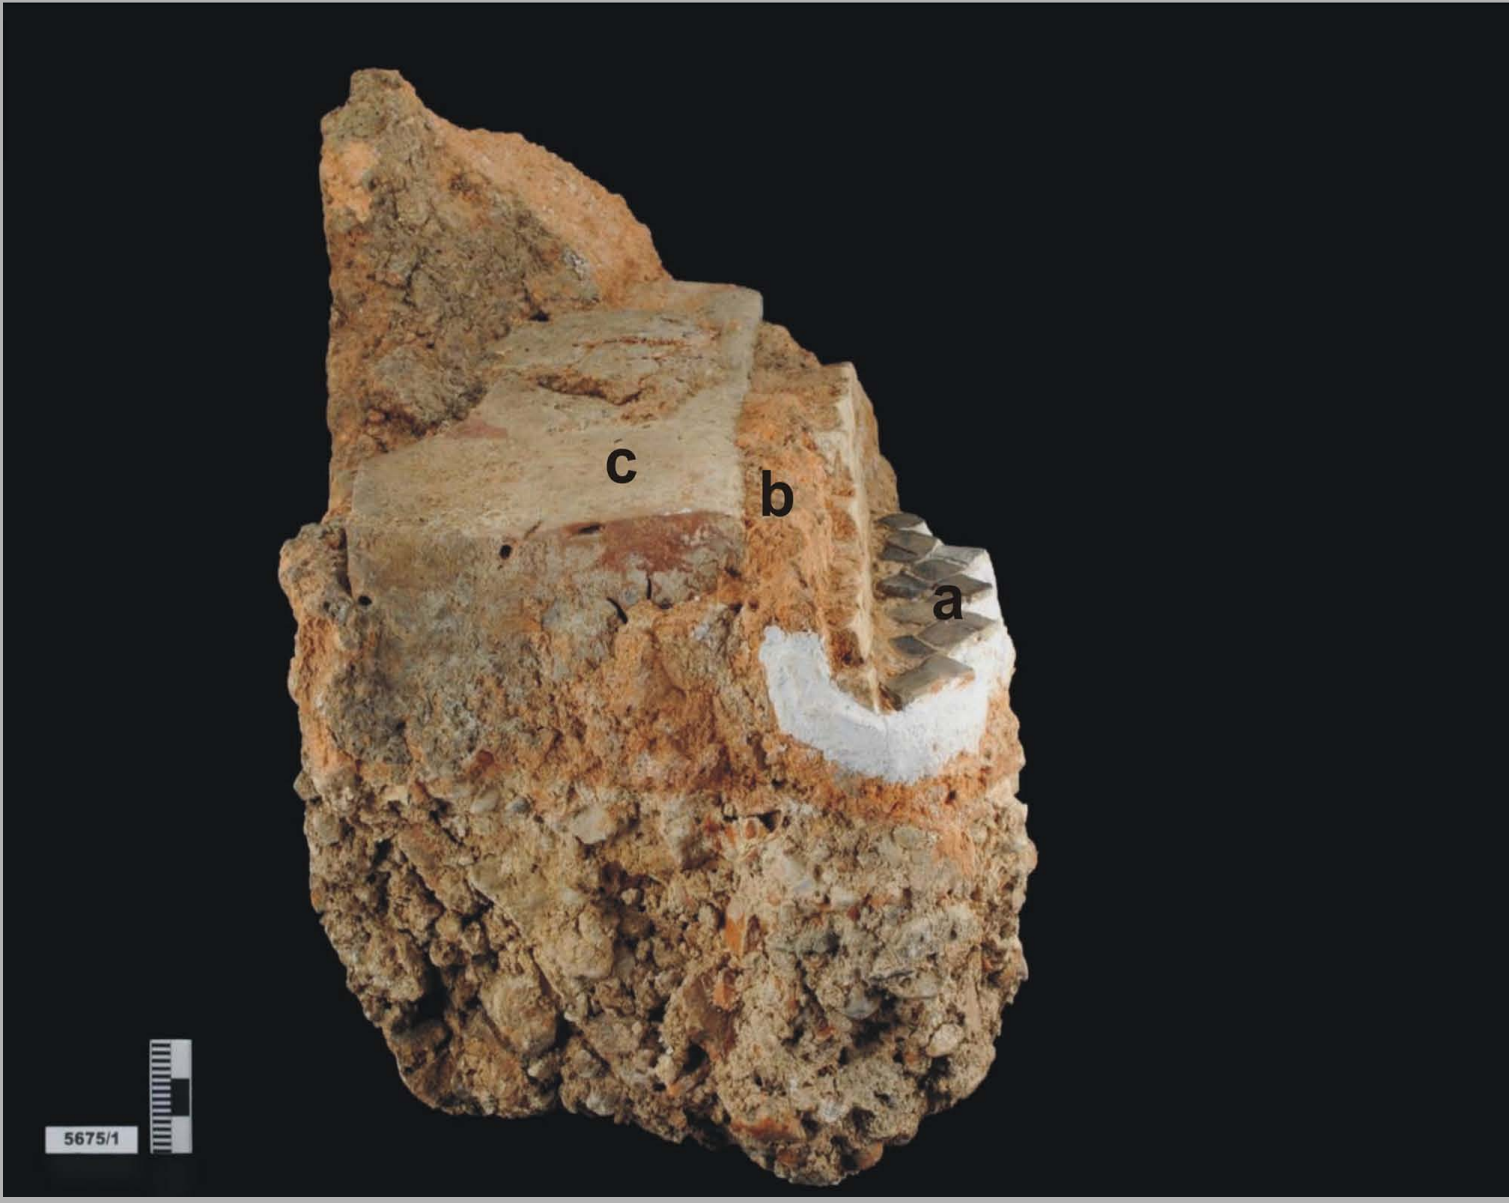
The presentation proposed aims to ensure an adequate preservation of some parts of the mosaic floor from the archaeological site near Mošnje. Starting points for decision how the fragments would be presented to the public were the respect for the original materials (different layers of mortar) and the reversibility of choices. We have decided for the solution in which fragments are put on the supports that are in shape of the mortar of each mosaic fragment and assembled in a way to give the same height to all fragments. Advantage of this solution is also the possibility to change the location of the fragments on the ground of new reconstruction of the mosaic. Smaller fragments that were wrapped on the excavation site well tolerated transfer to the restoration workshop, while larger fragments were somewhat damaged. Fragments of the mosaic were only partially consolidated and are now prepared for further process but not appropriate for public presentation.

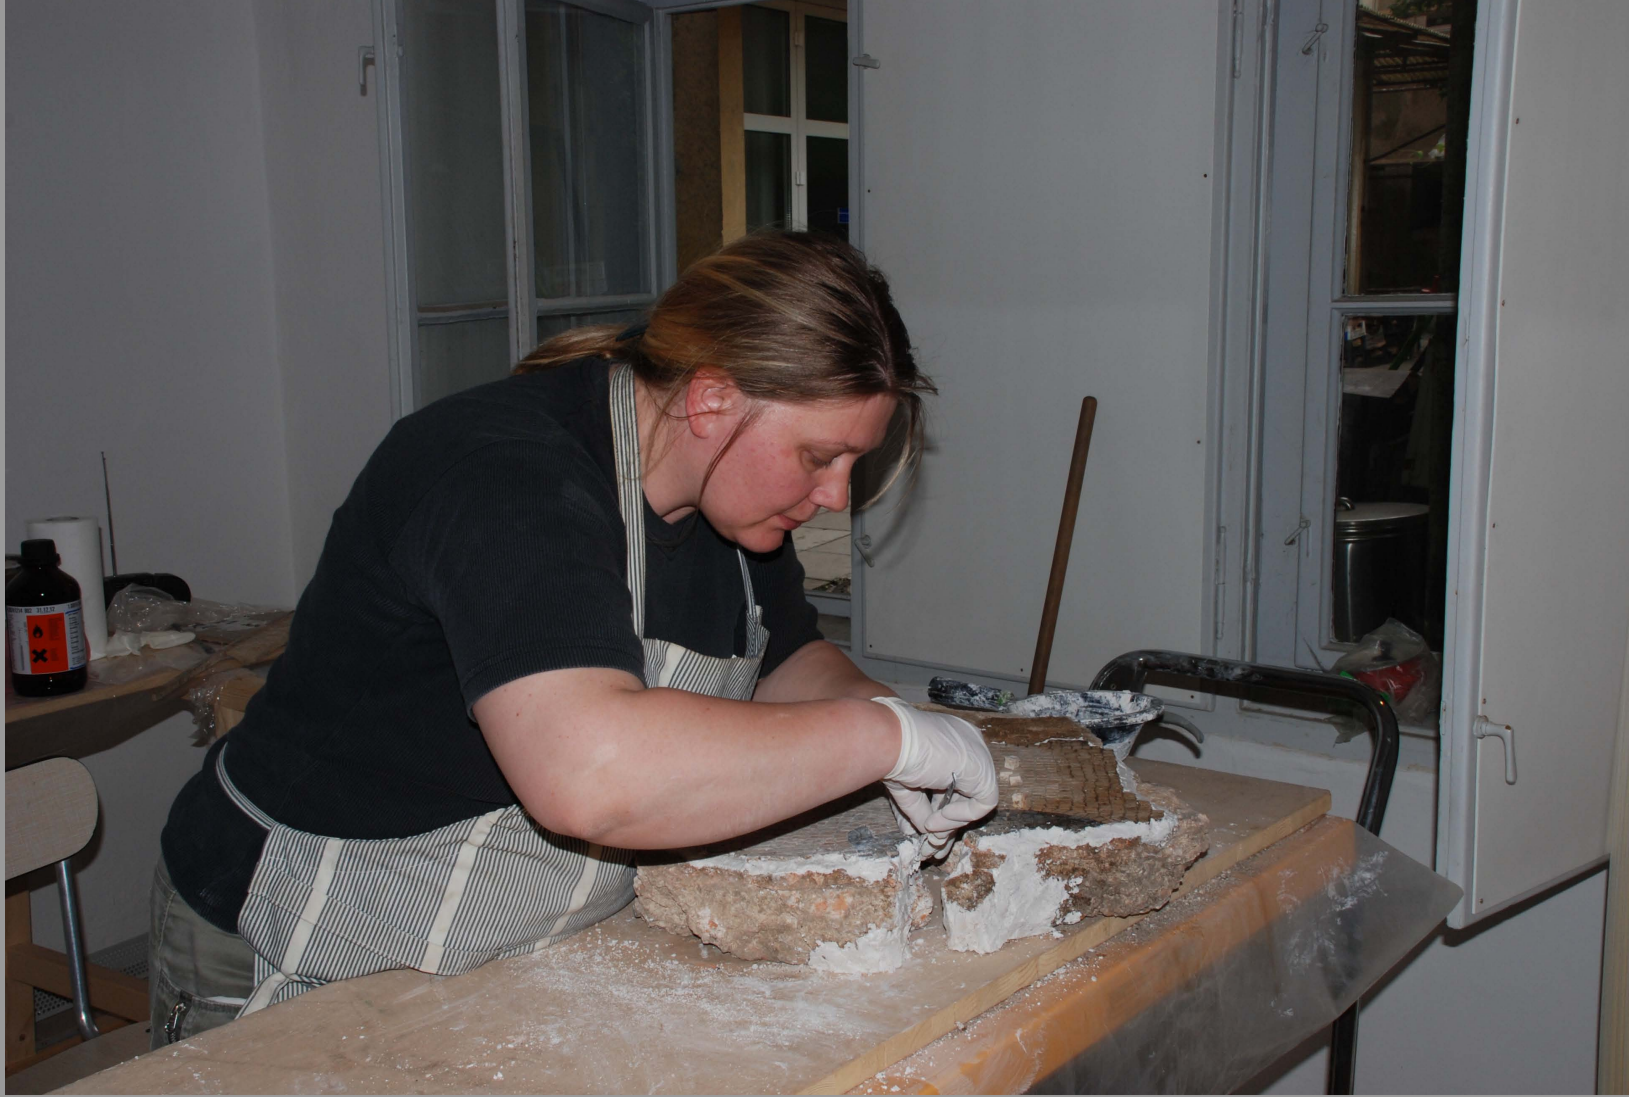
The particular conditions in which the fragments in our possession have been preserved make the anchorage operations on new supports very complex. One of the main technical difficulties is the adjustment of the height of single mosaic fragments. Since all the mosaic fragments have significant differences in thickness of the preparatory layers, they cannot always be treated with conventional methods. So it is necessary to create a system specifically suited to the situation through the creation of a support capable to give the mosaic surface a coplanar structure and, at the same time, ensure a secure grip on the new support.

In this particular case, the designed methodology involves the installation of small magnets in the rudus of the mosaic. With this solution is possible to anchor the various portions of floor on the new supports.

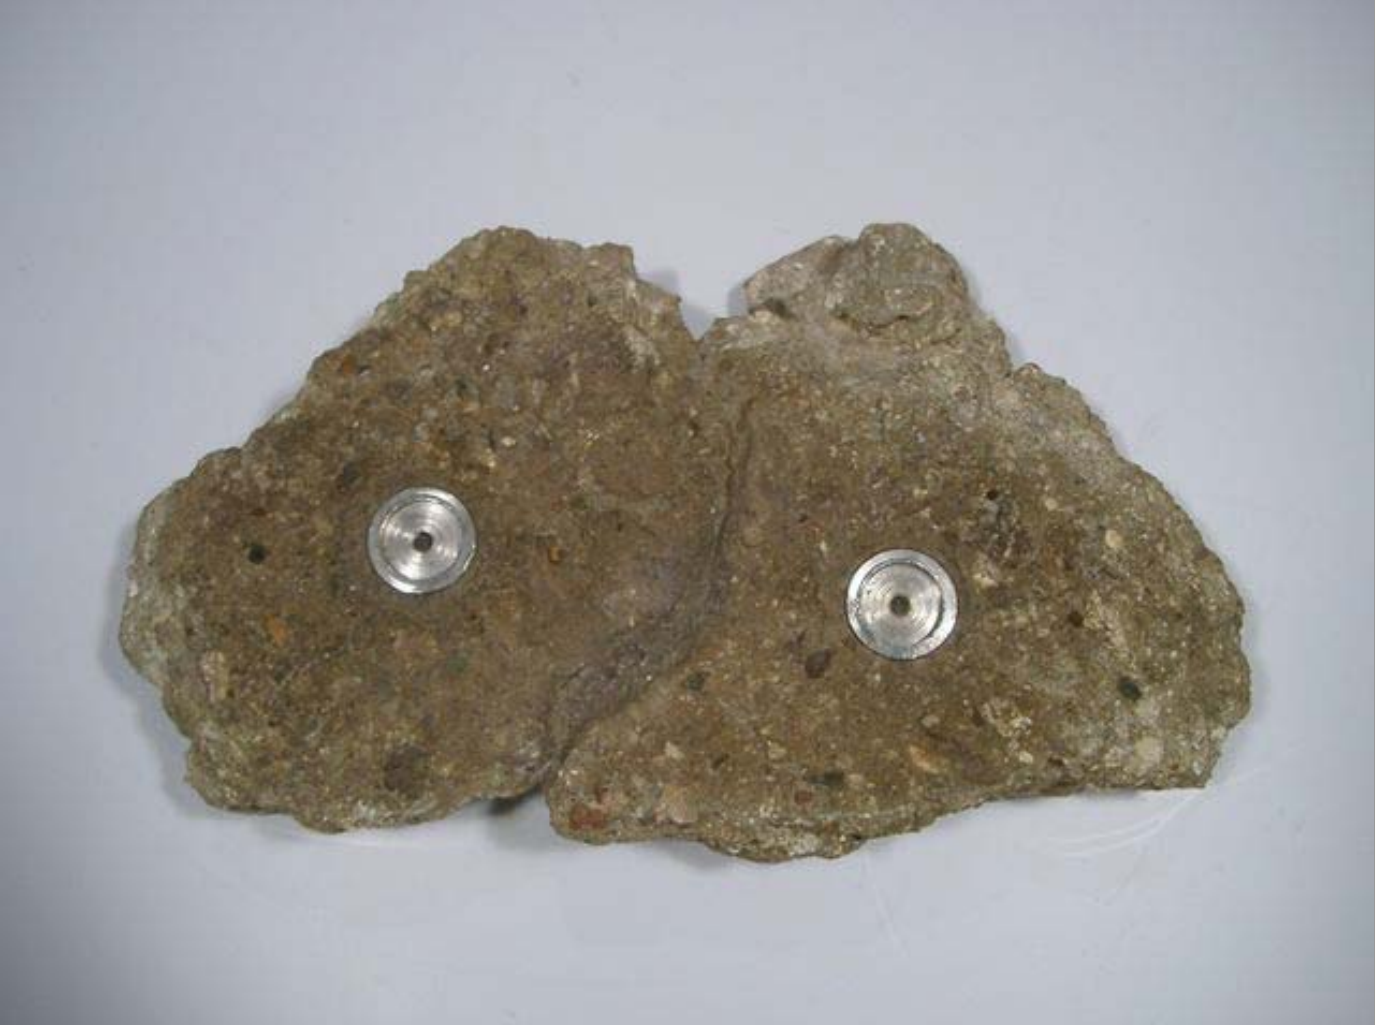
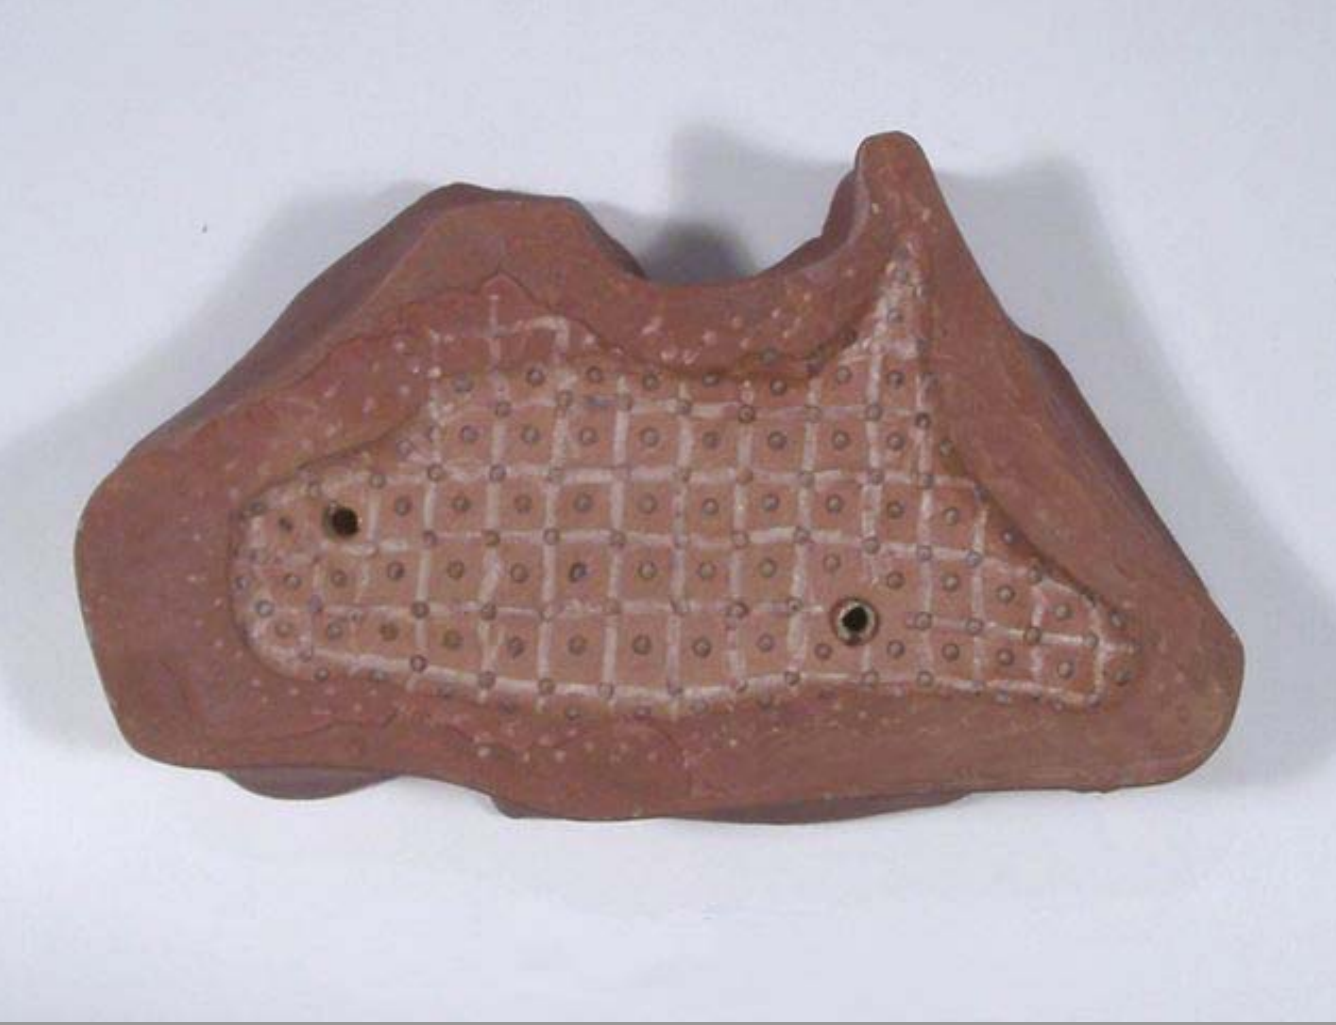
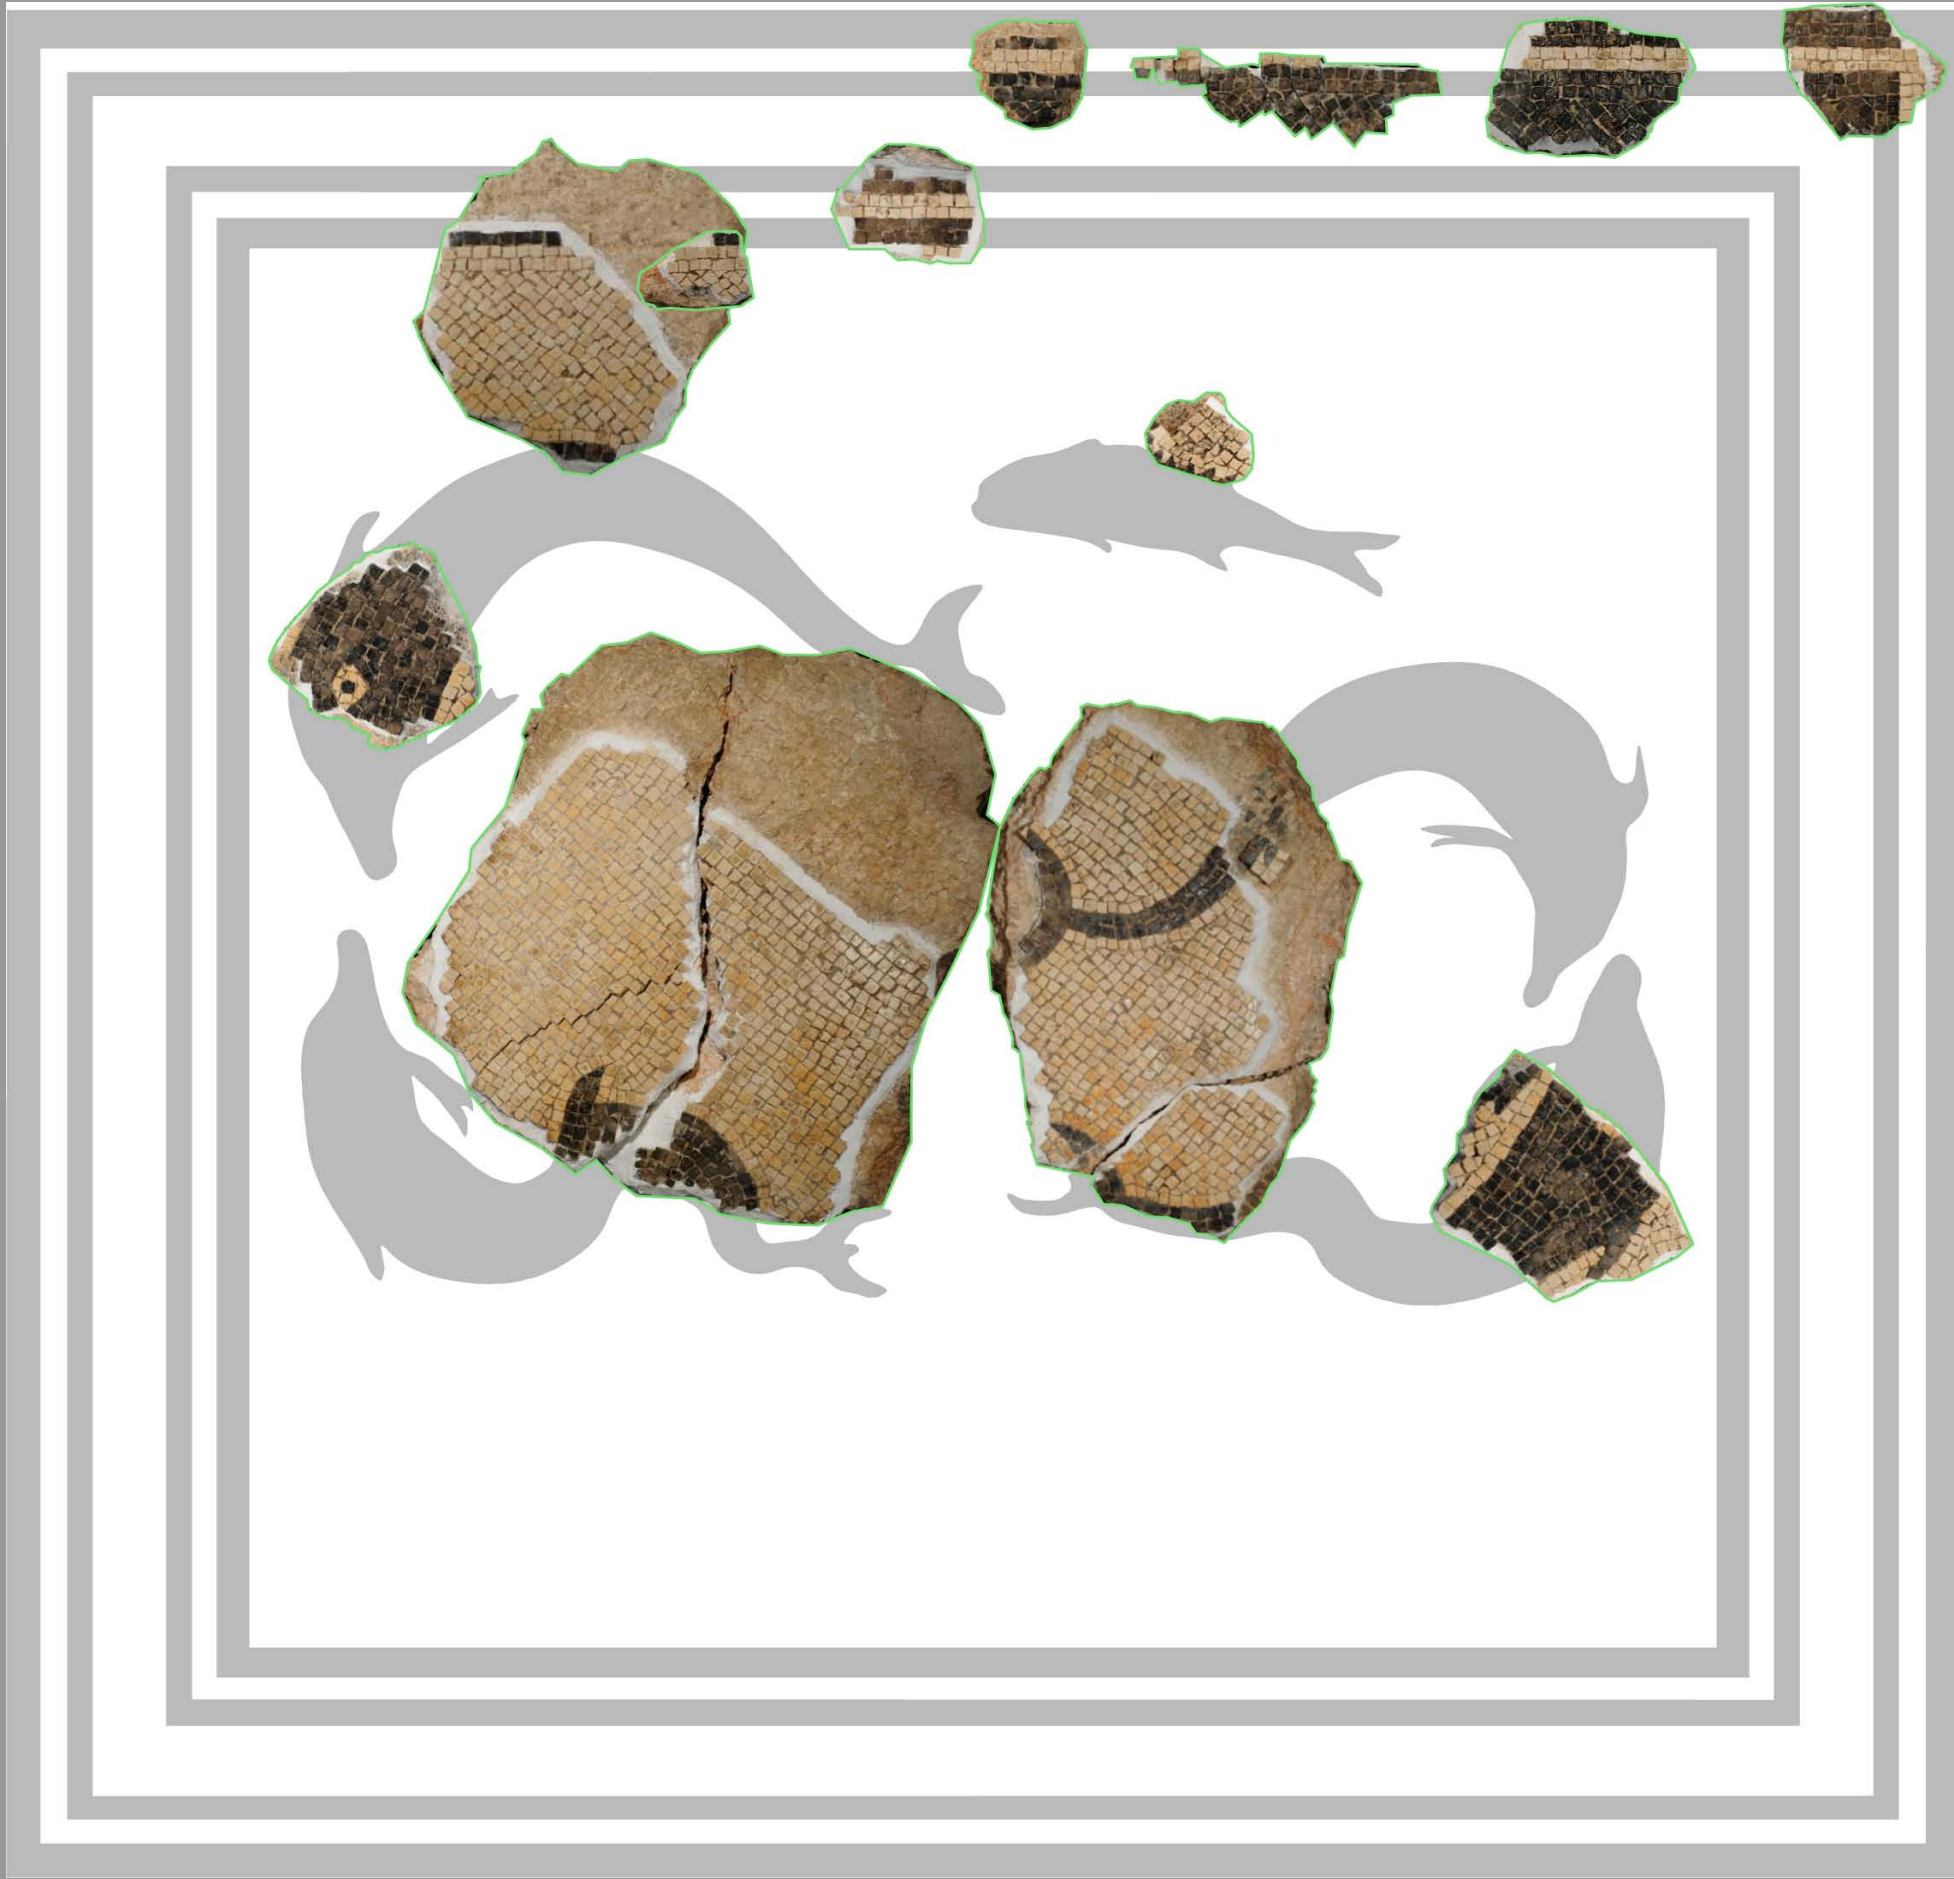
Restoration project-proposal  
On the one hand, the primary requirement of restoration is to preserve all ancient materials through operations targeted to inhibit all the degradations, on the other hand, final presentation of the mosaic has to be compatible with the data collected during preliminary studies. For the anchorage on new support, has been taken into account the positive results of the restoration adopted for the mosaic fragments preserved in the Provincial Archaeological Museum of Western Lucania in the city of Padula, Italy.

The work will consist of at least 4 stages:  
1. Cleaning of the surfaces of the pieces.  
2. Pasting of the detached parts.  
3. Consolidation of the mortars subject to the disintegration.  
4. Anchoring on new support and final presentation.

For this purpose we will use synthetic substrates made with a system based on epoxy Araldit SV427 and hardener HV 427. This product, as in the case of the mosaics of Padula, is particularly suitable for this type of intervention because it has a high dimensional stability and good mechanical strength, and allows easy processing even after hardening as well.
