The Conservation *in situ* of Mosaics on
Archaeological Sites

Proceedings of the VIth
International Conference of the
International Committee for
the Conservation of Mosaics

Proceedings of the VIth Conference
of the International Committee for the Conservation of Mosaics
Nicosia, Cyprus, 1996

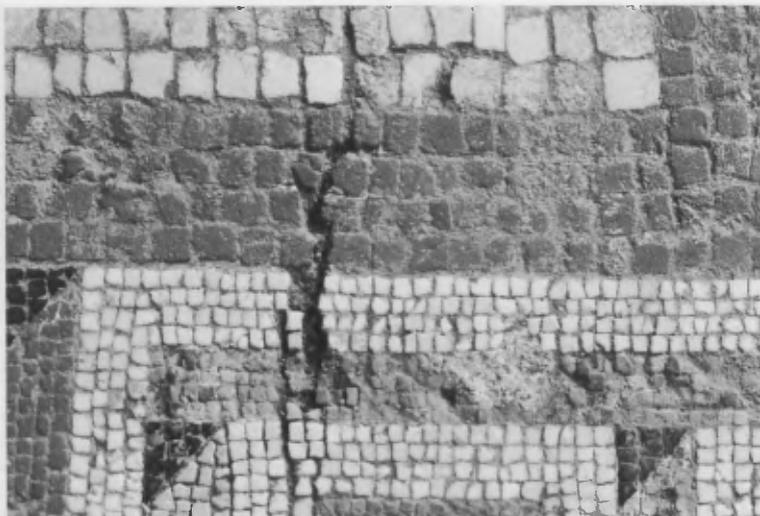
Fig. 3: *Andron* of the Hellenistic building. Detail of the band with the three-dimensional meander with a fissure.

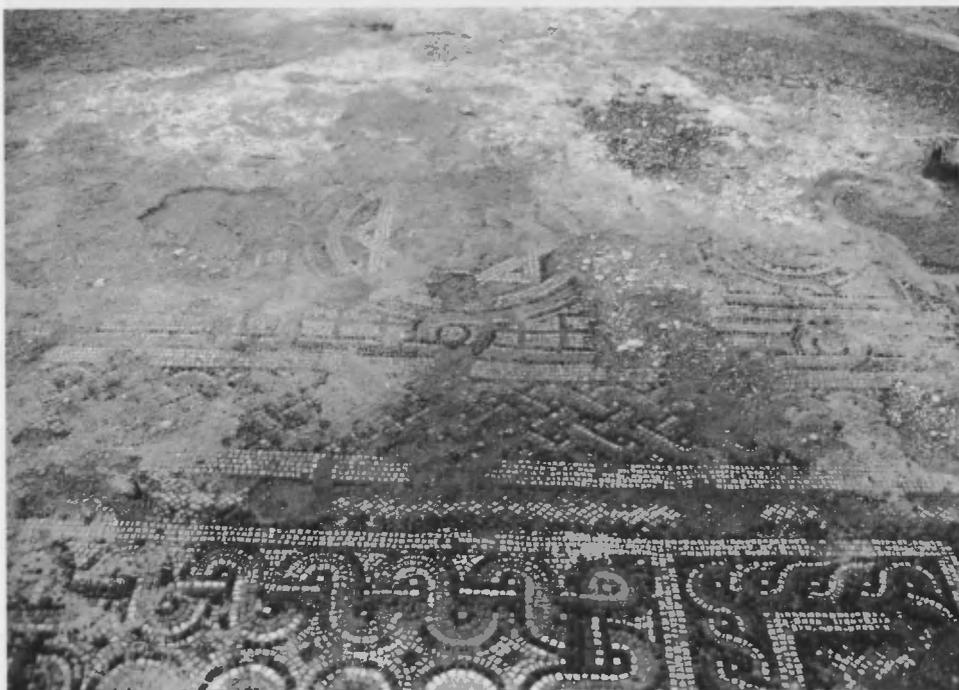
Fig. 4: Detail of the mosaic of the central nave of the basilica at *Tria Dontia*. Crusts on the surface of the tesserae.

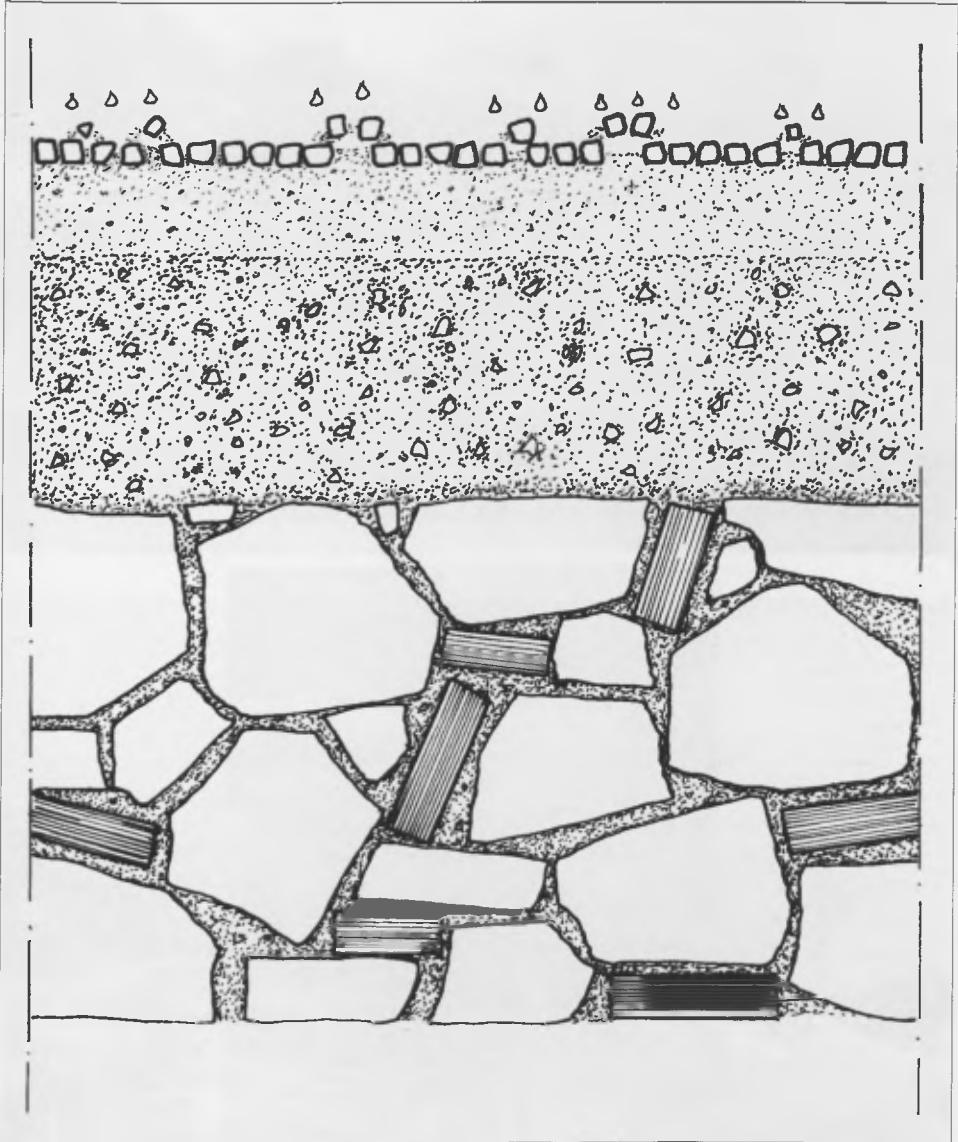
Fig. 1: Philippes. Le substrat de la mosaïque et le décollement des tesselles.

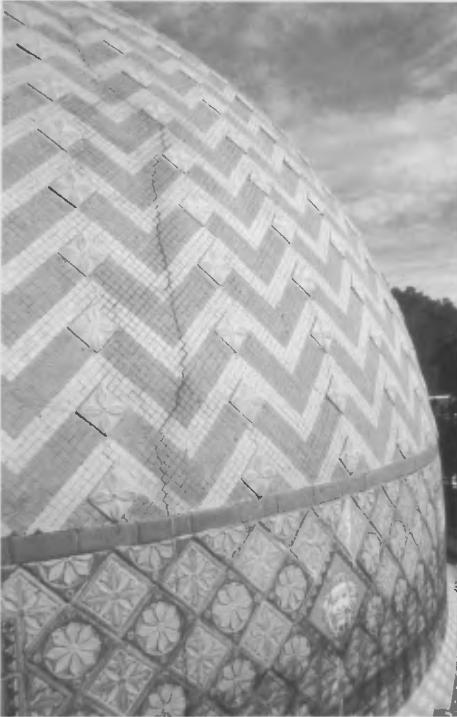
Fig. 1: A section of the Quapaw Dome with a through vertical crack (photo by Jake Barrow).

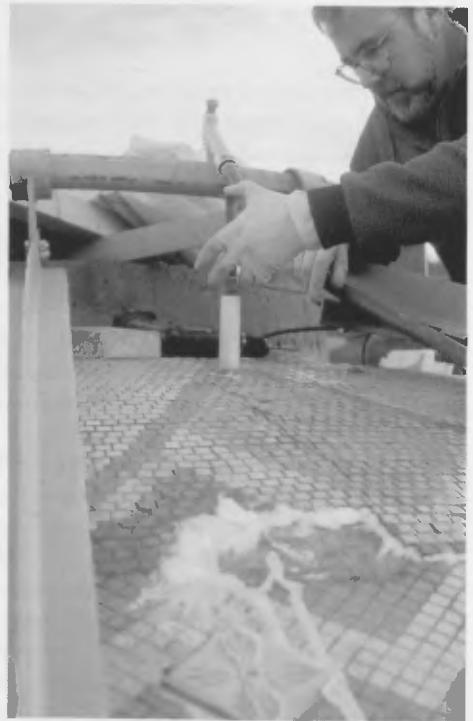
Fig. 2: Injection grouting to re-adhere delaminated surface (photo by Anne Oliver).

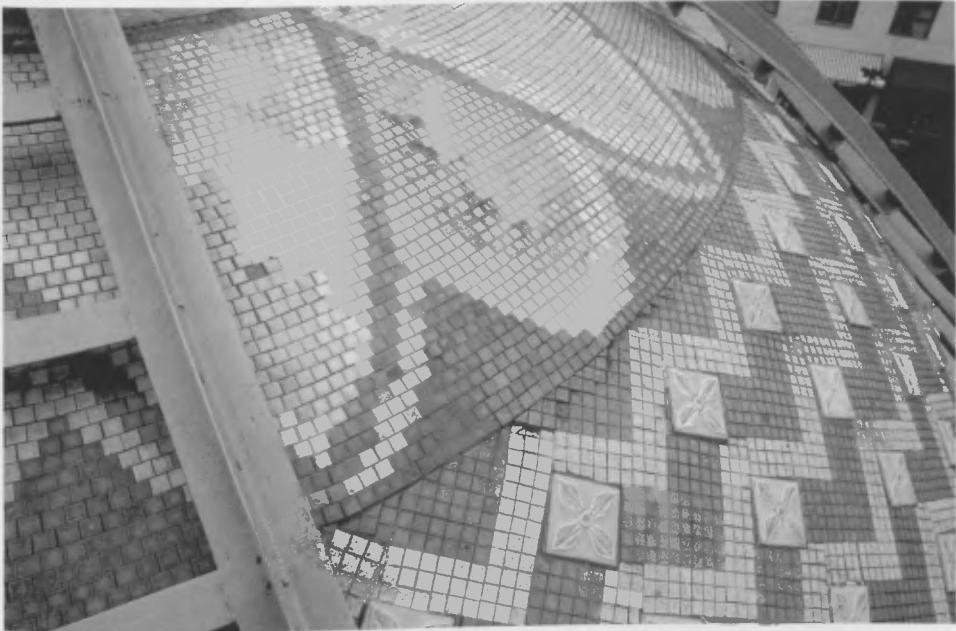
Fig. 4: Close-up view of mosaic surface after repair (photo by Bob Hartzler).

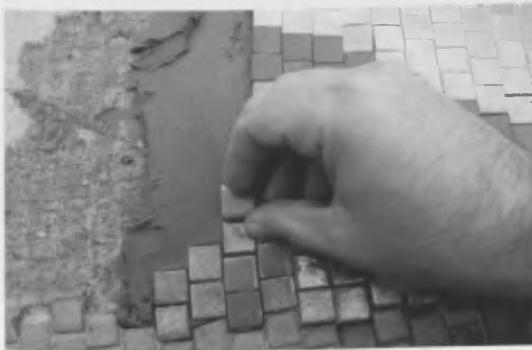
Fig. 5: Piece-by-piece restoration of lost tesserae (photo by Bob Hartzler).

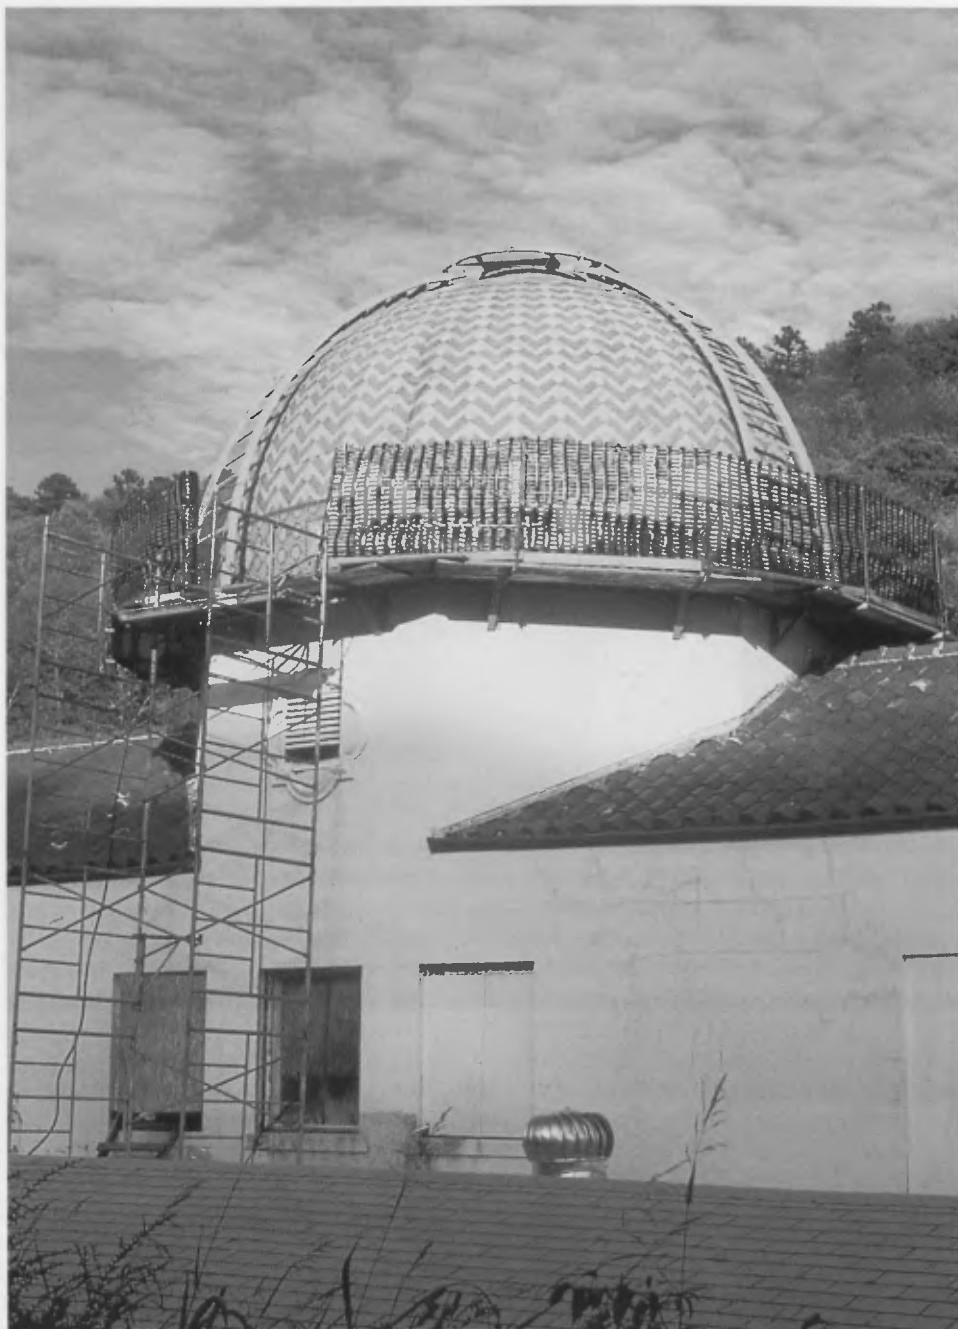
Fig. 6: View of dome with rotating scaffolding in place (photo by Jake Barrow).

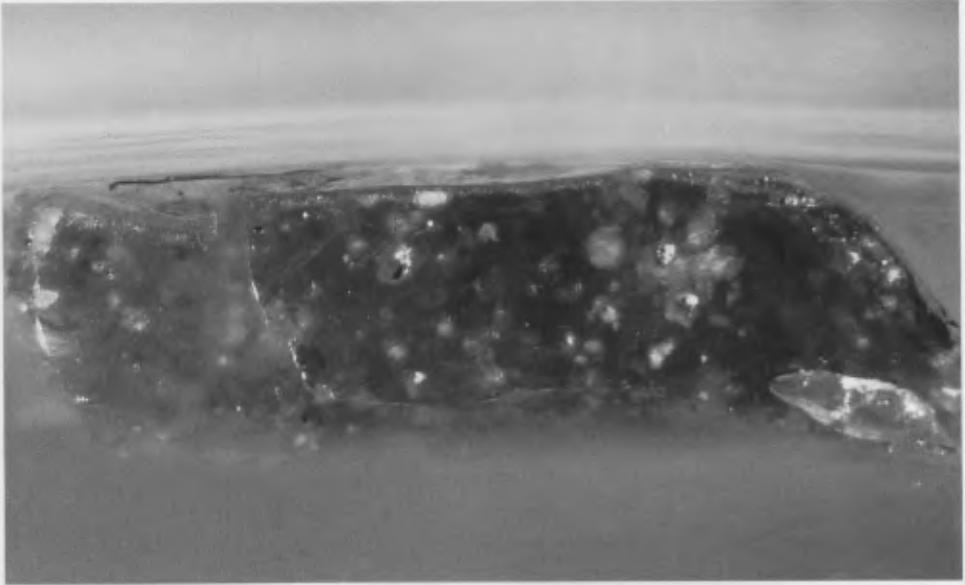
Fig. 3: Close-up of glass tessera cross-section showing the glass' heterogeneity and porosity. Because of its composition and high heterogeneity, this glass is very vulnerable and prone to corrosion.

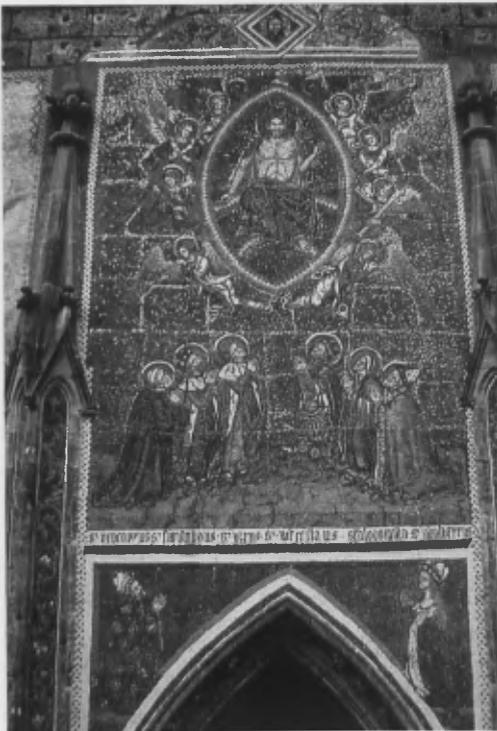
Fig. 4: Last Judgement mosaic. Central panel after cleaning, before re-gilding. The gold leaf, added in 1910 when the mosaic sections were repositioned, has maintained its gilded appearance. The resulting optical effect is of a gilded grid on a darker background, particularly evident in the central panel.

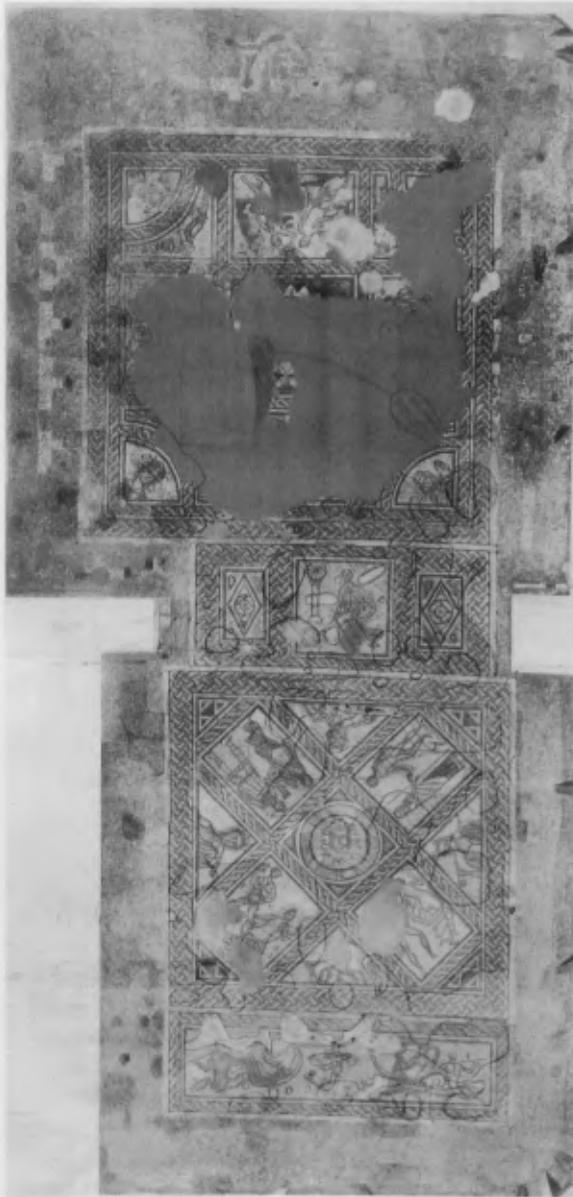
Fig. 3: Condition survey of the Brading Roman Villa overlaid onto a black and white photomosaic. The survey shows areas of detachment outlined in red, and the areas of algal growth in green. Photogrammetric survey by English Heritage, Condition Survey by Carol Edwards, Southern Archaeology, Chichester, West Sussex.

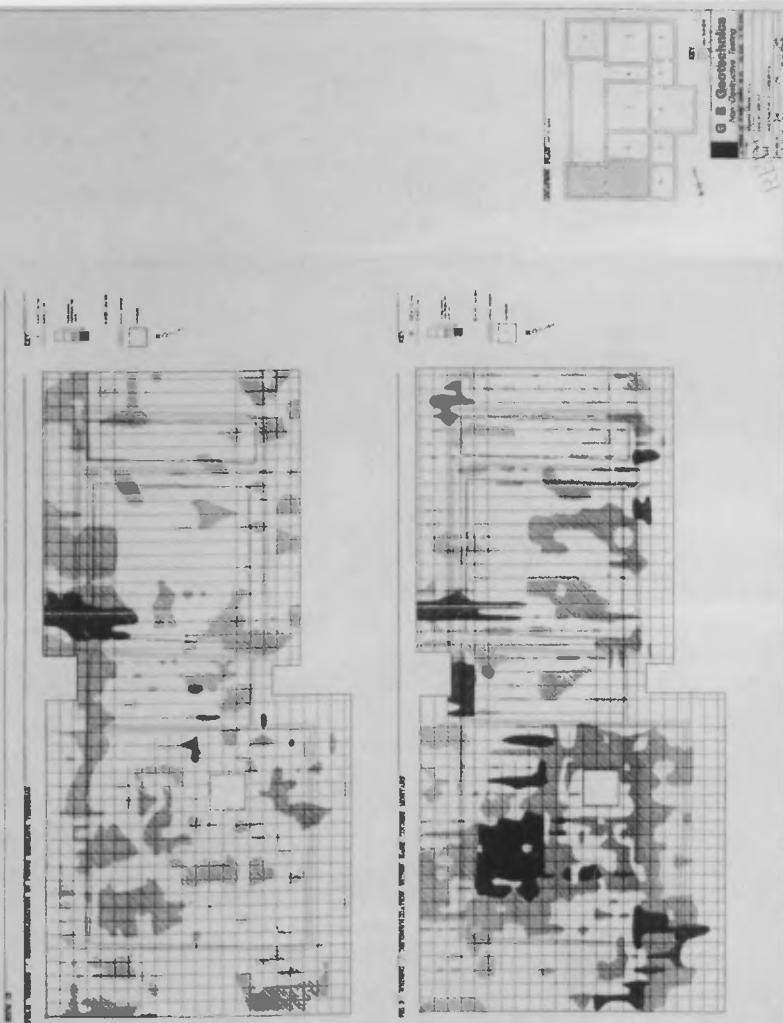
Fig. 4: Radar survey of Room 12, Brading Roman Villa. Two levels of depth are shown: in the upper image the delamination between the tesserae and the bedding is shown, and in the lower image, the areas of weakness in the foundation layers; the darker areas are those of greatest voiding. Survey by Geotechnics, Cambridge, UK.

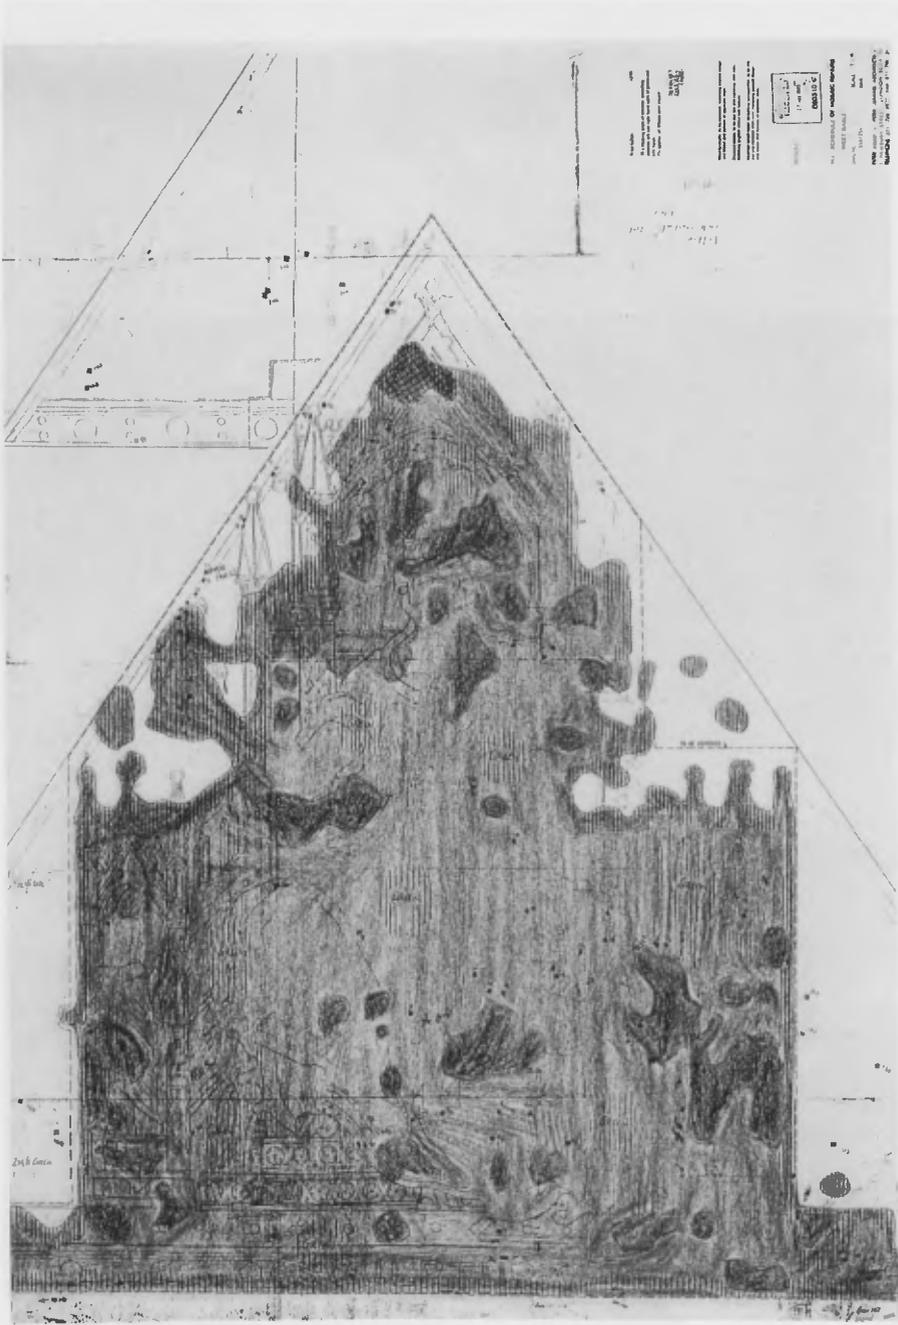
Fig. 7: Graphic documentation of the mosaics on the north gable showing three levels of detachment: green — slight detachment, blue — moderate detachment, red — severe detachment.

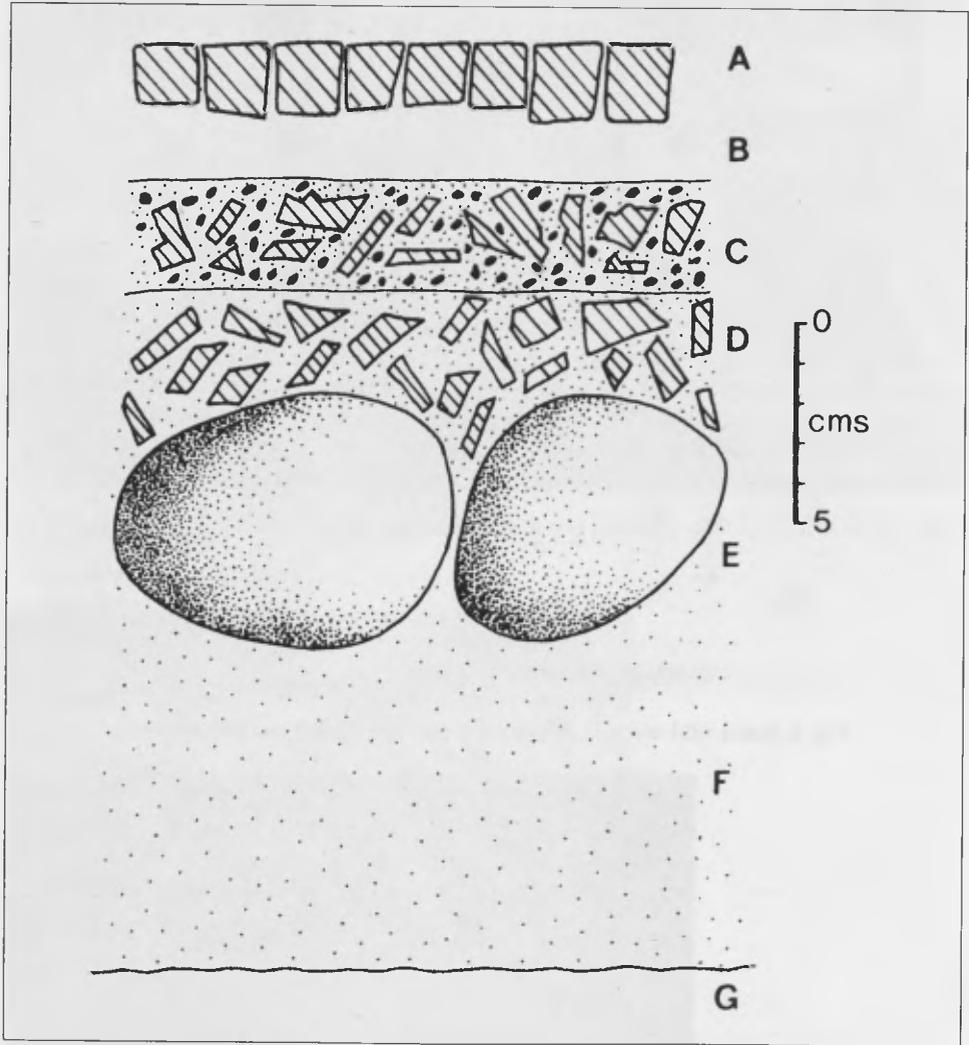
Fig. 5: Section drawing of bedding of mosaic pavement in the nave of church (by S. Chlouveraki).

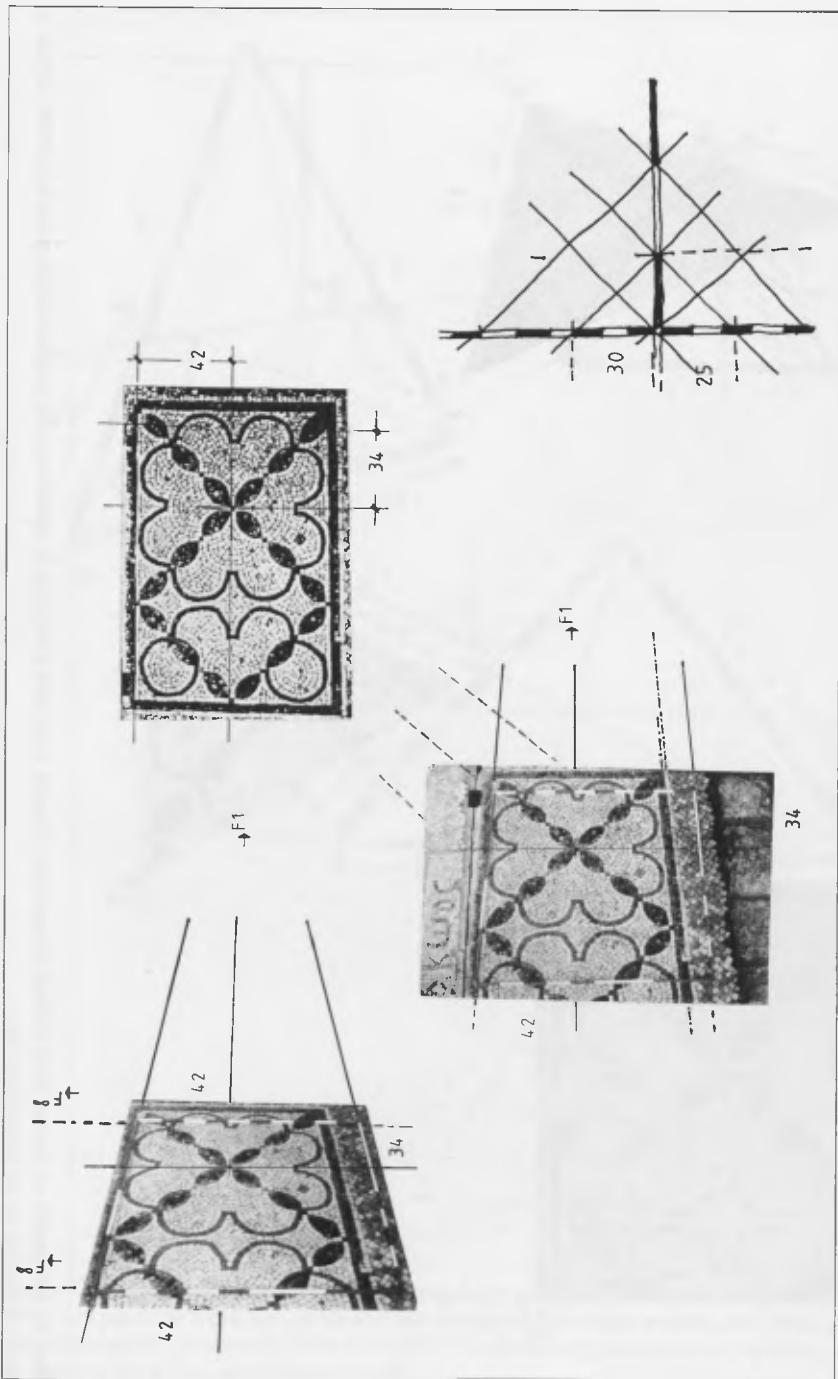
Fig. 2 : Image esquissée dans le plan vertical. Les mesures des points projetés sur les tiges verticales sont vérifiées à travers l'intersection entre les tiges et les alignements vers le point de fuite F1; les mesures projetées sur les tiges horizontales se lisent en utilisant des alignements depuis le point de fuite jusqu'à l'infini. Dans le cas d'une image dans le plan incliné, les projections seront faites depuis les deux points de fuite. L'expansibilité du système se fonde sur la construction de nouvelles grilles (carrées ou rectangulaires), en partant de la base de la grille matérialisée par les côtés du grillage de base.

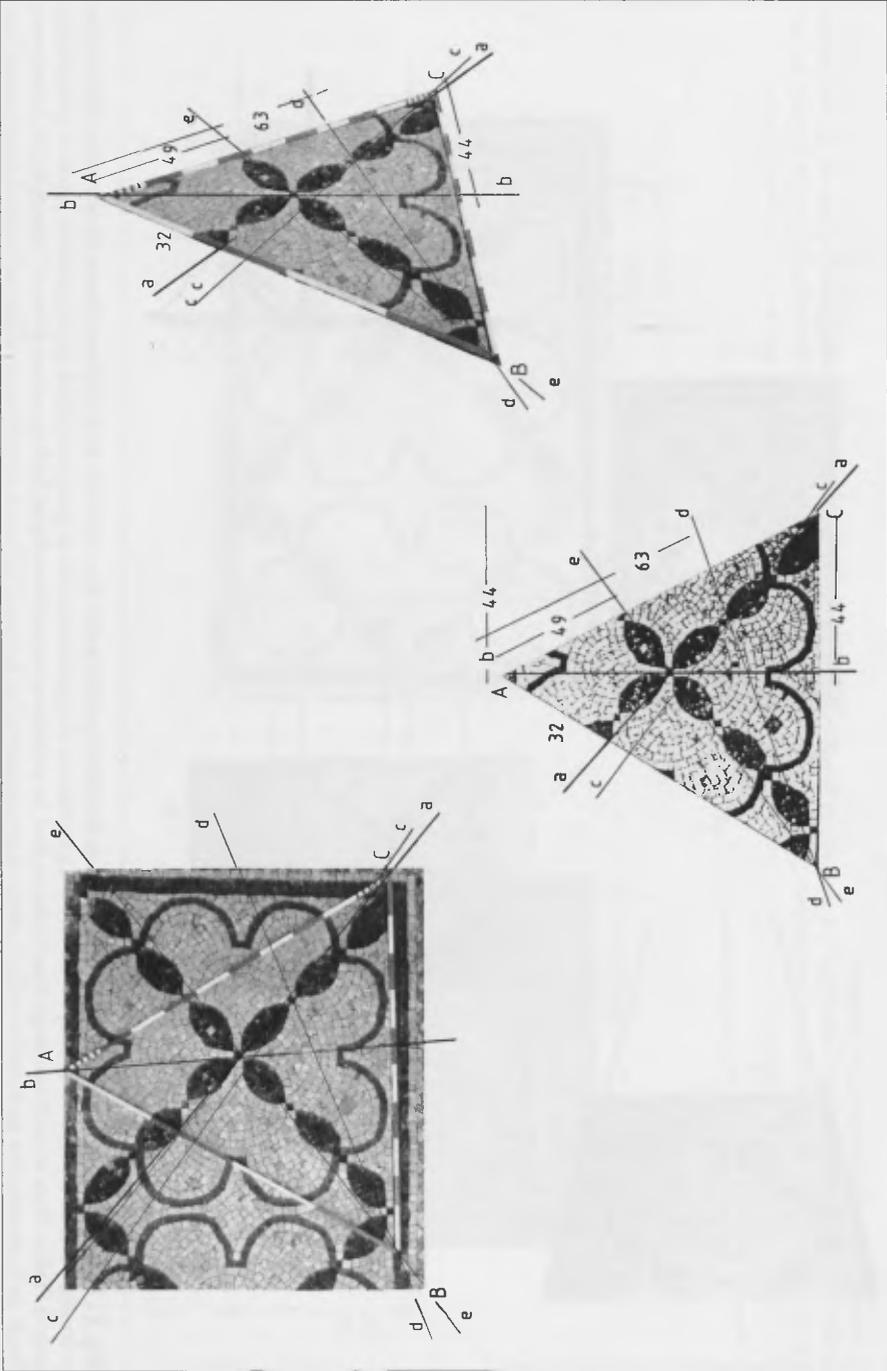
Fig. 3 : Restitution en partant d'un grillage triangulaire. Chaque point sera donné par le croisement des projections du point lui-même, depuis le sommet opposé sur les côtés du grillage.

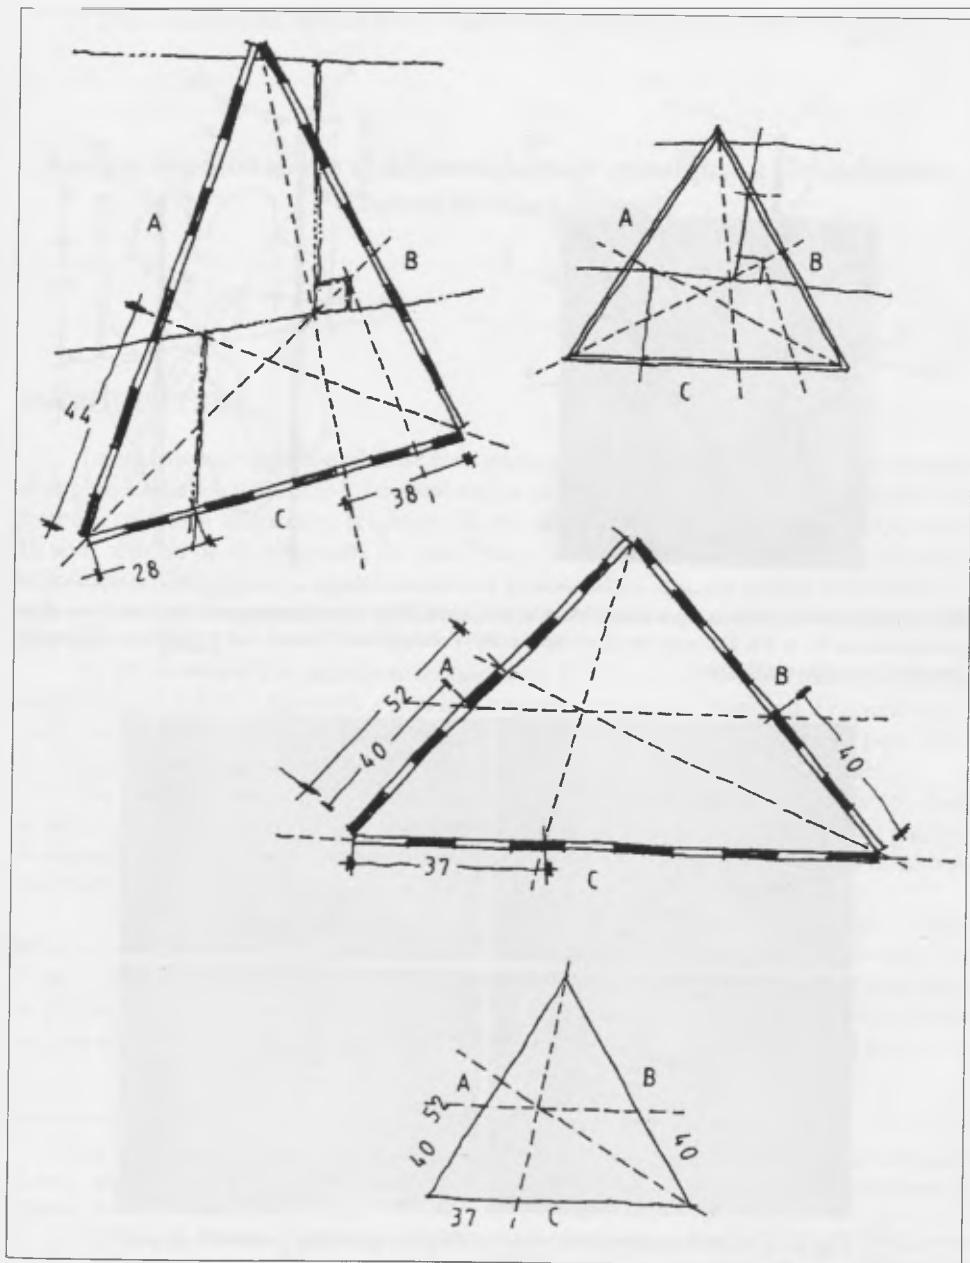
Fig. 4 : Restitution en partant d'un grillage triangulaire: une grille placée dans une position quelconque, l'autre sera placée de façon à ce qu'un côté soit horizontal. Les points peuvent être obtenus individuellement sans utiliser de points de fuite, mais grâce à de simples alignements entre le point et les sommets. Les mesures seront lues sur les côtés opposés.

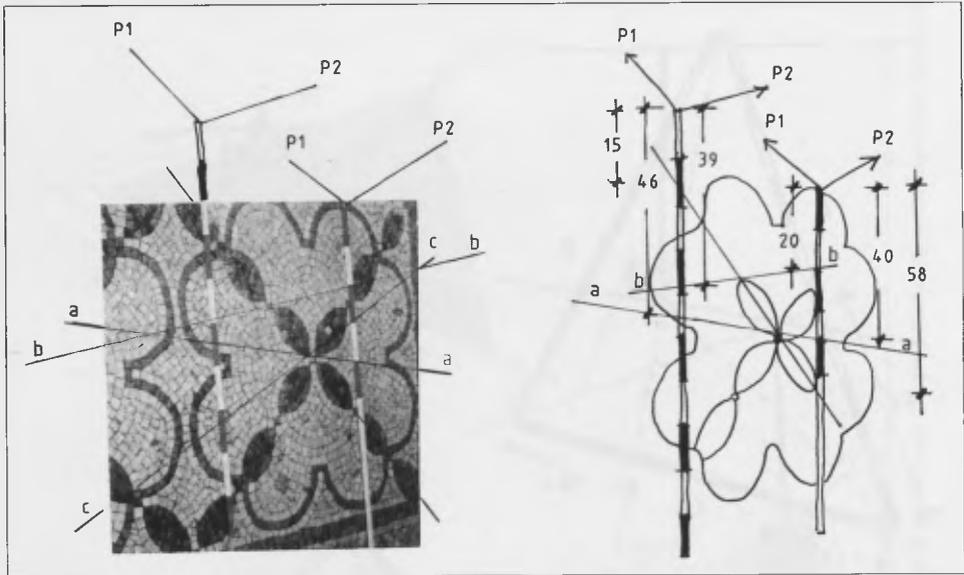
Fig. 5 : Utilisation de deux tiges libres (dans ce cas, parallèles) mais se rapportant en tout cas à deux points connus P1 et P2. Les mesures de chaque point s'obtiennent à travers des projections d'éléments connus d'une tige sur l'autre.

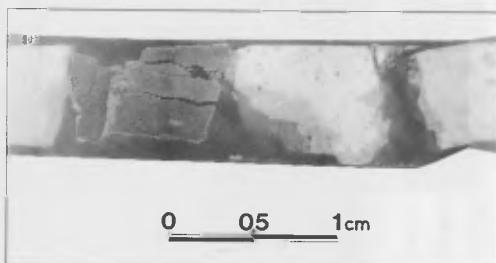
Fig. 3 : Coupe mince au travers du même échantillon (Fig. 2). Fissuration des calcaires sombres altérés et résidus de jointoyage.

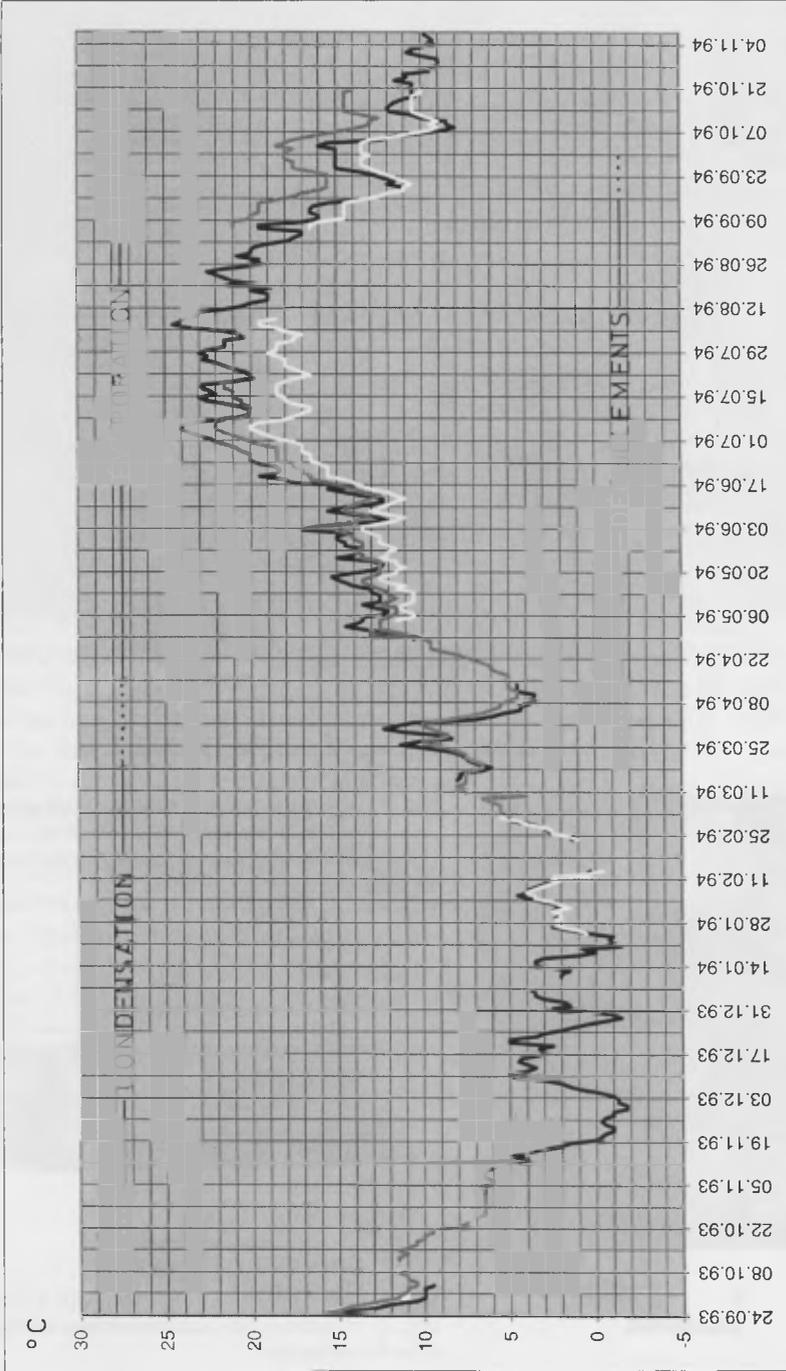
Fig. 4 : Mosaïque 6. Cycle annuel 1993/1994 de la température intérieure (noir), sur le tessellatum (blanc) et sous le statumen (gris).

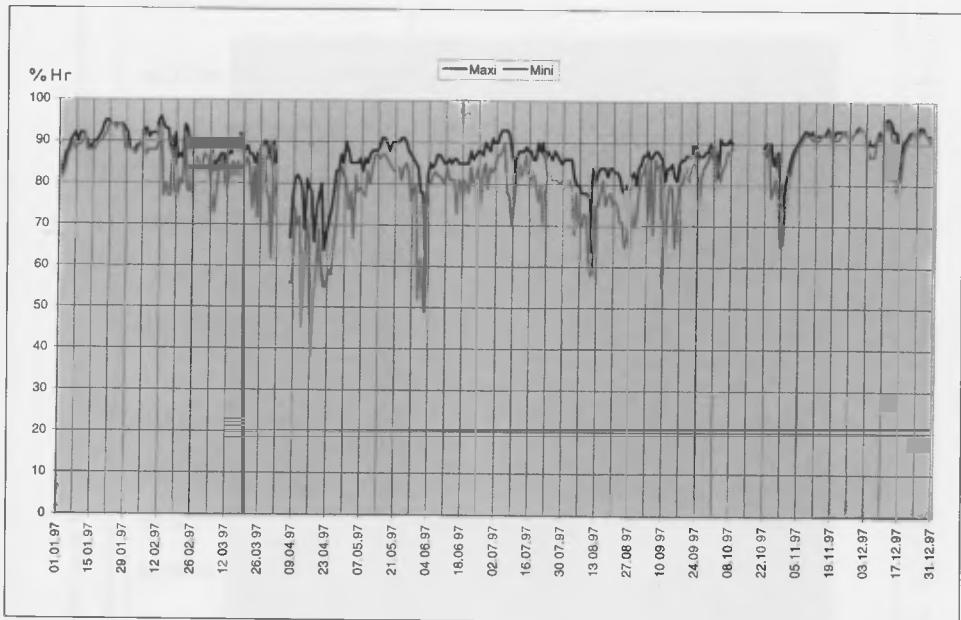
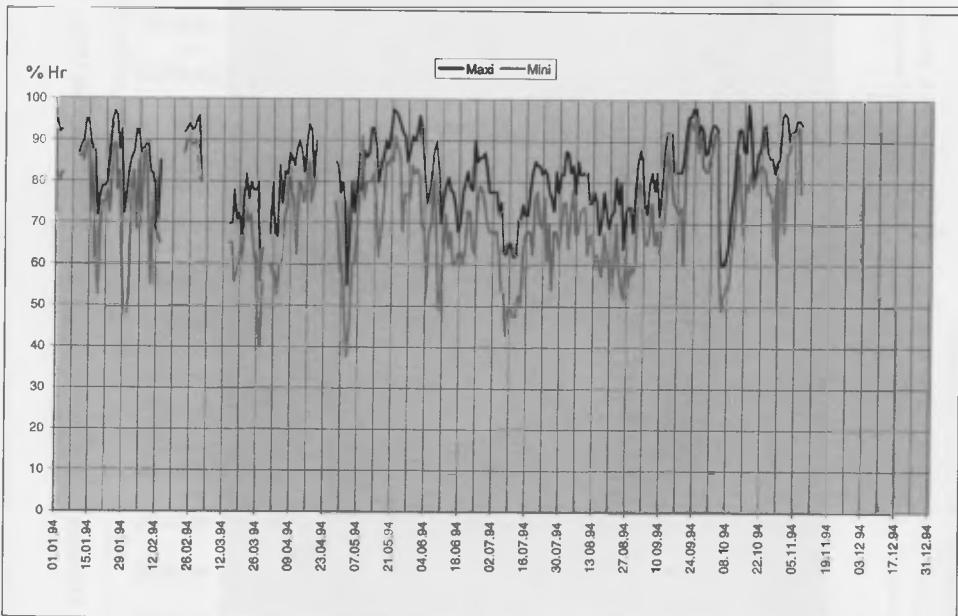
Fig. 5 : Mosaïque 6. Variations annuelles du taux d'humidité relative dans l'abri avant (1994) et après (1997) l'isolation de la toiture.

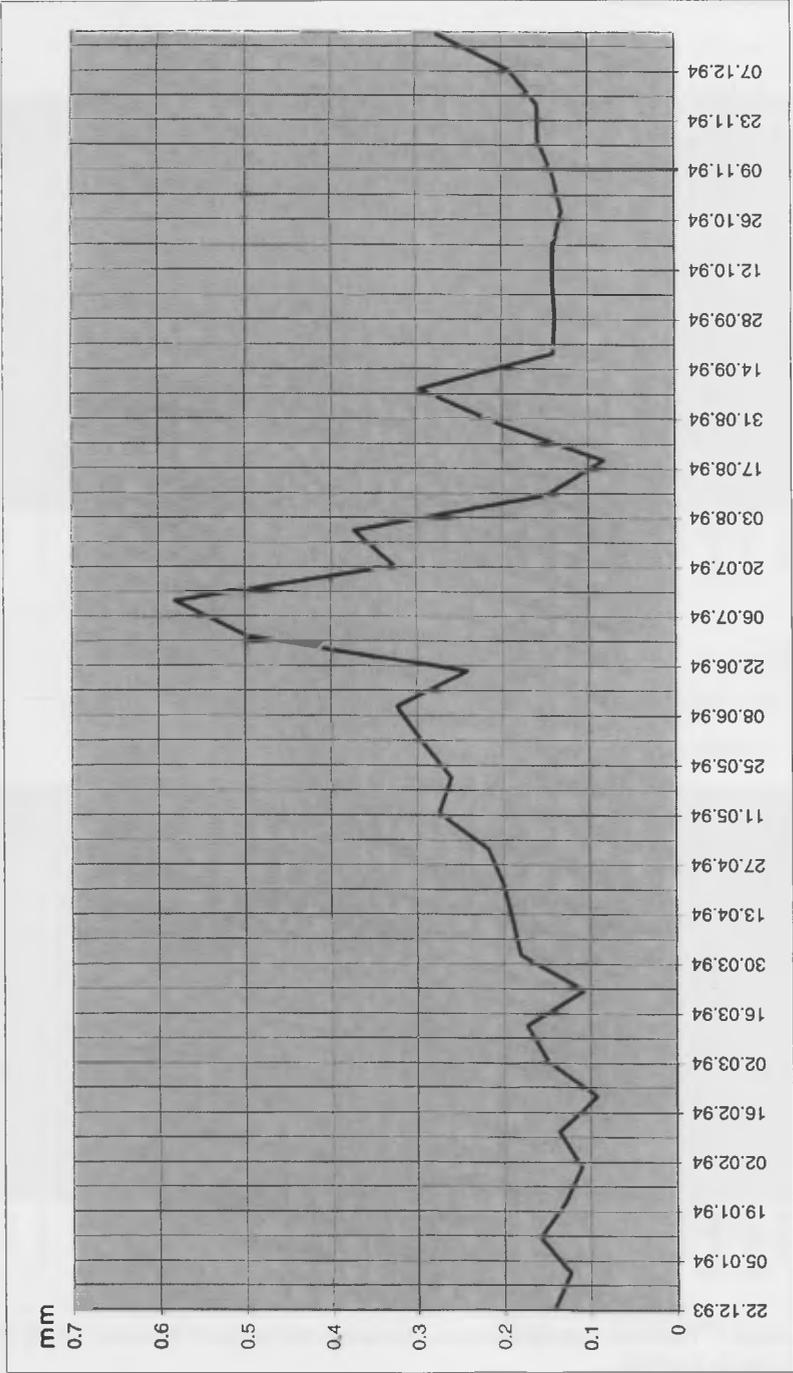
Fig. 6 : Mosaïque 6. Mouvements verticaux d'un décollement en 1993-1994. La plus forte amplitude représente une hauteur de 1,25 mm environ.

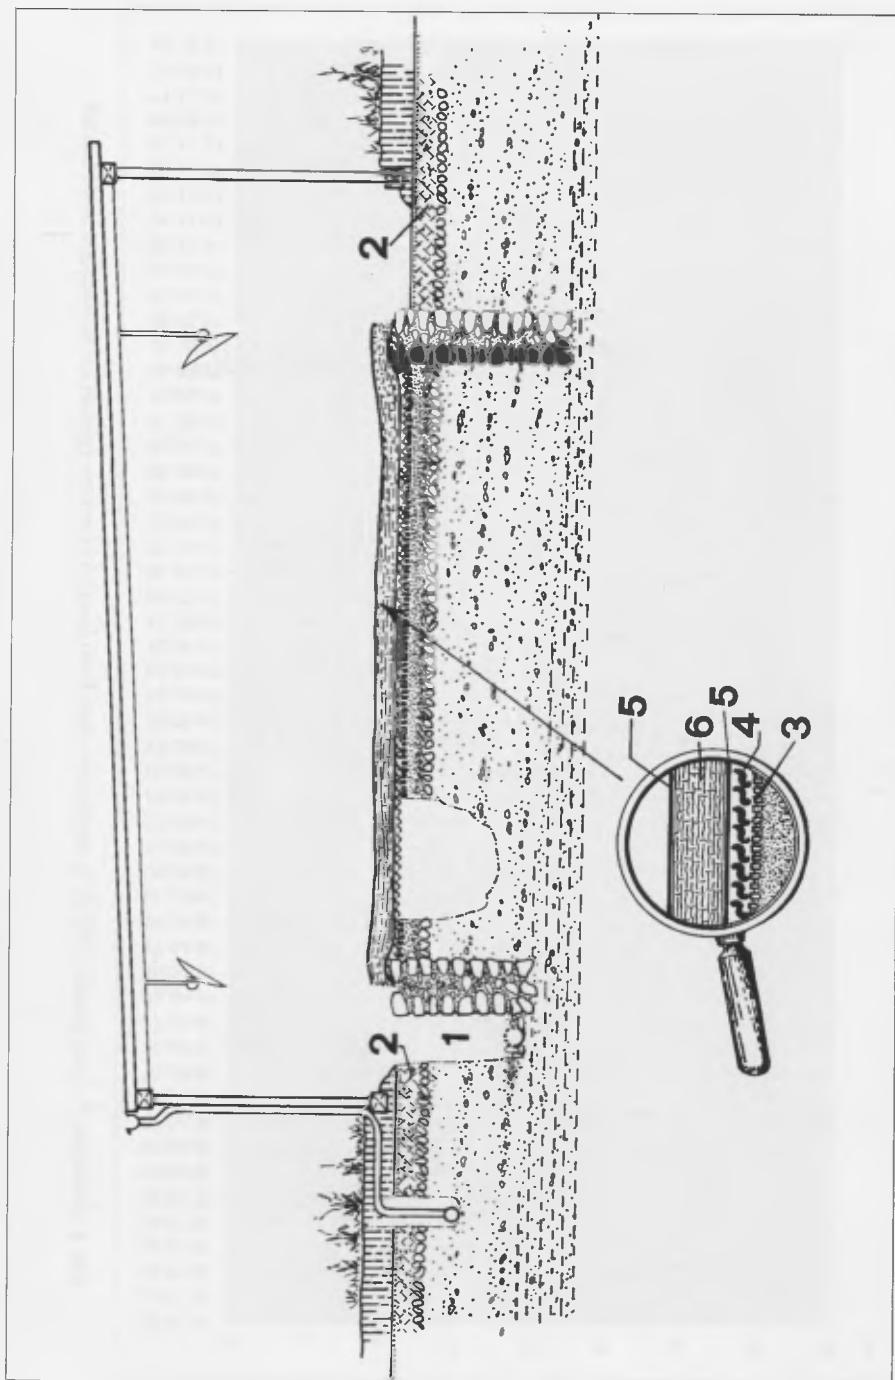
Fig. 7 : Protection provisoire de la mosaïque 9 maintenue en état humide. 1: drain. 2: sol des pièces voisines. 3: tessellatum. 4: filtre industriel. 5: film polyéthylène. 6: isolant thermique.

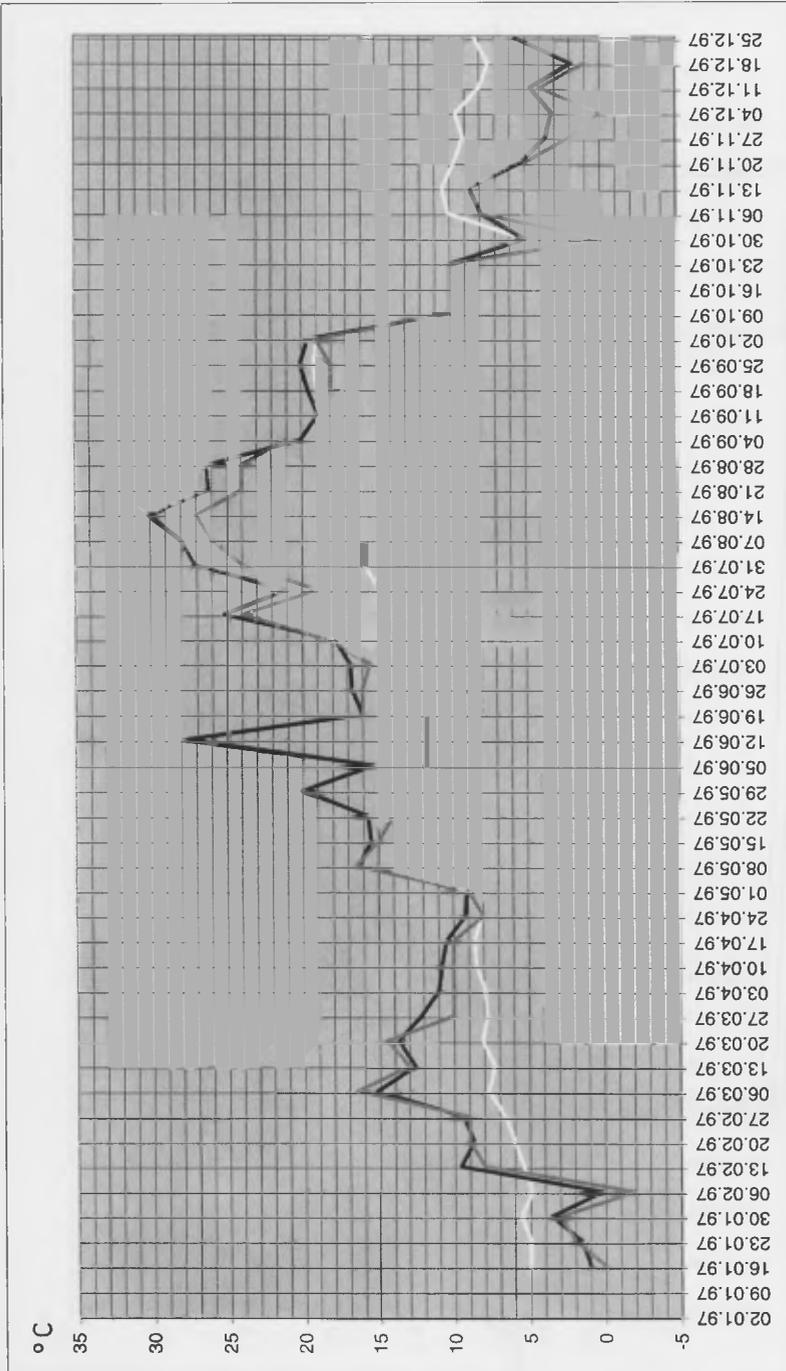
Fig. 8 : Mosaïque 9. Cycle annuel 1997 de la température dans l'abri (noir), à l'extérieur (gris) et sur la mosaïque isolée (blanc).

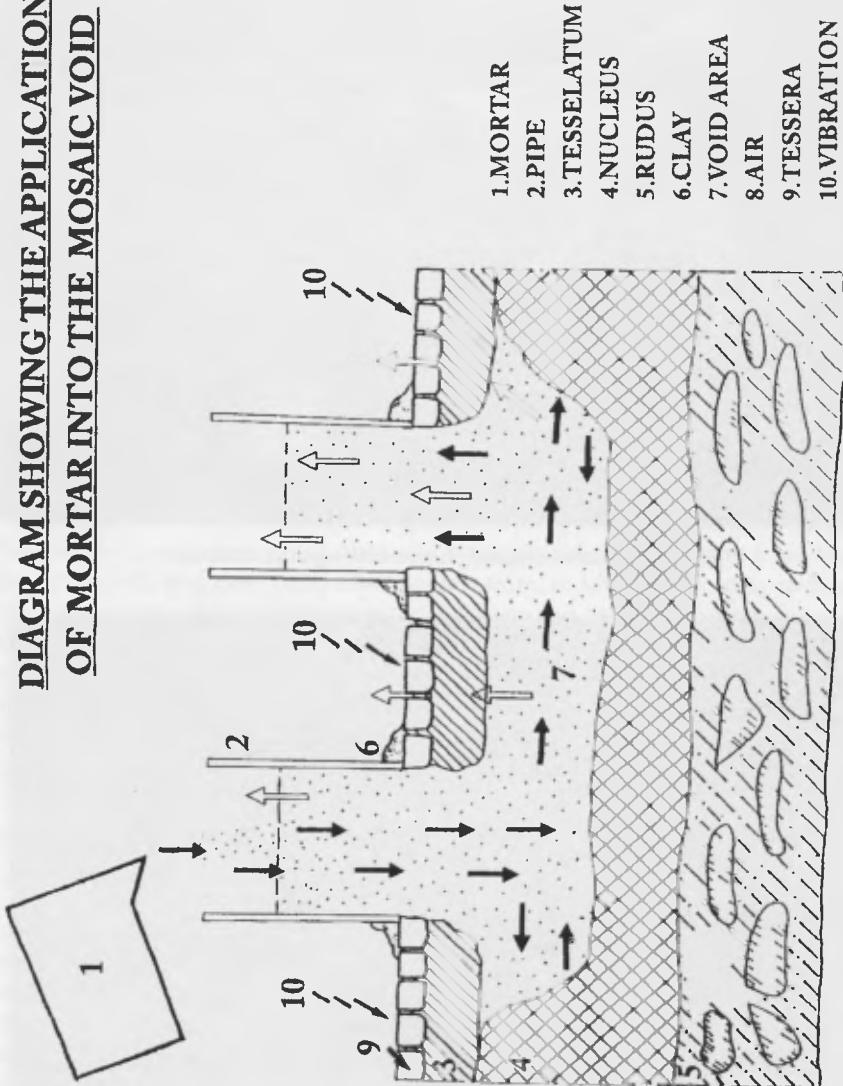
DIAGRAM SHOWING THE APPLICATION OF MORTAR INTO THE MOSAIC VOID

- 1. MORTAR
- 2. PIPE
- 3. TESSELLATUM
- 4. NUCLEUS
- 5. RUDUS
- 6. CLAY
- 7. VOID AREA
- 8. AIR
- 9. TESSERA
- 10. VIBRATION

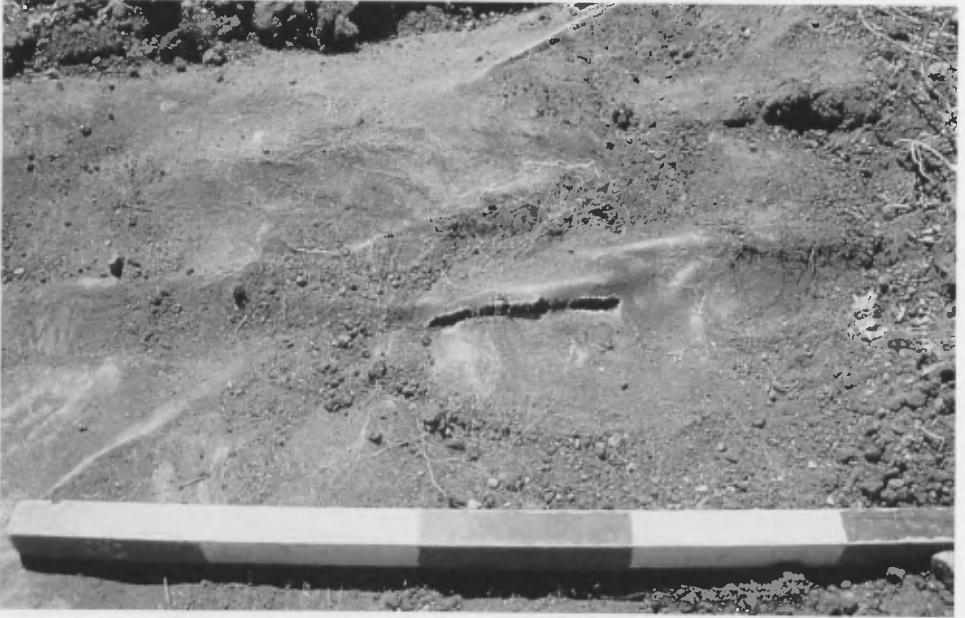
Fig. 5: Tablinum. Holes in 'Typar' geotextile (centre) caused by ants after two years of reburial.

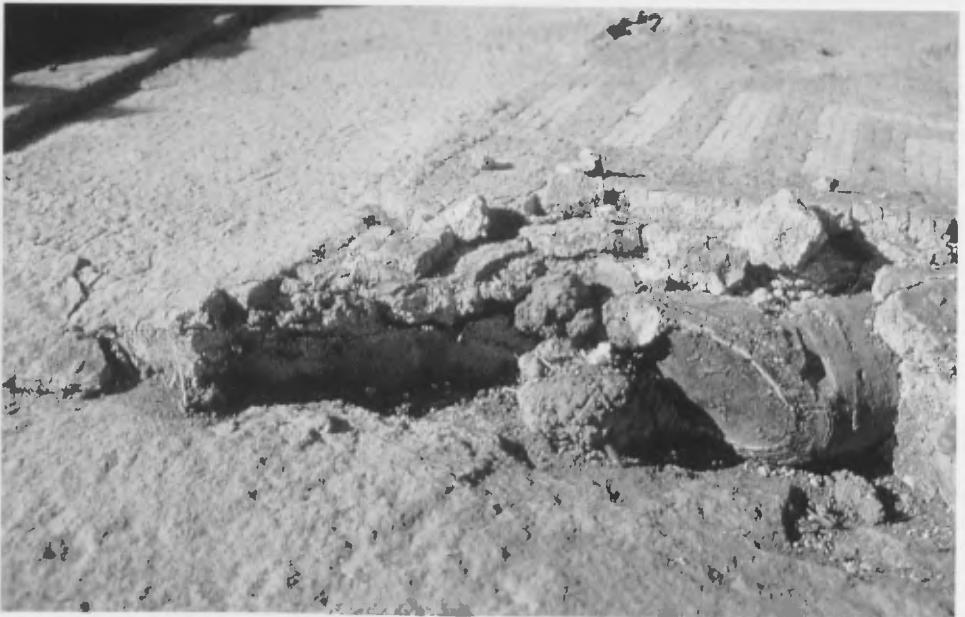
Fig. 6: Tablinum. New bulbous root growth at left edge of cut root section which has caused further damage to raised area of tessellatum and cracking of temporary mortar edging repairs.
