The Conservation *in situ* of Mosaics on
Archaeological Sites

Proceedings of the VIth
International Conference of the
International Committee for
the Conservation of Mosaics

Proceedings of the VIth Conference
of the International Committee for the Conservation of Mosaics
Nicosia, Cyprus, 1996

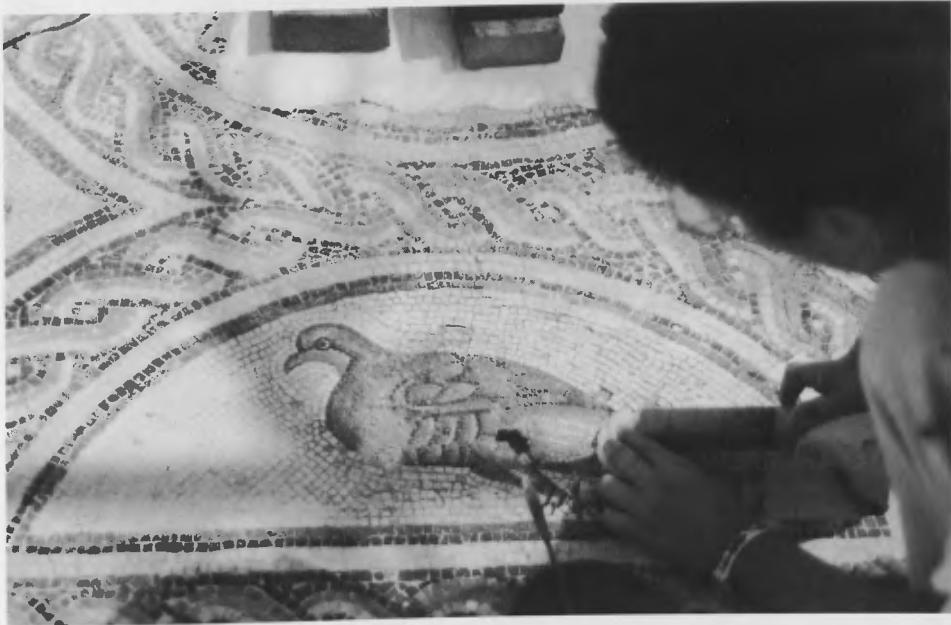
Fig. 3: Consolidation of the deep-level detachments. This operation was carried out to restore adhesion between layers in detached areas and to compensate in those areas where the mortar in the second preparatory layer was completely disintegrated or missing. The areas prepared this way were consolidated using a hydraulic consolidant mixture based on lime, whose components were similar to the original mortars (Lafarge hydraulic lime, sifted brick dust 1:1, and sufficient water to create a fluid mixture). The consolidant was injected through the holes using hypodermic needles.

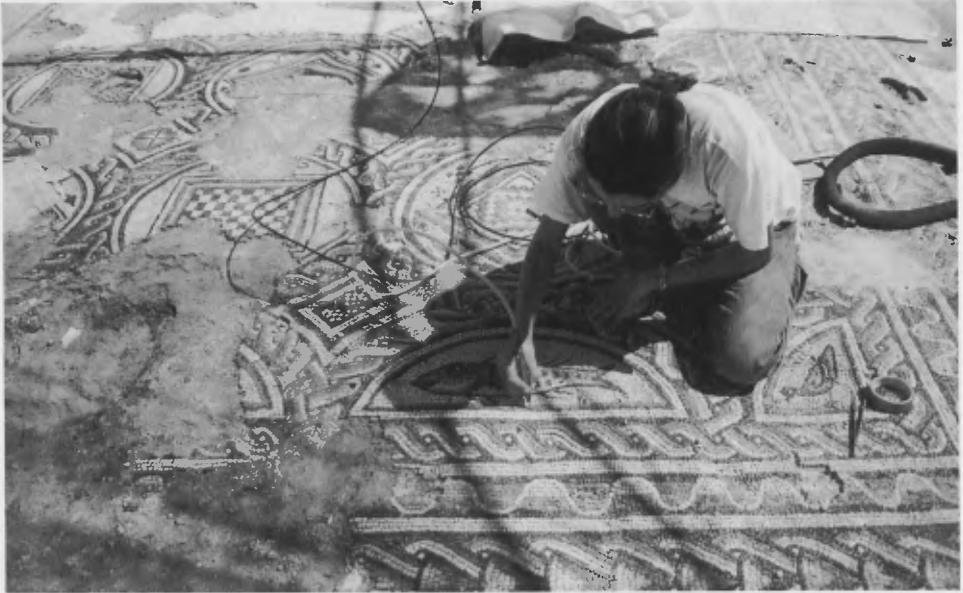
Fig. 4: Further cleaning was carried out by using paper pulp compresses soaked in a slightly alkaline solvent and followed by packs of paper pulp and distilled water.

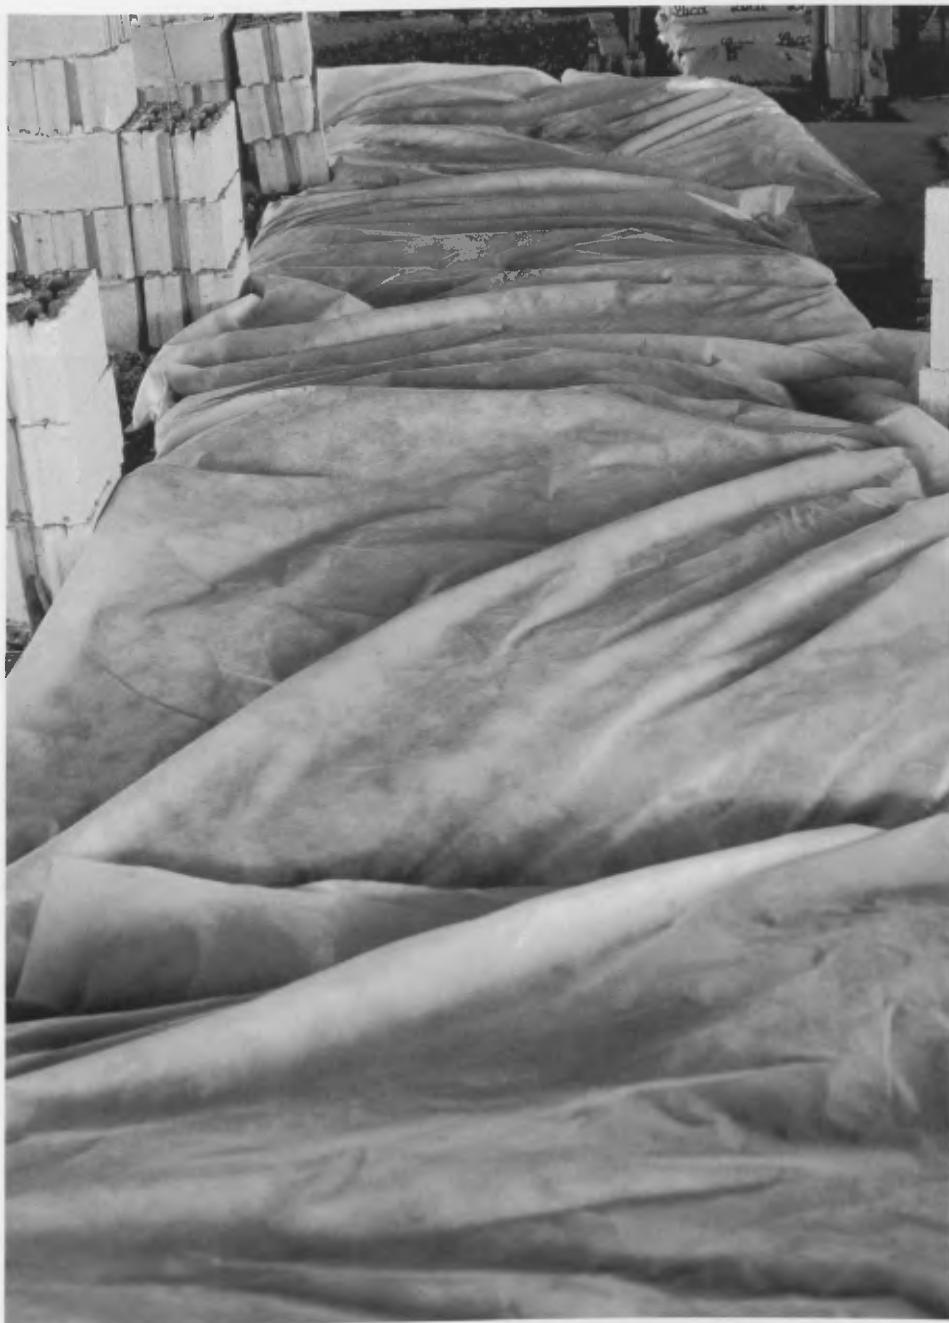
Fig. 5: Castelleone di Suasa, direct contact protection of mosaics, mattress of geotex and expanded clay.

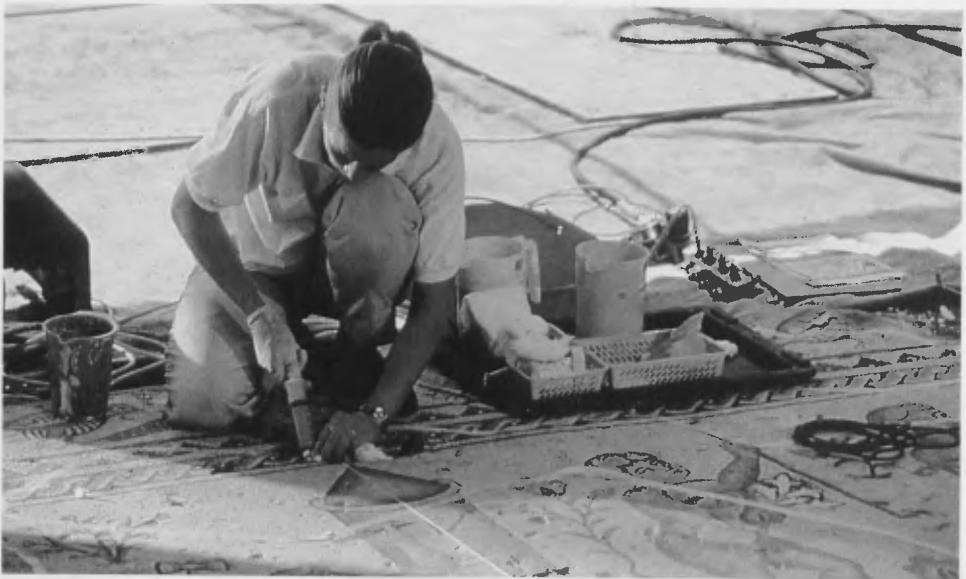
Fig. 4: Deep consolidation. This operation is carried out with grouting mortar. The infiltration is done with catheter syringes starting from one side of the hollow and working progressively towards the other. The process is slow and needs constant tapping up until the space is completely saturated.

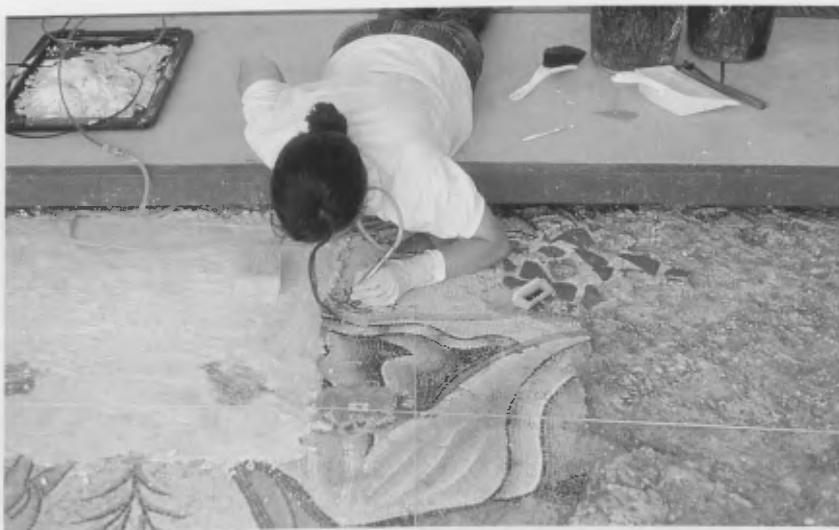
Fig. 5: Cleaning. This was carried out preferably by using mechanical hand tools and pneumatic tools, followed by application of paper-pulp compresses of AB57. Each application was followed by a distilled-water compress in order to lift away salt residues.

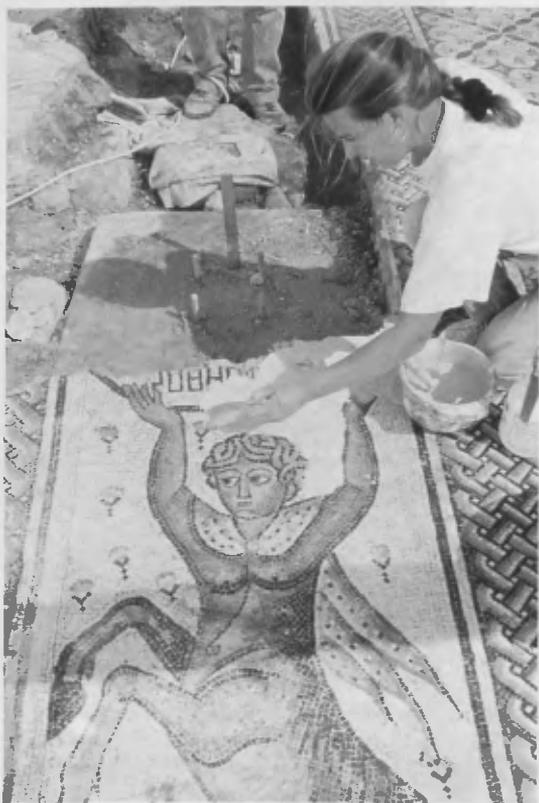
Fig. 6: Surface consolidation. The tessellate surface is carefully prepared: the spaces between the tesserae are mechanically cleaned to the depth of the original mortar. An abundant layer of very fluid Lafarge hydraulic lime and pulverized stone dust (1:1) is applied by brushing and rubbing. This is left to dry for an hour, the excess is removed using dampened synthetic sponges. This renews the original mortar network among the tesserae, recreating the homogeneity of the surface that had been lost as the mortar decayed.

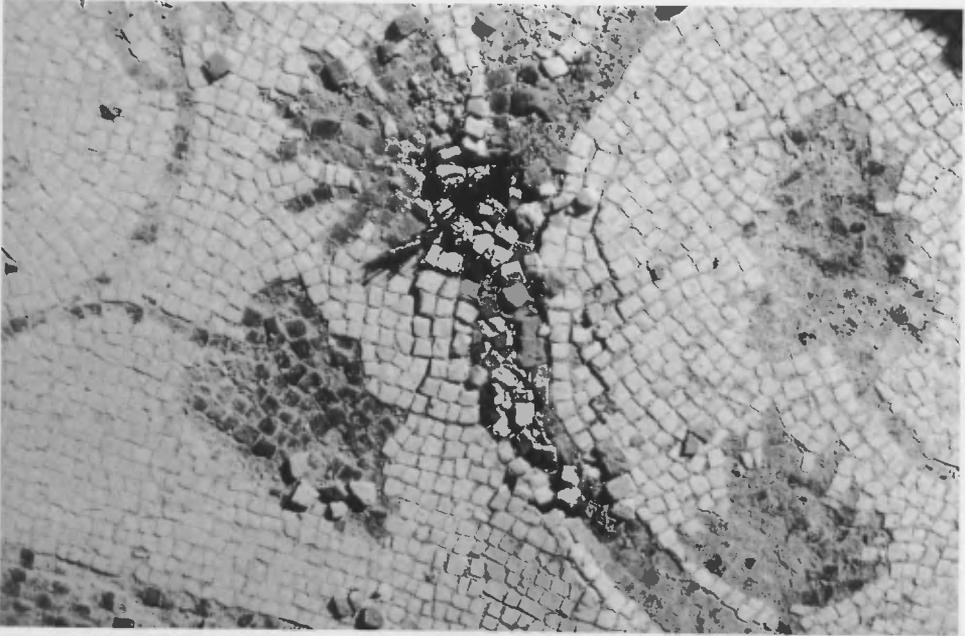
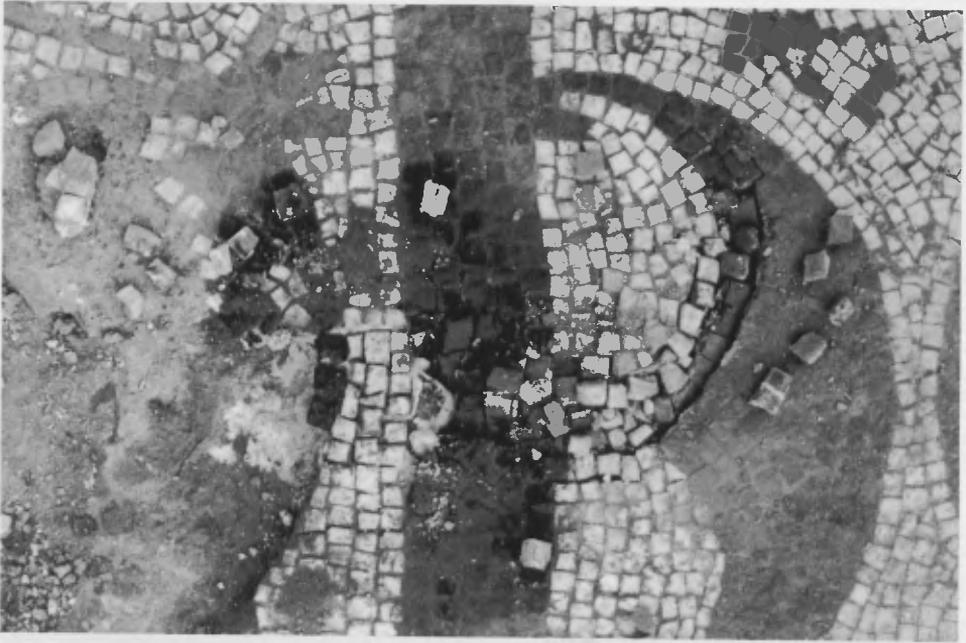
Figs 3 and 4: The majority of fragments of the mosaic were suffering from problems of adherence to the original support and required consolidation.
