Conservation of mosaic floor detached from Yasileh site in northern Jordan

Prepared By lecturer :Wasif Hwari

Faculty of Archaeology, Department of Conservation, Yarmouk University– Jordan

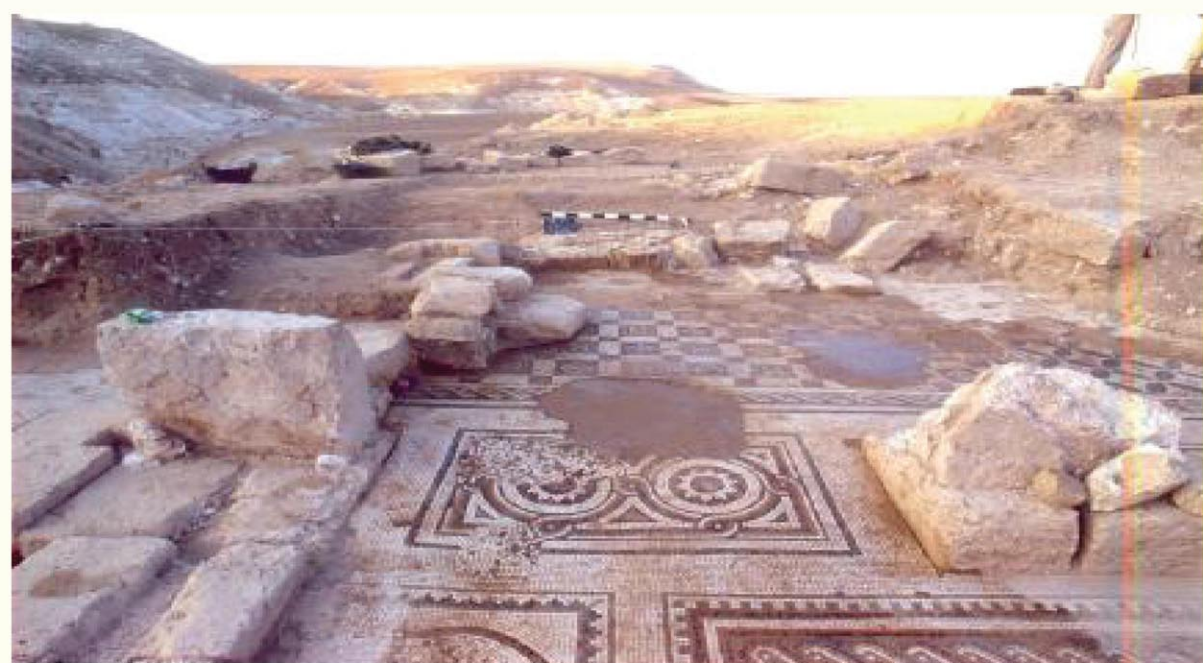
Fig 1

Figure (1)- Explains the mosaic floors in Situ

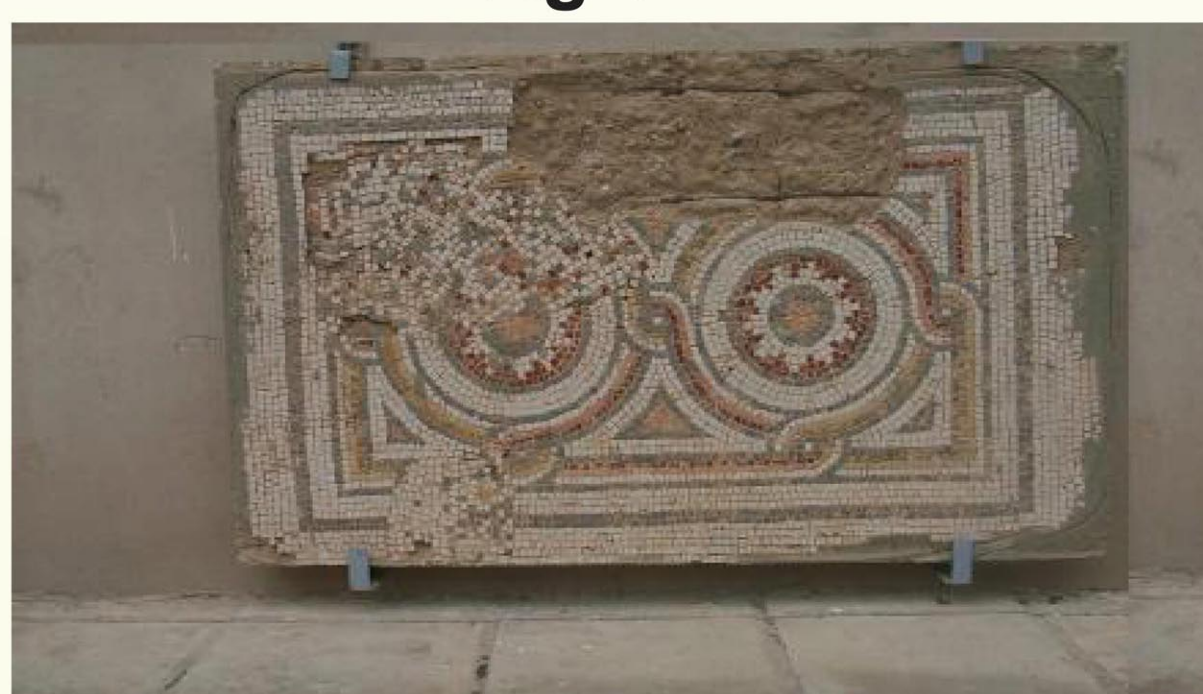
Fig 2

Figure 2 : The floor displayed on the wall of the Jordanian Heritage Museum

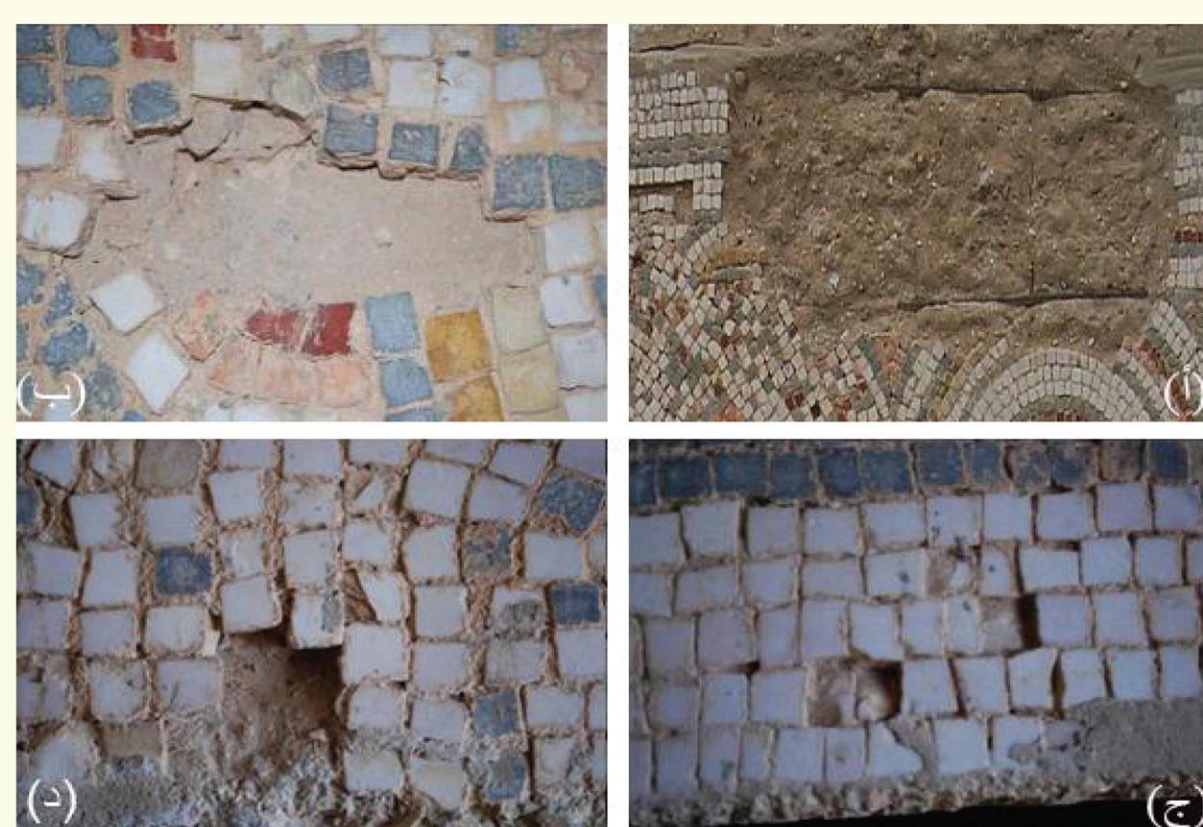
Fig 3

The problem resulted from the heavy layer of Portland cement background; this affected the floor in different aspects: mechanical, chemical, physical, and aesthetic deterioration . Figure (3)

Figure (3) –shows different forms of deterioration which affected the mosaic floor

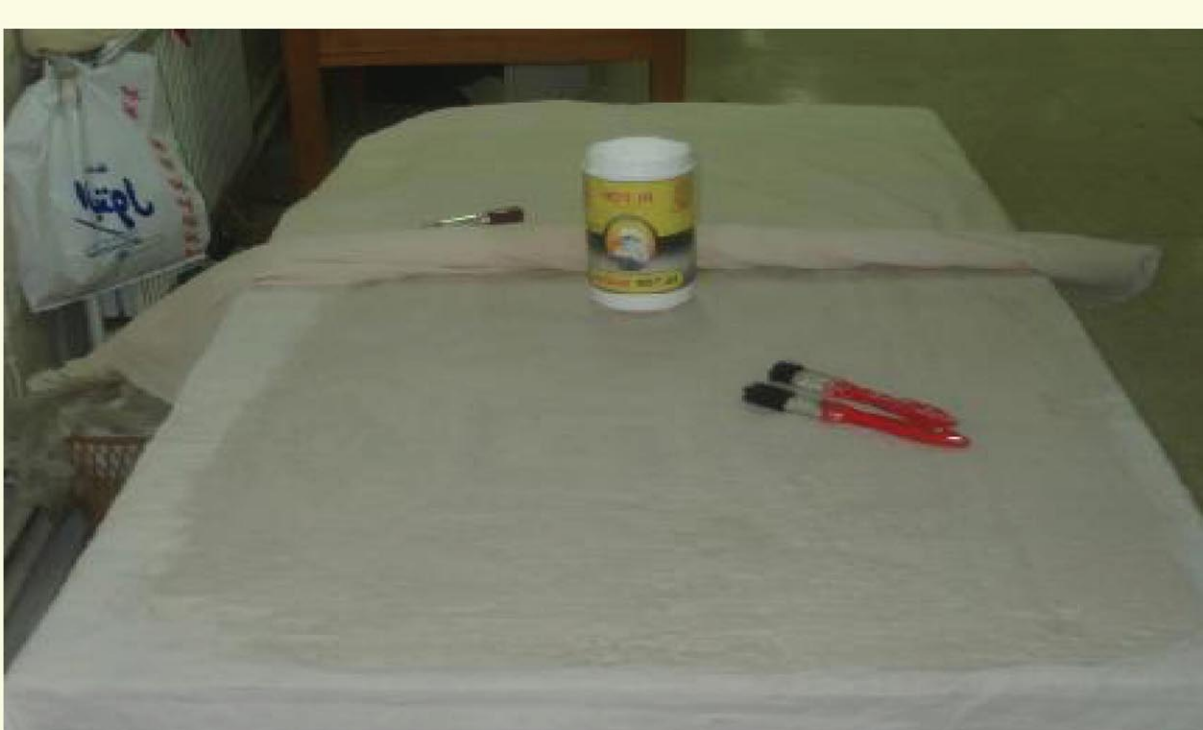
Fig 4

Figure 4 –shows gluing the surface of mosaic

A-After accurate documentation of the tessellated layer of mosaic floor by using drawing technique 1 : 1 which applied on Non-perishable tracing paper . Animal glue and wood glue has been used to stick double pieces of cotton cloth on the surface of the mosaic floor,to preserve the tesseraes from loosing through removal of the layer of cement..(Figure 4)

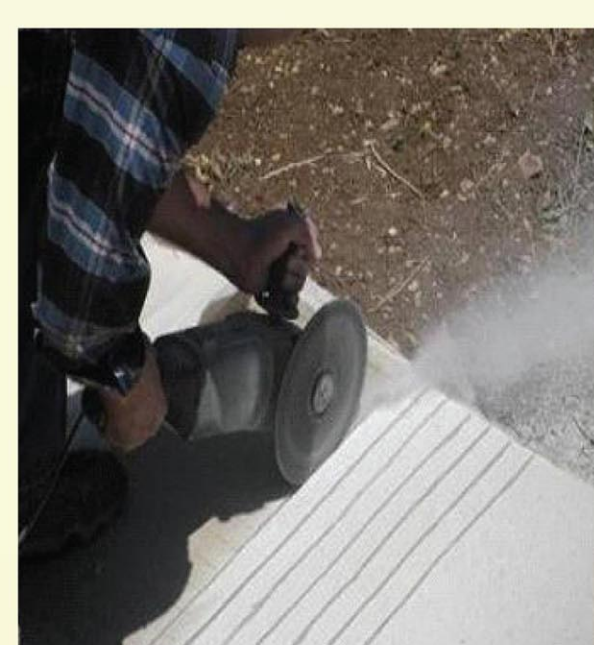
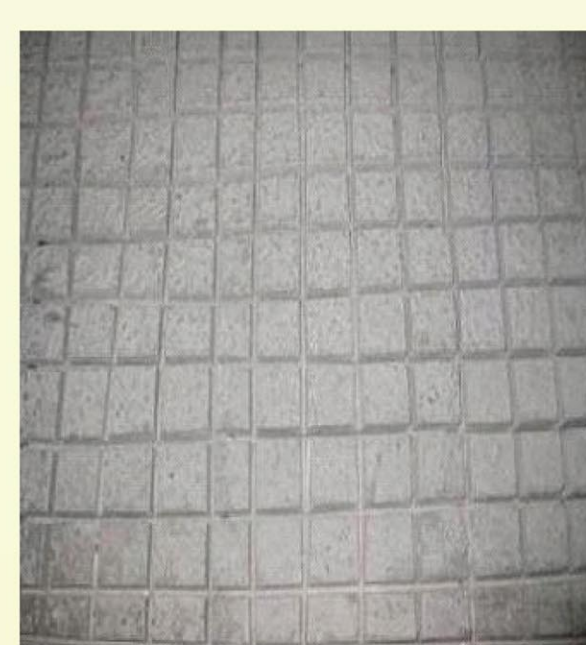
Figure 5,6:-shows dividing of the back Portland cement by using cutter of marble

B-All the Portland background cement is divided into pieces, each 4 cm x 4 cm,(Figure 5,6)

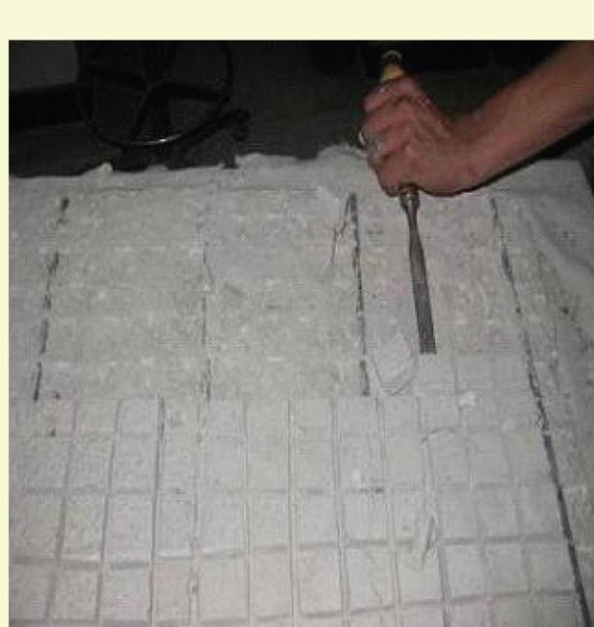
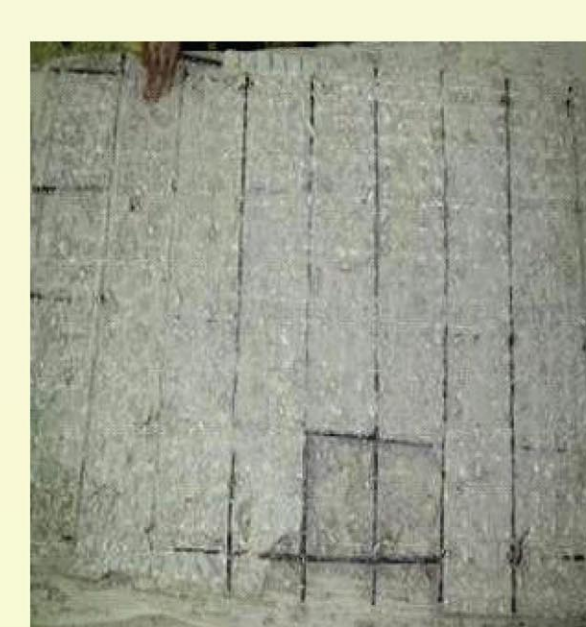
Figure 7,8 :- shows dividing and removing of the backed cement and iron bars

C- Complete removal of the Portland cement layers and Iron bars from the reverse side of the tesseraes by using different mechanical tools. Figures (7, 8)

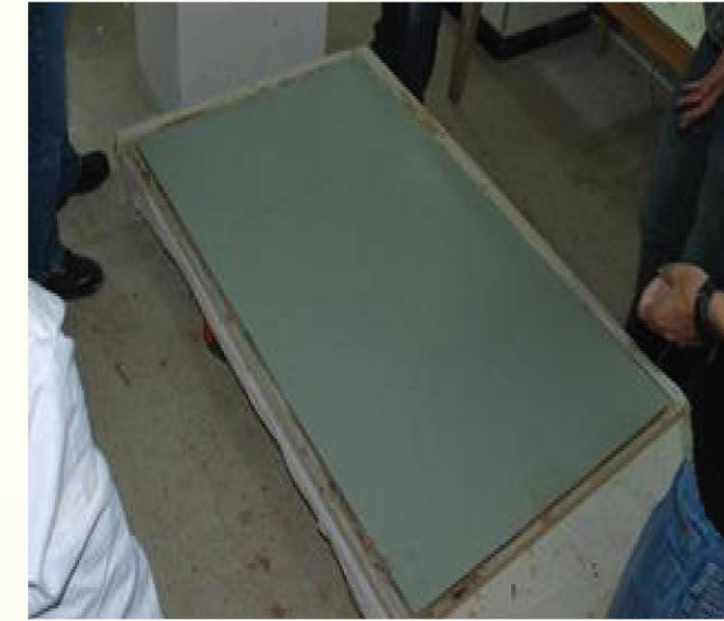
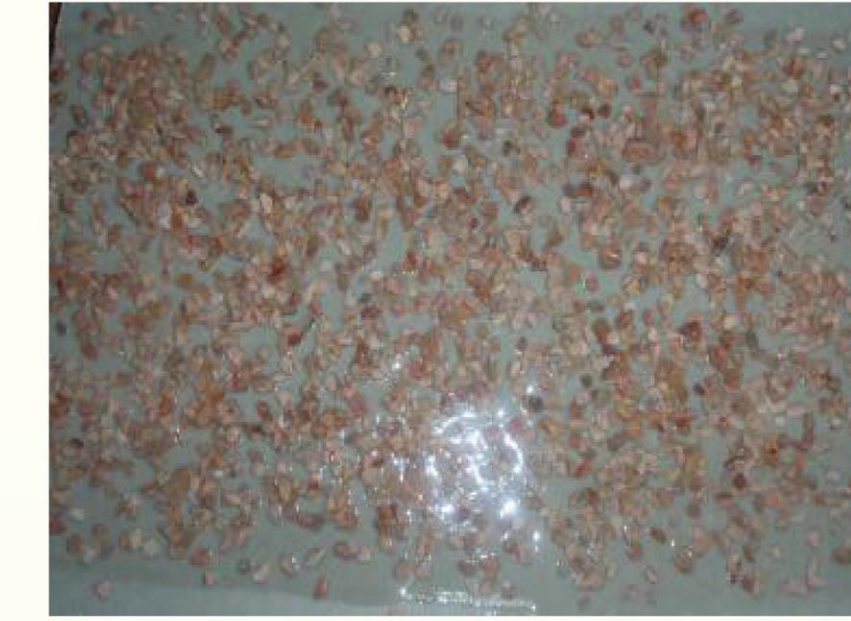
Figure 9 -10:- shows honeycomb light panel used as supporter

D-Preparation of the honeycomb of the lightweight panel in the same dimension and to get rough surface, small gravel glued on the honeycomb by using epoxy resin. (Figure (9,10)

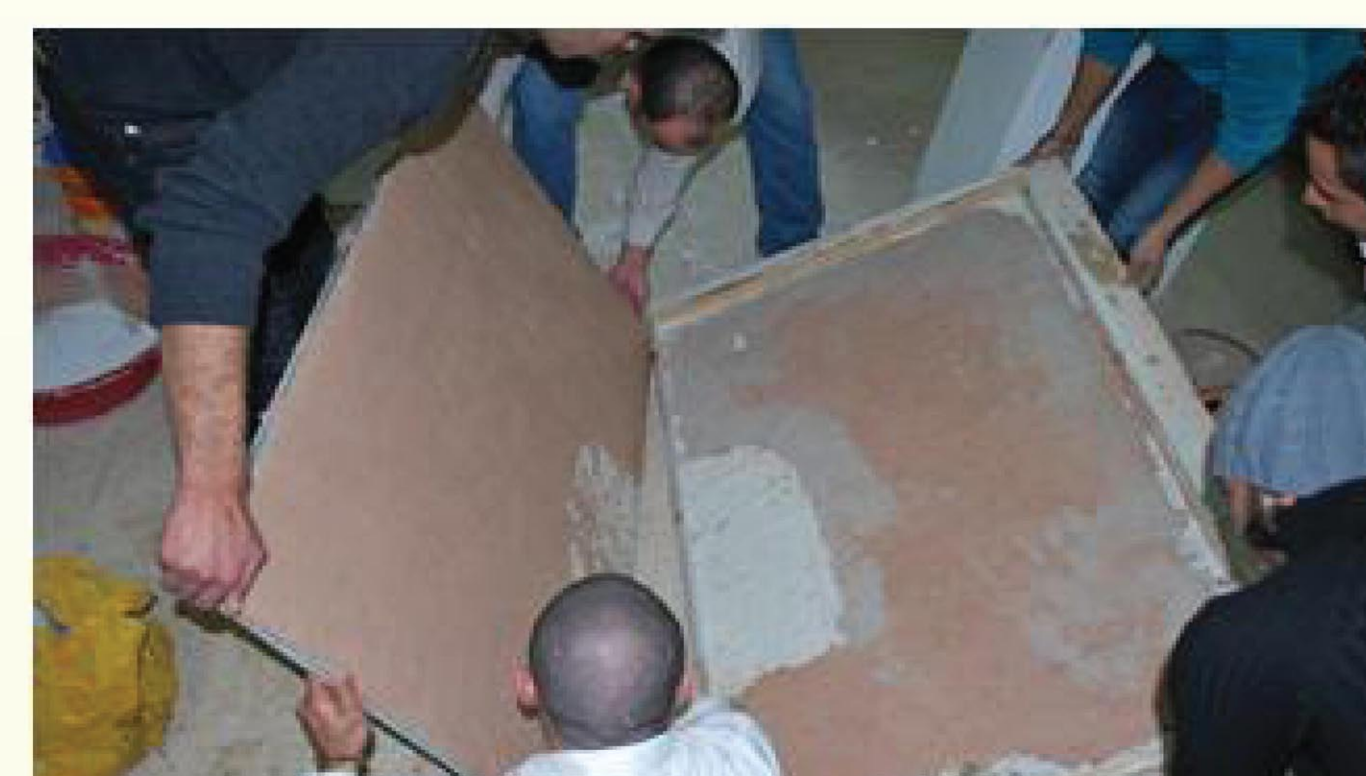
Fig 11

Figure 11 :-shows the adhesive layer of the mortar between the honeycomb panel and revers side of the mosaic floor.

E –New mortar prepared to adhere between the reverse side of the floor and the rough surface of the honeycomb. The mortar consists from the following ratios : Brick powder 1, Silica 1, hydraulic lime 1, and marble Powder 1. All four ratios were mixed with water solution which has 8 % of wood glue. Figure (11)

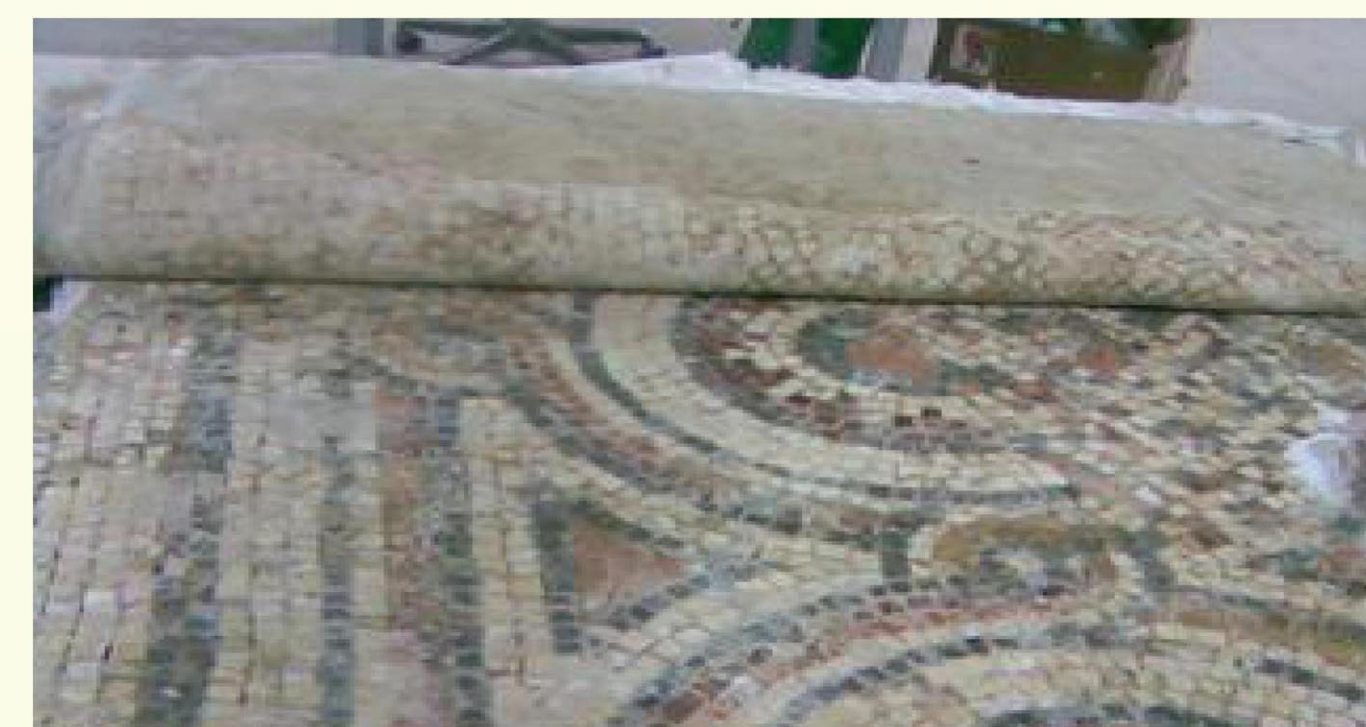
Fig 12

Figure 12:-shows removal of cloth from the surface of mosaic floor .

F-Removal of the cotton cloth that covered the mosaic surface by using warm water, then using different mechanical techniques to clean the surface from deposits. Figure (12) .

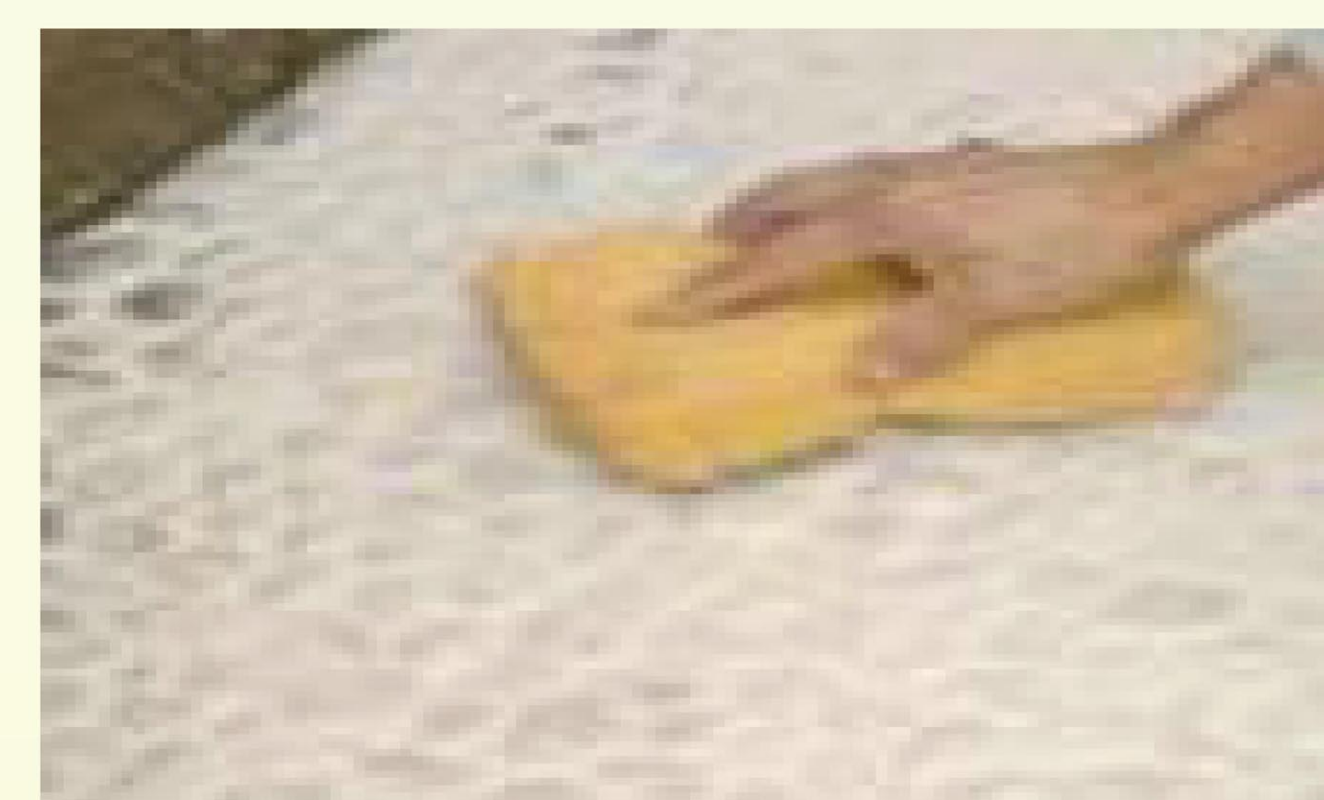
Fig 13

Figure 13 shows spreading out of the liquid mortar on the mosaic surface

G-Reconstitution of the surface : New layer of liquid mortar was applied to fill the joints among tesseraes; it contained the following materials and ratios: Marble Powder 1 , Brick Powder 1, pozzolana 1, and (Lafarge)-Hydraulic Lime 1. Figure (13)

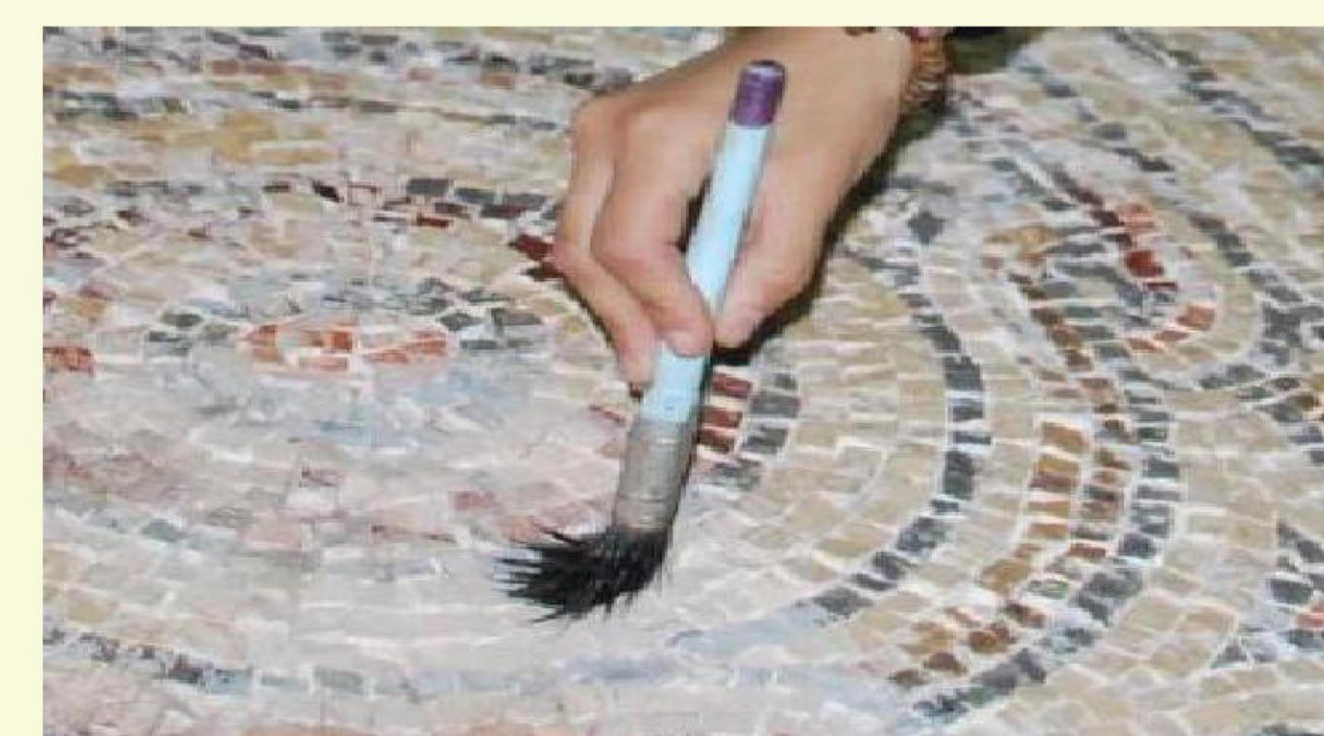
Fig 14

Figure 14 shows applying the protection layer on the mosaic surface

H-Surface protection: surface protection layer consists of 1, 5% of acrylic resin (Paraloid B72) solved in acetone was applied by brushing Figure (14)

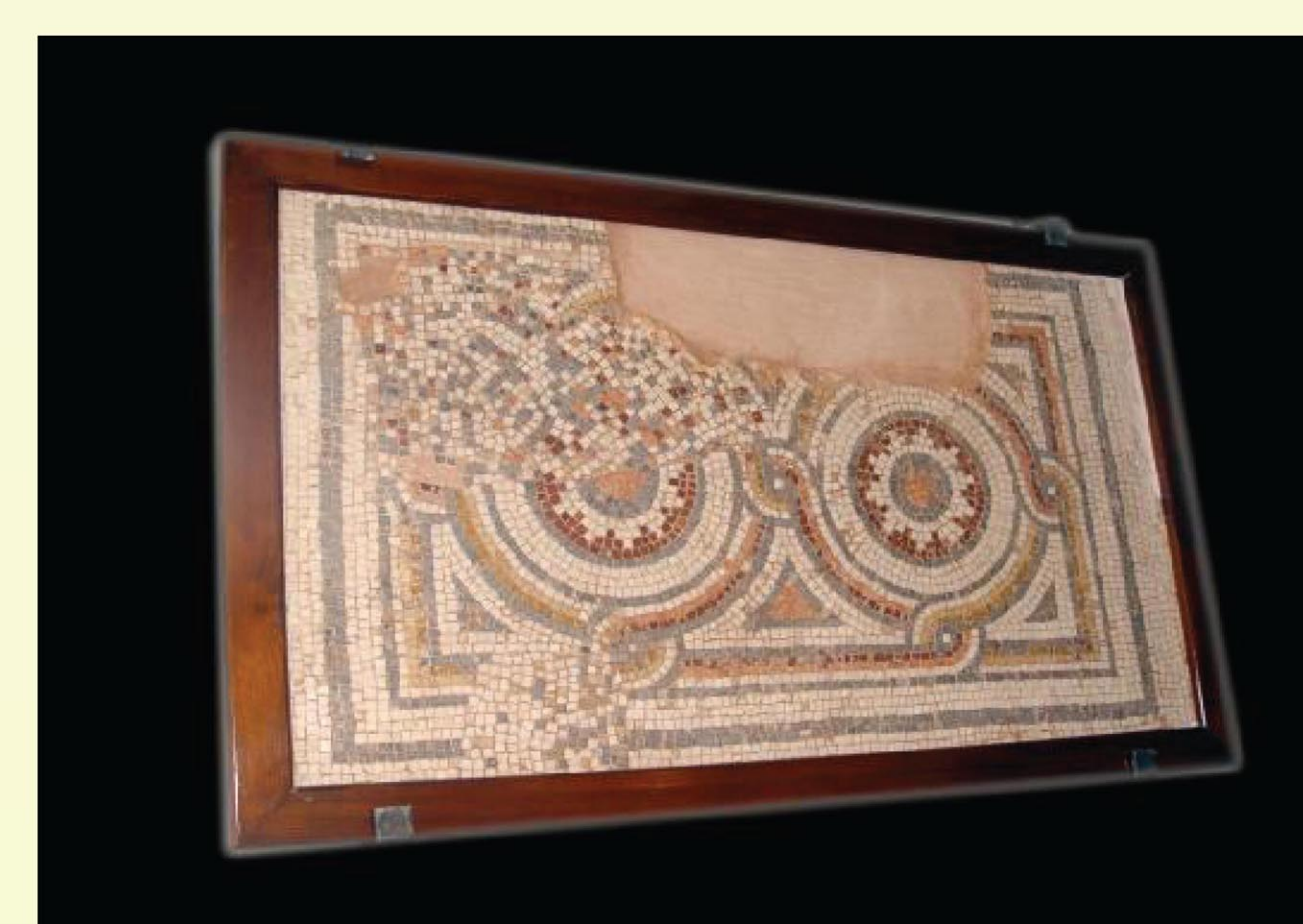
Fig 15

Figure 15 :- shows the final case of the mosaic after conservation

I-Finally , the mosaic floor was placed in a new wooden frame, and is currently being displayed in a proper surrounding environment inside the Jordanian Heritage Museum -Yarmouk University (Figure 15) .
