In the light of MOSAIKON program in Tyre, Lebanon – May 2010 , we identified several mosaics in Al-Bass Site, Tyre. All mosaics are of high significance. Among them, The Blue team pavement is chosen as a final project.

The Blue Team Mosaic

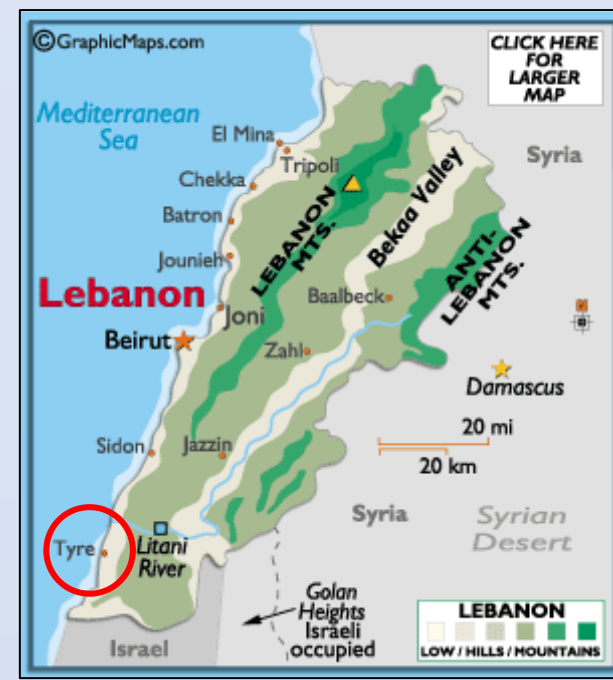
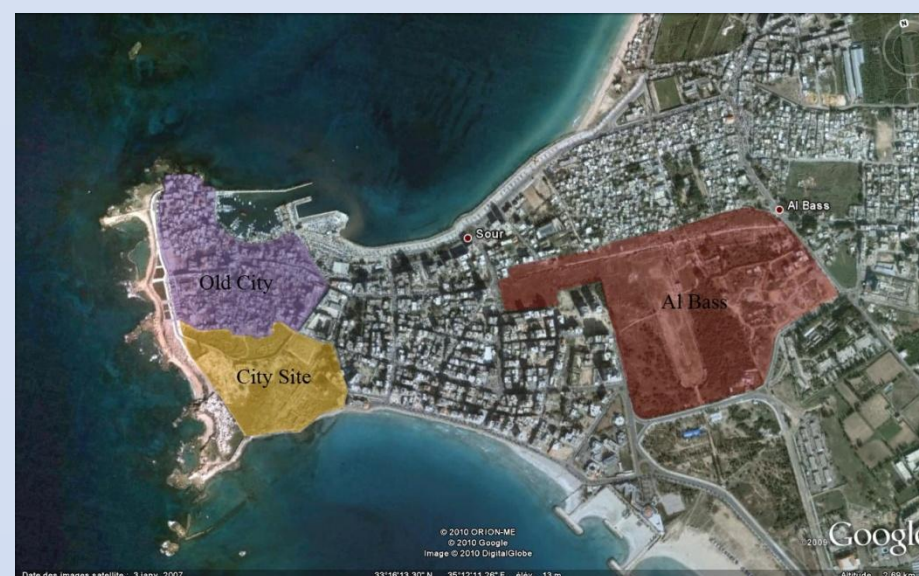
MOSAIKON documentation, prepared by Nesreen Bouza, May 2010)

- \* The Al-Bass site contains more than 50 pavements;
- \* They reflect the social way of life of Roman and Byzantine periods which enhances their historical and economical values;
- \* The variety of the techniques used shows their cultural value;
- \* Most of the mosaics are *in situ* on their original bedding and they are still integrated into their structural context;
- \* The Blue Team pavement contains rare inscriptions of the games that used to take place in the hippodrome.

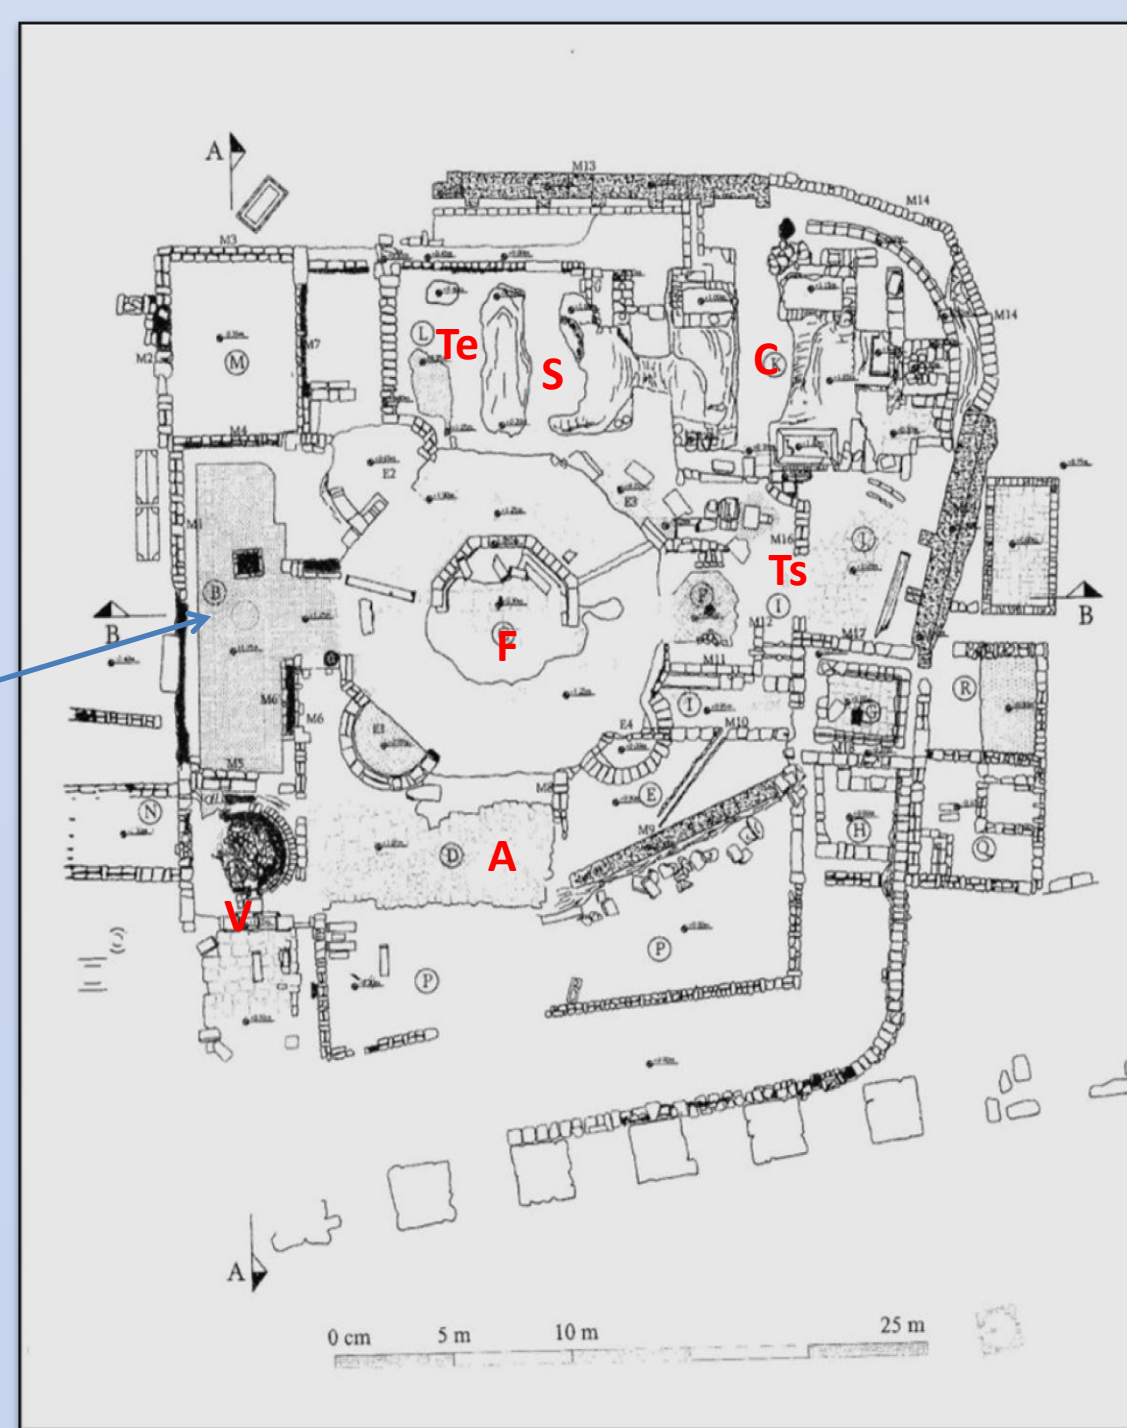
The Blue Team context  
Circular circuit: vestibule **V** -> apodyterium **A** -> frigidarium **F** -> tepidarium d'entrée **Te** -> sudatorium **S** -> caldarium **C** -> tepidarium de sortie **Ts** -> frigidarium **F** -> apodyterium **A**. (Kahwagi-Janho , 2006)

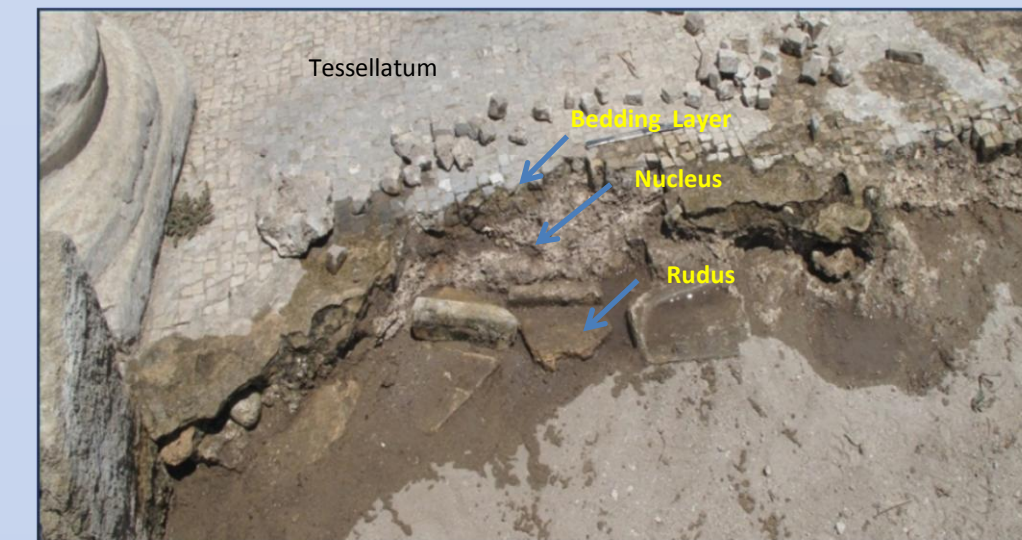
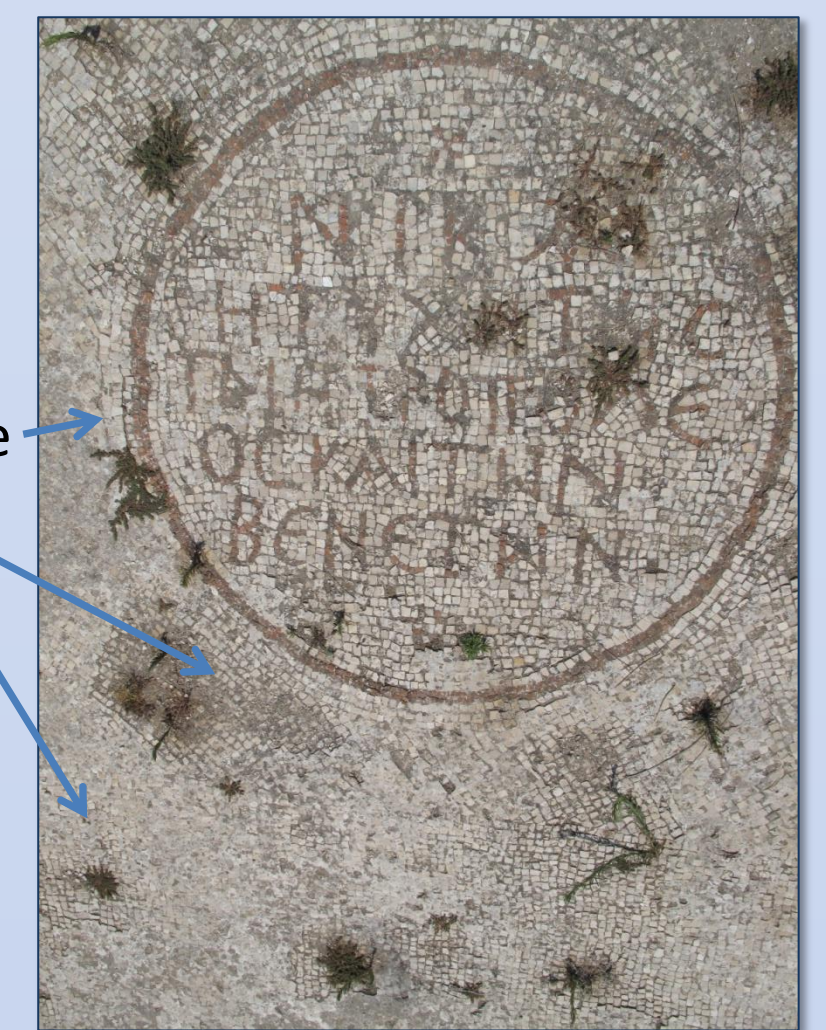
- Monochrome pavement of 54.5 m<sup>2</sup>
- Medallion of 123 cm of diameter
- Tesserae roughly cubic (1x1x4cm)
- White tesserae are Lime stone
- Red tesserae are ceramic
- Technic: Tesserae arrange in circle shape  
Tesserae arrange obliquely  
Tesserae arrange horizontally
- It is an *Opus tessellatum* pavement
- It is laid in its original bedding

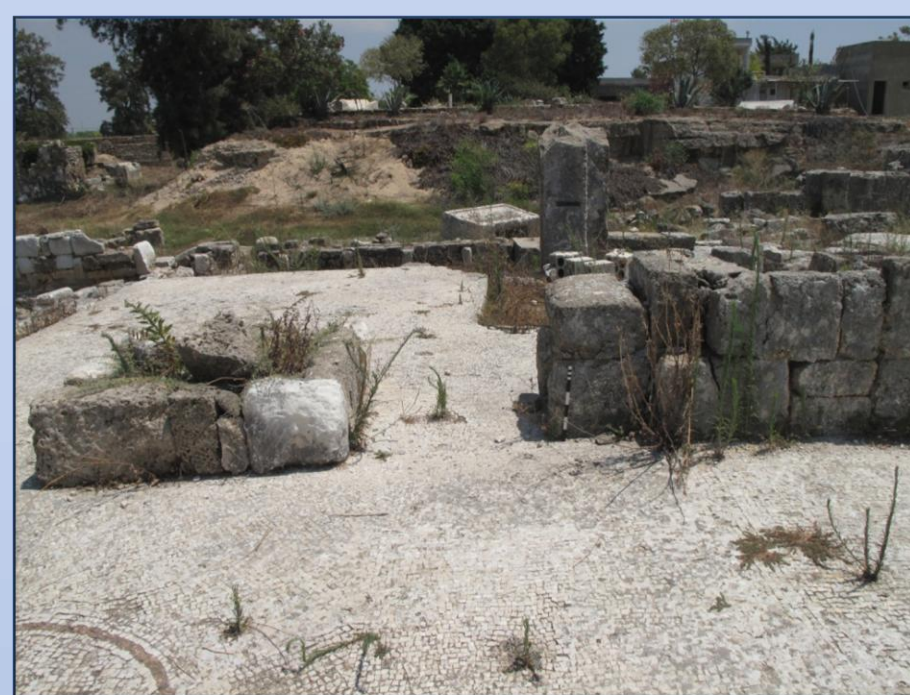
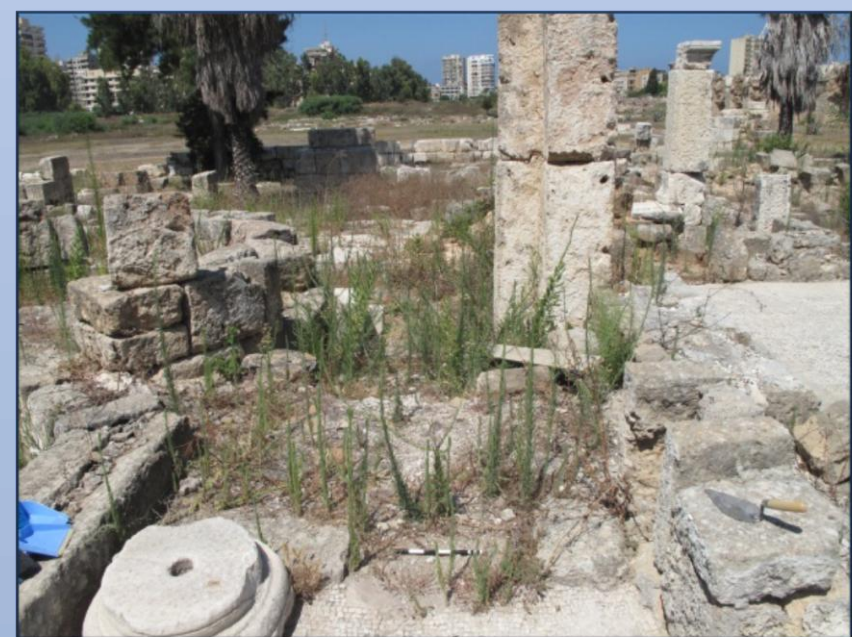
- Vegetation and micro-biological organism present a critical condition.
- The tesserae condition is acceptable in term of flaking and erosion. In specific places, certain fracturing are noted on the surface of tesserae.
- Three patches of discoloration of tesserae is recorded.
- In many places, the surface of the pavement is covered by a calcareous deposit.
- The tesserae condition at the edges is very poor.
- The mortar between tesserae is in moderate state.

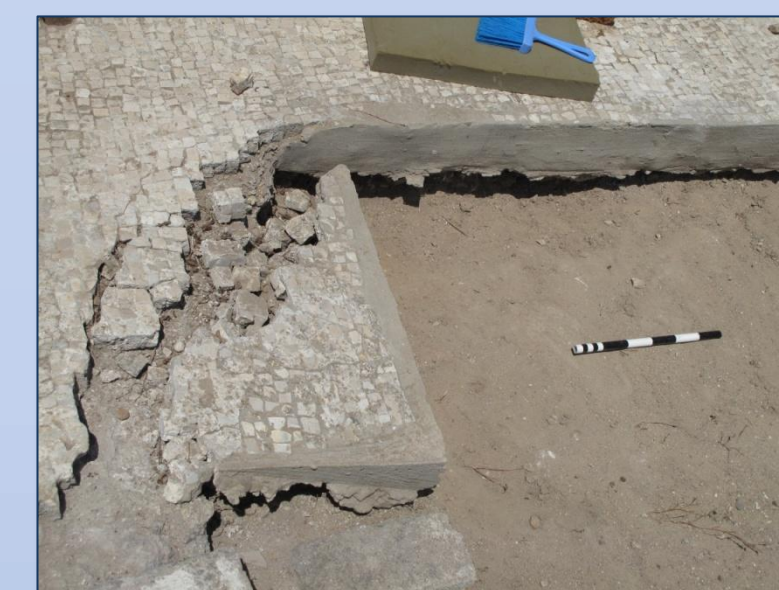
- Moderate state represented in the cracks and the bulging, but a specific structural crack is extremely critical at the small corner South/East the medallion.
- Many depressions are moderate, but the one between the *Frigidarium* and the *Apodyterium* is poor because it is pooling water and soil.

- Vegetation is damaging the mortar between tesserae and is dislocating tesserae;
- The North edge and the Est edge of the pavement are losing their foundation which causes major cracks and lots of depressions on the pavement;
- The big depression on the pavement between *Fridigarium* and *Apodyterium* is due to leveling problem, the mosaic is lower than the *Apodyterium*.

- Improve vegetation growth control;
- Promote preventive interventions;
- Resolve pooling problems due to pavement leveling ;
- Provide documentation on mosaics for the tourists.

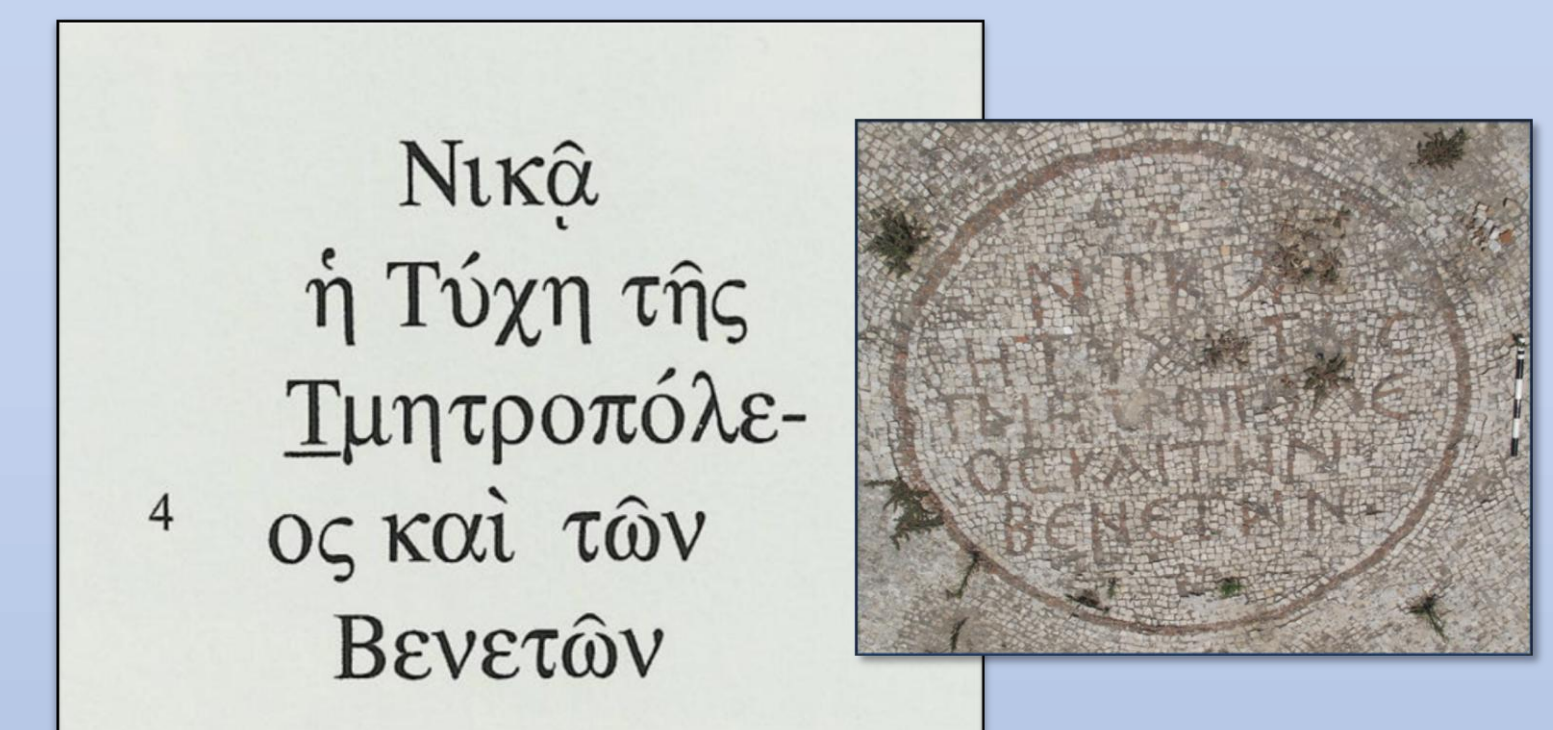
Critics by J.-P. Rey-Coquais in his publication « Inscriptions of the Hippodrome » in Baal, special issue III, 2006 : « The damages caused by weather led to the loss or the misplacement of some tesserae, the necessary consolidations did not abide to or restore a misunderstood link ».
