RESTORATION OF MOSAIC IN AL ZAHIRYA LIBRARY

Arranged and Presented by : Maher JBAAE

D.G.A.M SYRIA
MOSAIC CONSERVATION LABORATORY

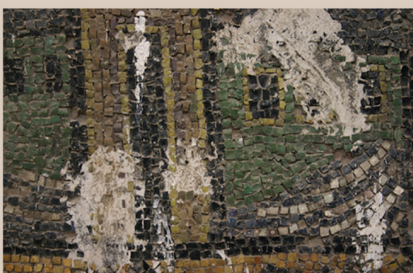
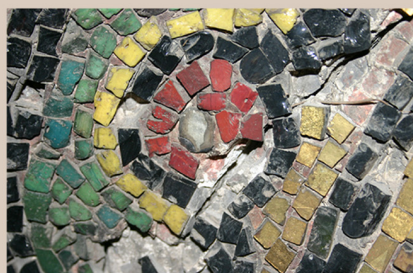
Mosaic area is approximately 80 m2, covered parts from the walls, in height of 4 m from the ground and a width of 1.70 m, in addition to 6 arches and the roof of the Mehrab in the middle of the south wall.

The corners of the hall are columns in the form of Zik Zak with four facades, it was designed in this form, to carry the arches and the high dome, and it was decorated with mosaics at the same height.

Tesserae are hand-made glass produced in Damascus, made in variety dimensions /from 7 mm to 1.3 mm/, and in variety of colors, black, red, light green, dark green, yellow, brown and blue, in addition to some stony cubes white and pink, which used to formation of some leaves and twigs of trees, and they used the silver cubes especially in the decoration of houses and palaces roofs, gold cubes have been used extensively as a background of the subjects.

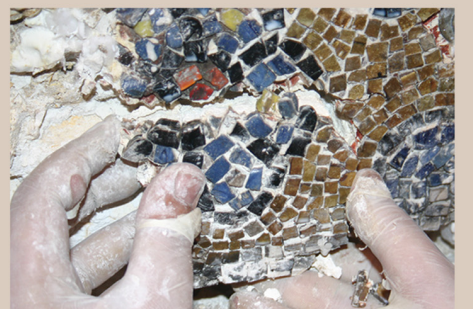
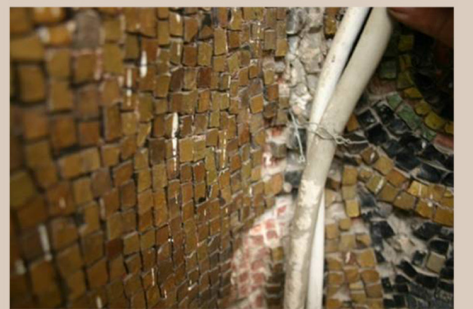
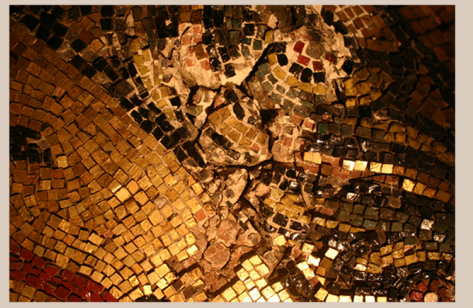
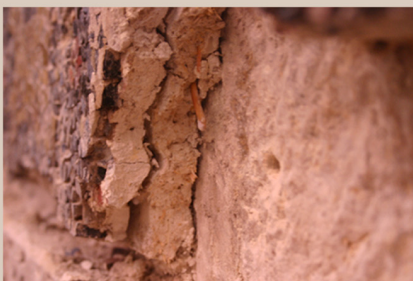
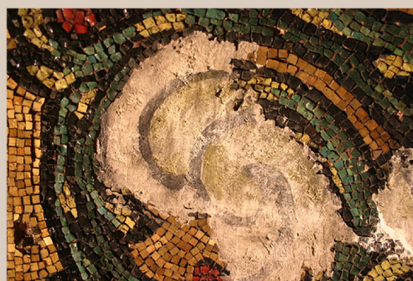
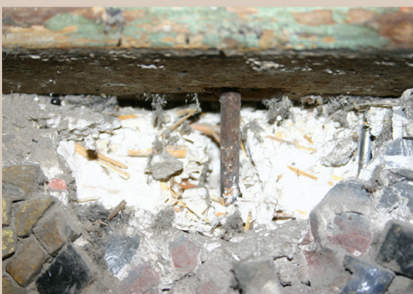
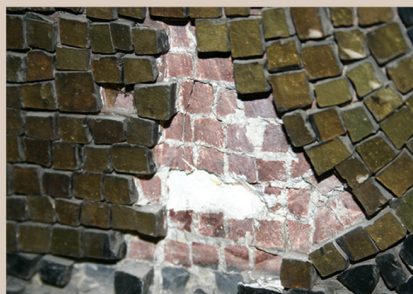
During this long time, Mosaics has tesserae is made on it, in accordance with the daily possible production of the exposed many continuing damaging factors, like rain leakage, dust and materials from cars exhausts and factories.

In addition to structural damages like the detachment of layers, due to the earthquakes which passed during this long time and vibration resulting from large cars around the building, which despite its simplicity, was enough through this long time to cause damages to the structure of the mosaic layers. In addition the infiltration of water and humidity that led to detachment of large parts from mosaic, separations was either between the first layer and the wall, or between the second and the first layer, or between tesserae and the second layer, whereas the latter case caused the fall of many cubes, and thus the appearance of (Lacunas). In addition to deep cracks extended in some cases along the width of the mosaic, and some human damages, such as using metal nails for fixing wooden frames on the edge of the mosaic, which penetrated the tesserae and the lower layers, and caused damages in many places, and one more reason is fixing electric lines which used for lighting the hall by nails inside the mosaics.

It should be mentioned that some previous interventions by the previous guardians in the last century, such as replacement of the lacunas by using the gypsum mortar then paint it to be similar to the original, these interventions has helped in stopping the continuation of damage and consolidation of the mosaic.

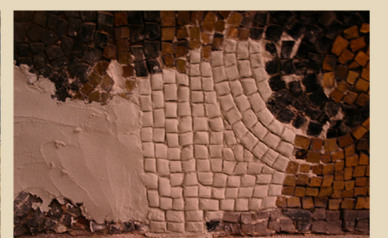
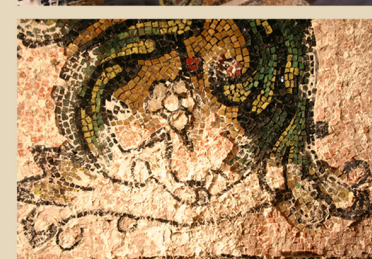
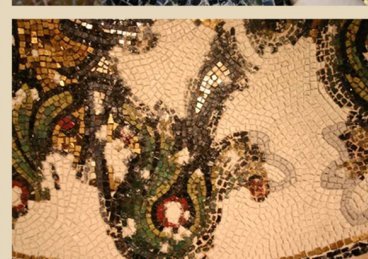
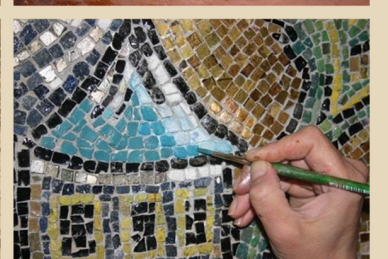
Important Note: The first idea for treatment of the lacunas, especially in the Mehrab, was by refilling the lacunas by new harmonious mortar with the environment, or cleaning the lacunas to show the original mortar layer, but after starting the cleaning process, the coloring layer (Sinobya) appears, which placed by the artist or the mosaic worker, this layer clarified the main lines of the drawing, and the color of cubes which placed above it, so then we changed our idea with new one, which includes creating new cubes from mortar and placing it in the lacuna, then coloring it by suitable colors and similar to original colors, especially in the Mehrab, due to the wonderful decorations used, and to its close location to the visitor, then we adopted this method to refilling the lacunas in the entire mosaics.

- Refilling the lacunas, by using the previously fallen cubes, or by using mortar, as a replacement of the missing cubes to create new cubes from mortar to be placed in the lacuna, and then colored by suitable and harmonious colors, in the final phase.

- Coloring the new cubes of mortar, by suitable constant colors, and very close degree to the original color.

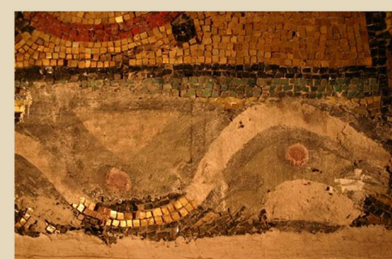
BEFORE

AFTER
