# CONDITION, PROBLEMS AND PRESENTATION OF THE MOSAICS IN MEDIANA, SERBIA

Dr Gordana Milošević, Faculty of Architecture Belgrade  
Vesna Cmoglavac, National Museum Niš  
Dr Nadežda Gavrilović, Archaeological Institut Belgrade

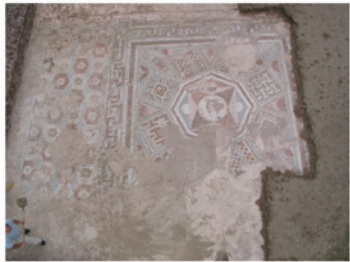
## MOSAICS IN VILLA WITH PERISTYLE (1)

Mosaics were lifted, conserved and put back during 1972-1973. They were covered with sand since then. The mosaic floors which covered the whole of the peristyle porch and the audience room (aula) are in good state of preservation.

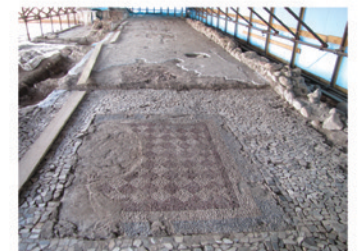
## MOSAIC IN THE CORRIDOR (1c)

Mosaic has a lot of damage in the form of lacuna, cracks and detachment of tesserae. It was once again re-buried in 2011 when cleaning was done in part by large deposits of dirt and lime mortar seals were put. Also, some investigation treatments were done as preparation for conservation of mosaic in situ that is planned in 2012.
