Mosaic conservation planning and implementation at the site of Bulla Regia, Tunisia

Thomas Roby*; Livia Alberti~; Cristina Caldi~; Ermanno Carbonara^; Moheddine Chaouali°; Leslie Friedman*

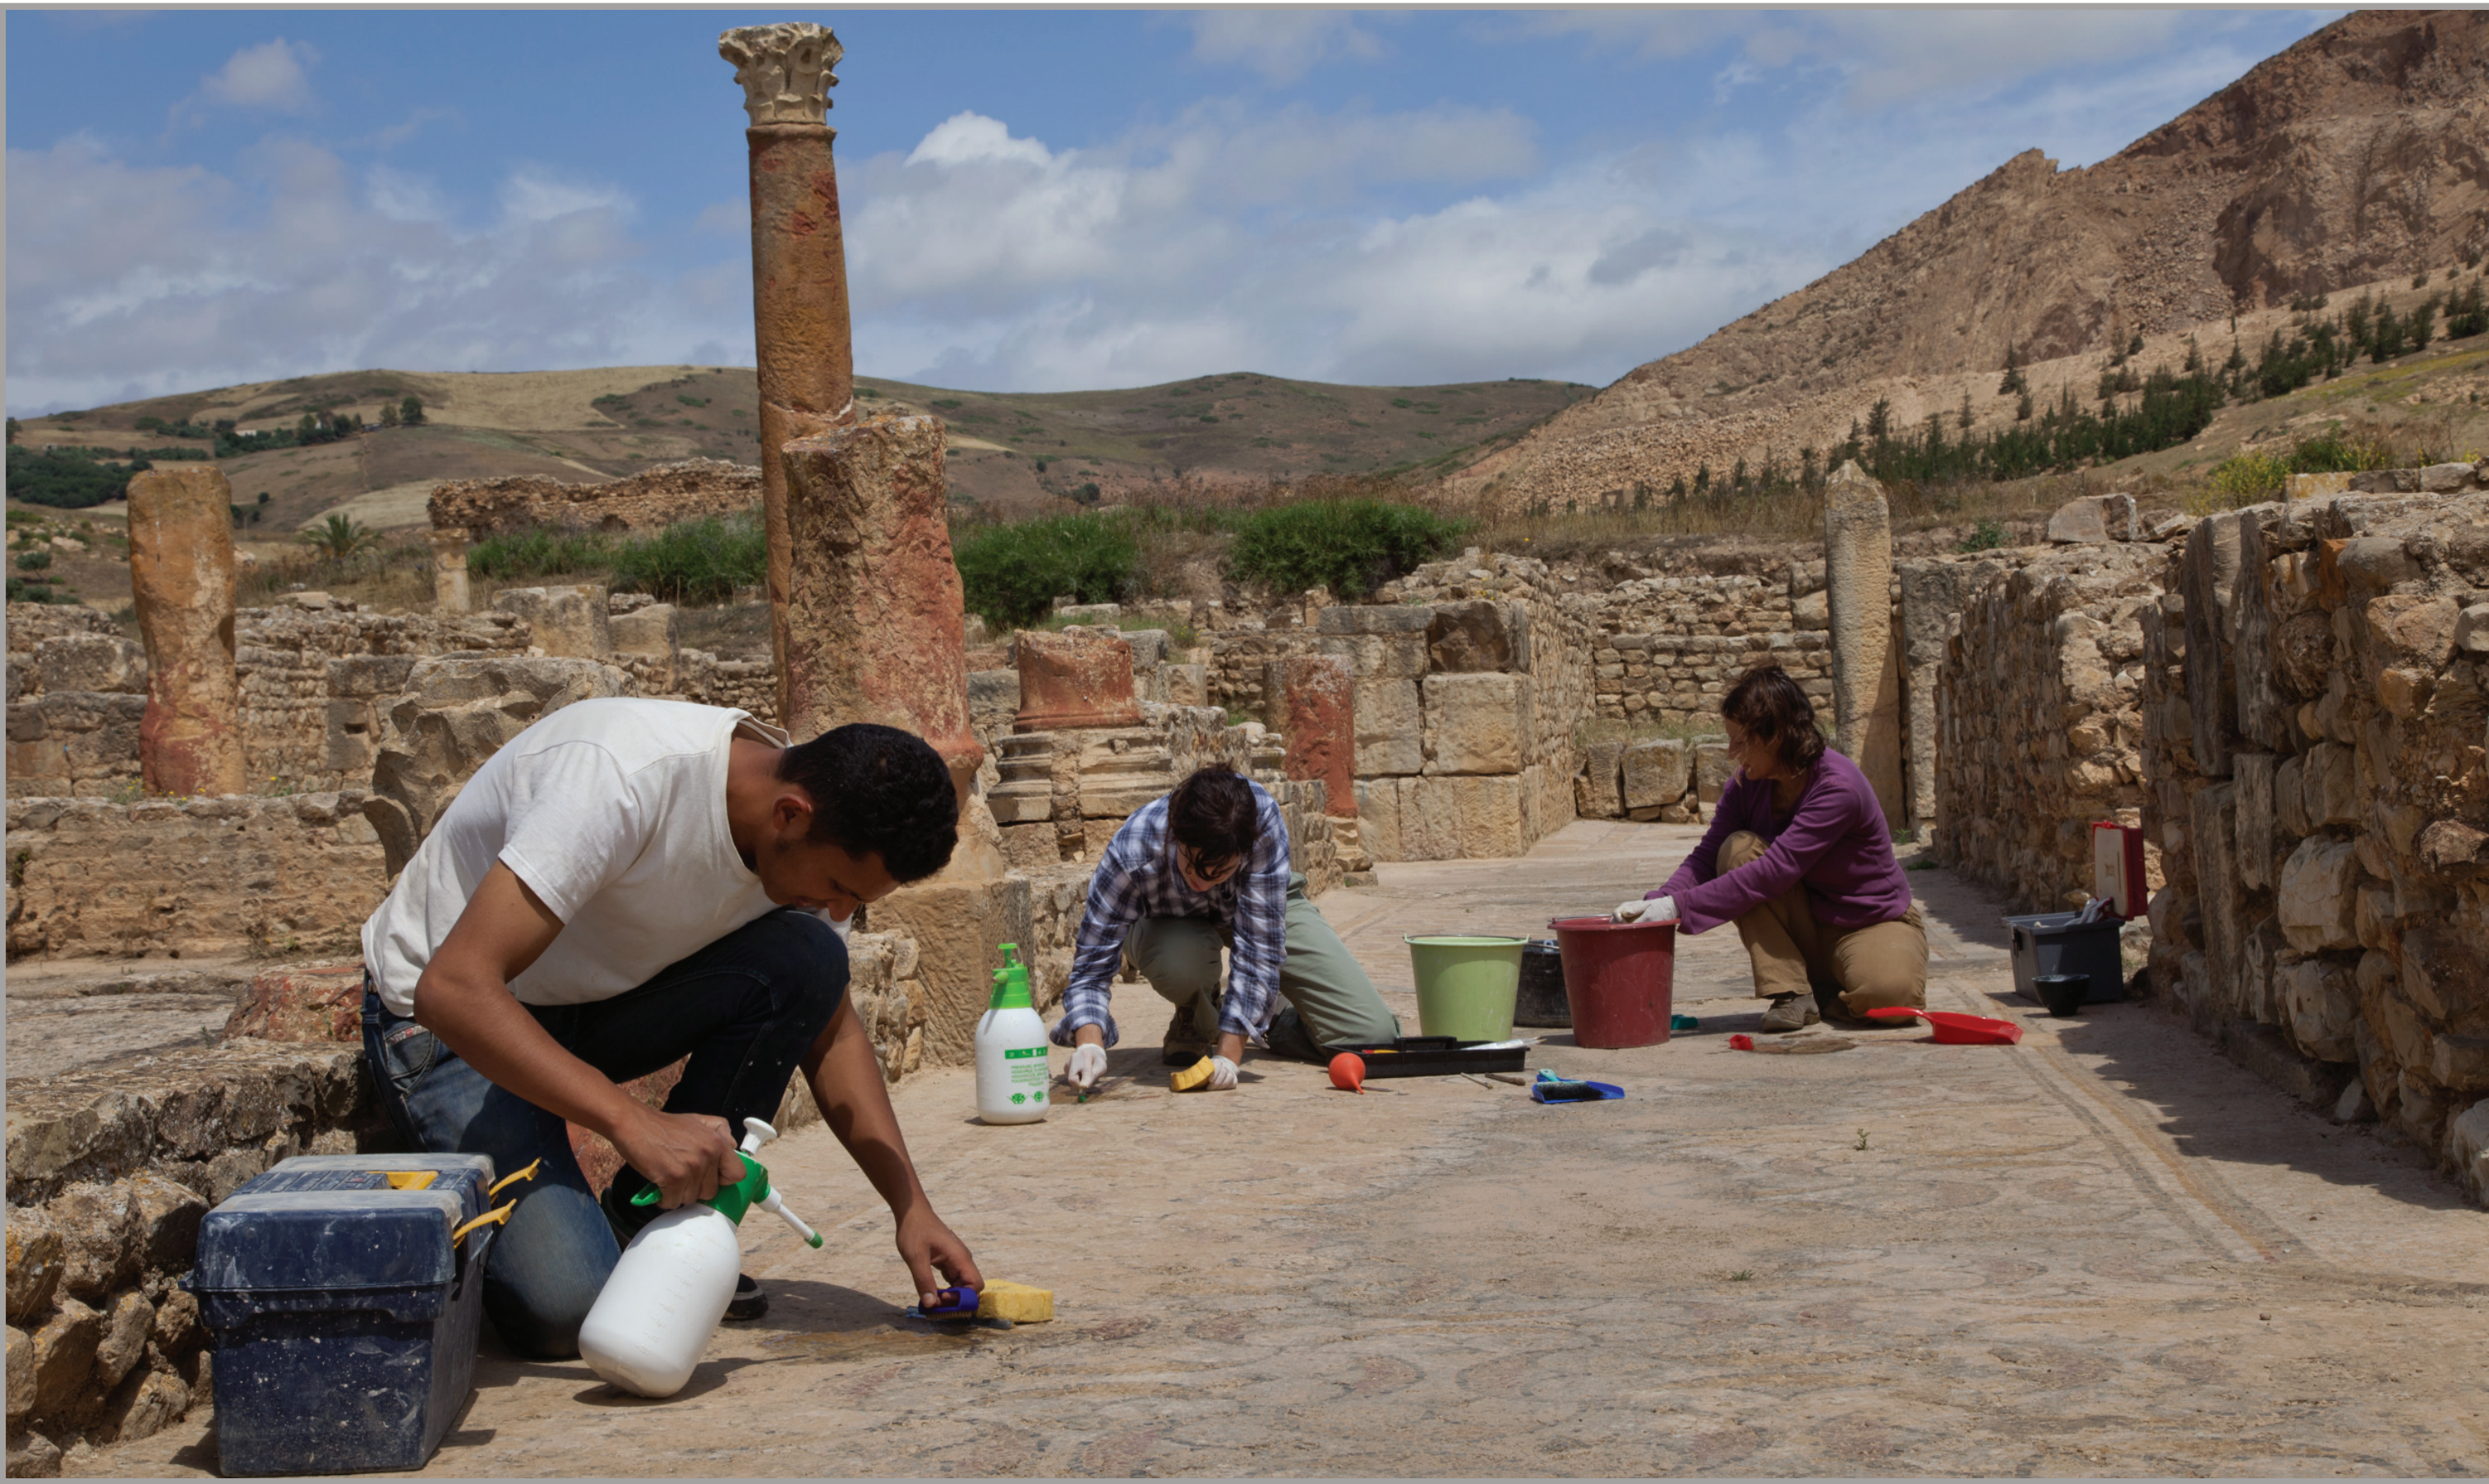
Recently trained INP technicians with periodic GCI supervision conserving the mosaics of the Maison de la Chasse. Photo: Scott S. Warren © J. Paul Getty Trust.

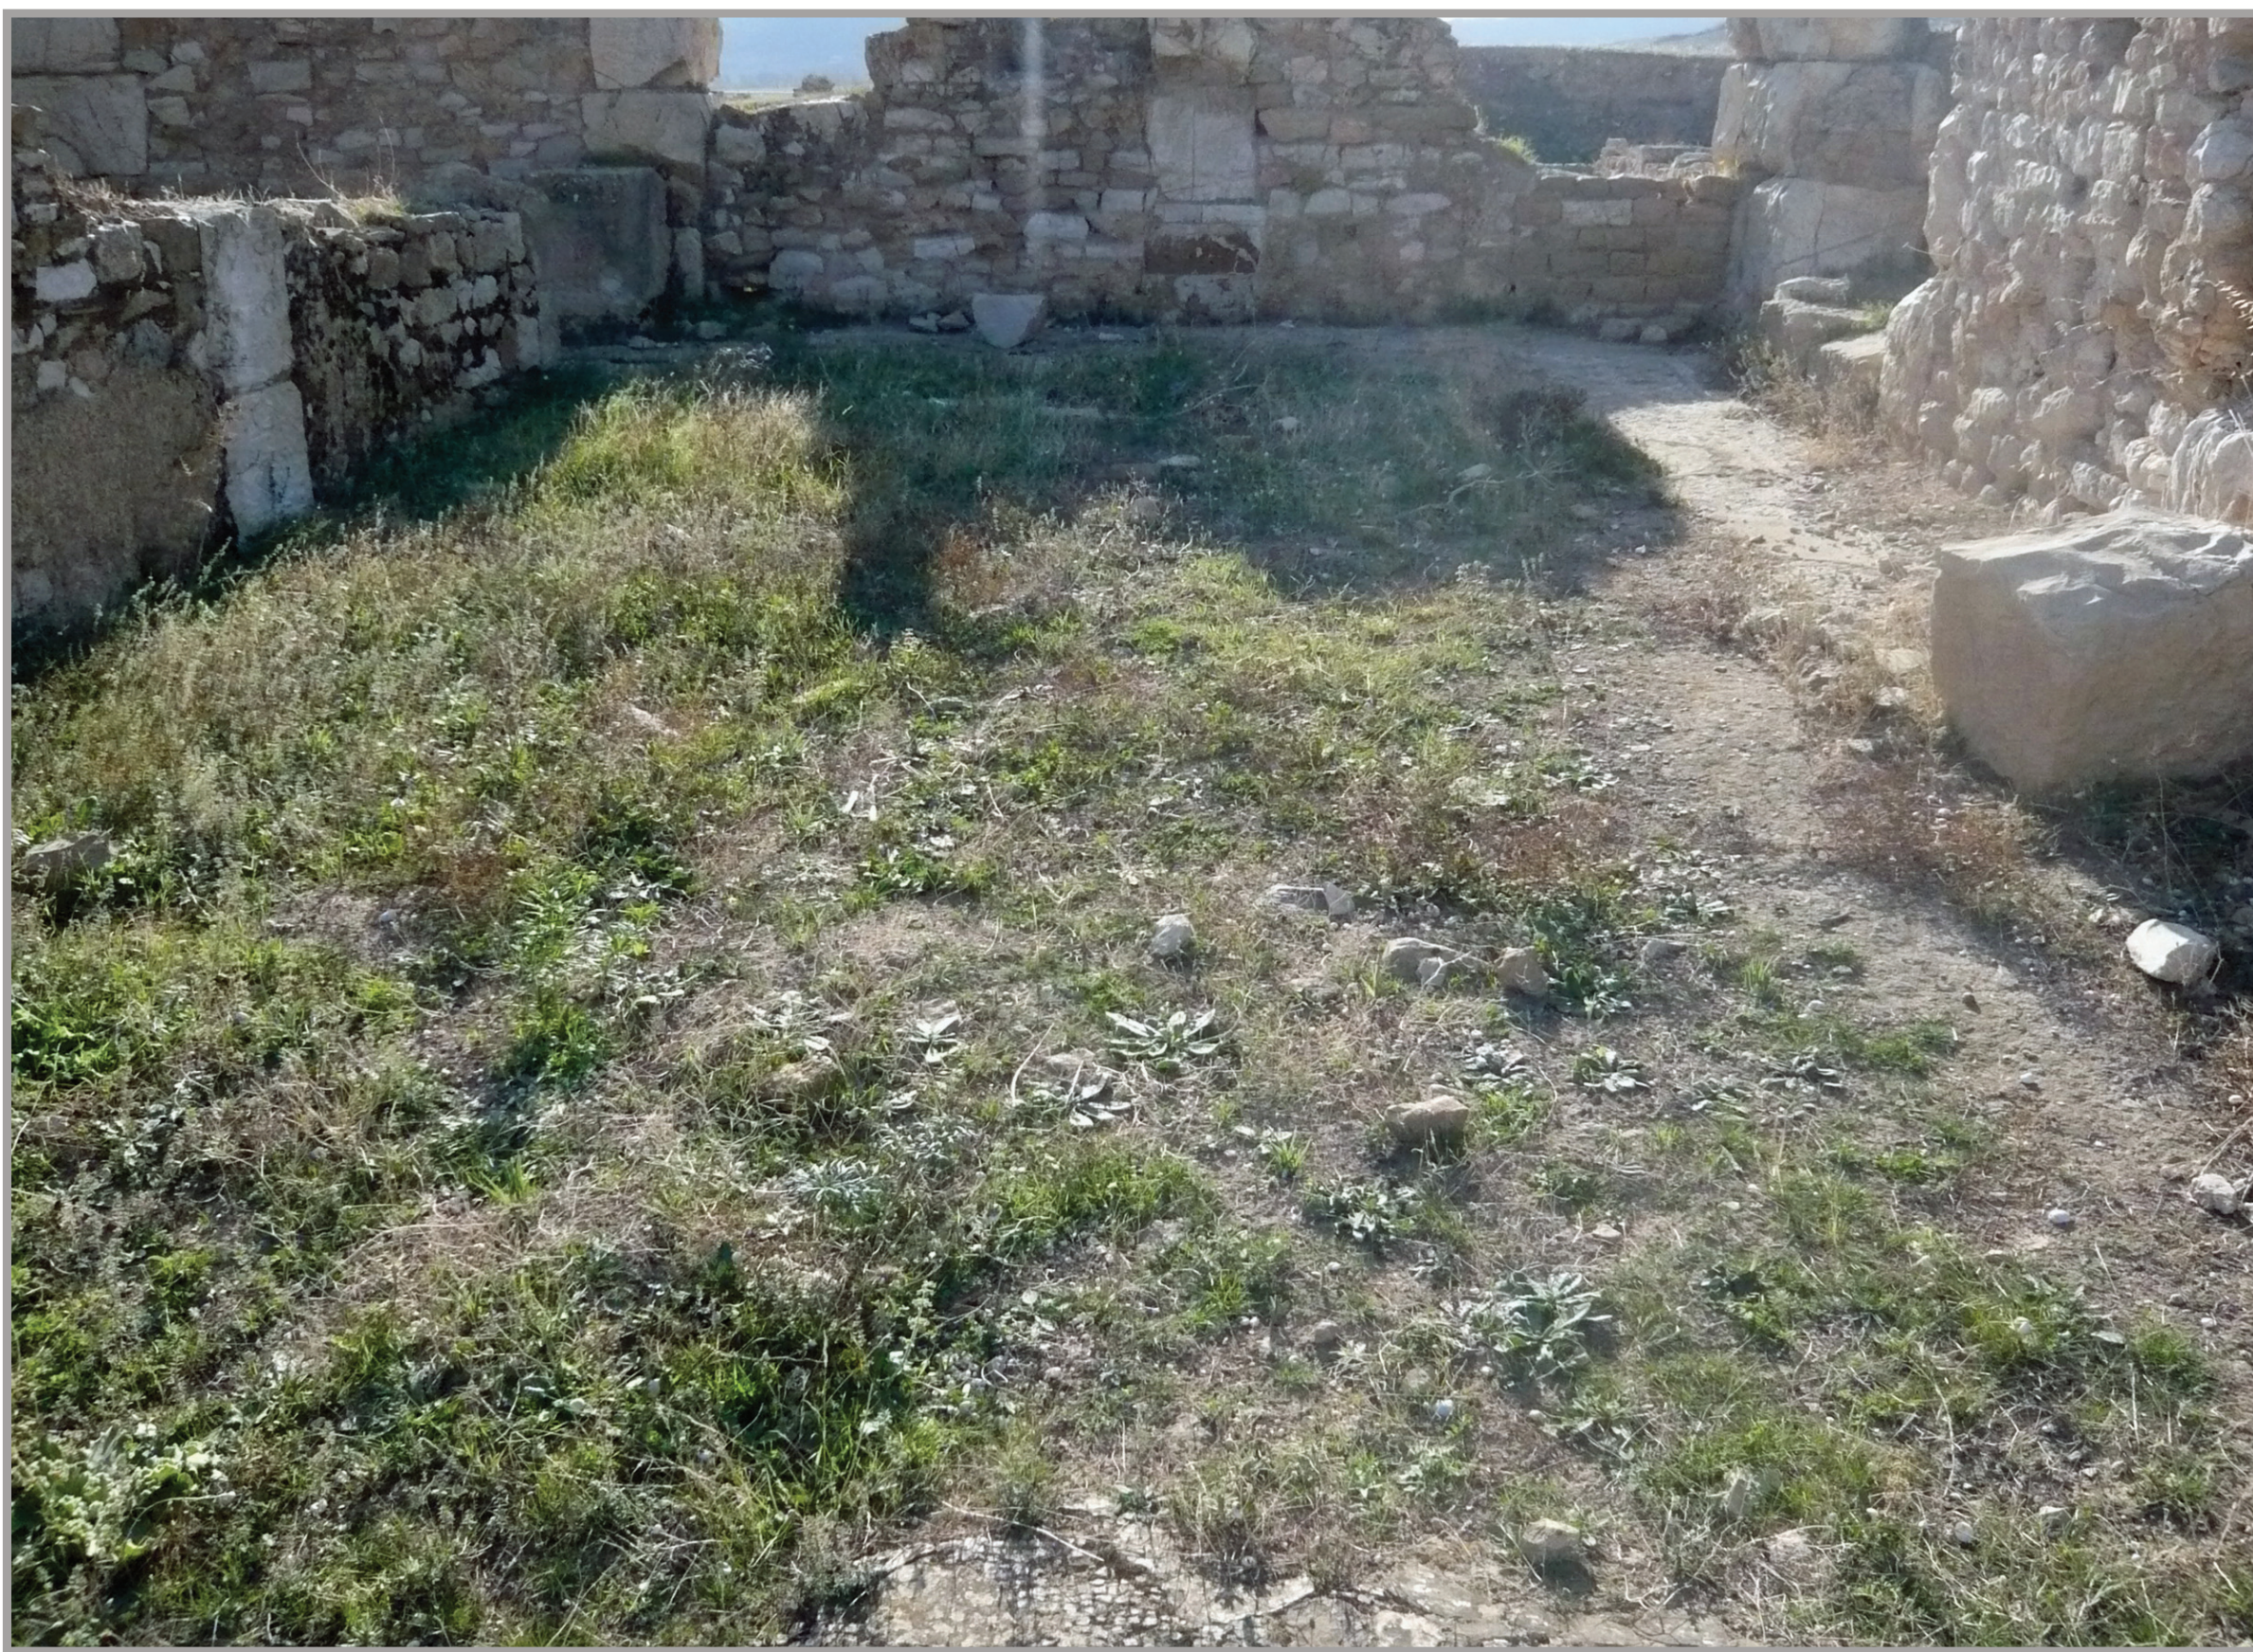
One of many abandoned mosaics in very poor condition throughout the site of Bulla Regia. Photo: Livia Alberti.

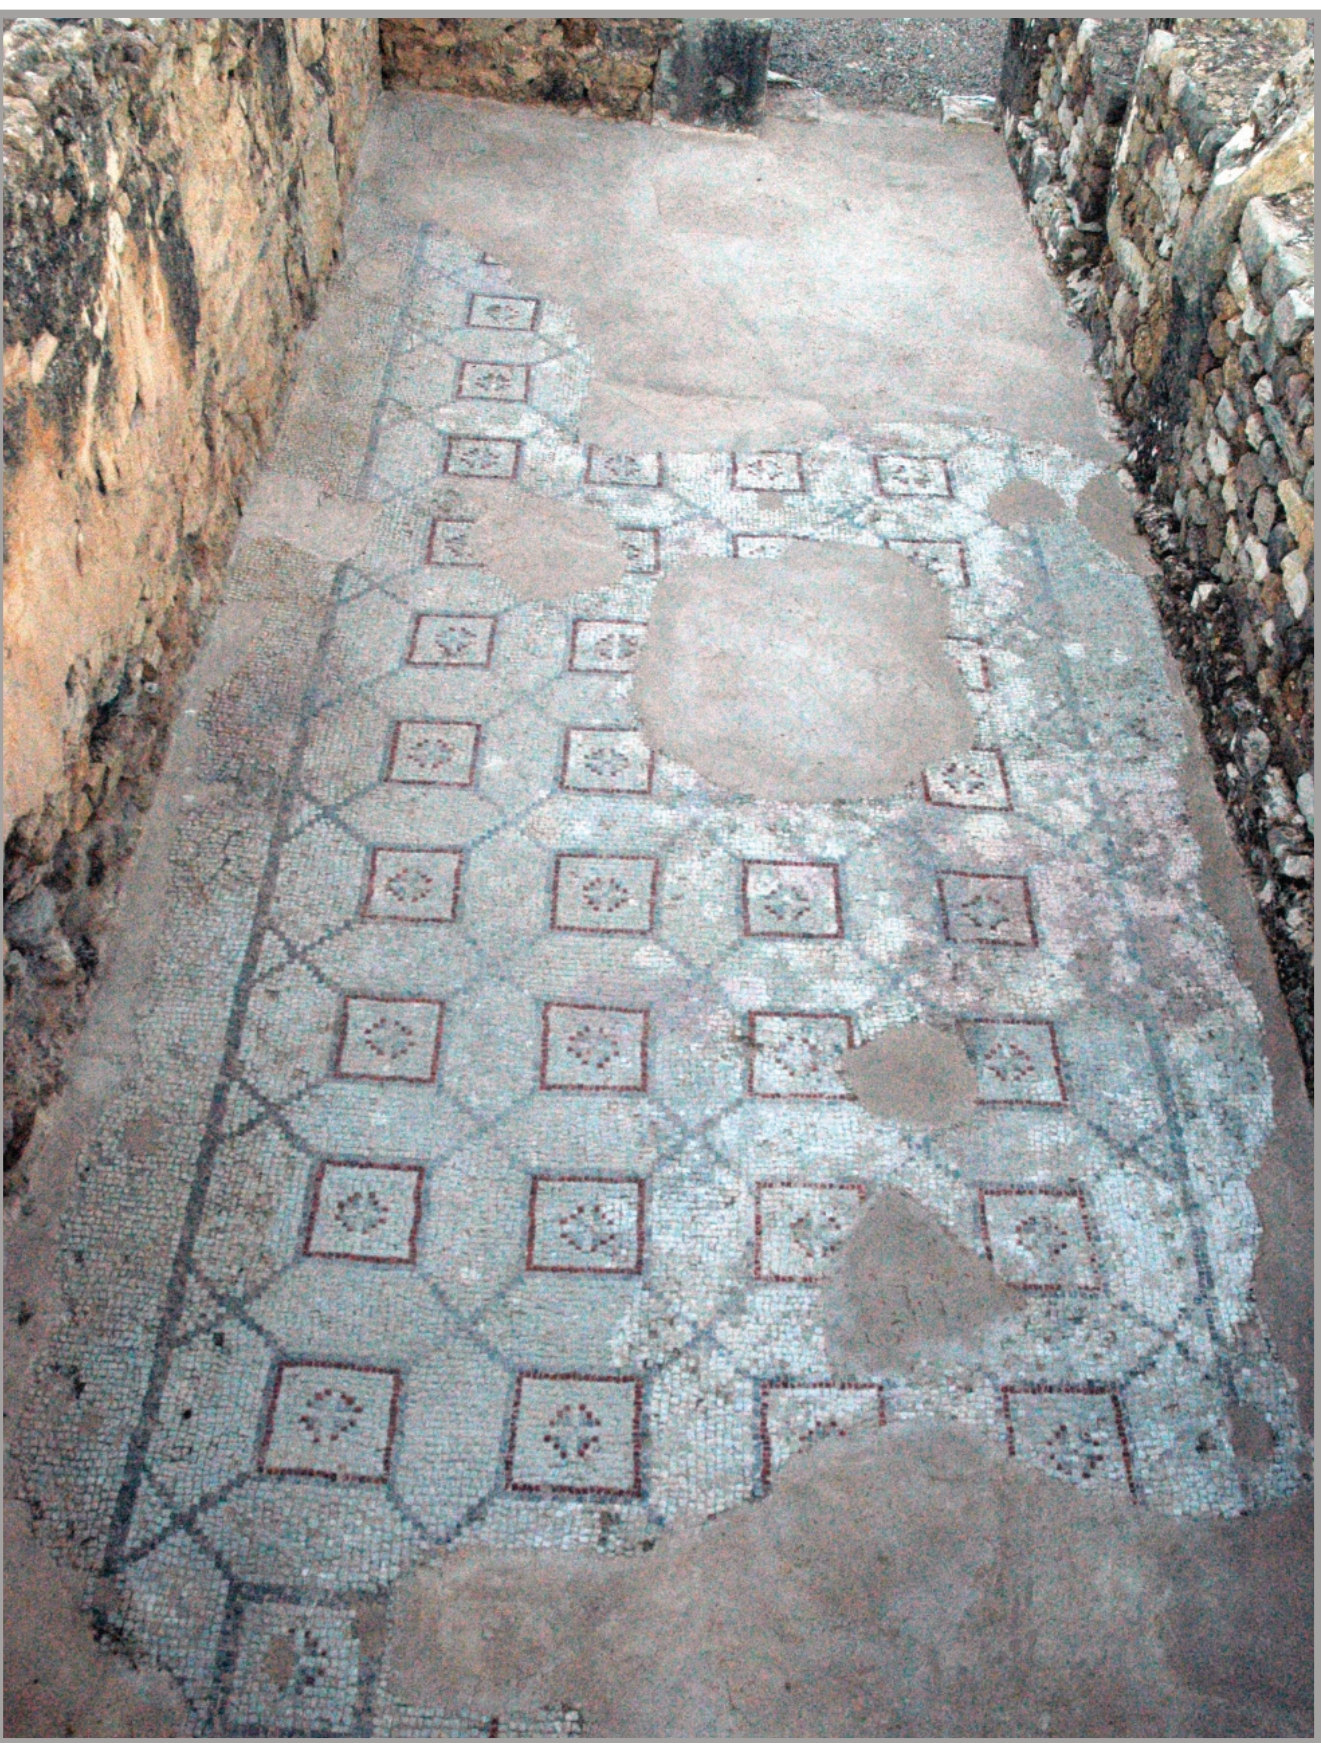
A mosaic after recent maintenance treatments by INP technicians based at the site. Photo: Ermanno Carbonara.

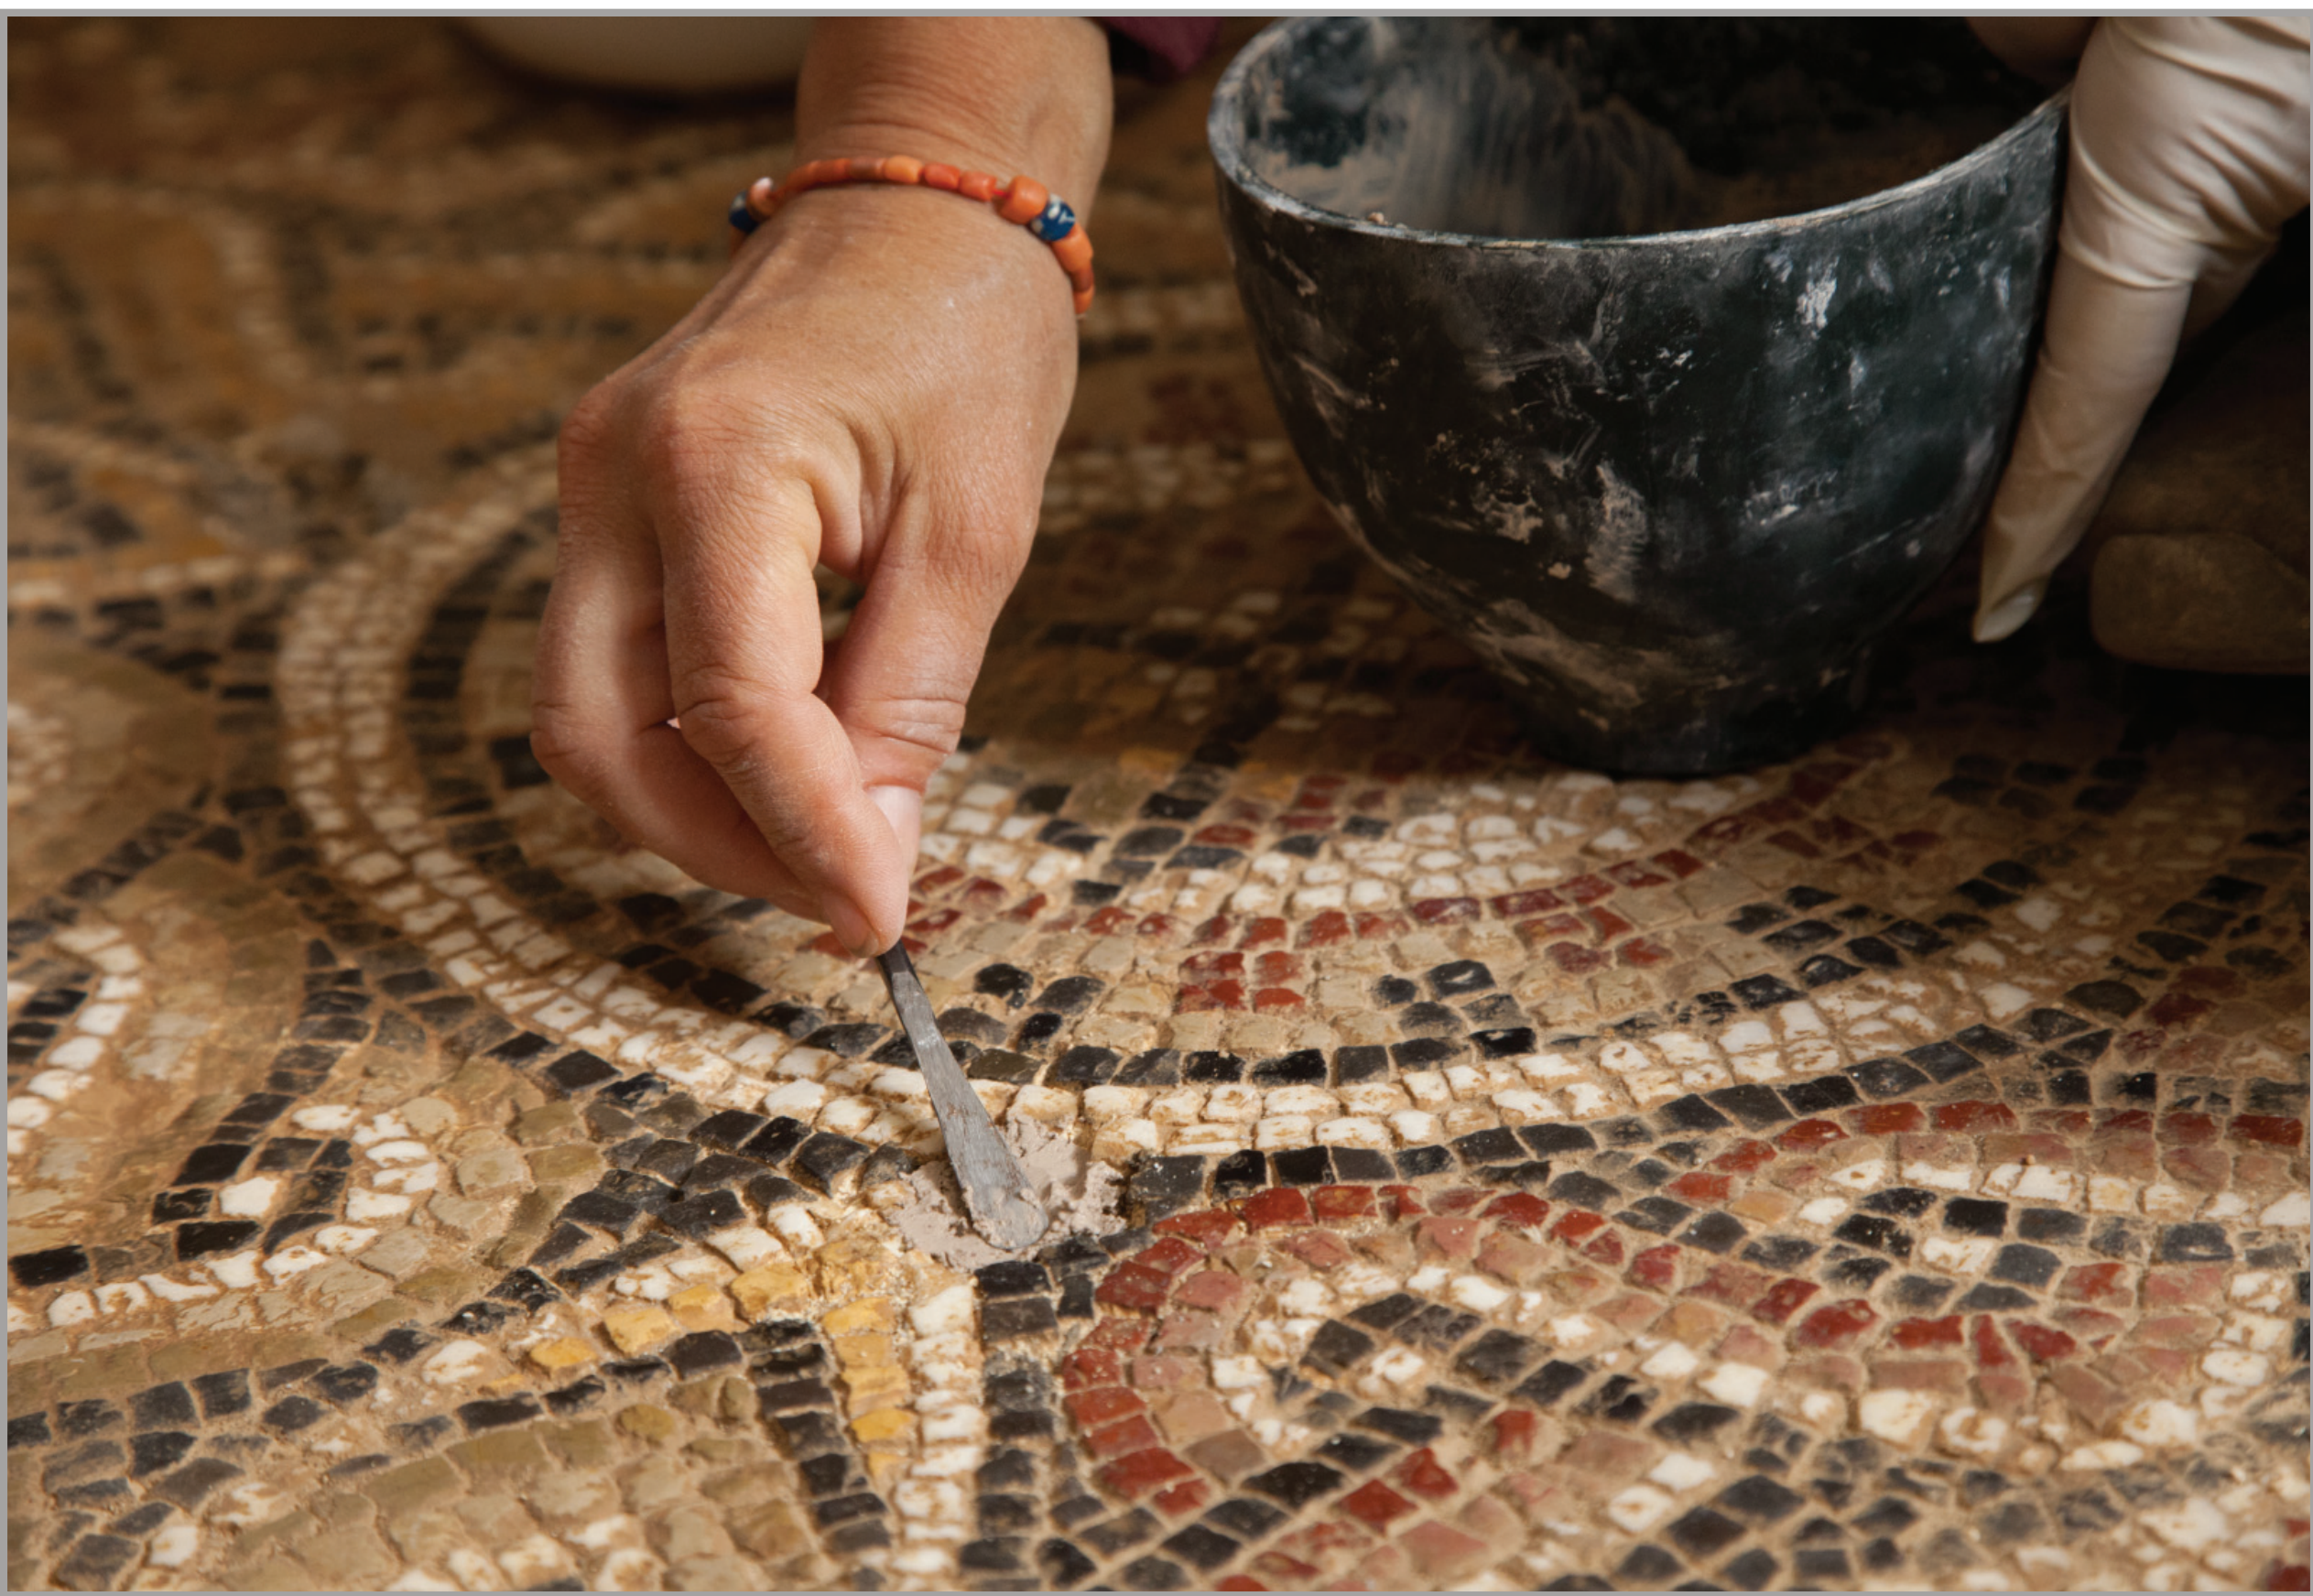
Infilling of a lacuna using lime mortar, a common maintenance operation. Photo: Scott S. Warren © J. Paul Getty Trust.
