Learning from the consequences of inappropriate lifting methods: Case studies at the Mosaic Conservation Lab in Hama, Syria

Anna Tsoupra¹, Ali Al Ahmad², Nader Lada³, Georgios Misemikis¹, Stefania Chlouveraki¹

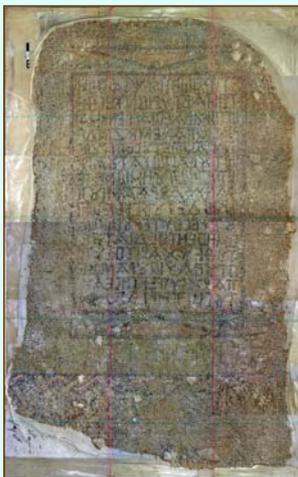
Mapping of losses caused by inappropriate lifting methods on the inscription from the Early Christian mosaic of the Basilica of Abu Rubeiss

The losses were documented and mapped at the back side of the tessellatum on a photomontage that was prepared in the Hama mosaic laboratory as part of the training process

- Cracked/broken tesserae
- Remains of surface flakes of tesserae
- Total loss of tesserae
- Remains of original mortar on the surface
