Managing archaeological parks with *in situ* mosaics in Ljubljana, Slovenia

evaluation, conservation and maintenance

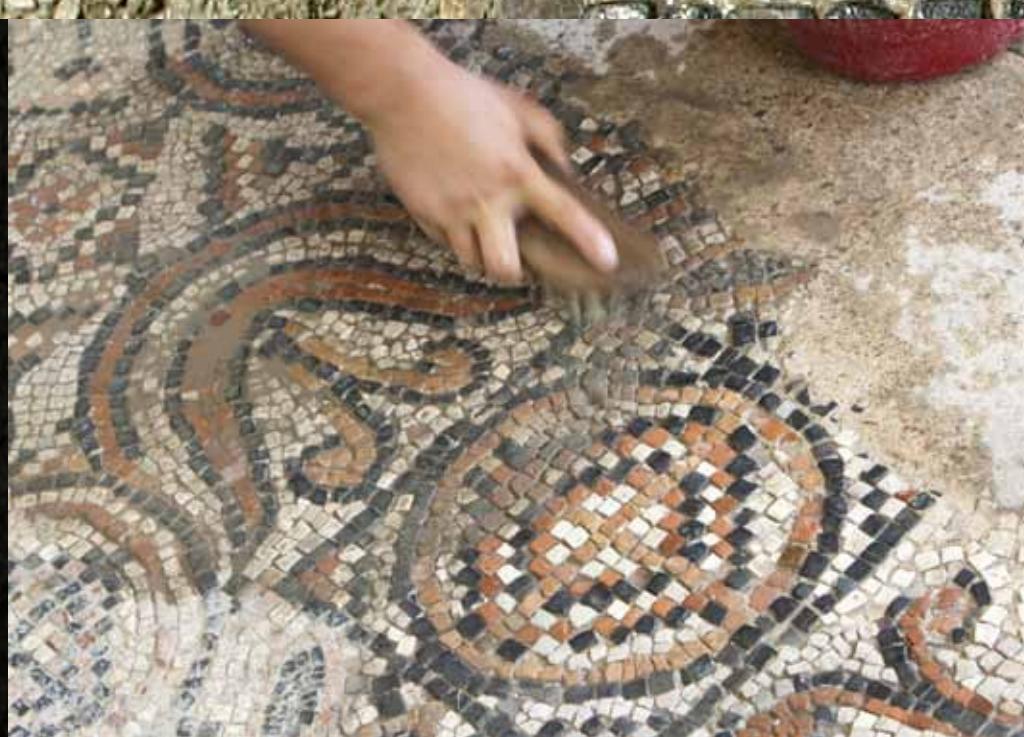
Maintenance of mosaics in the Early Christian Centre archaeological park is demanding. Many of the tesserae are made of ceramics, not stone, thus making the mosaic more susceptible to climatic and other influences. Moreover, no visitor paths have yet been built to prevent visitors walking on the mosaics. The photo shows the regular mechanical cleaning of the mosaics, which is fully documented by a camera suspended beneath the roof.

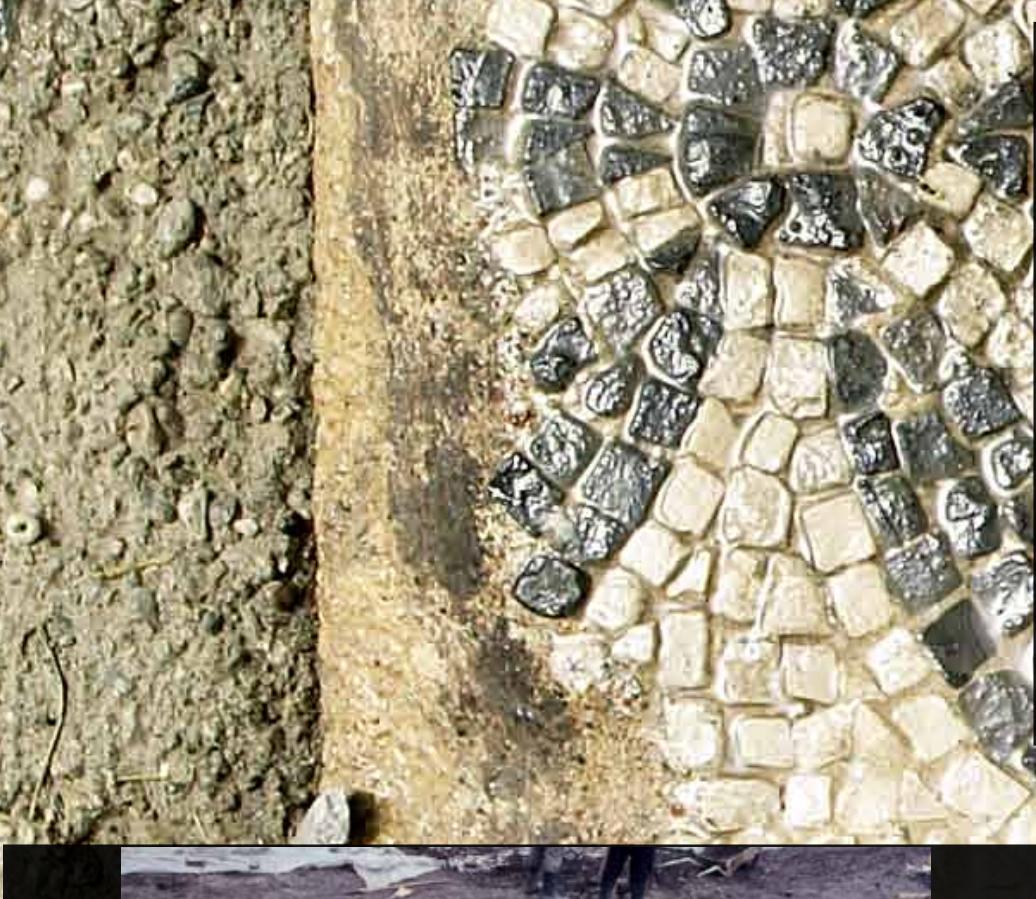
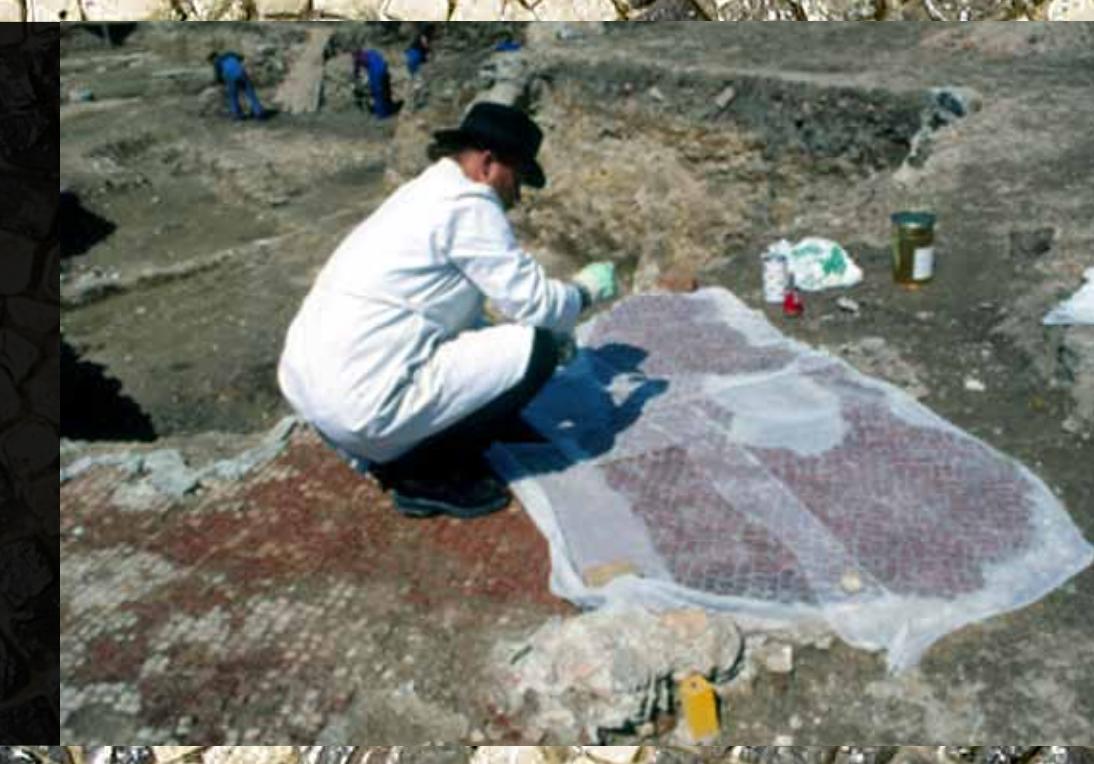
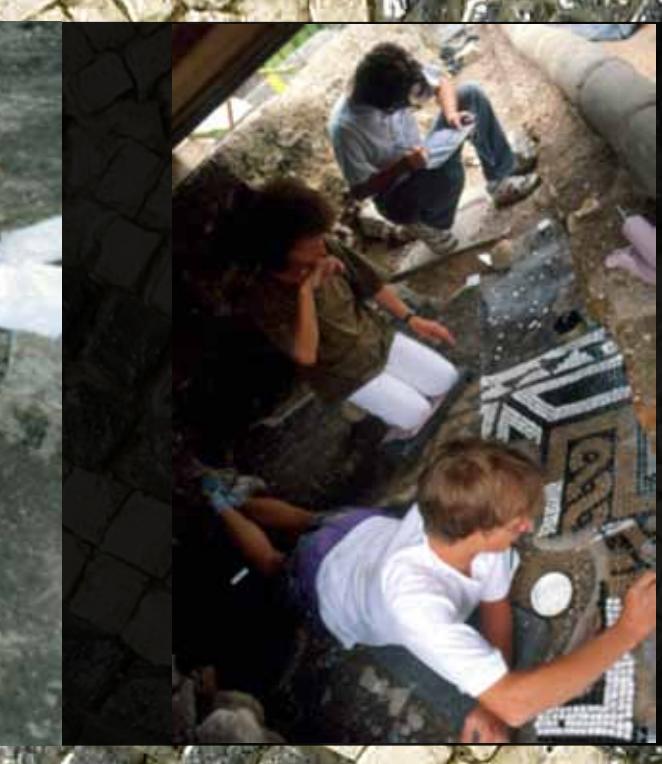
Several Emonian mosaics are not exhibited *in situ* but stored in the depot. They have been carefully documented during the archaeological excavation, and then lifted and consolidated. Some of them have already been conserved and prepared for exhibiting. Others remain stored in protective packaging in a controlled environment.

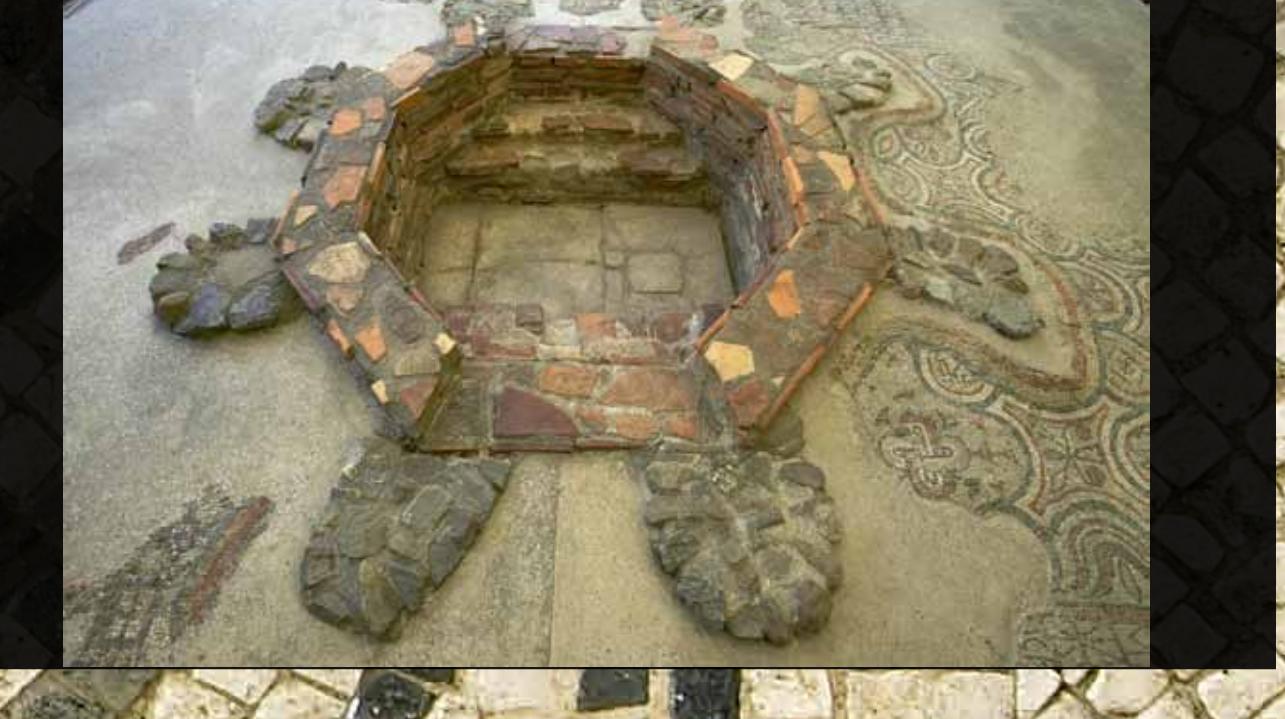
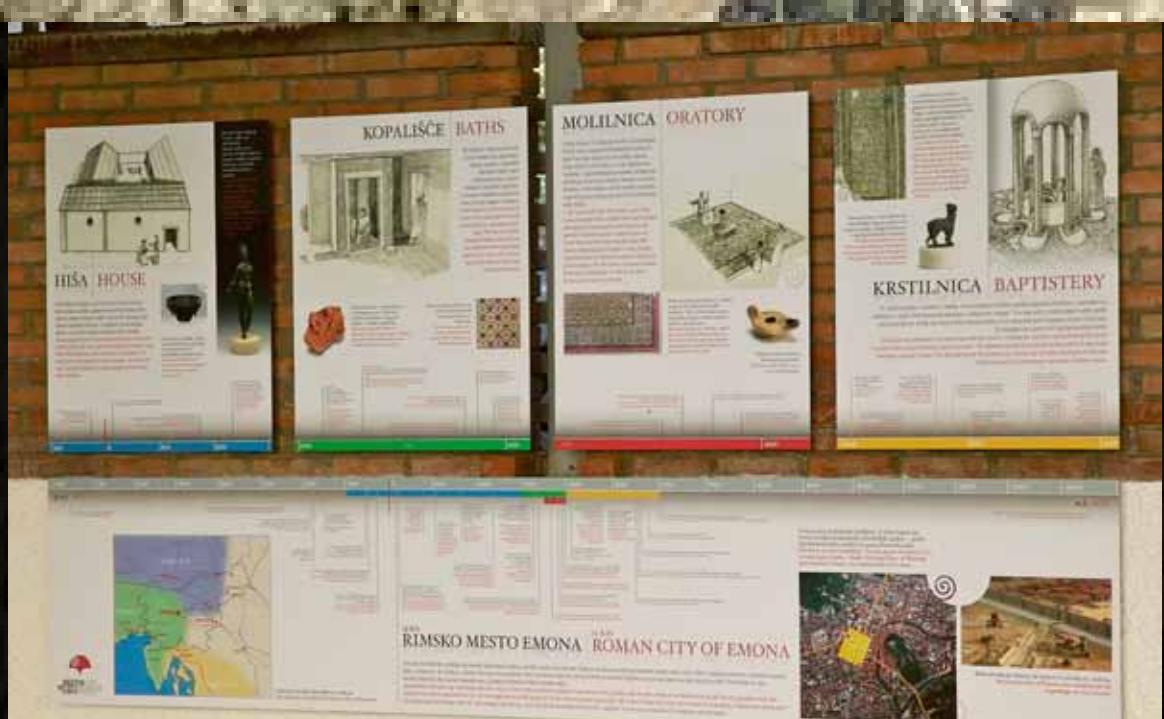
During the archaeological excavation, the decision to preserve the Early Christian baptisterium with adjoining mosaic was made. The mosaic was temporarily lifted, the baptisterium and the surface consolidated, and a drainage system installed. Then the mosaic was mounted on the pre-prepared surface. After 35 years, the presented baptisterium with mosaic is still in a very good condition.

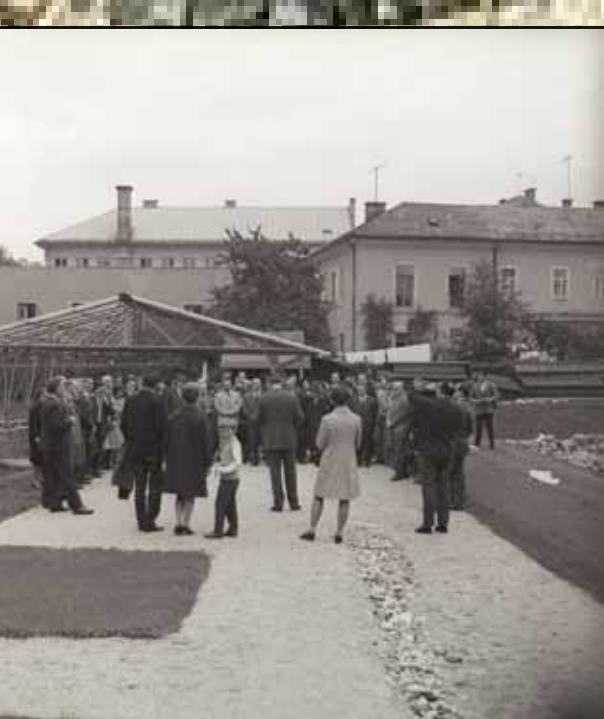
Late Roman mosaic in the Emonian House archaeological park. In 1964 the mosaic was lifted on several panels and put back in place after structures and consolidation had been completed. Today, cracks on the seams between panels are visible. The roof has proved inadequate in terms of both function and design, and we plan to replace it with a larger one.

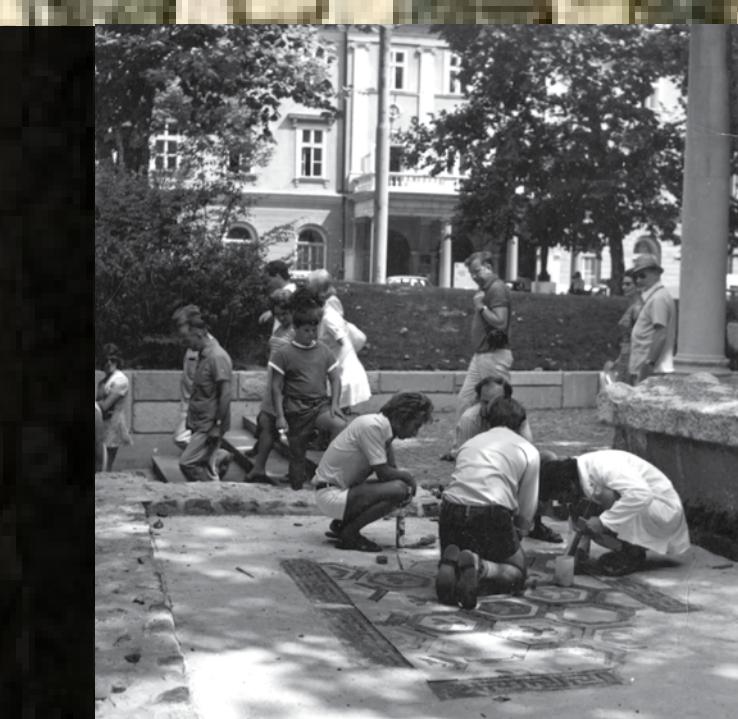
Not all endeavours to present Roman mosaics *in situ* have been successful. The photo shows the mounting of a mosaic in one of Ljubljana's public parks in the 1970s. Due to the poor implementation and unsecured location, the mosaic was dismounted shortly afterwards and today is kept in the museum depot.
