BAROQUE TARSIA IN VENICE: TWO CASE STUDIES OF A PARTICULAR MAKING PROCESS

Basilica di Santa Maria della Salute

Basilica dei Frari, S. Antonio Altar

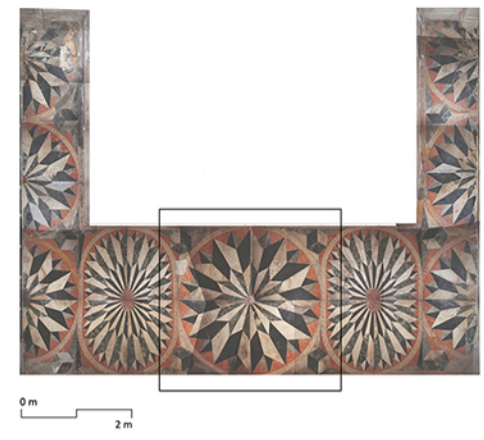
Basilica dei Frari, S. Antonio Altar floor

□ Stone slabs settled on a rosin layer
■ Stone slabs settled on a grout layer

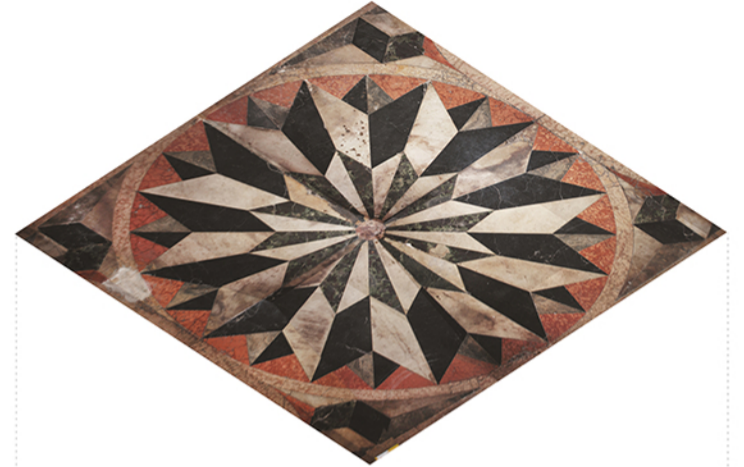
Sanctuary area: use of different kinds of mortars, employed side by side with no differentiation, to settle the marble slabs.

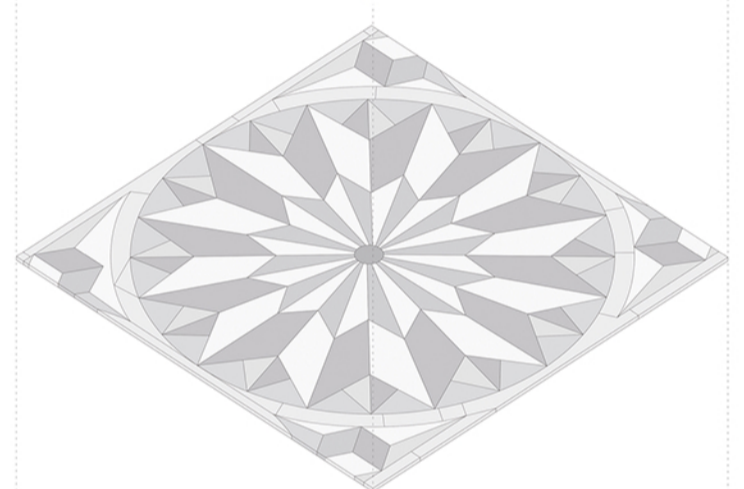
Sanctuary area: fragments of mortar behind the stone slabs. Between the two mortars' layers there are numerous stone fragments. These can be due to the use to perfect the slabs one by one *in situ* before the settlement.

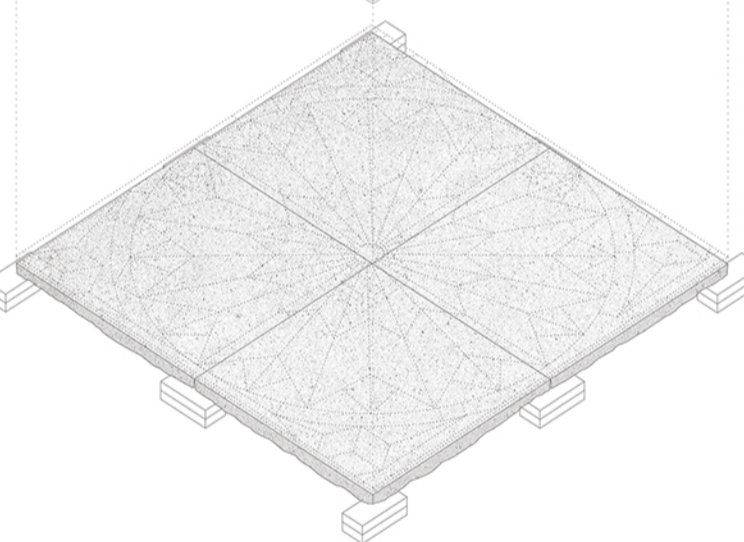
Altar front side: where the floor is isolated from the building structures, the stone slabs are in quite good conditions. Fractures and deformation occurred just alongside the *steleri* edges.
