# THE PAVEMENTS OF THE ROMAN SITE OF COSTA DE LA SERRA (LA SECUITA, TARRAGONÈS). A MULTIDISCIPLINARY STUDY

The aim of this poster is to briefly present the first results of an interdisciplinary investigation developed by archaeologists, conservator/restorers and archaeometrists on a set of mortars recovered from the destruction levels of Costa de la Serra site. The samples have been analysed by means of scanning electron microscopy coupled with an energy dispersion X-ray spectroscopy analyzer (SEM-EDX), x-ray diffraction (XRD) and petrographic inspection through thin section analysis (PE). The goal was to determine the composition and method of preparation of these mortars to enable establishing their type and function, prior to undertake the conservation and restoration work. Besides, we intend to highlight the interest of this type of pavement, often underestimated, as well as to emphasize the importance of multidisciplinary teams contributing to the preservation of our heritage.

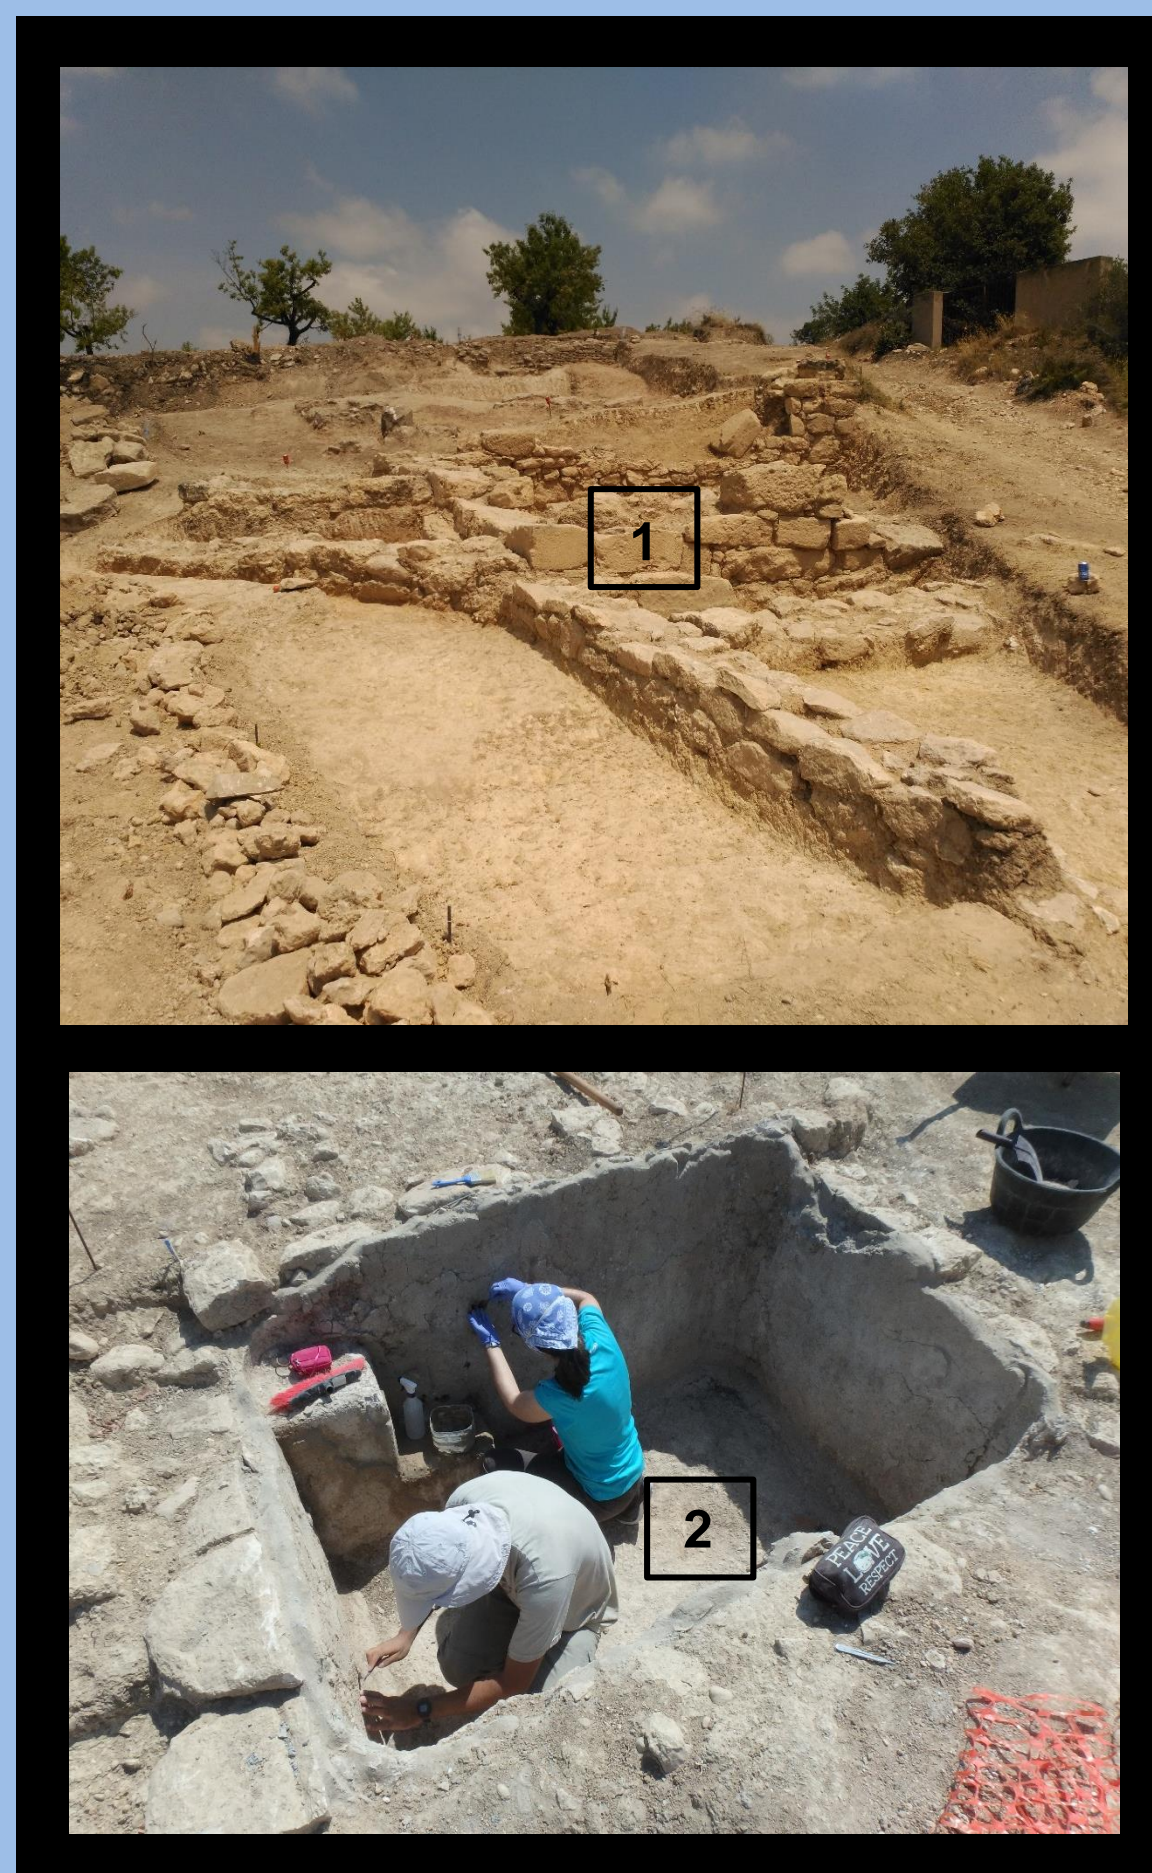
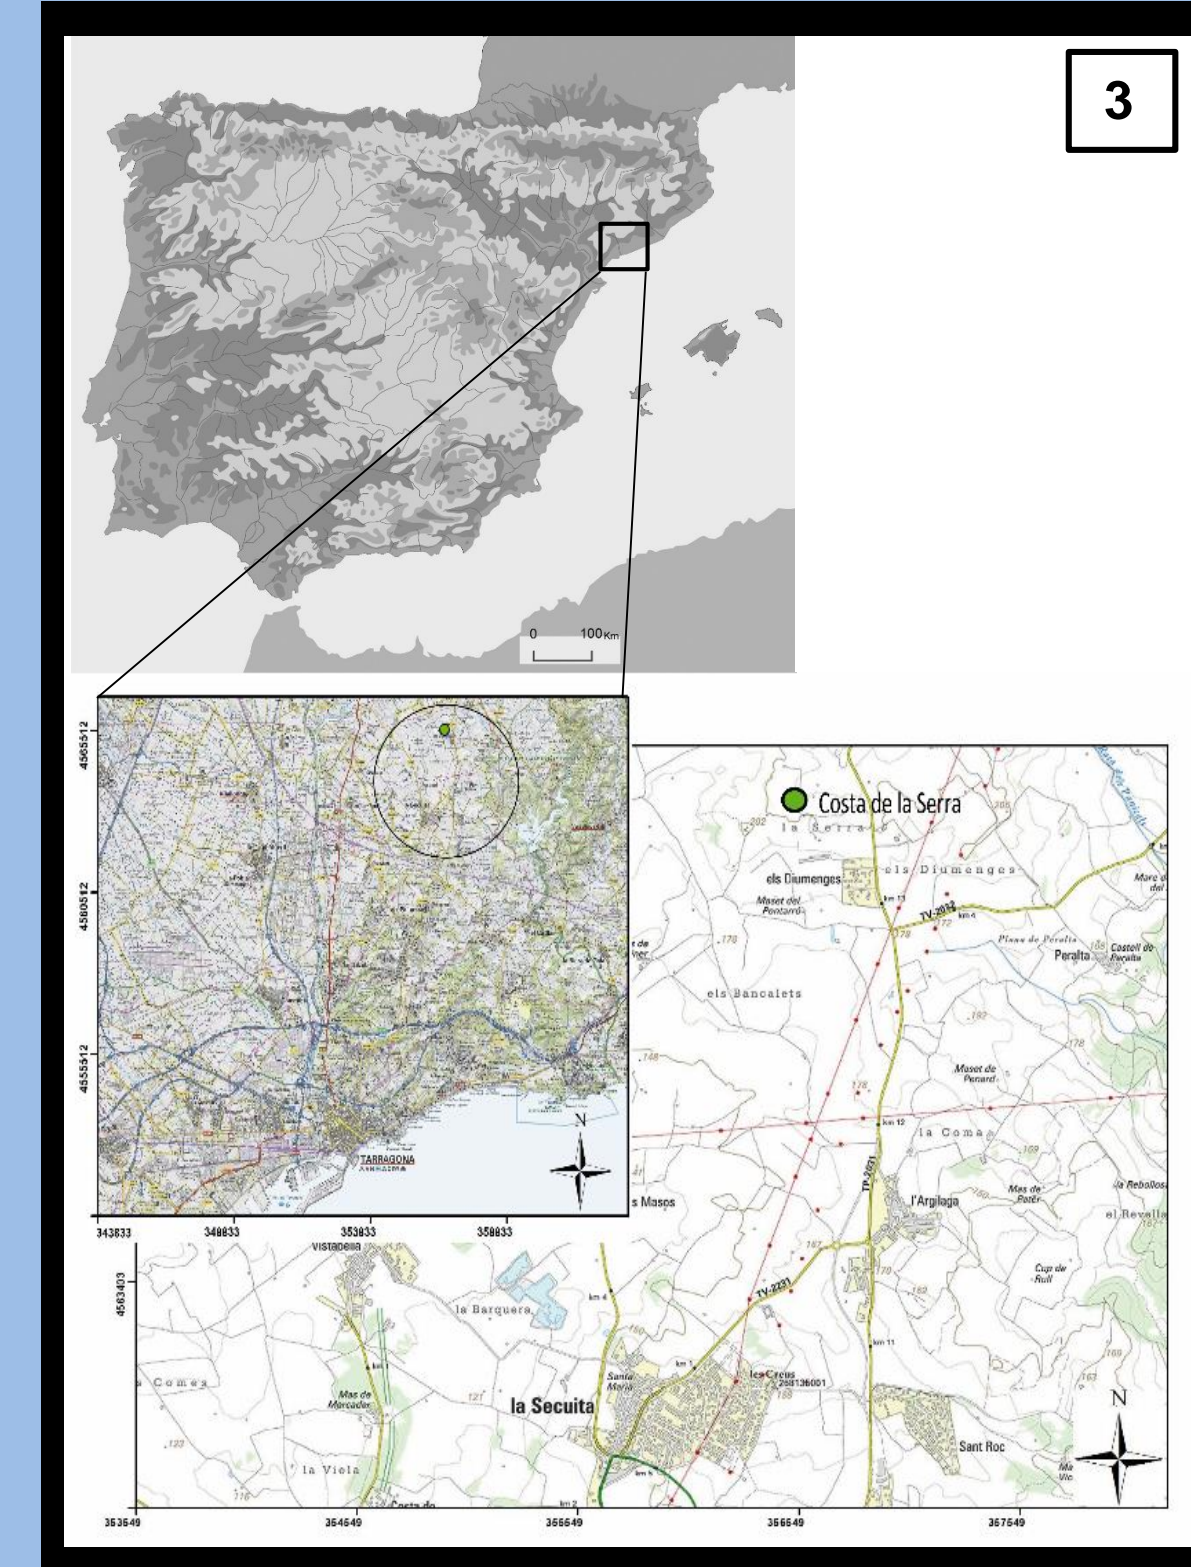
1. Detail of the tower located at the SW of the fortification and structures related.  
 2. Cistern located on the upper zone of the site. Consolidation work in progress.  
 3. Location of the site of Costa de la Serra (La Secuita, Tarragonès).

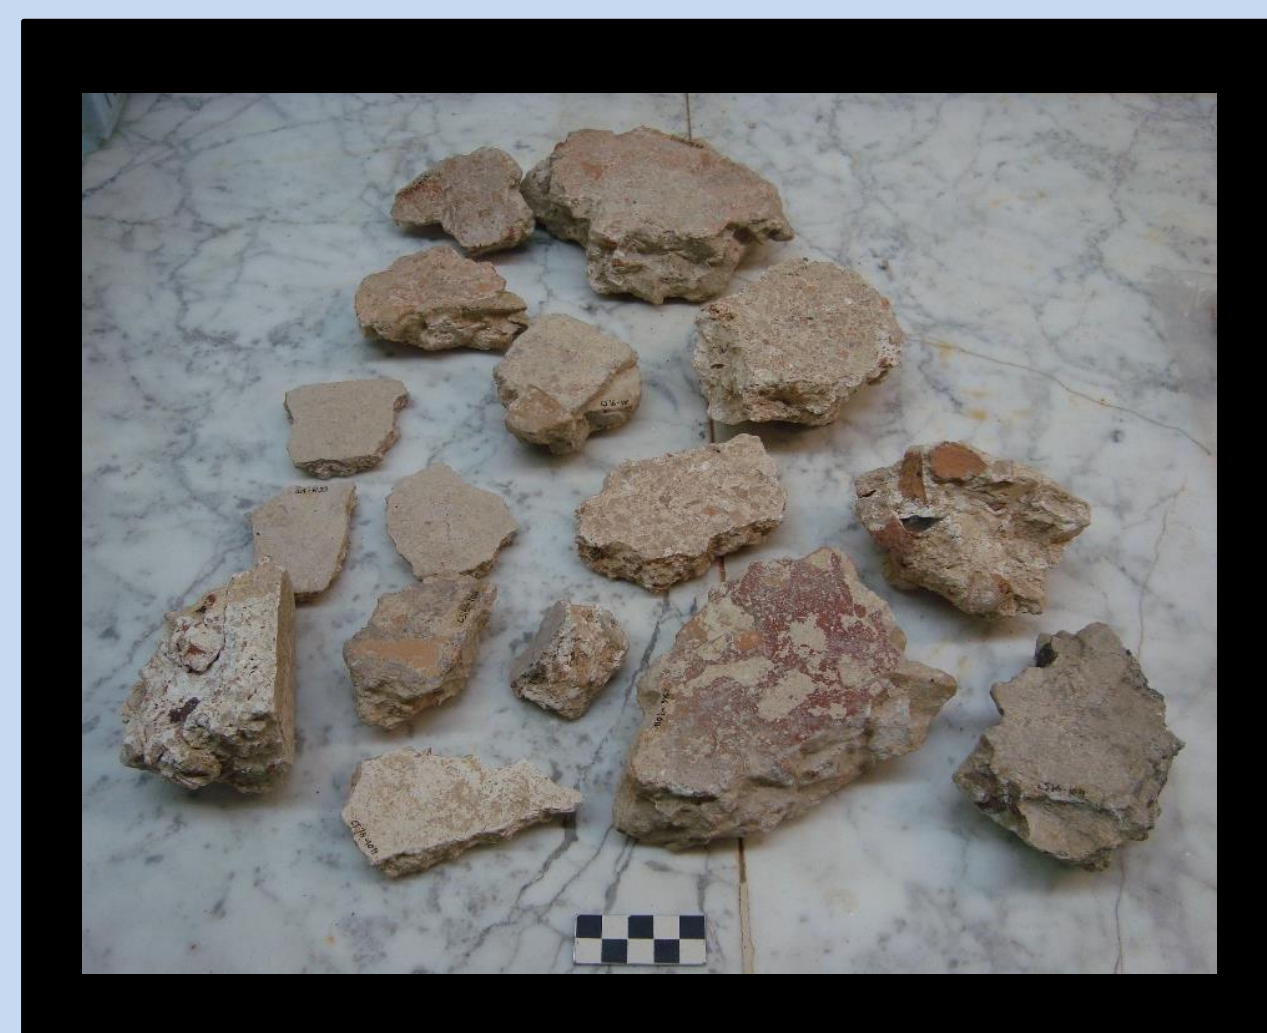
Different fragments of mortars recovered at Costa de la Serra

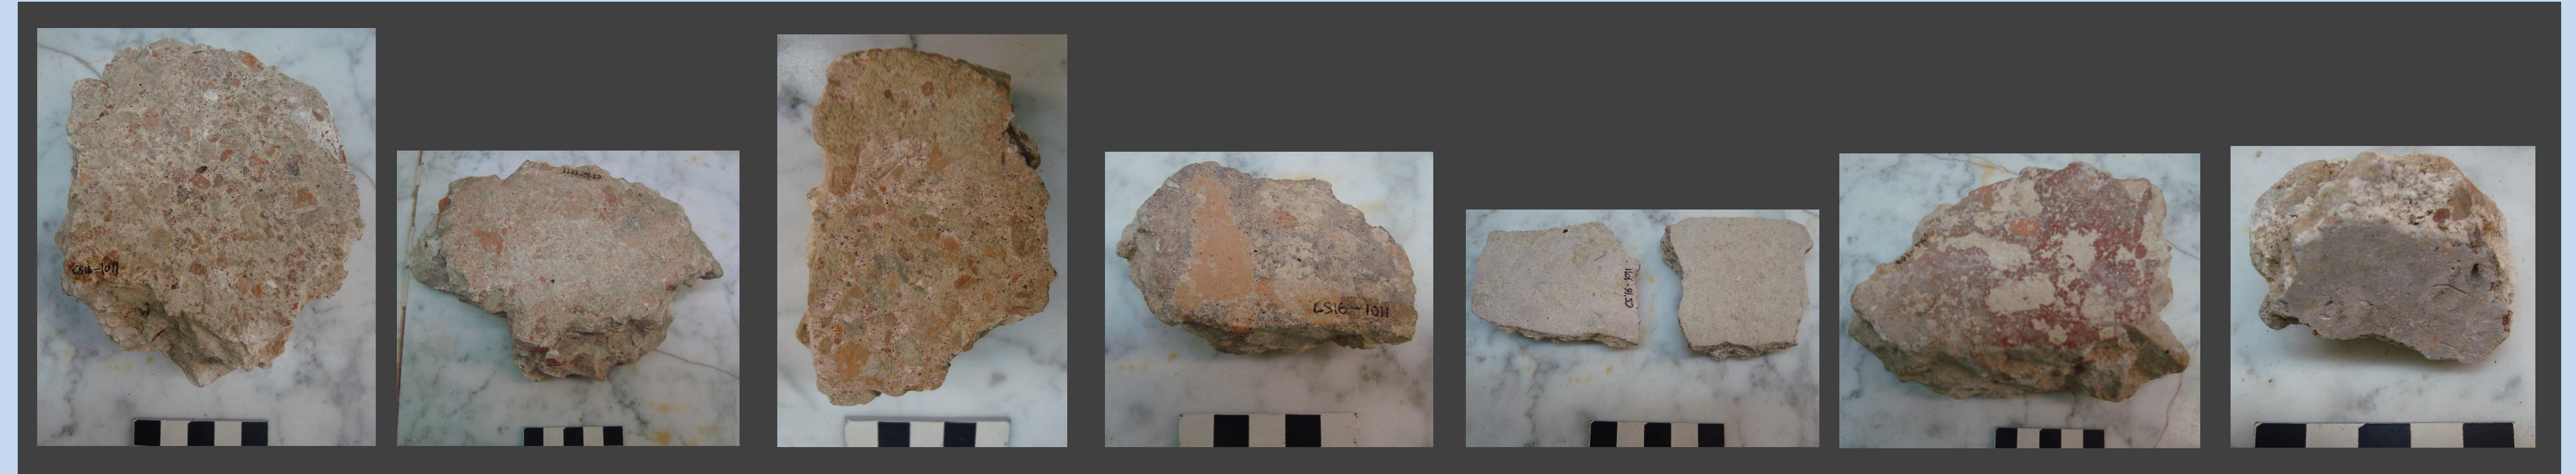
**Mortar:** made up of ceramic fragments of small size in the upper preparation layer and big size in the lower one.  
**Surface:** no incrustation layer disturbs the visibility of the ceramics included in the upper layer of mortar.  
 (4 – 5 cm thickness)

**Mortar:** single layer mortar made up of ceramic fragments of different types and varying size.  
**Surface:** it exhibits areas with incrustation layers. The visible surface is more regular and smooth than PAV001, showing a pinkish base with visible fragments of ceramics.  
 (4 – 5 cm thickness)

**Mortar:** single layer mortar made up of ceramic fragments of different types and varying size.  
**Surface:** it shows an incrustation layer that partially covers the surface. The visible surface is finer than PAV001 but coarser than PAV002. Similar appearance to PAV001 but showing more heterogeneous size of visible ceramics.  
 (3.5 – 3.8 cm thickness)

**Mortar:** single layer mortar made up of ceramic fragments of different types varying from medium to big size.  
**Surface:** it shows an incrustation layer that partially covers the surface. This is as fine as PAV002 but showing a greyish color. The visible surface is similar to PAV002 but showing a greyish base. The visible ceramics are clearly bigger than those observed in the previous individuals.  
 (5 cm thickness)

Mortar probably from a cistern.  
**Mortar:** made up of small ceramic fragments very homogeneous in size in the upper preparation layer over a layer having ashes, characteristic of structures for containing liquids.  
**Surface:** it shows few rests of incrustations. The visible surface of this individual can be considered the finest and smoothest of all individuals. It exhibits a pale salmon color without visible ceramic fragments.  
 (1.5 cm thickness)

**Mortar:** single layer mortar made up of ceramic fragments of different types varying from medium to big size.  
**Surface:** it shows areas of incrustations covering a red, probably painted, layer. Overall, it is a regular, fine and smooth bright red surface with certain medium size ceramics.  
 (3.5 – 4.5 cm thickness)

Mortar probably from a cistern  
**Mortar:** made up of ceramic fragments of small size in the upper preparation layer and big size in the lower one.  
**Surface:** very fine surface of powdery appearance, regular and smooth. The base is greyish with isolated visible ceramic from the upper layer of the mortar.  
 (2 – 2.5 cm thickness)

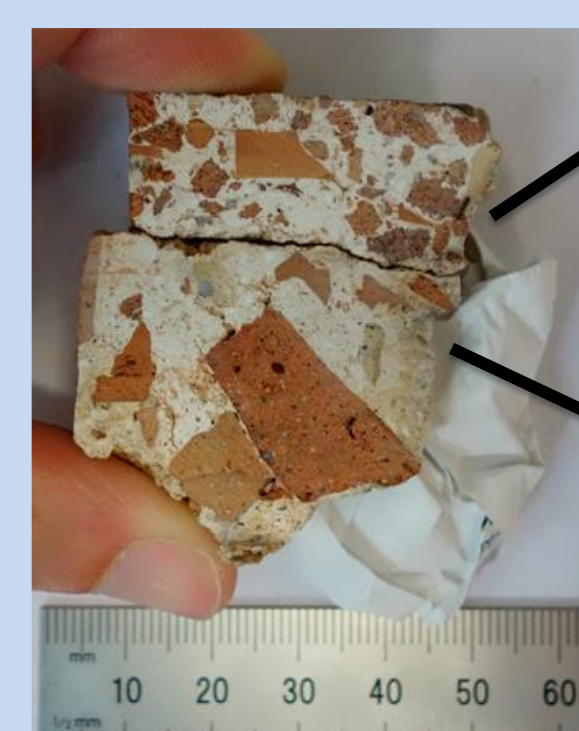
### PAV001

Mineralogical and petrographic analyses point out that all individuals are lime based mortars, showing differences in grain size, without mixing of gypsum or clays. The study also shows that most of the inclusions are fragments of angular ceramics, of assorted composition and varying size, together with other stone aggregates. The ceramics can be classified in four different fabrics (some of them with subfabrics). All mortars exhibit ceramics belonging to more than one fabric and these fabrics are shared by different individuals. Textural and compositional study allows to distinguish differences among the preparation of mortars. While most of them are single layer, PAV001, 5 and 7 exhibit two different layers. The lower one contains larger inclusions in PAV001 and 7, while in PAV005 the lower layer is composed of ashes. Finally, it must be highlighted that individuals PAV005, 6 and 7 exhibit a covering layer in the surface.

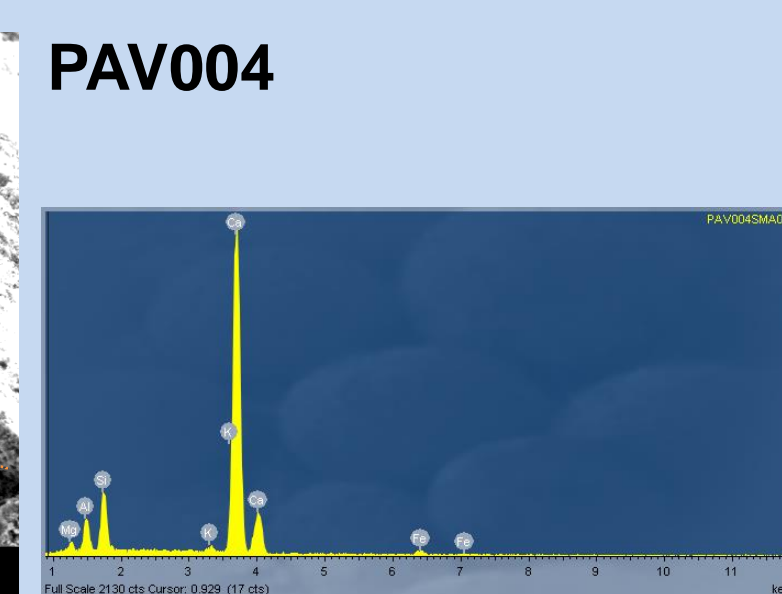
Some individuals exhibit incrustation layers (4) in the surface. In all cases, the examination reveals that these layers are the result of calcium carbonate precipitation.
