Geophysical Investigations of an in situ Roman Mosaic floor in Volubilis, Morocco

A. DEKAYIR^{1*}, N. BOUZOUBAA¹, M. ROUAI¹, A. LACHHAB², M. ATKI³, M. ALILOU³, BAKADI¹,
E.M. BENYASSINE¹

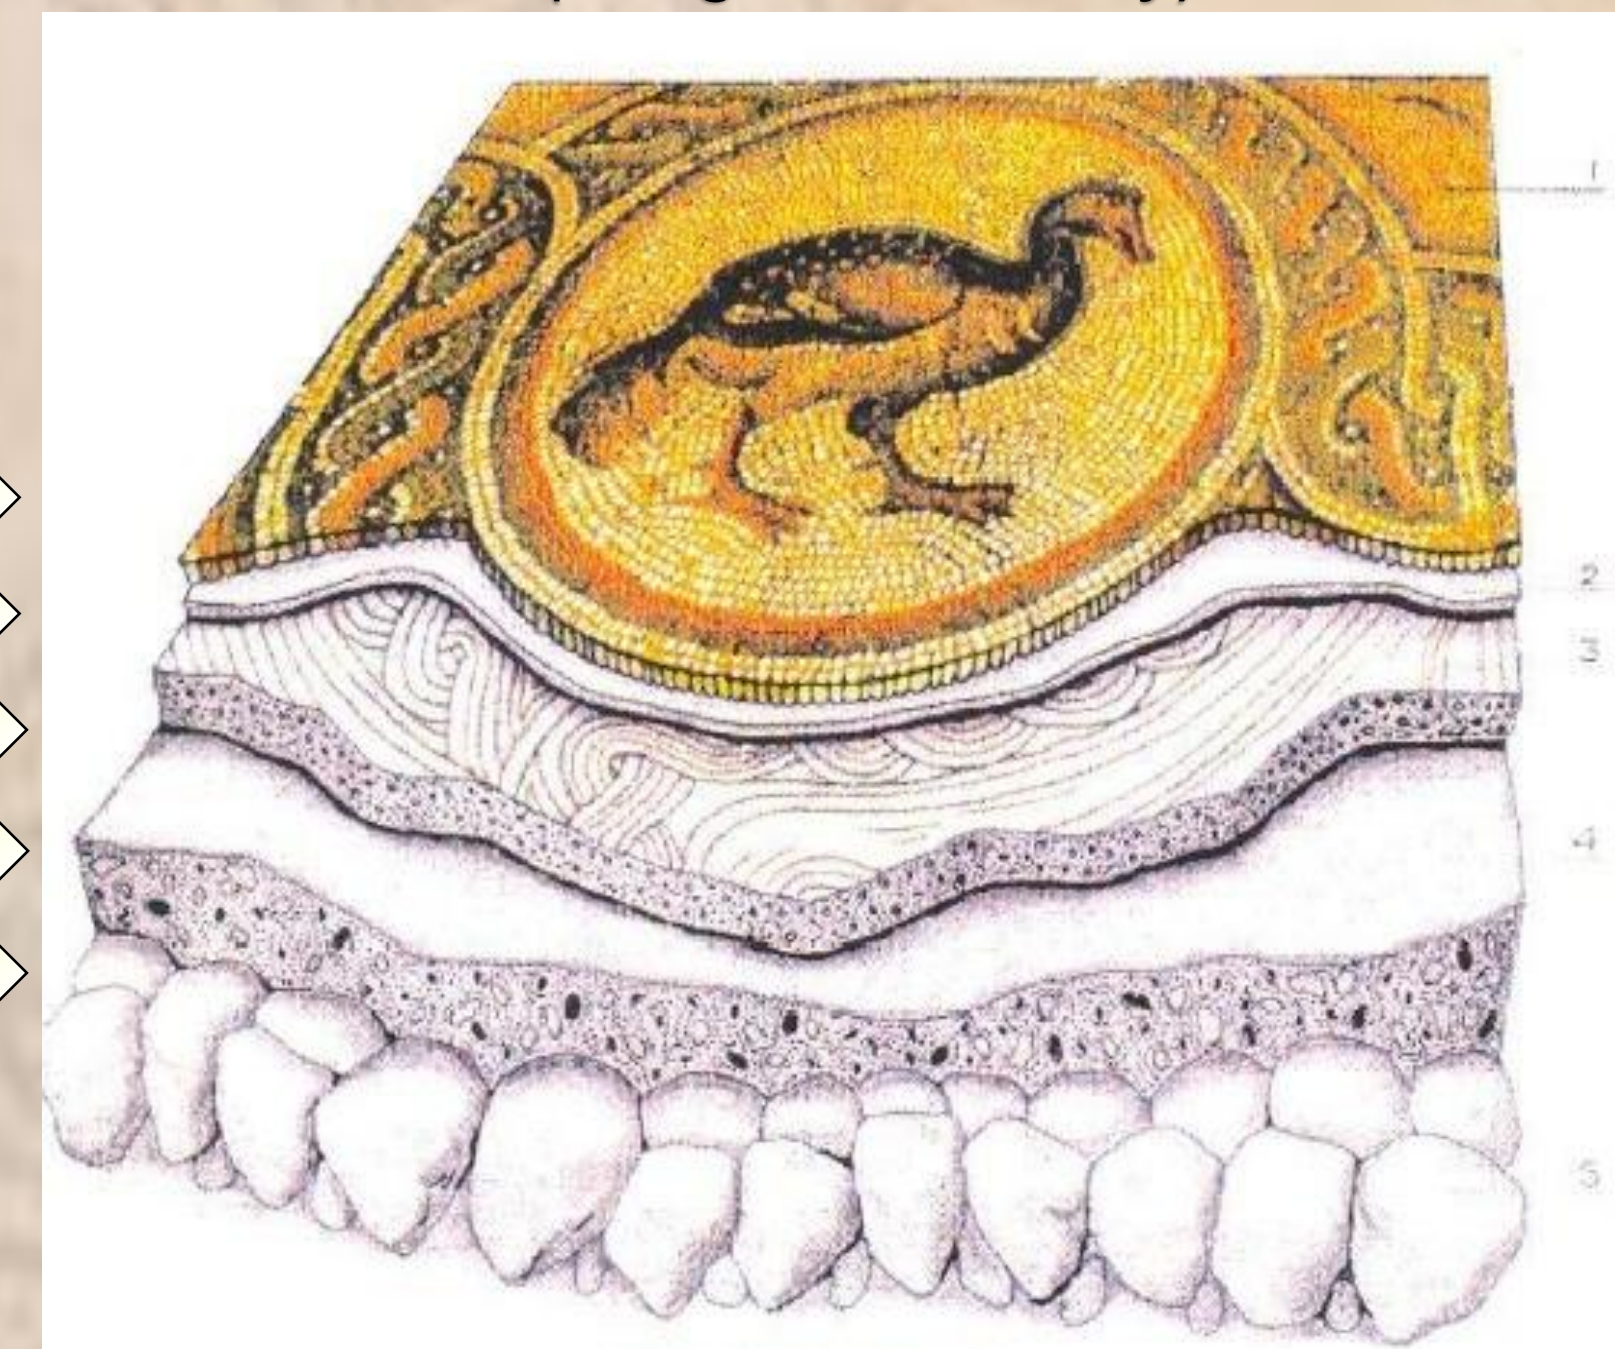
Structure of Roman Mosaic (image from Getty)

Tesselatum
Bedding layer
Nucléus
Rudus
Statumen

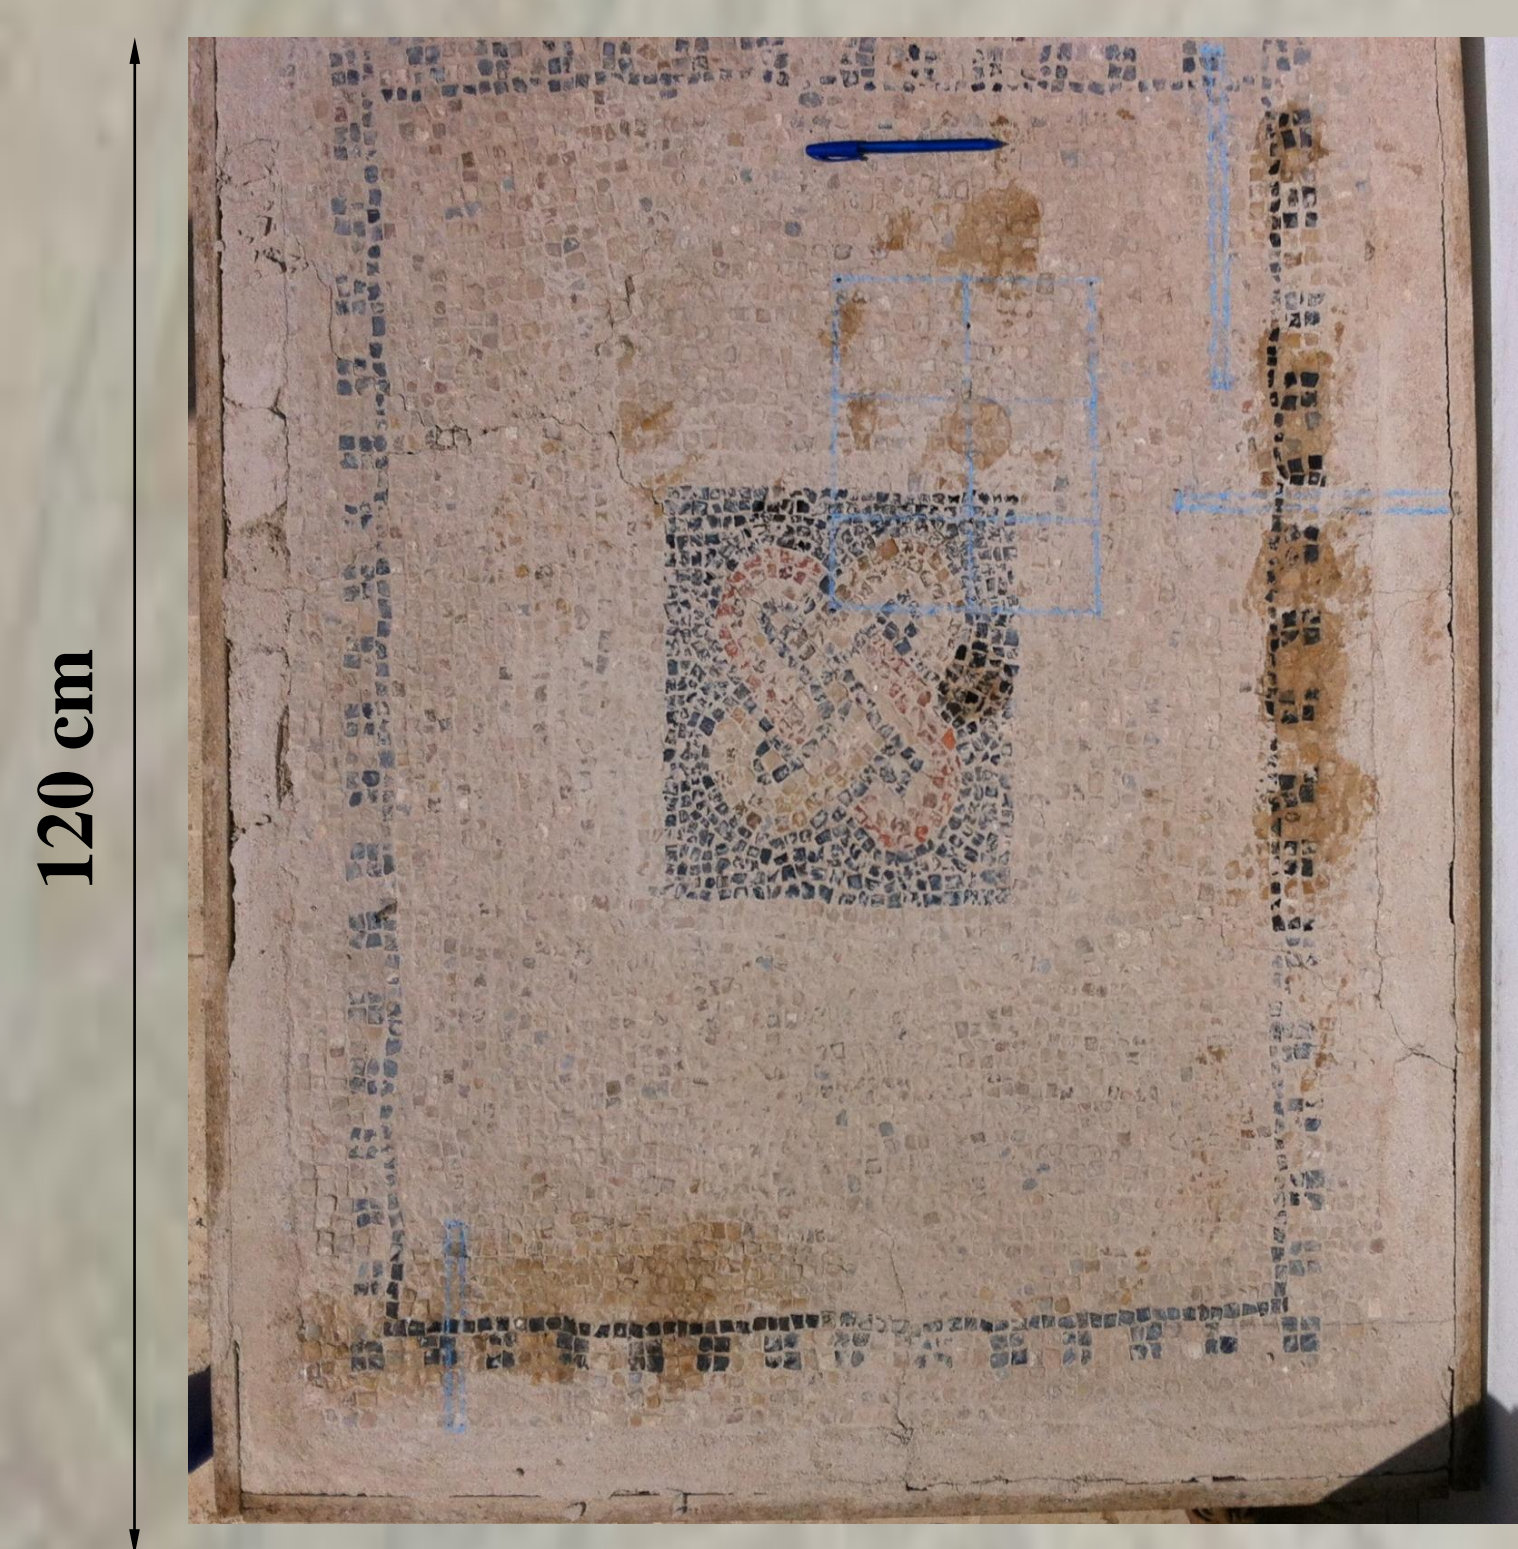
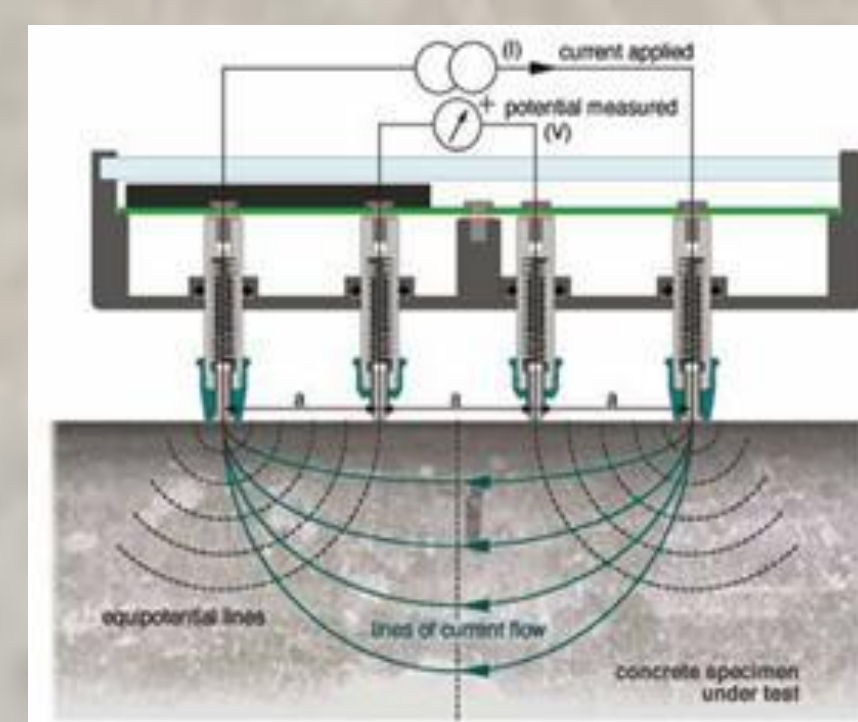
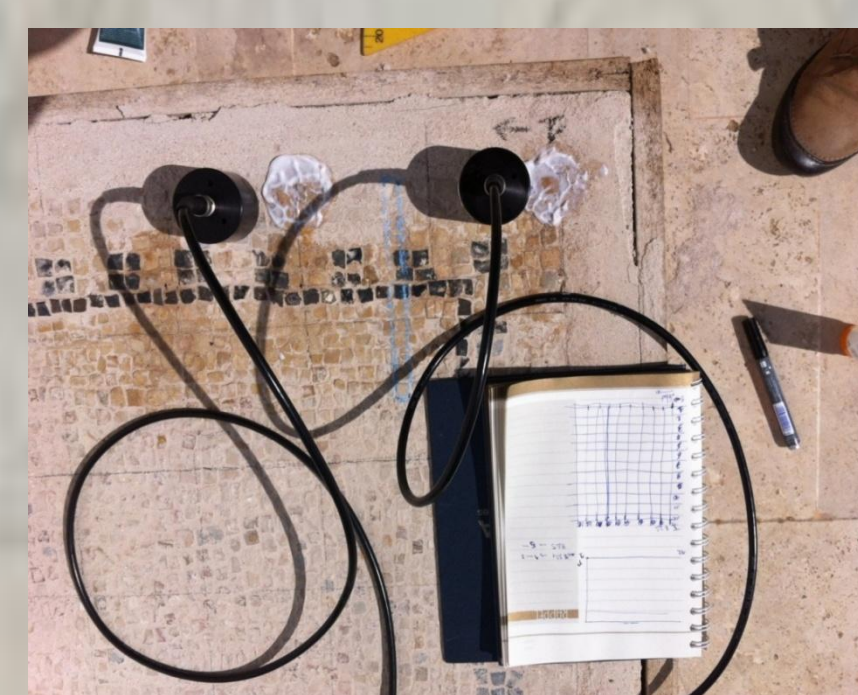
Model: Size and characteristics

Equipment setup

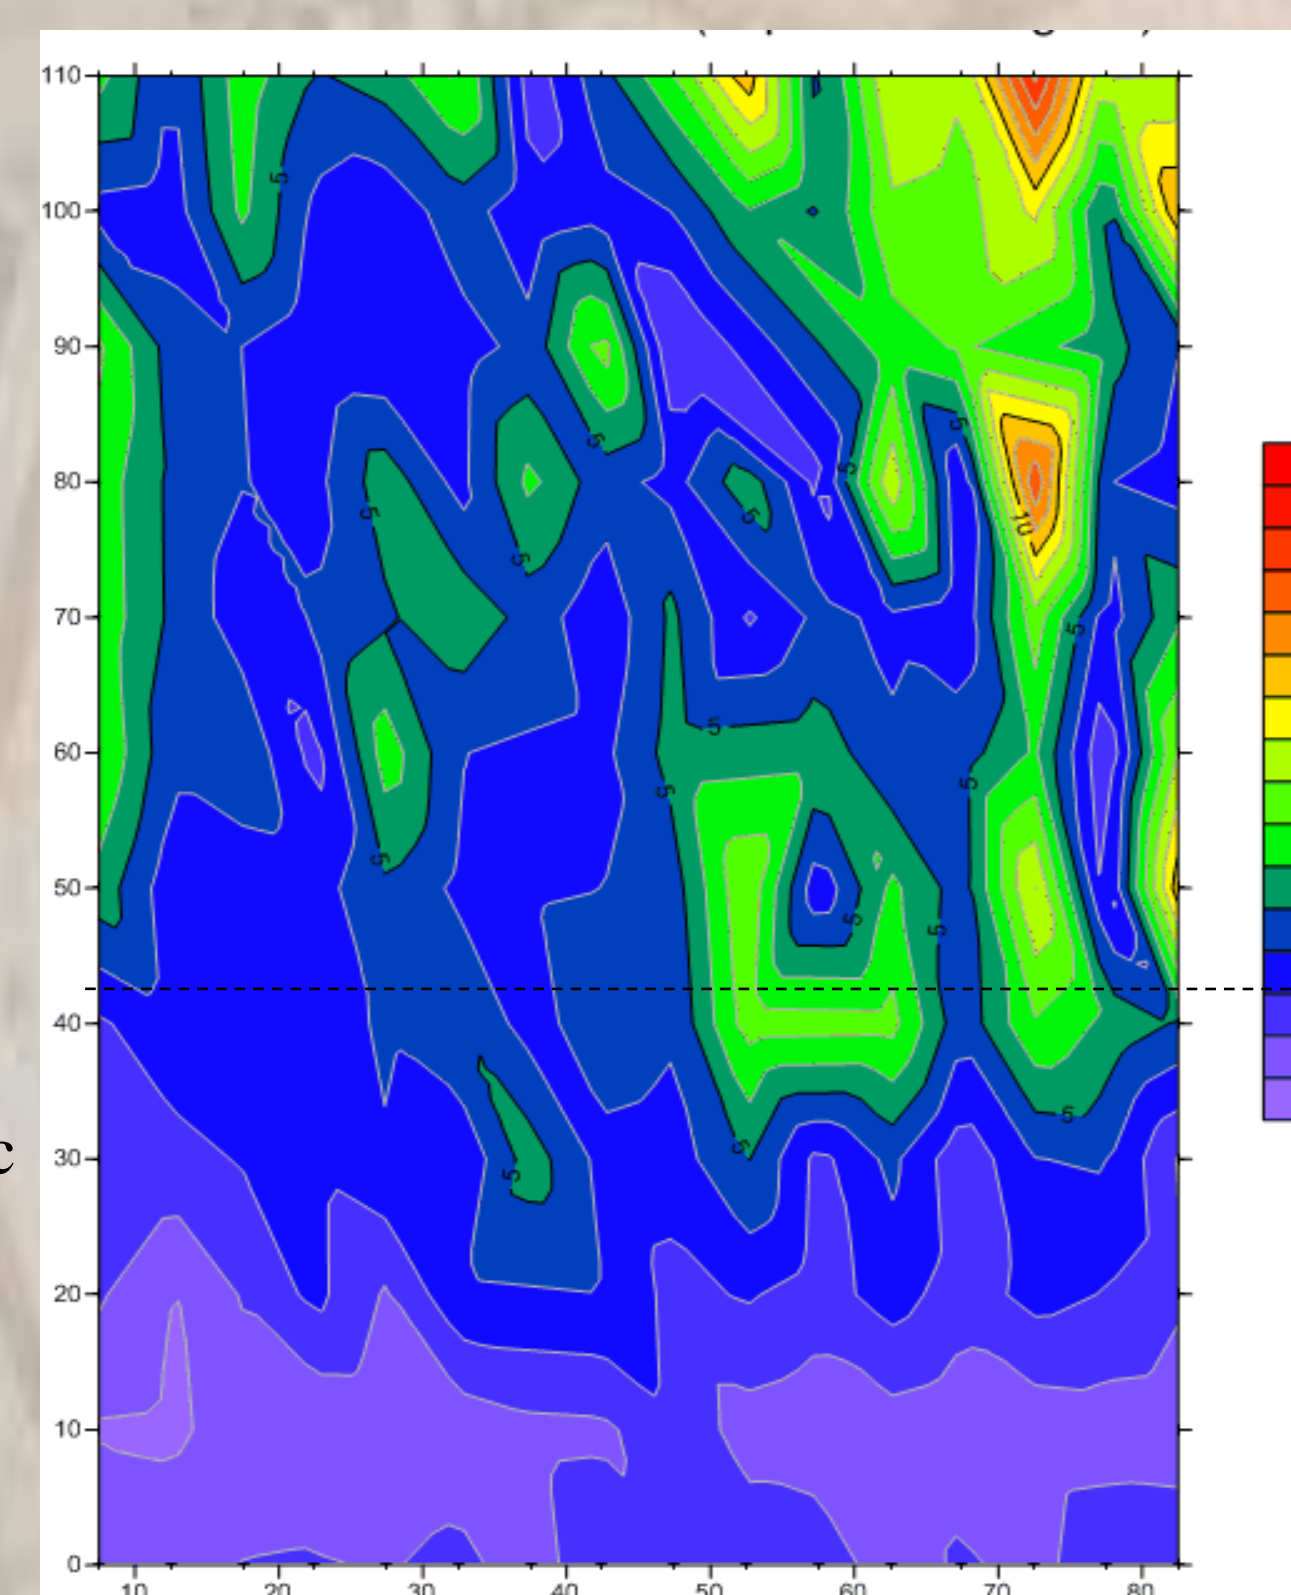
Electrical resistivity

The geophysical Survey showed that:

1. Areas highly resistive (due to the presence of hallow spaces, existence of joints and fractures) and therefor have low ultrasonic velocity values.
2. The less resistive area with high elastic properties and characterized by strong ultrasound velocities

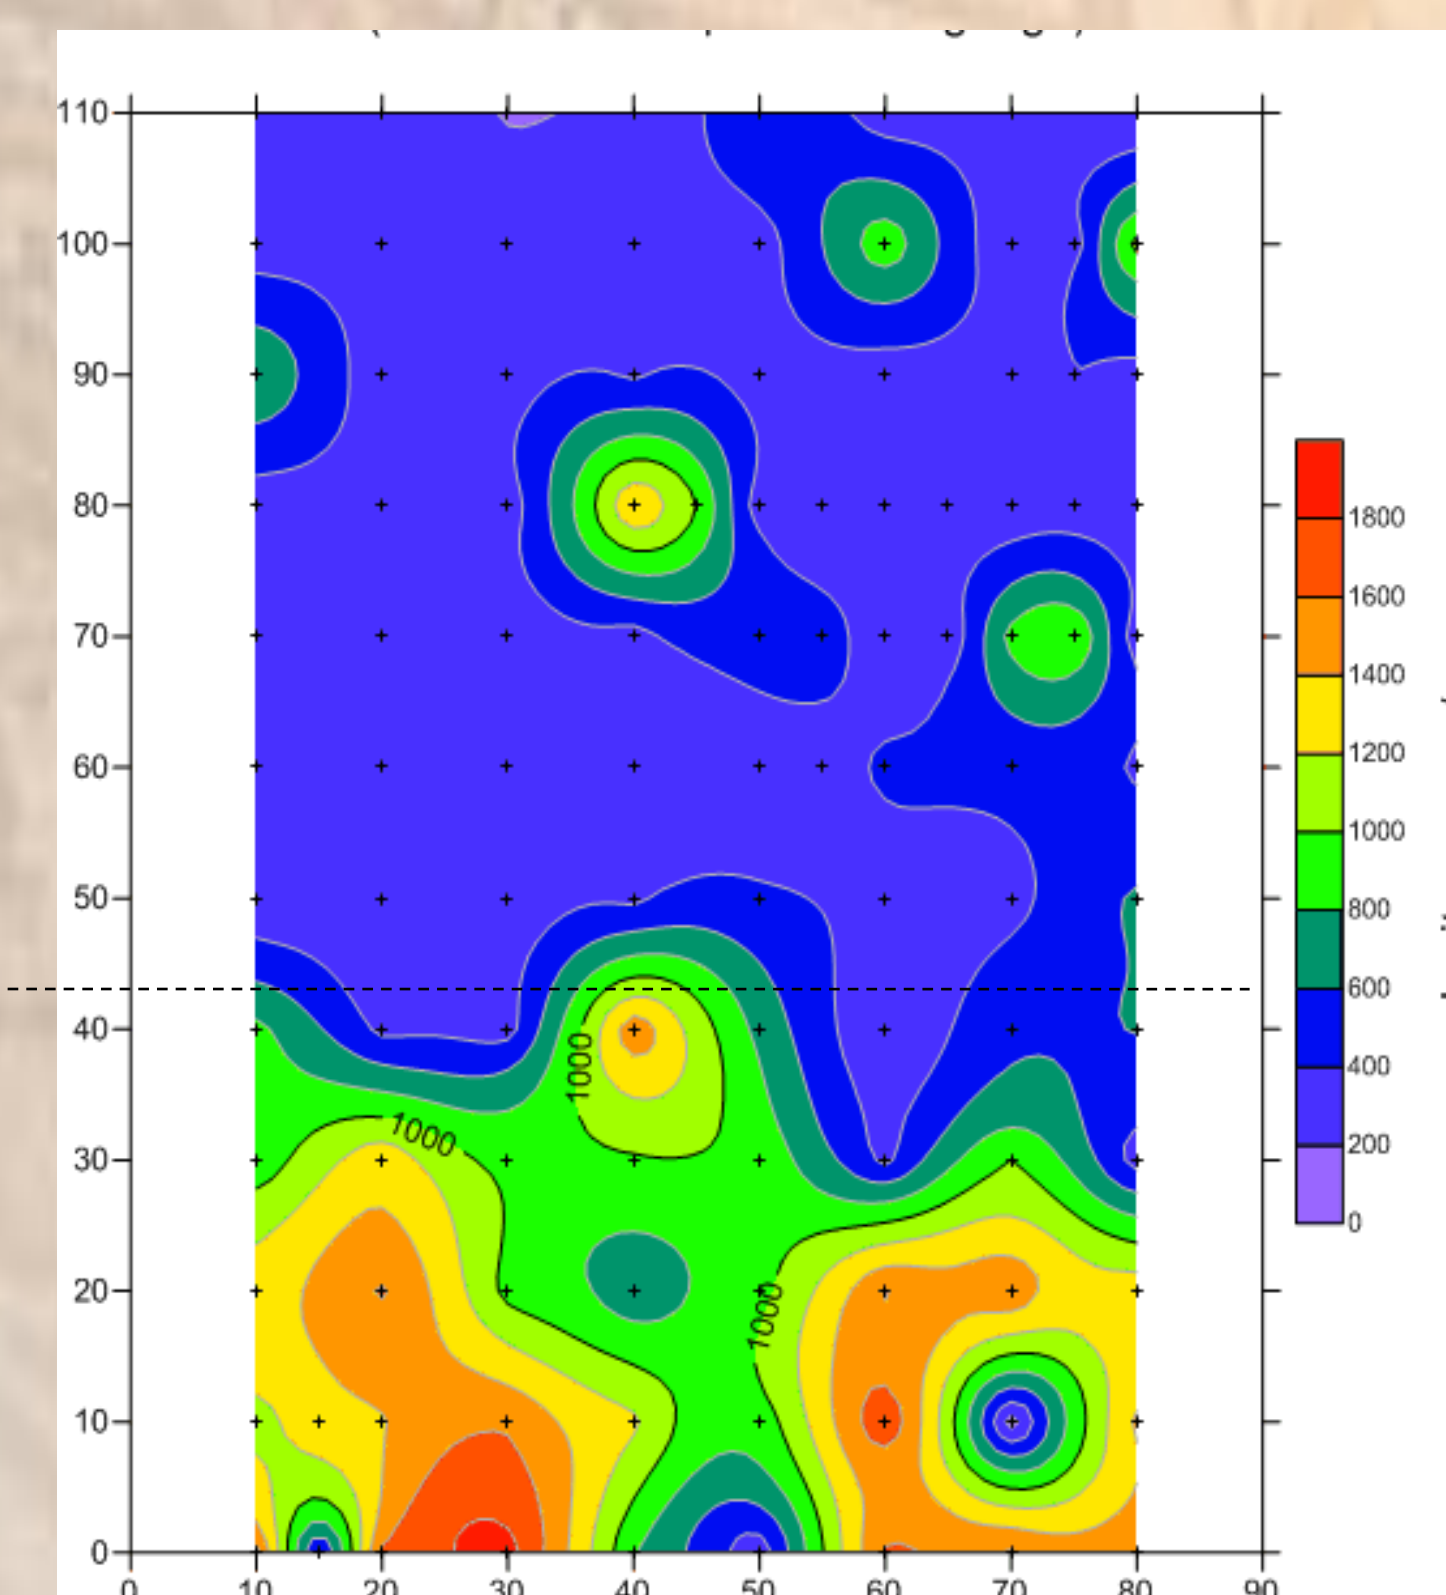
Ultrasonic velocity

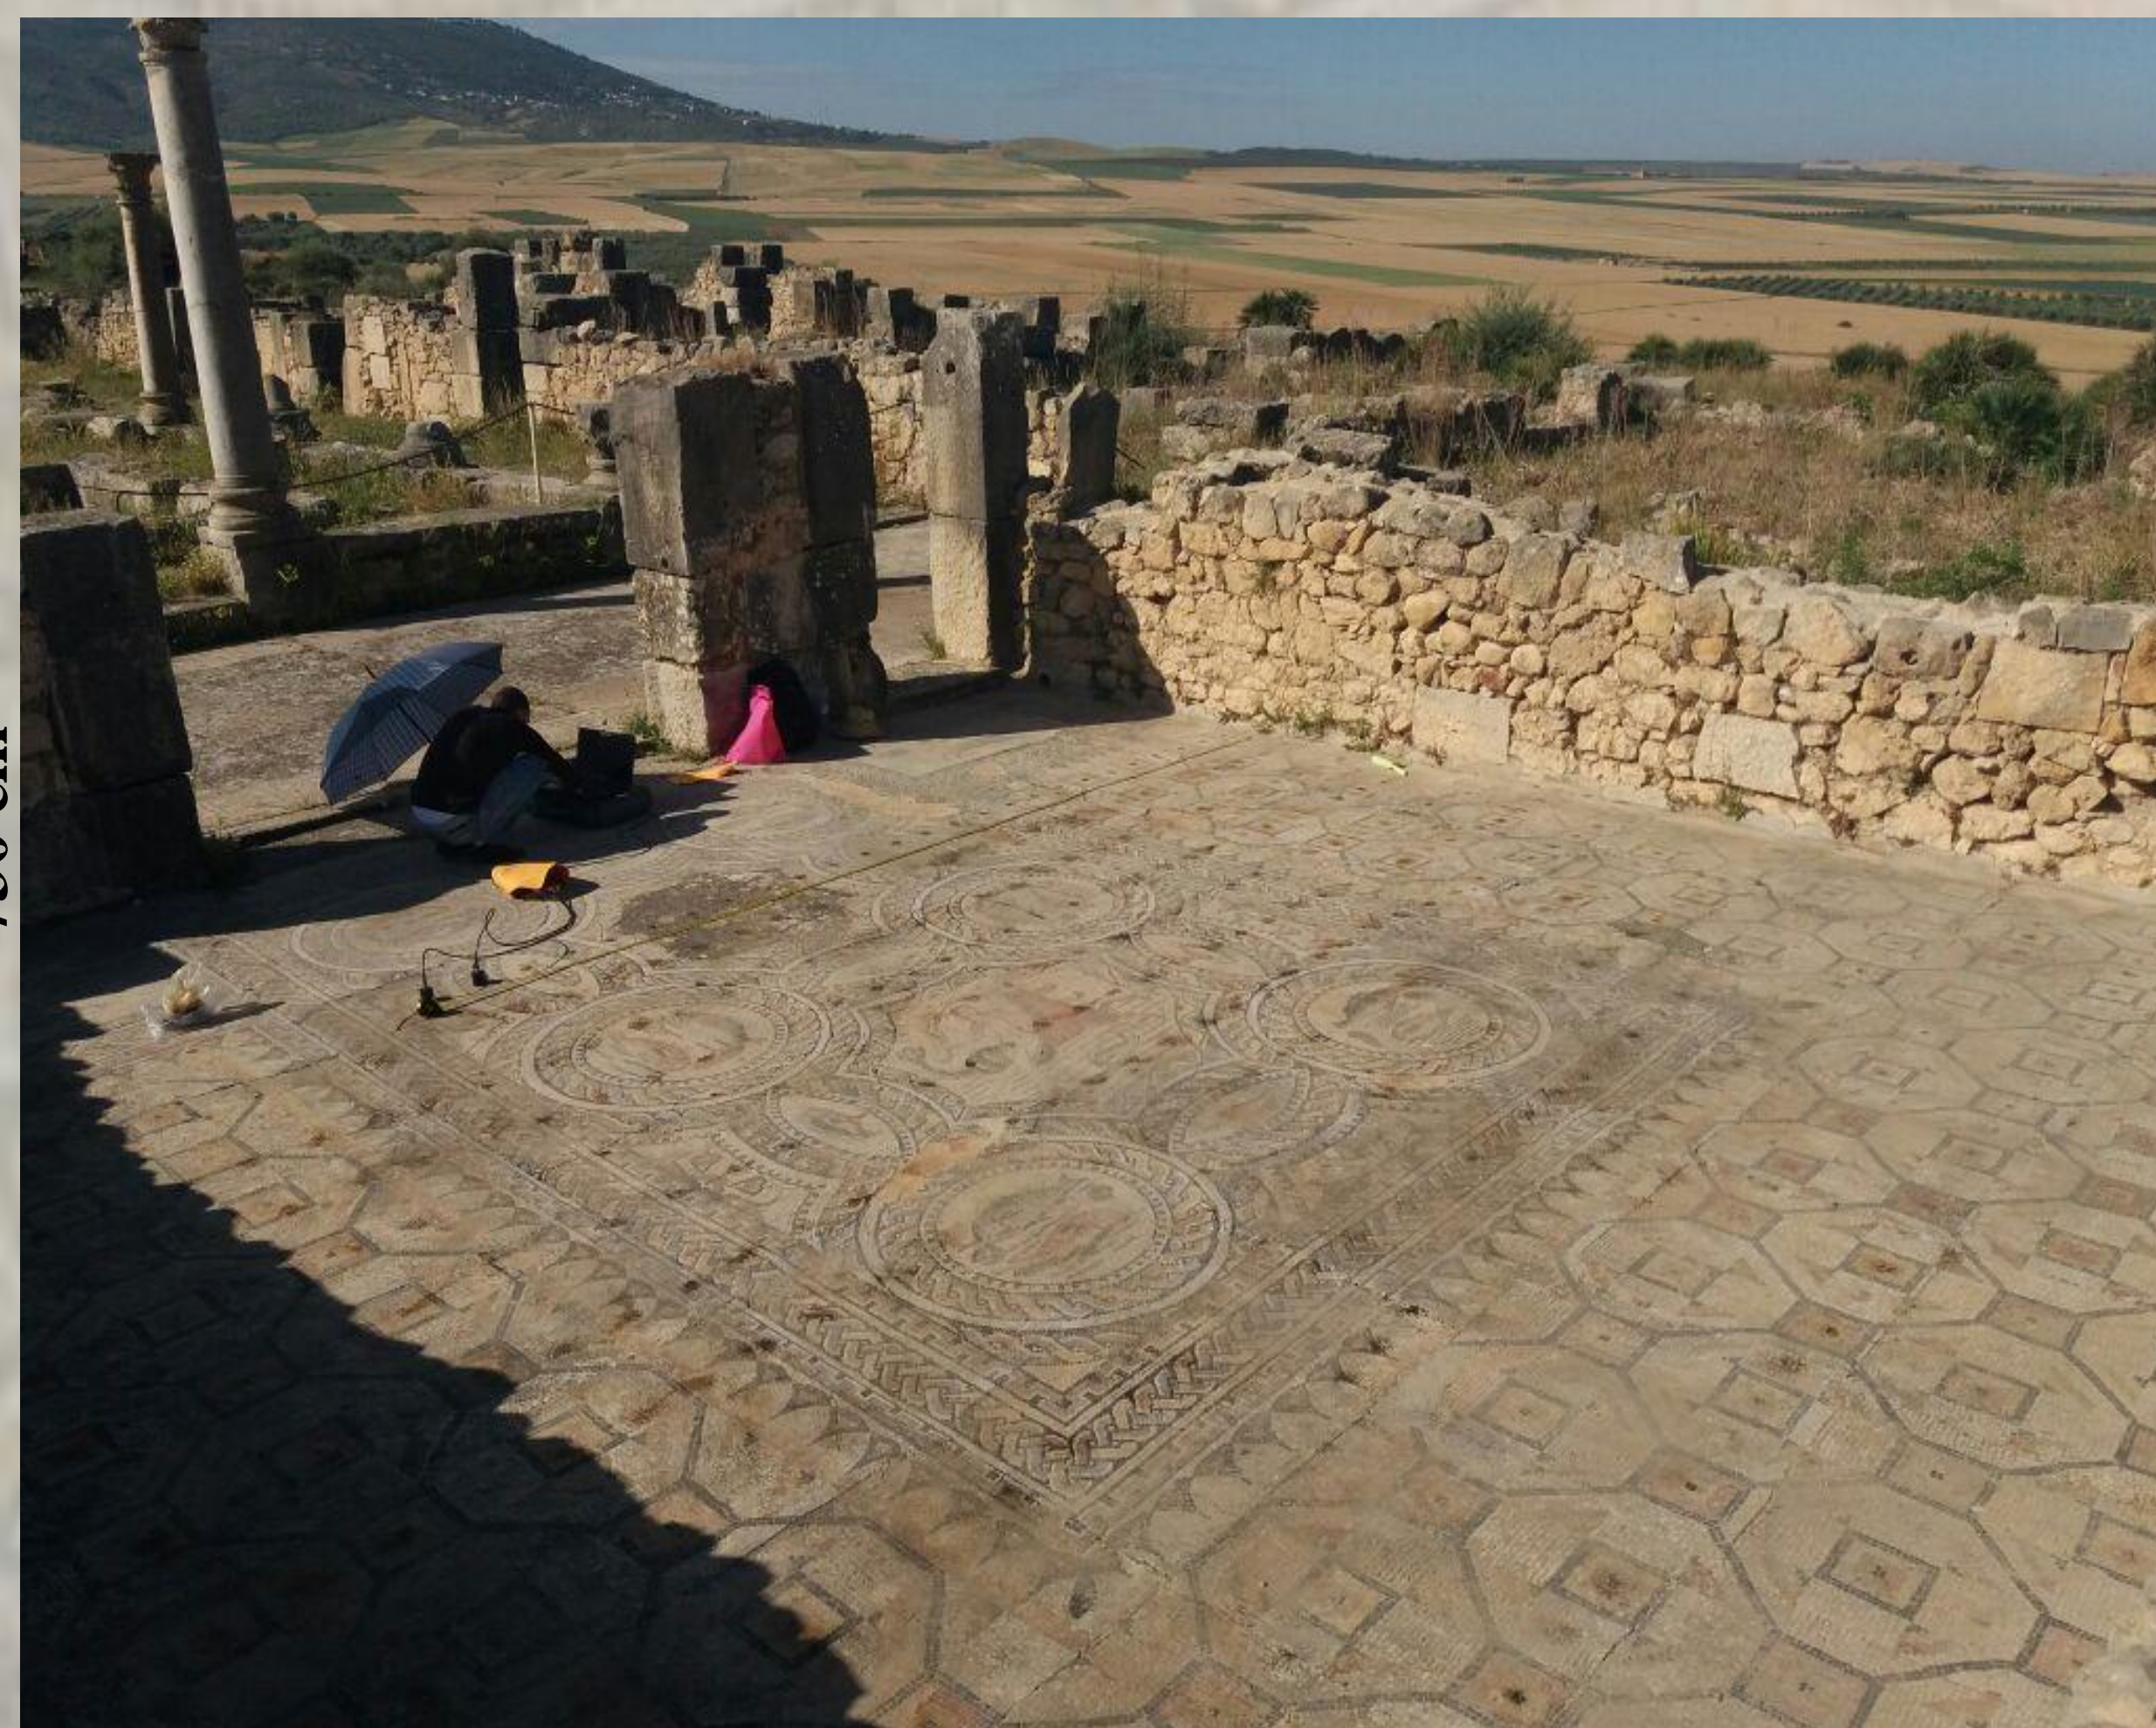
Case Study: Ephebe in-situ floor Mosaic

The Mosaic floor found at the house of Ephebe which was placed over a concrete platform was found to witness significant degradation of tessellatum mainly due to the oxidation of steel rebars
