What Comes to Mind When You Hear Mosaic? Conserving Mosaics from Ancient to Modern

THE MOSAIC OF THE FIGHTERS IN OSTIA ANTICA Historic data through the conservation work

This contribution describes the conservation work carried out in 2015-2016 on the 2nd century A.D. floor mosaic named "Lottatori" (fighters), located in the Archaeological Site of Ostia Antica. The mosaic floor is made of white and black tesserae and has been modified and restored since the late antiquity. The state of conservation of the mosaic was strongly compromised due to degradation factors characteristic of the artifacts located outdoor and exposed to adverse weather conditions. These factors have caused, during the centuries, the detachment of a large number of tesserae from their setting bed and the alteration of previous conservation interventions.

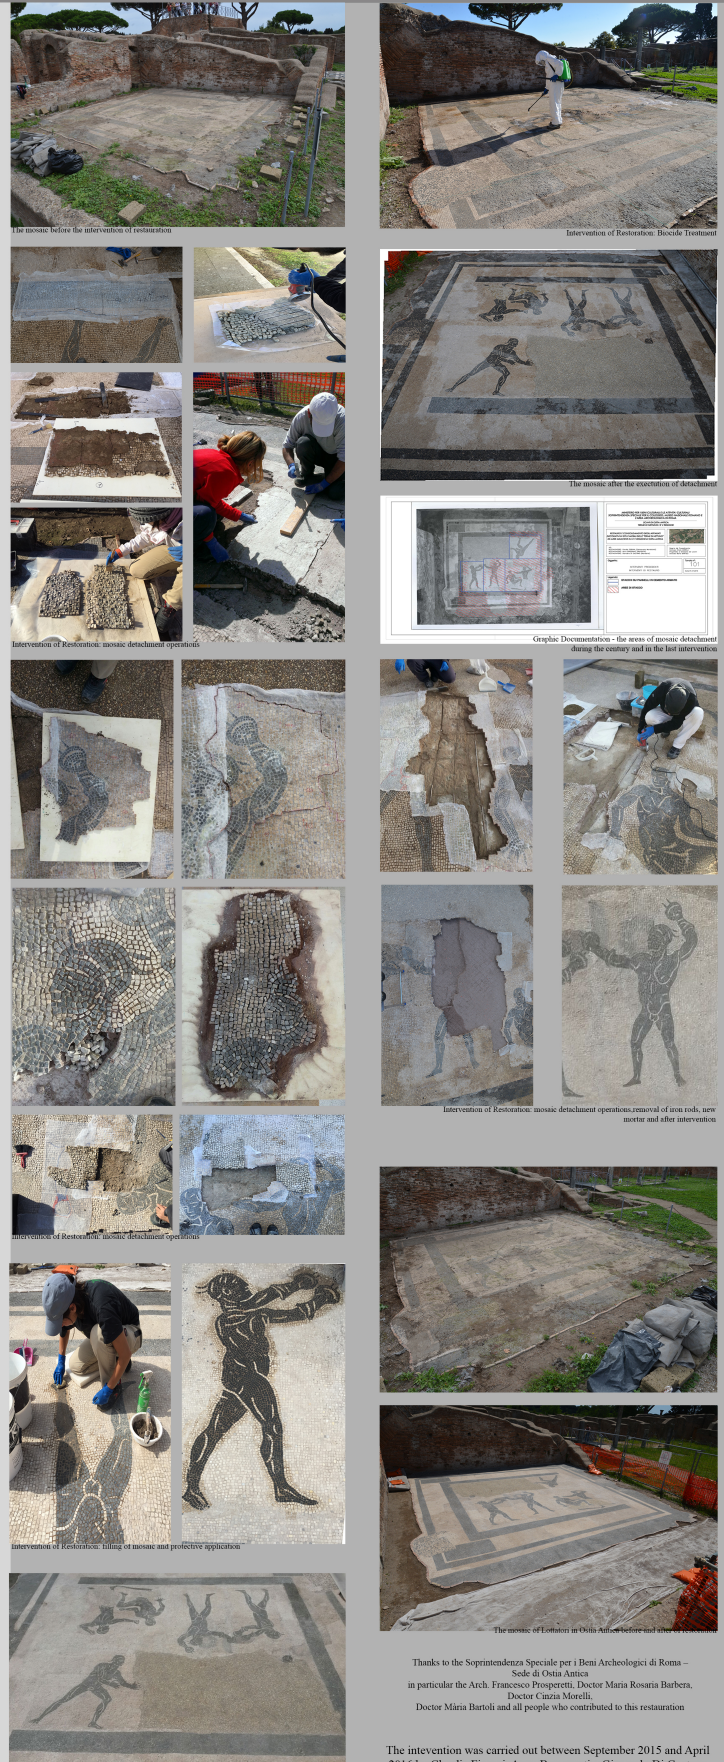
The state of conservation of the mosaic was particularly critical, already during the first inspection. Different vegetative phenomena (microorganisms and upper plants) had interfered with the mosaic surface up to the tiling bed. There was a general and widespread impairment of the adhesion of the dowel to the lining layers, with hundreds of detached tiles.

The most significant degradation form was related to a general and advanced loss of adhesion of the mosaic over the laying bed.

The surface was characterized by a considerable amount of areas that had concave and convex deformations. The first due to the complete disintegration of the original nucleus and the backdrops with inevitable collapse of the mosaic rug. The second ones, concentrated along the perimeter of the panels that were set up in the 1970s, were the result of a repositioning of tiles during the 2003 restoration campaign.

Very important was the deformation that was on the north side at the top of the right boxer and involving his face, right arm, and part of the left arm.

The restoration intervention carried out between September 2015 and April 2016 was carried out in several phases.

The advanced state of degradation and the complete loss of planarity of many parts of the mosaic fabric forced the choice to perform detachments of large mosaic areas.

The decorative surface was covered with acrylic adhesive in solution and detached with the help of metal lances and wooden support boards for the overturning of the pieces. In order to be able to insert the chains it was necessary to open gates, "sacrificing" a few rows of tiles subsequently repositioned.

The cuts made have highlighted the underlying situation by highlighting the presence of numerous metal elements. Iron rods where possible have been removed and elsewhere have been treated with an oxidation inhibitor and then painted with an acrylic resin in solution to make them waterproof and slow down their degradation.

After the repositioning of the shutters, organic solvents were needed to remove bandages / wrapping. The final phase of the restoration project provided for interstitial plastering on the totality of the surface, which gave a uniform reading of the product.
