13TH ICCM CONFERENCE - INTERNATIONAL COMMITTEE FOR THE CONSERVATION OF MOSAICS - BARCELONA- October 2017

PRESERVATION AND PRESENTATION OF MOSAICS IN TYRE - WORLD HERITAGE SITE IN LEBANON

MINISTRY OF CULTURE - DIRECTORATE GENERAL OF ANTIQUITIES
SAMAR F. KARAM - ALI KHALIL BADAWI

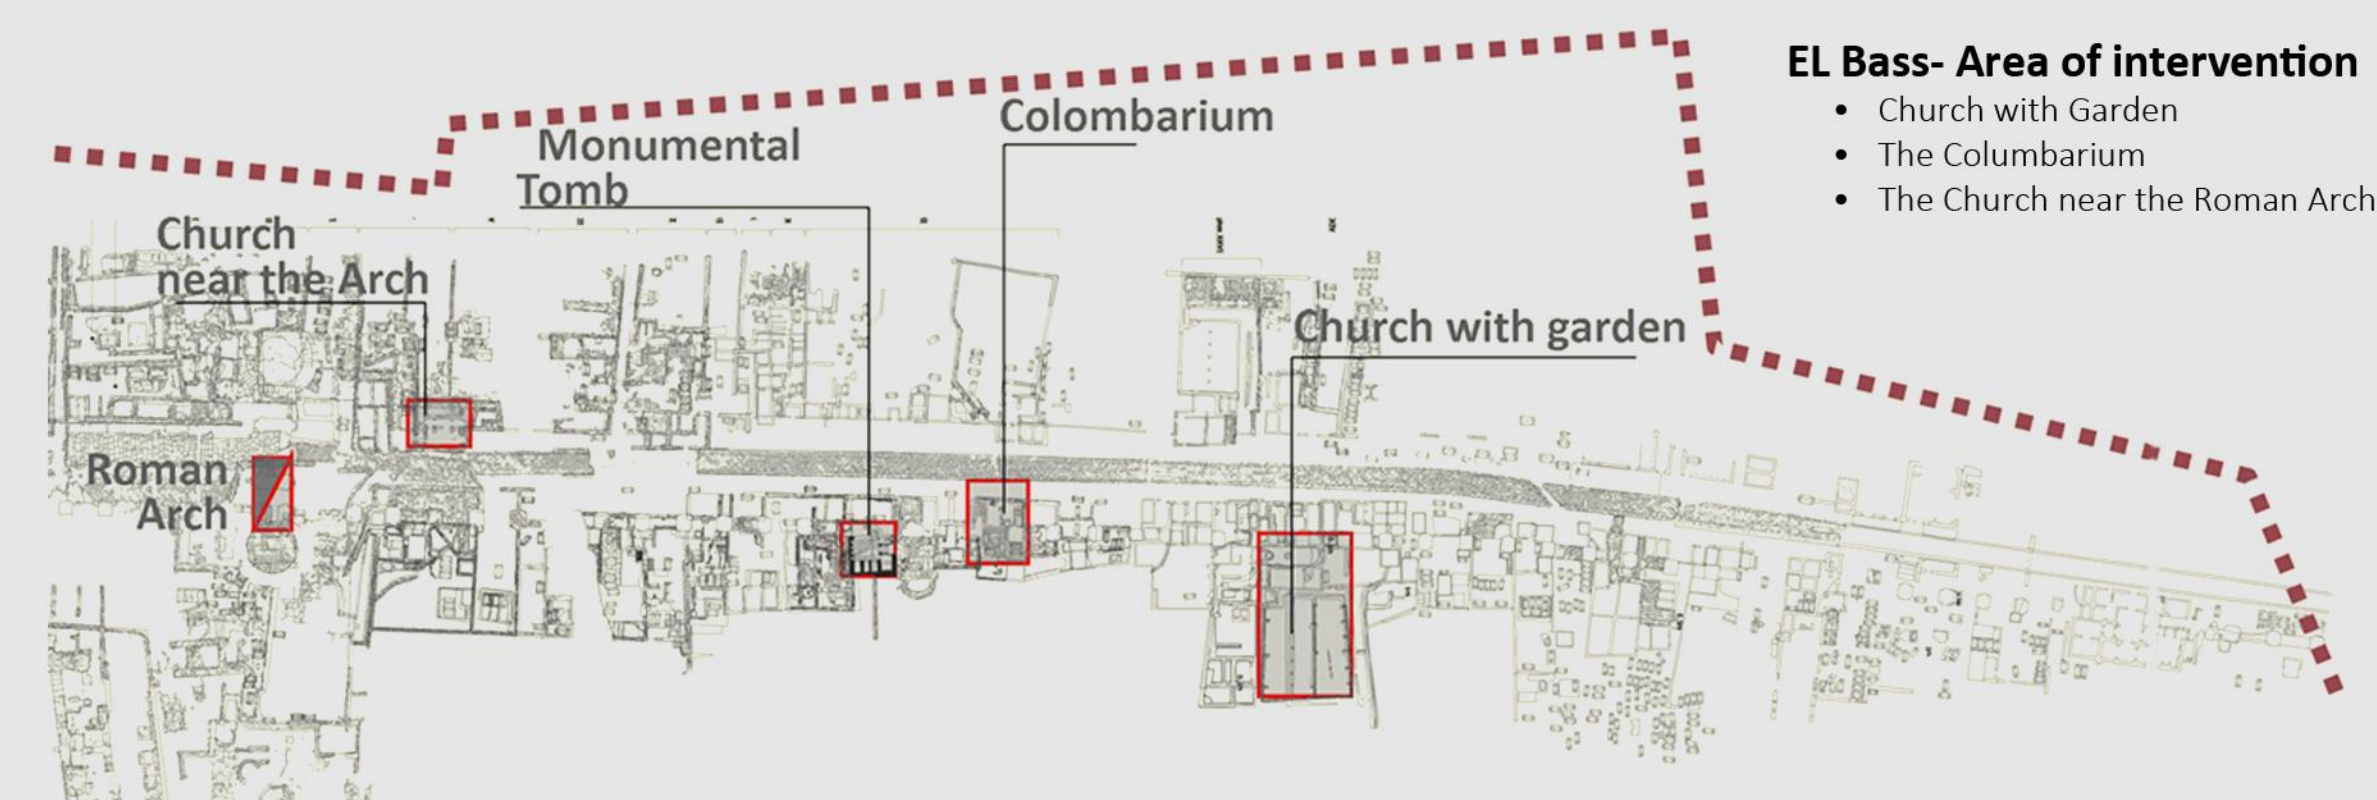
EL BASS

EL Bass- Area of intervention

- Church with Garden
- The Colombarium
- The Church near the Roman Arch

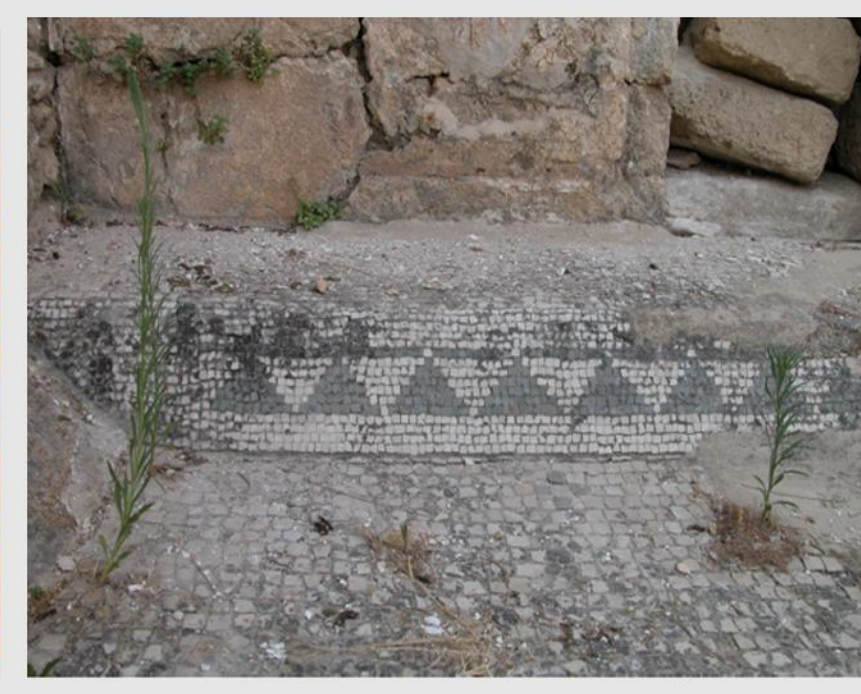
CHURCH WITH GARDEN

The opus sectile is frequently encountered in late imperial houses and public buildings. The extended presence of inappropriate materials, such as Portland cement and iron bars, associated with mechanical stress and salt efflorescence, required their urgent removal.

- Documentation and precise mapping of the intervention areas
- Numbering of fragments
- Removal of the loose opus sectile fragmented slabs from the original mortar bed or cutting away cement edging
- Bridging the fragments with animal glue and textile
- Application by means of animal glue and canvas layer bandage
- Biocide treatment to mortar
- Consolidation of original mortar by Calosil
- Hydraulic lime mortar levelling
- Arrangement of the fragments on fiberglass mesh with Epoxy Resin EPO121
- Replacement of the opus sectile on the mortar with modified hydraulic lime to suit the original mortar bed.
- Filling voids between sections with a suitable gravel mix on geotextile to accomplish its drainage

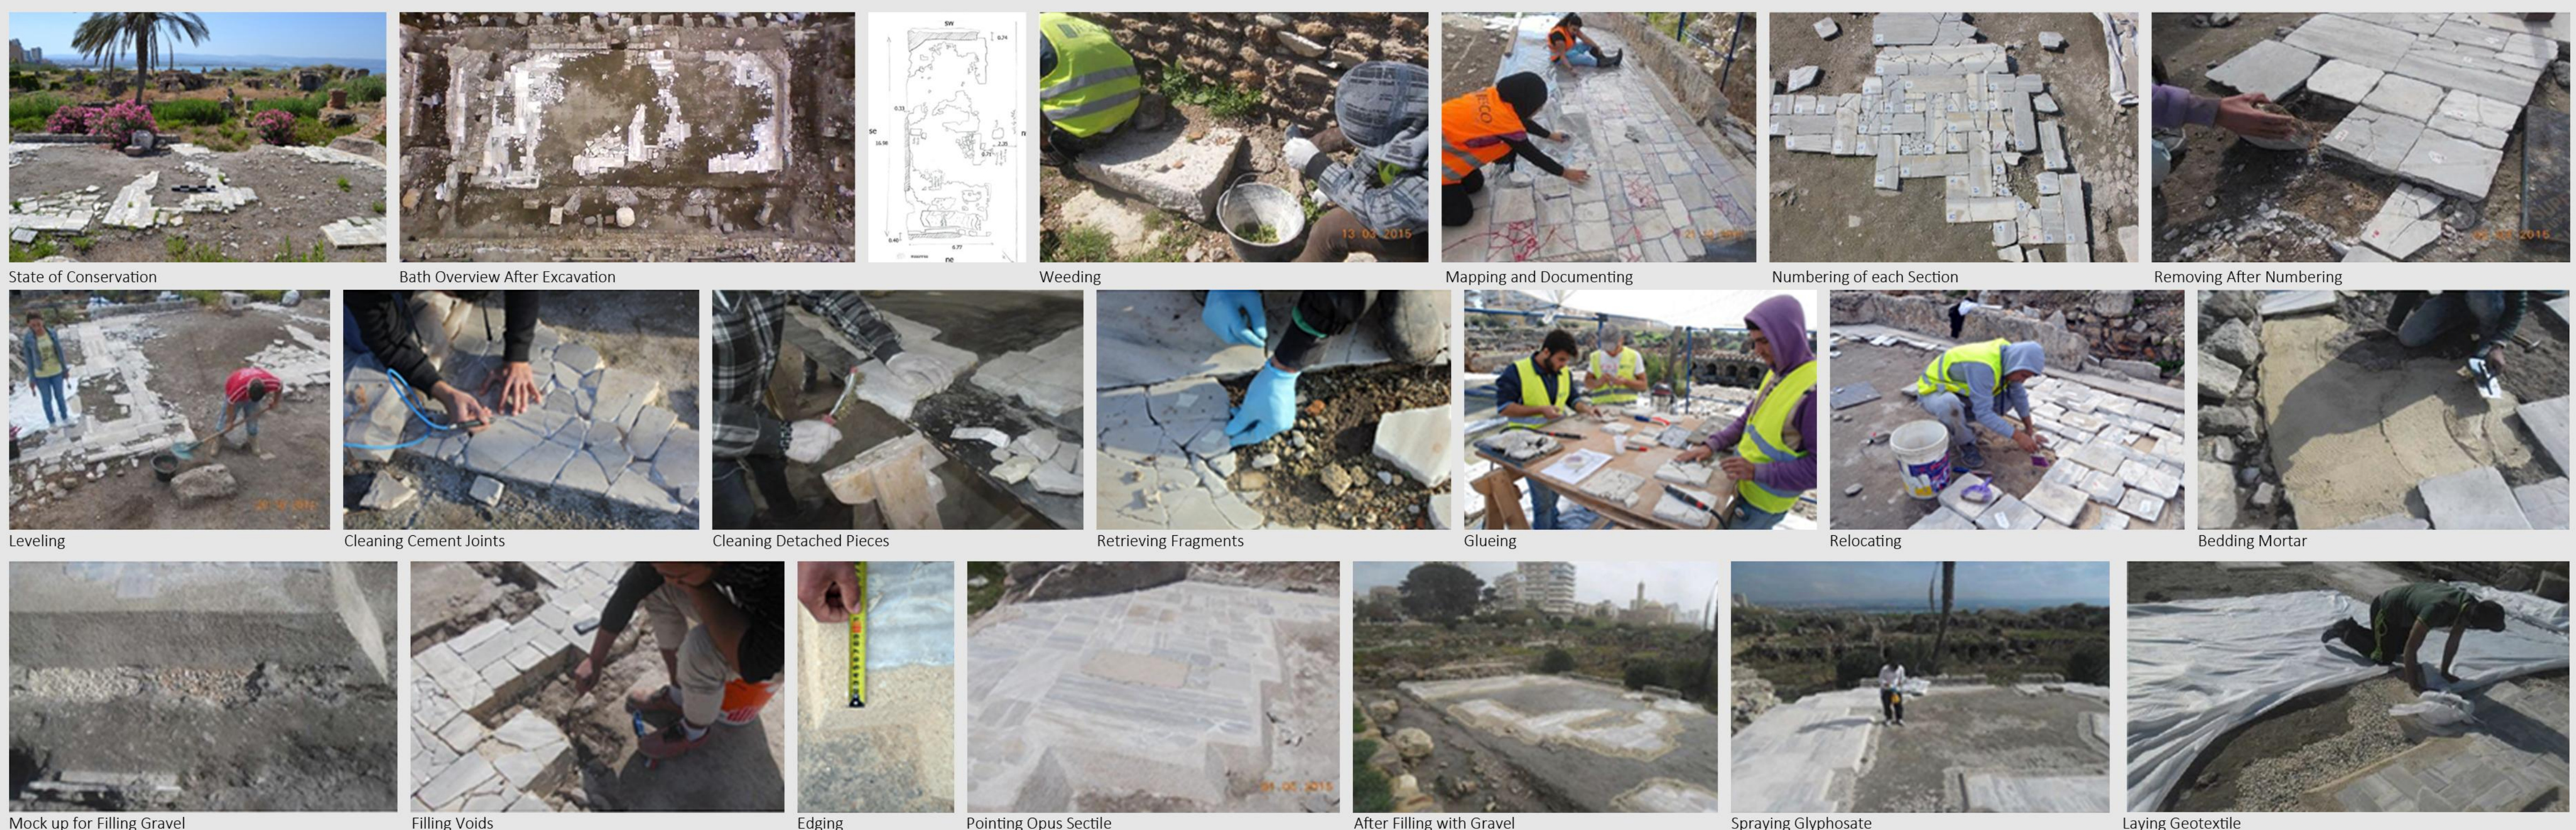
ROMAN BATH

The area selected for the intervention is the central and largest room called Frigidarium. The intervention can be considered as a case for the conservation treatment of a large remain of the opus sectile. The Opus sectile between the Roman Baths and the Grande Allée required an overall consolidation with re-fixing of the much loose marble slabs, made of Proconnesian marble (from the Island of Marmara in Turkey) in a sufficiently good state of preservation. The total floor area of this section measures 114.07 sq.m, the area still covered with opus sectile measures 56.81 sq.m, the areas of voids are 57.27 sq.m.

- Hand removal of small plants, followed by the removal of the big ones through injection of glyphosate in the roots
- Disinfection from autotrophic/heterotrophic organism colonies by spray/brush applied biocide (Otracide 25%)
- Brushing
- Mechanical cleaning of the back side of the opus sectile fragments and slabs
- Removing all debris and cleaning the underlying mortar

- Bedding**
- Grey coarse to fine mix of limestone powder: 2 parts
 - White fine limestone powder: 2 parts
 - Sand: 1.5 parts
 - Brick (medium size powder): 0.5 parts
 - NHL 5: 2 parts
 - NHL2: 0.5 parts
- Edging and filling lacunae:**
- Grey coarse to fine mix of limestone powder 2 parts
 - White fine limestone powder 3.5 parts
 - Brick (medium size powder) 0.5 parts
 - NHL5 2.5 parts
- Pointing:**
- Grey fine limestone powder: 2 parts
 - White fine limestone powder: 4 parts
 - NHL5: 2.5 parts

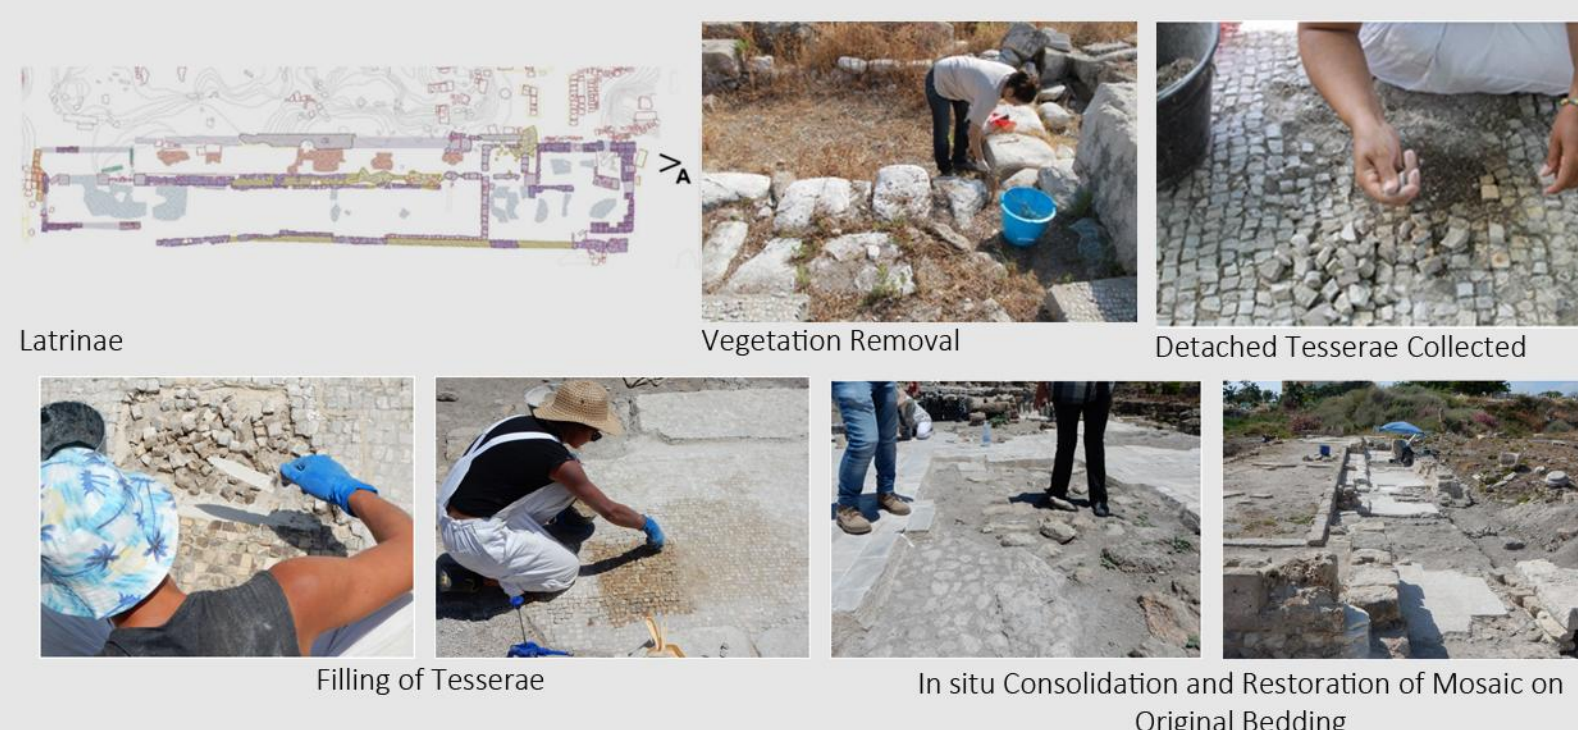
LATRINA

The mosaic located in the Latrina was in a very bad state of conservation, totally covered by tall vegetation, grass, bushes and earth.

- Dried plants were removed manually
- During the cleaning in the lacks, many tesserae were recovered from the earth, and stored after marking their location
- Fixing the edges and all the sides more decayed of the mosaics by means of gauzes soaked in a water solution 6% with rabbit-skin glue (a natural adhesive).
- Reconnection of the mosaic tesserae
- Partial recovery of cohesion of the mosaic by impregnation of acrylic resin
- Reintegration of missing parts with hydraulic mortar
- In case of lacks, protection bandages with acrylic resin removed after the cleaning
- Reintegration of the lacks with layer of hydraulic mortar.

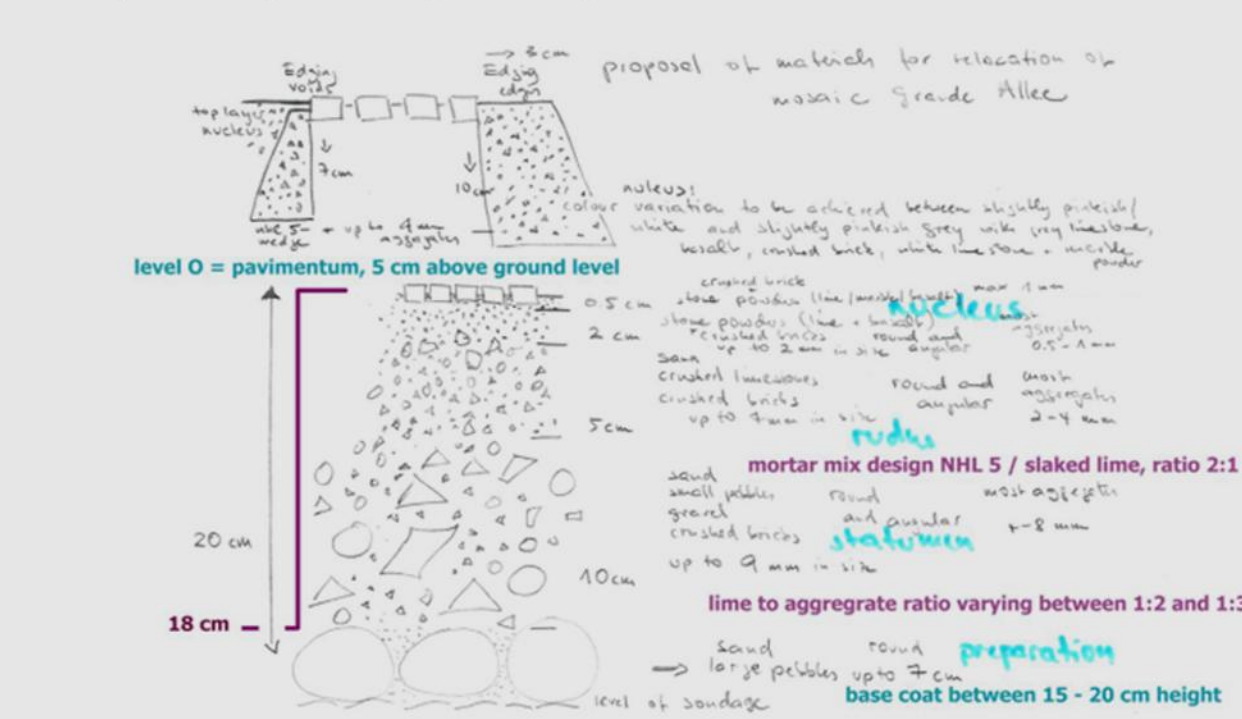
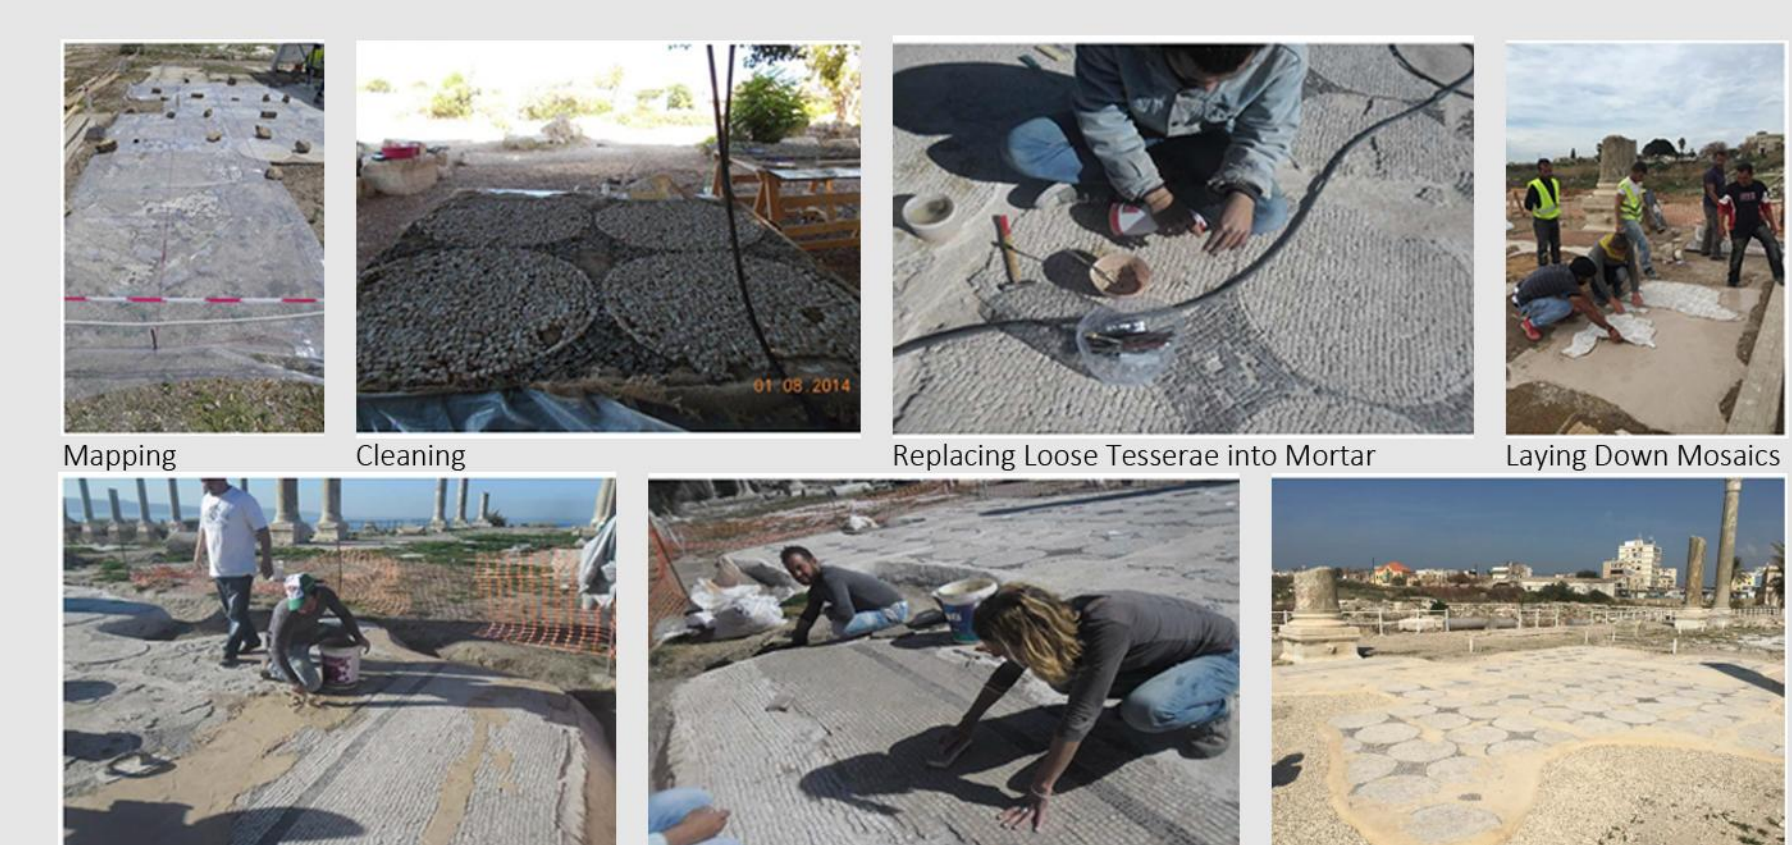
GRANDE ALLEE

The Mosaic- Opus Tessellatum- of the Grande Allée was in a very poor state of conservation, with diffused vegetation growth and abundant cracks produced by the rusting of the iron embedded in the concrete bed. Other serious problems were the de-cementation of tesserae which were detaching and being removed by tourists, and powdering of the original lime-ground.
