Barcelona, Mural G-333: a case study of the first public ceramic wall by Eduardo Chillida

Silvia Noguer, Alejandro Castro

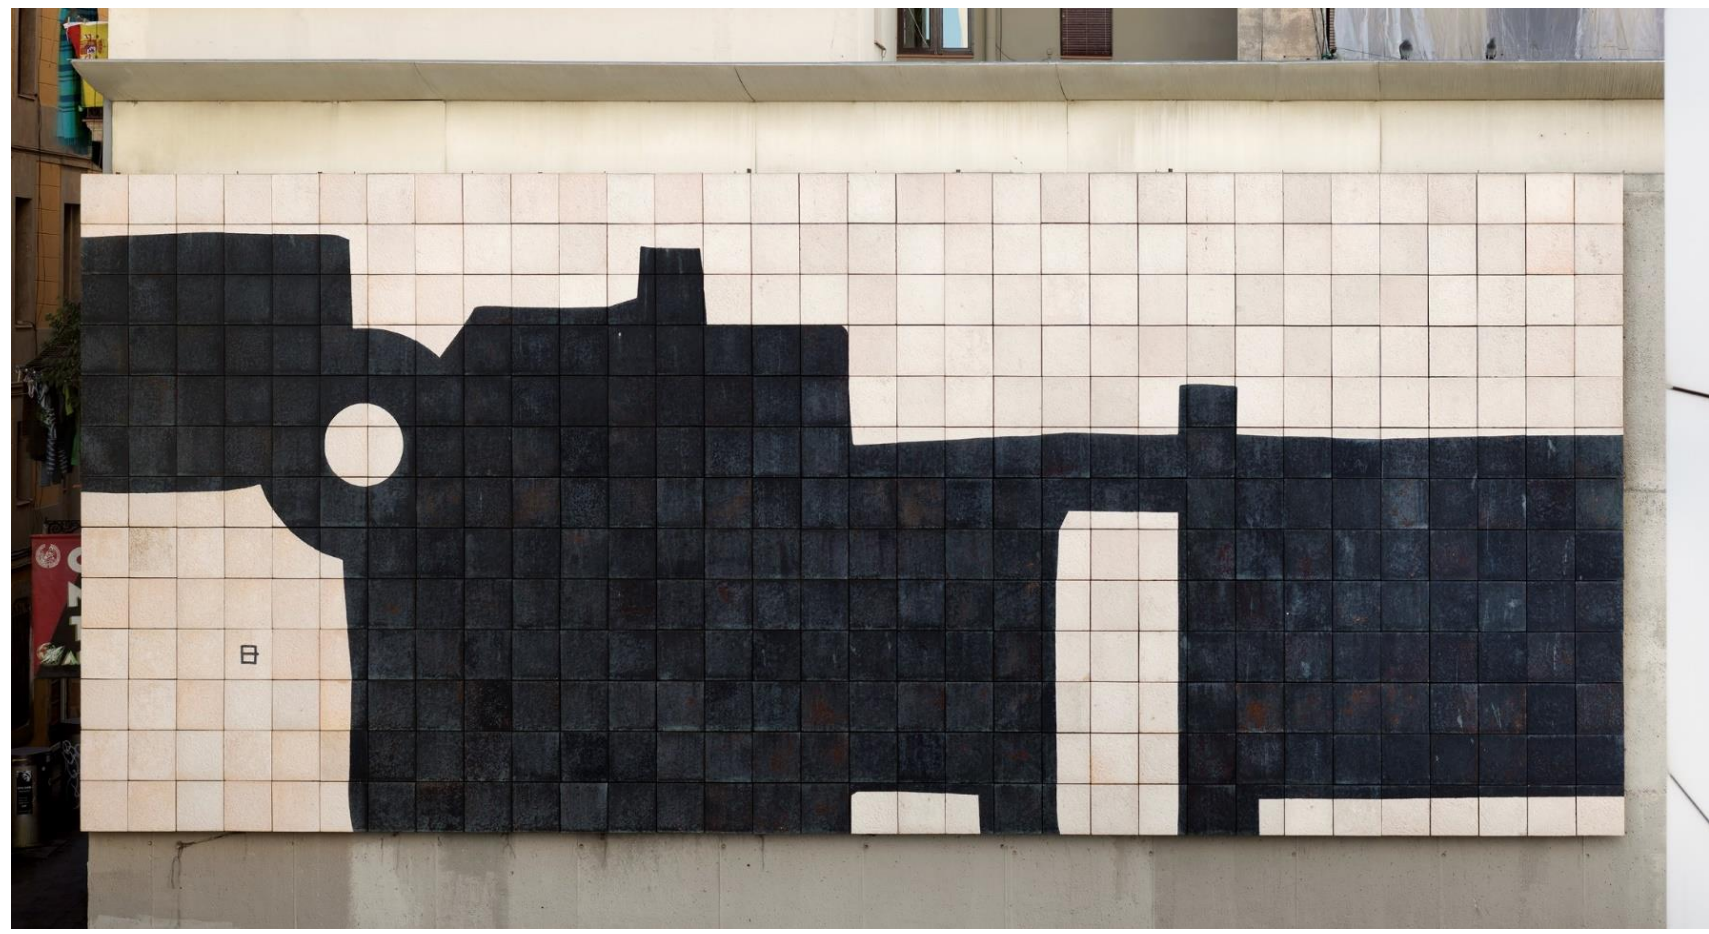
1

[1 and 3] *Barcelona, Mural G-333*. Photos: Gasull fotografia, 2016
[2] Eduardo Chillida. Photo: Unknown, 1998
[4] *Proyecto mural de Barcelona*. Photo: Archivo Chillida, c. 1996
[5] Eduardo Chillida working in the Hans Spinner workshop. Photo: Hans Spinner, c. 1998
[6, 7, 8 and 10] Stored replacement tiles. Photos: Alejandro Castro, 2017
[9, 11 and 12] Detail of the *Barcelona, Mural G-333* tiles. Photos: Lluís Roqué, 2017

The general state of the mural is good, though there is a slight change in color.

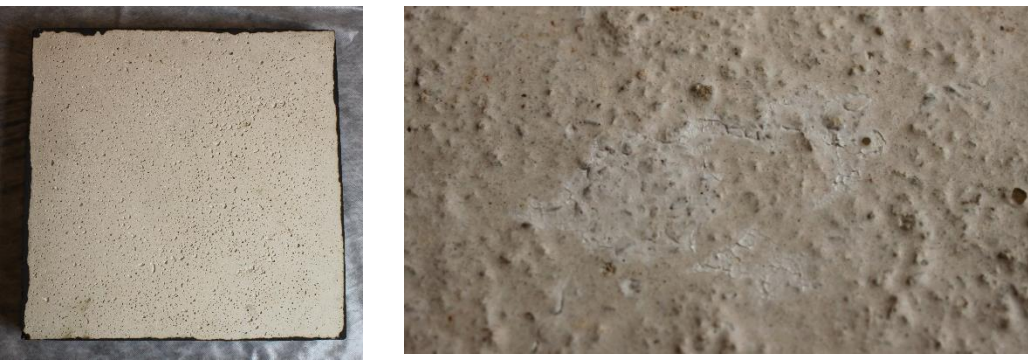
If we compare the current appearance of the mural and the two pieces that were stored and not exhibited (figures 6 and 10) we can observe a certain shift in the colors of the mosaic, specifically in the areas painted black. A whitish layer is present, principally in the lower part of the tile, possibly caused by an accumulation of rainwater or atmospheric humidity.

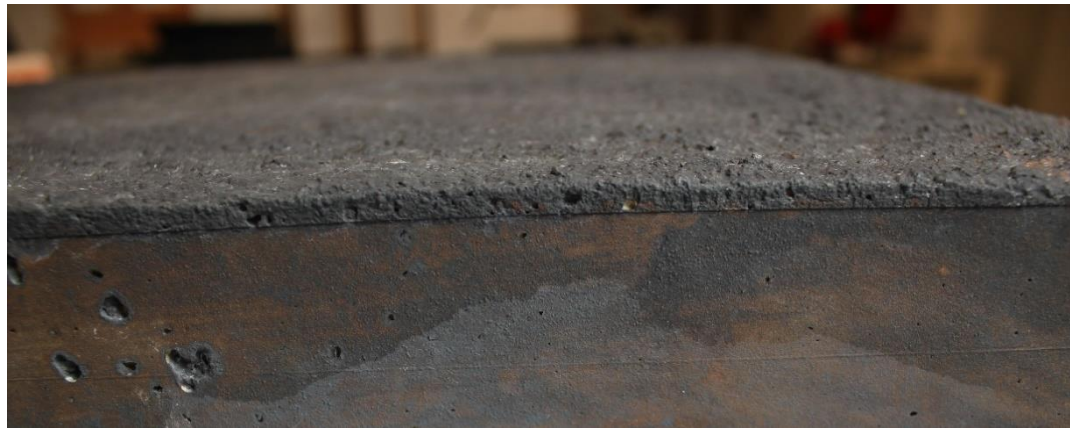
8

On the surface of the work there are whitish spots or deposits: this may be caused by the degradation of the protective layer of siloxane resins which has brought to the surface — together with the crystallization of salts in the surface — microbiological activity and agents of atmospheric contamination. The protective layer it can be clearly seen over the replacement tiles (figure 8). Another aspect worth noting is the bleaching effect of the avian detritus present on the mural.
