Introduction

In this poster we will try to count and study each case of the new supports most commonly used to remount a deposited mosaic.

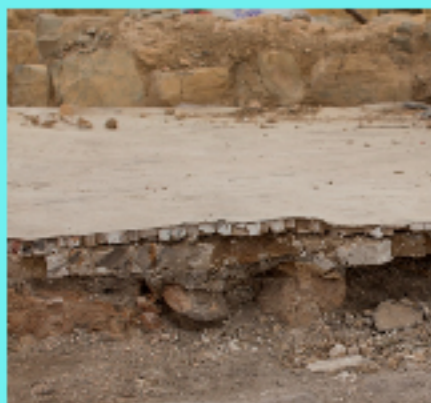
stratigraphic section

- 1 Statumen
- 2 Rudus
- 3 Nucleus
- 4 Bed of pose
- 5 Tessellatum

- 1- STATUMEN: it is the foundation layer composed of large stones that serves to stabilize the soil.
- 2- RUDUS: it is the layer situated above the statumen, composed of a lime mortar with large aggregates.
- 3- NUCLEUS: it is the layer that is in direct contact with the bed of pose, less thick and composed of a mortar based on lime and fine aggregates.
- 4- BEDDING LAYER: this is the layer in which the tiles are inserted. It is made of a mortar very rich in lime which allows it to remain soft and malleable for a long time period.

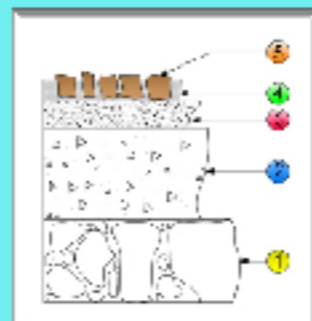
stratigraphic layers in situ

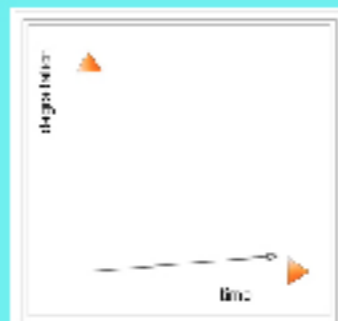
degradation curve as a function of time

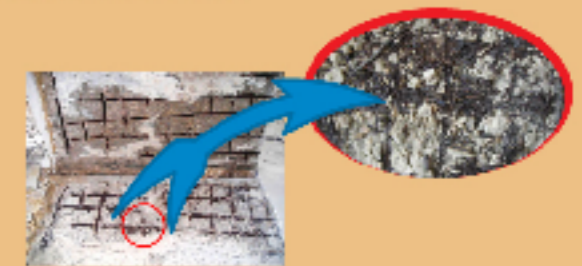
fracturing of the

- The structure iron oxidation causes an increase in the bars volume.
- The relative scale presence in the cement.
- The water penetration by micro fractures

These deterioration factors will exert pressure on the tessellatum layer causing:

- The panel fracturing.
- A surface lifting.
- Mosaic distortion.
- Edges lifting.
- Separation between the assembled mosaic fragments.
- Separations between layers.
- Tiles loss.

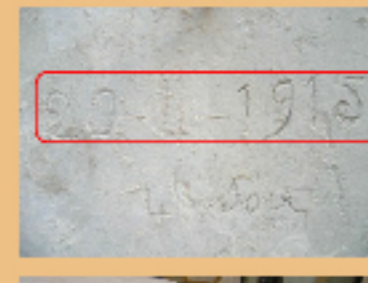
cement support

The technique of reassembling antique mosaics on a reinforced concrete panel has been used since the beginning of the 20th century. These panels are generally of medium thickness, they are exposed to the ground as well as to the wall and also in the outdoors sites thanks to their rigidity and their heavy weight.

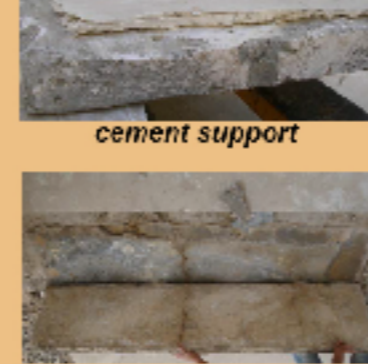
panel fracturing

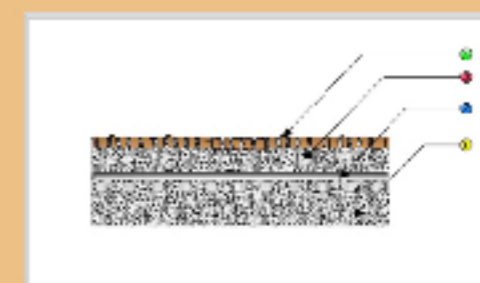
Layers section

- 1 cement mortar
- 2 metal frame
- 3 cement mortar
- 4 Tessellatum

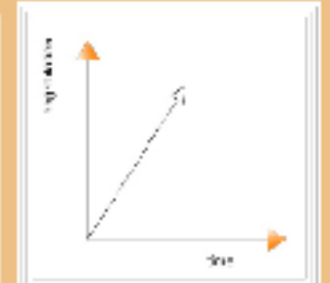
degradation curve as a function of time

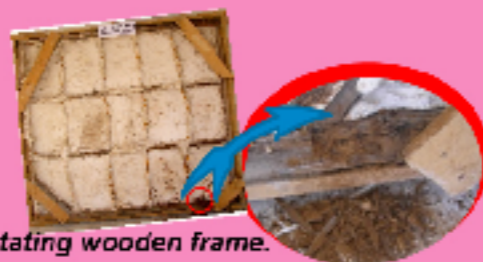
Rotating wooden frame.

- Detachment between the mosaic layers.
- Uplift and / or depression.
- Surface cracking and fracturing.
- Tiles loss and detachment.
- Inlays and efflorescence.
- Rotating wooden frame.
- Plaster crumbling.

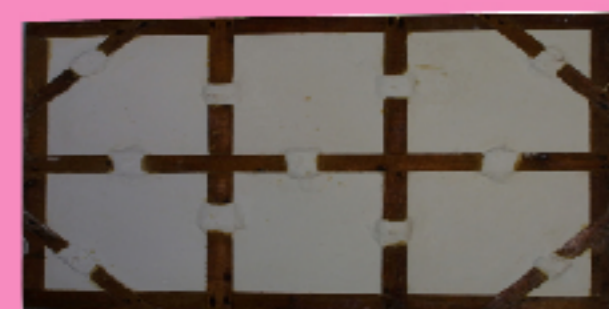
Plaster support

This panel is reinforced by the tow (material consisting of the filaments taken from the stem of the plants) or sometimes by means of burlap, mounted on a wooden frame and reinforced by rafters and wooden cleats and sometimes with slats metal.

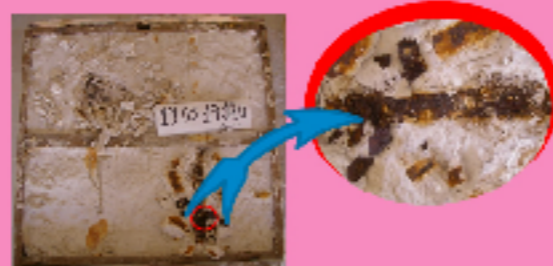
corrosion of slats metal

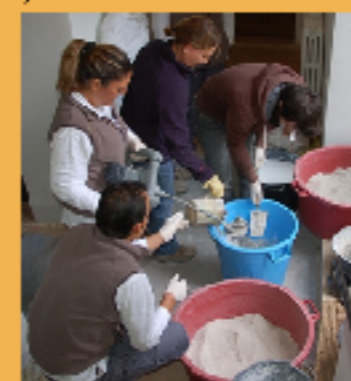
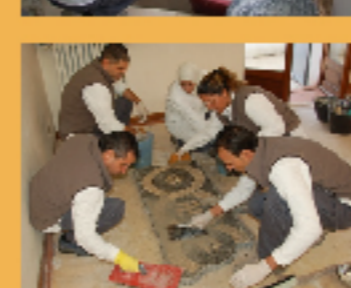
execution aerolam support

The panels in aerolam consist of an aluminum (anodized) layer, a lime-based mortar compatible with the original one and a bonding layer (Puzolan - resin).

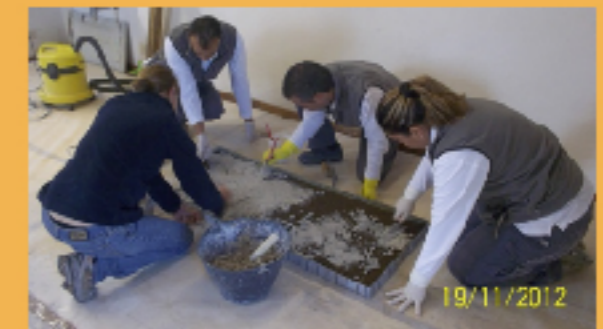
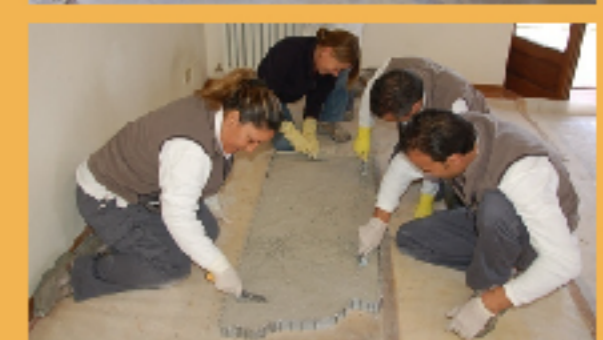
aerolam support
