The mosaic of the room C6 of the “House of Cantaber”, Conimbriga. Past, present and prospects in the future.

Our study presents the condition of conservation of the different fragments of a mosaic, which covered the *cenatio* C6 of the “House of Cantaber” in Conimbriga, Portugal

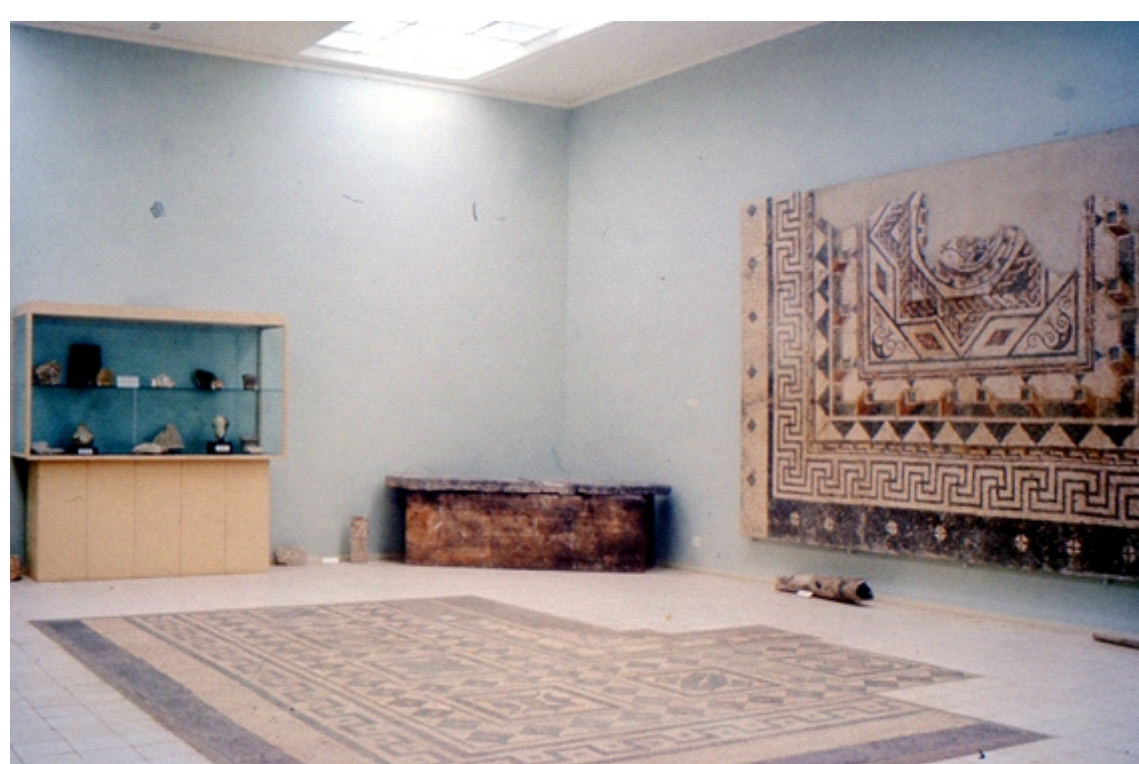
In 1961, they were transferred to the Monographic Museum of Conimbriga, where they were exposed after the restructuring of the support according to the method of consolidation with reinforced concrete (fig. 4).

Fig. 4 - Here, we can see 2 fragments of mosaics in the Museum of Conimbriga discovered in the surveys in 1899 (©MMC).

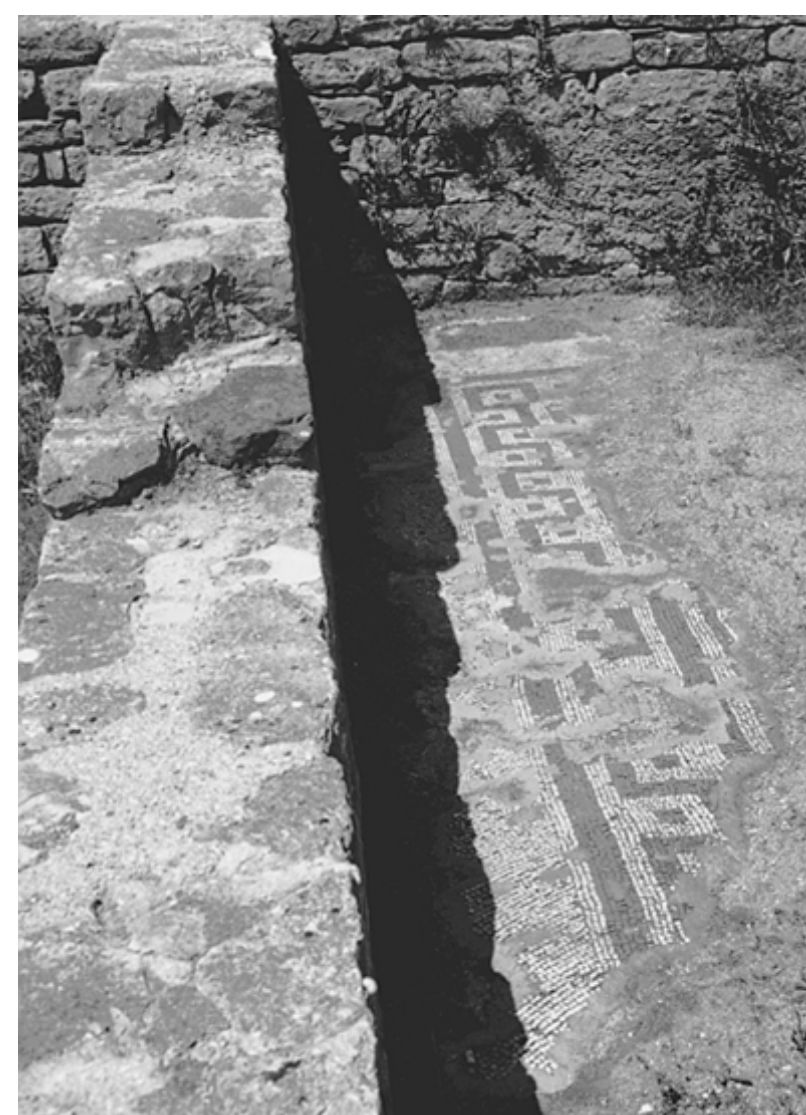
Fig. 10 - we can see the fragment 1 of the mosaic of the room C6 of the “House of Cantaber” *in situ* (see fig. 9). The photo shows the frame of the mosaic that covered the room C6, still *in situ*, and confirms that the mosaic belongs to this room, because there isn't other mosaic decorated with an identical frame. In the 80s this fragment of mosaic, that was *in situ*, it was raised and placed on support of reinforced cement and continues in the room C6. ©MMC

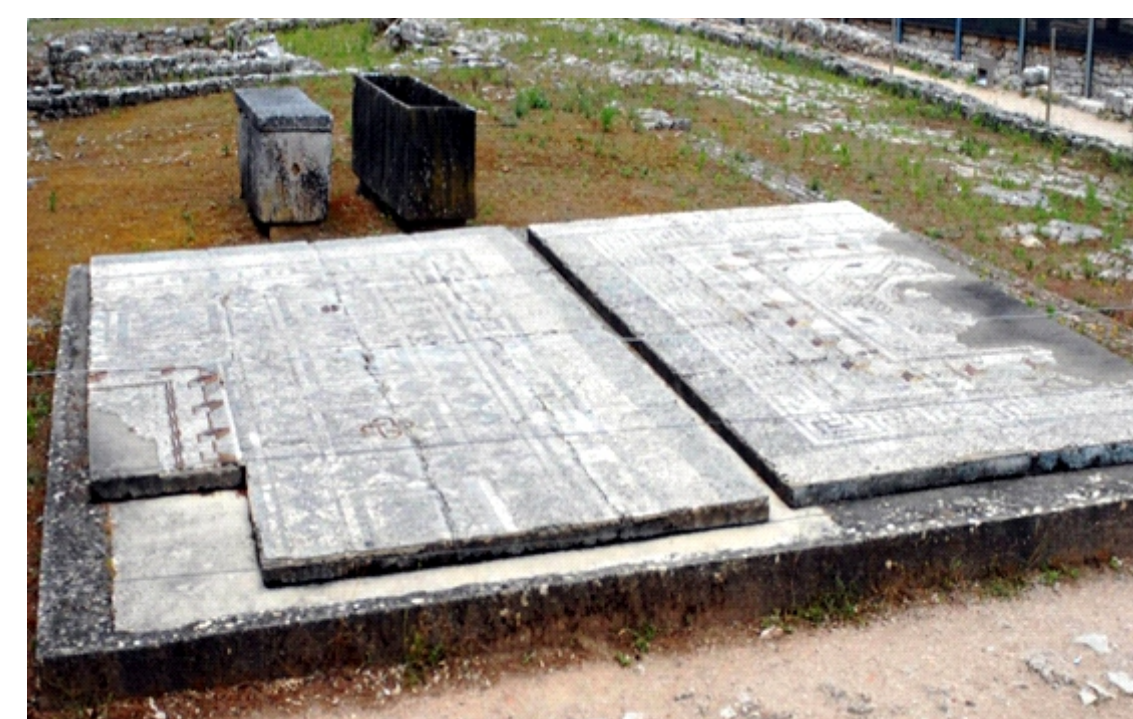
Fig. 11 - The largest piece of mosaic has been, since the last remodeling of the Museum (1975), at the entrance of the ruins of Conimbriga. (fragment 3, fig. 9). ©MMC

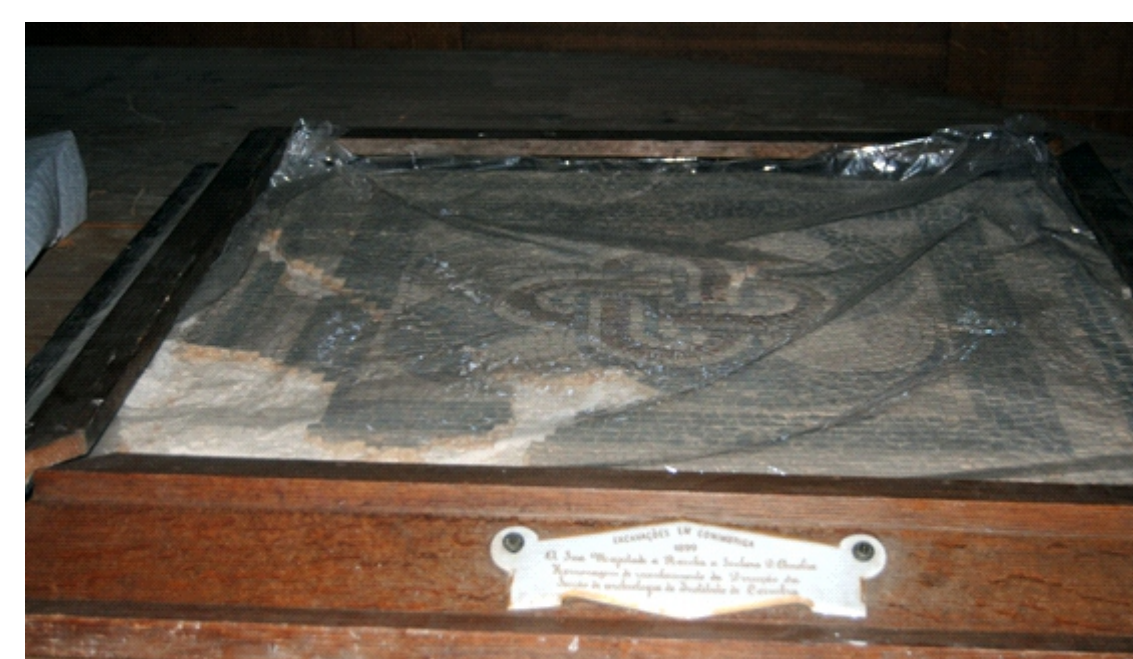
In February 2017, we returned to the Palácio Nacional da Ajuda to observe this mosaic. We found it on a table with the broken wooden frame and in very poor state of conservation.

Fig. 12 - The mosaic on a table with the wooden frame broken.

This fragment of the mosaic has recently undergone a strong mechanical action by shock that was caused by an inadvertent fall, in the reserve of the Museum, where it is deposited.

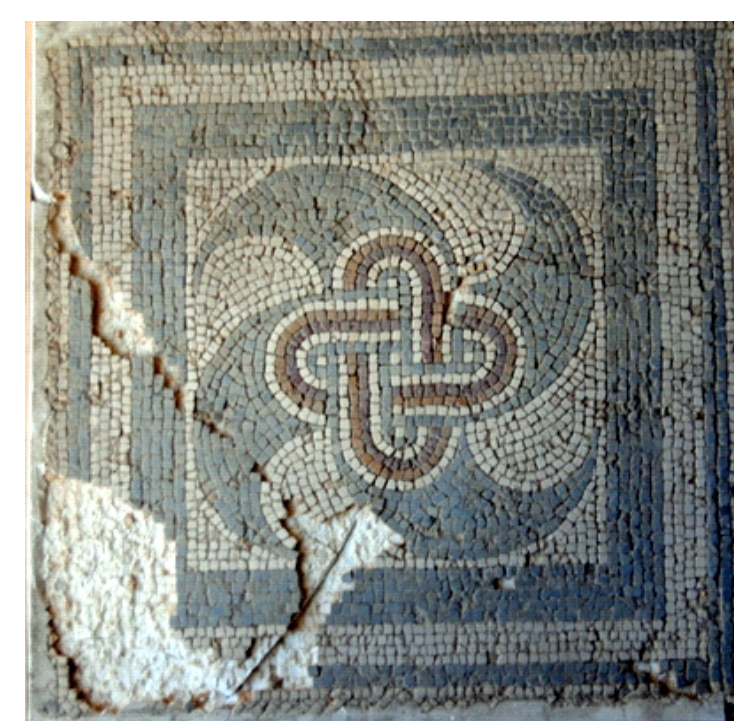
Fig. 13 - Aspect of the mosaic offered to the Queen in 1899, now in 2017.

The mosaic was placed in a layer of plaster of Paris and framed in brown frame reinforced with slats of this material arranged in the front part, in a scheme in crosses. Immediately we see the deep breakage of the *tesselatum* in about a quarter of the geometric composition and a slit that crosses it diagonally in almost the totality of its surface area, considerably affecting its conservation and presentation. Hundreds of white and black *tesselae* have been lost, and many others are in the process of stripping the gypsum support. This fragment of mosaic is in danger of total loss if the measures necessary to restore its physical and formal integrity are not carried out.

Thus, all of its support would be replaced in all the plates that were the object of intervention with concrete and in the fragment offered to the Queen and would be placed in light synthetic support, valuing its preservation and presentation and designing the possibility of its assembly can be carried out either in outdoor or indoor environment, allowing its use in temporary exhibition.

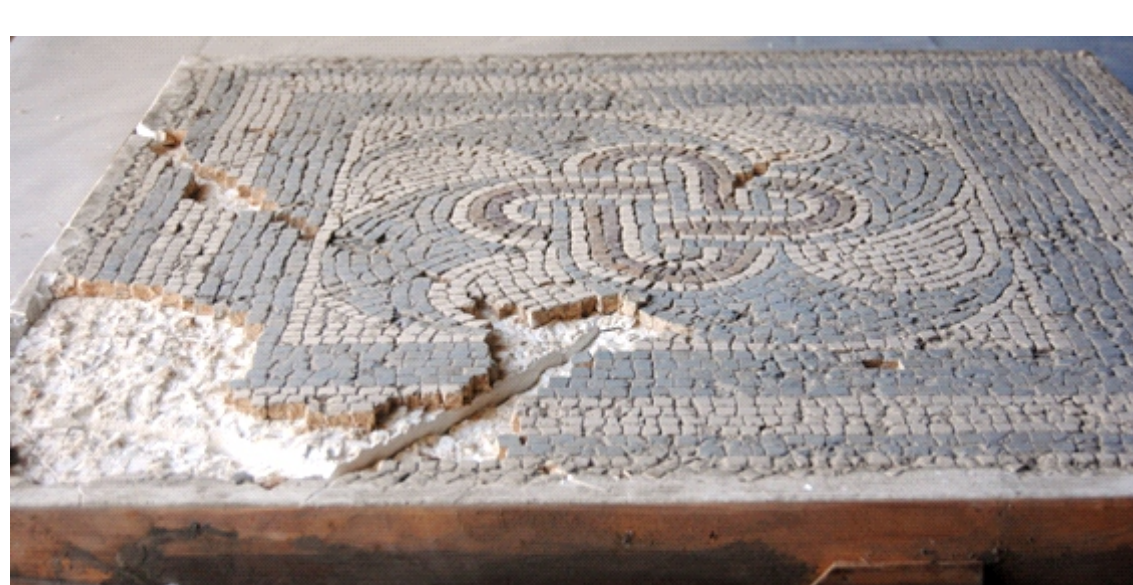
Fig. 14 - Another aspect of the mosaic offered to the Queen.

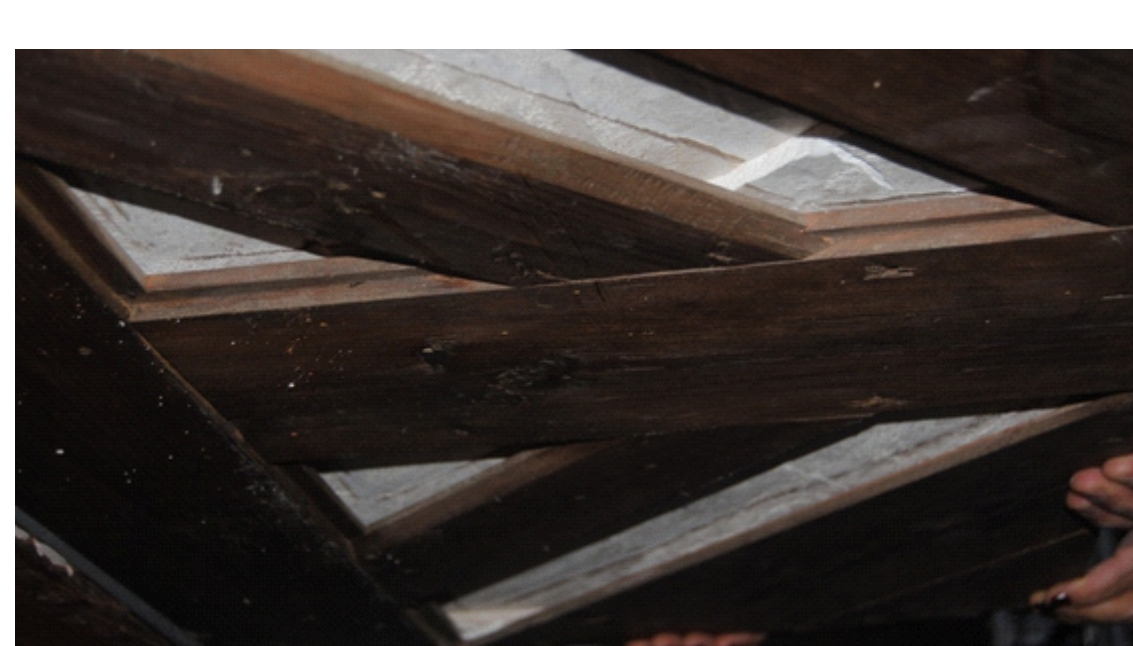
Fig. 15 - Aspect of the back of the mosaic offered to the Queen, now in 2017

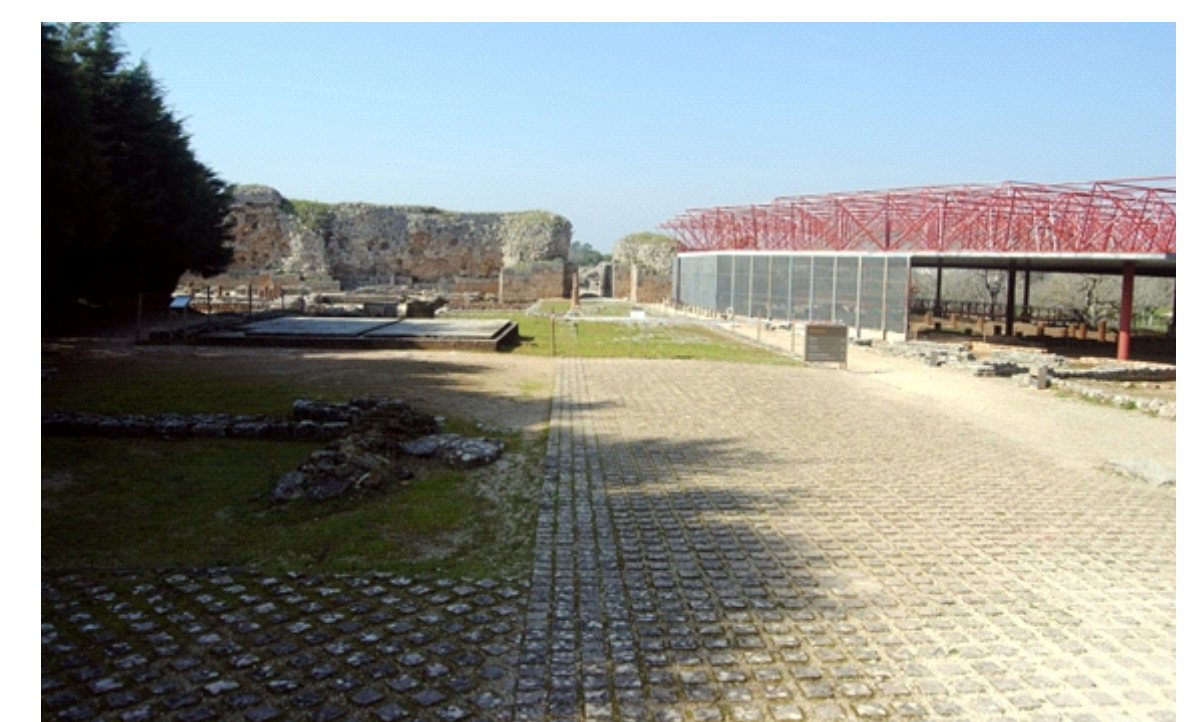
The shrubs that flank the mosaic to the south, shade for most of the day, making the environment humid, which allows the growth of plants in the cuts of the mosaics and favors the development of biological colonies of the type fungi, lichens and algae on the surface of the mosaic. The lack of light obscures the reading of the compositions and patterns.

Fig. 16 - Here, we can see the location of the fragment of the mosaic 3 (see fig. 9), since the last remodeling of the Museum, at the entrance of the ruins.

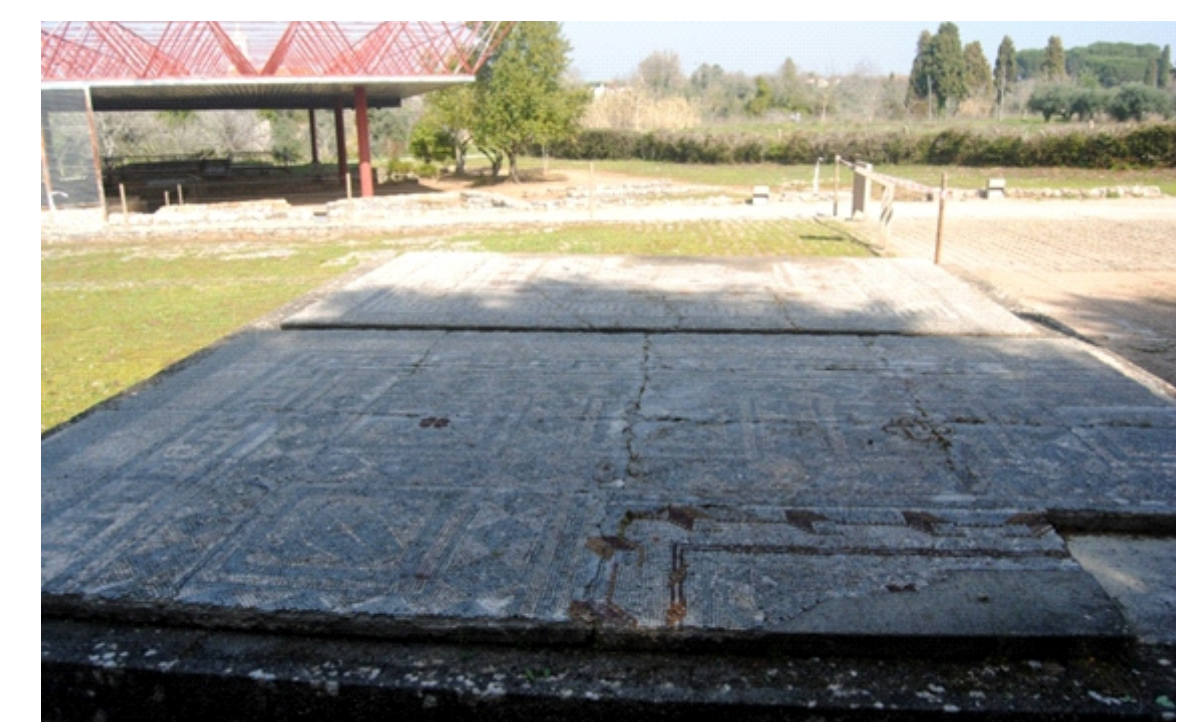
Fig. 17 - Aspect of the mosaic 3 (see fig.9) at the entrance of the ruins.

These mosaics have been for forty years under these conditions of exposure, subject to the harshness of the climate and the effect of thermal gradients. The mosaic shows symptoms of deterioration which, in combination with the intrinsic behavior of the building materials, especially the volumetric deformability characteristic of each of the plates that constitute it, resulted in undifferentiated movements in the mosaic and, consequently, in the development of cracking.

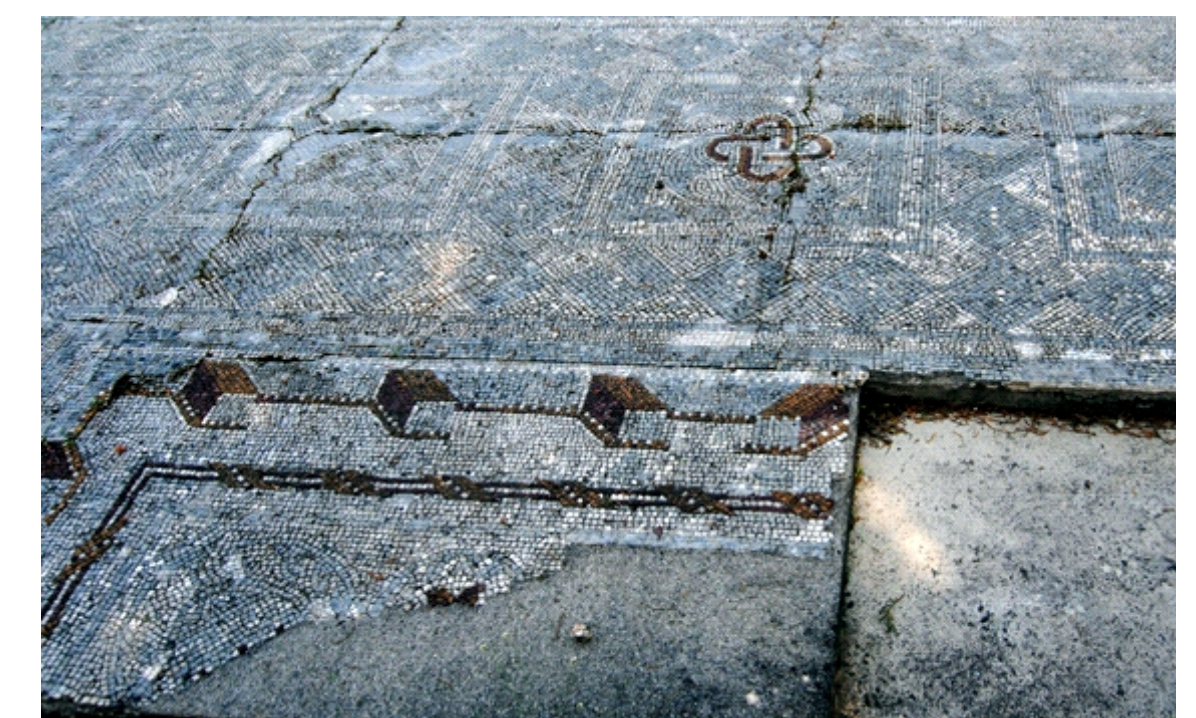
Fig.18 - Fragment of the mosaic 3 (detail).

These pathologies are mostly confined to the joints that the various sections of the assembly form together. The capacity of the concrete system applied to the mosaic to ensure the conservation of the *tesselatum* begins to be increasingly reduced, jeopardizing the durability of the pavement.

When the system contains iron rods, the oxidation of the metal results in strong mechanical stresses that give rise to cracks, lines of rupture and bursting in the *tesselatum*.

On the other hand, the deterioration of mortars with Portland cement causes the development of alkaline substances that normally effloresces the mosaic surface forming concretions. These, in turn, constitute a substrate that encourages the colonization of organic matter.

It is necessary to re-evaluate the possible interactions between the limestone and the concrete system applied to the pavements, which, after 60 years is approaching its useful life, so that, in advance, ways of action are solved for the good conservation of this and others mosaics of Conimbriga.

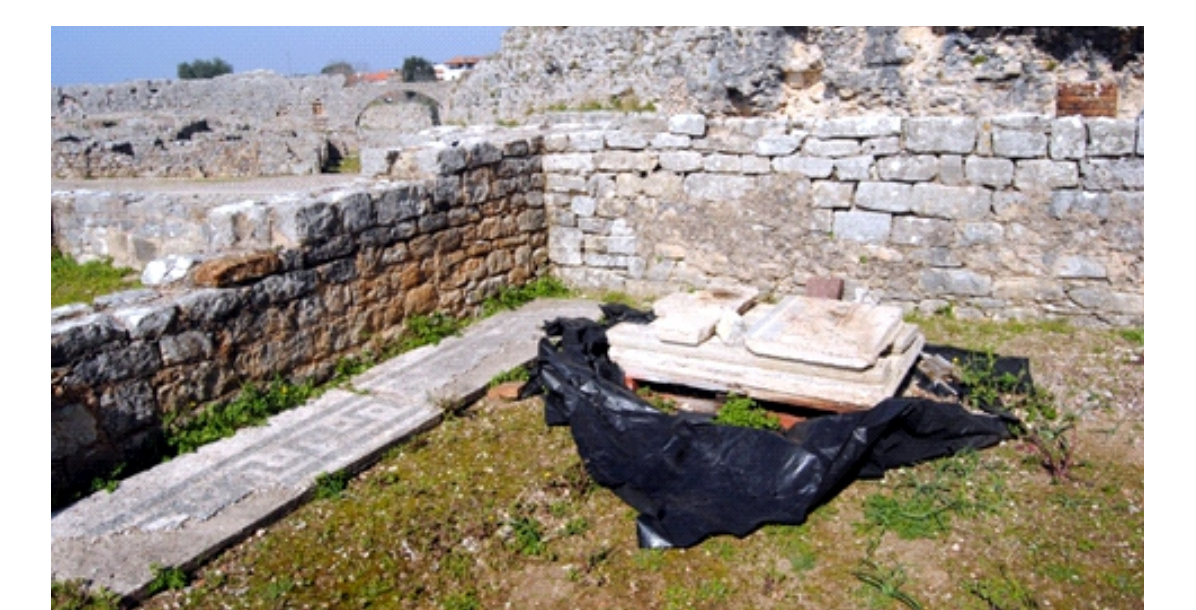
This mosaic of the room C6, since it was discovered in the nineteenth century has been the target of several amputations and transfers. With the return of the panel offered to the Queen and the fragments that are deposited in the room C6, we can gather them and proceed to its replacement or in the Museum, when its next remodeling, or their repositioning *in situ*, after probing or total excavation made in the “House of Cantaber” and confirming this origin of this mosaic, it should return to the place of origin and pave the room, according to the reconstitution. It would be an opportunity to carry out a profound conservation and restoration intervention at a time when such a procedure becomes urgent as this mosaic is in the process of advanced deterioration.

Fig. 19 - Some fragments of the mosaic that covered the room C6
