Mosaic: from Cement to Aeorolam

Written by: Hamadi Sillini

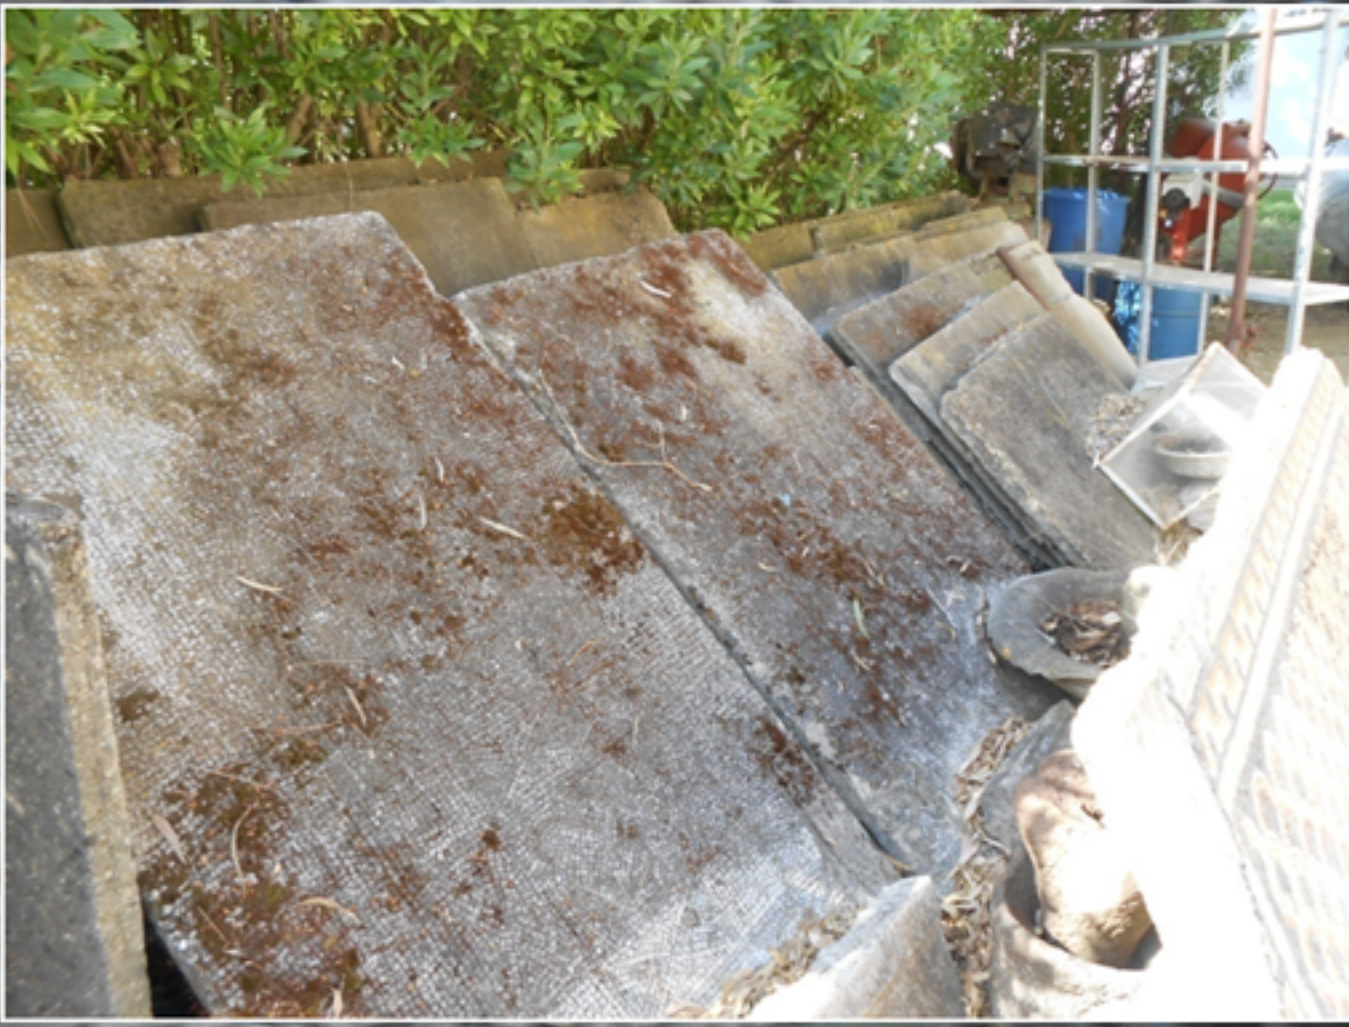
A collection of panels of concrete mounted mosaics stacked and open to the elements

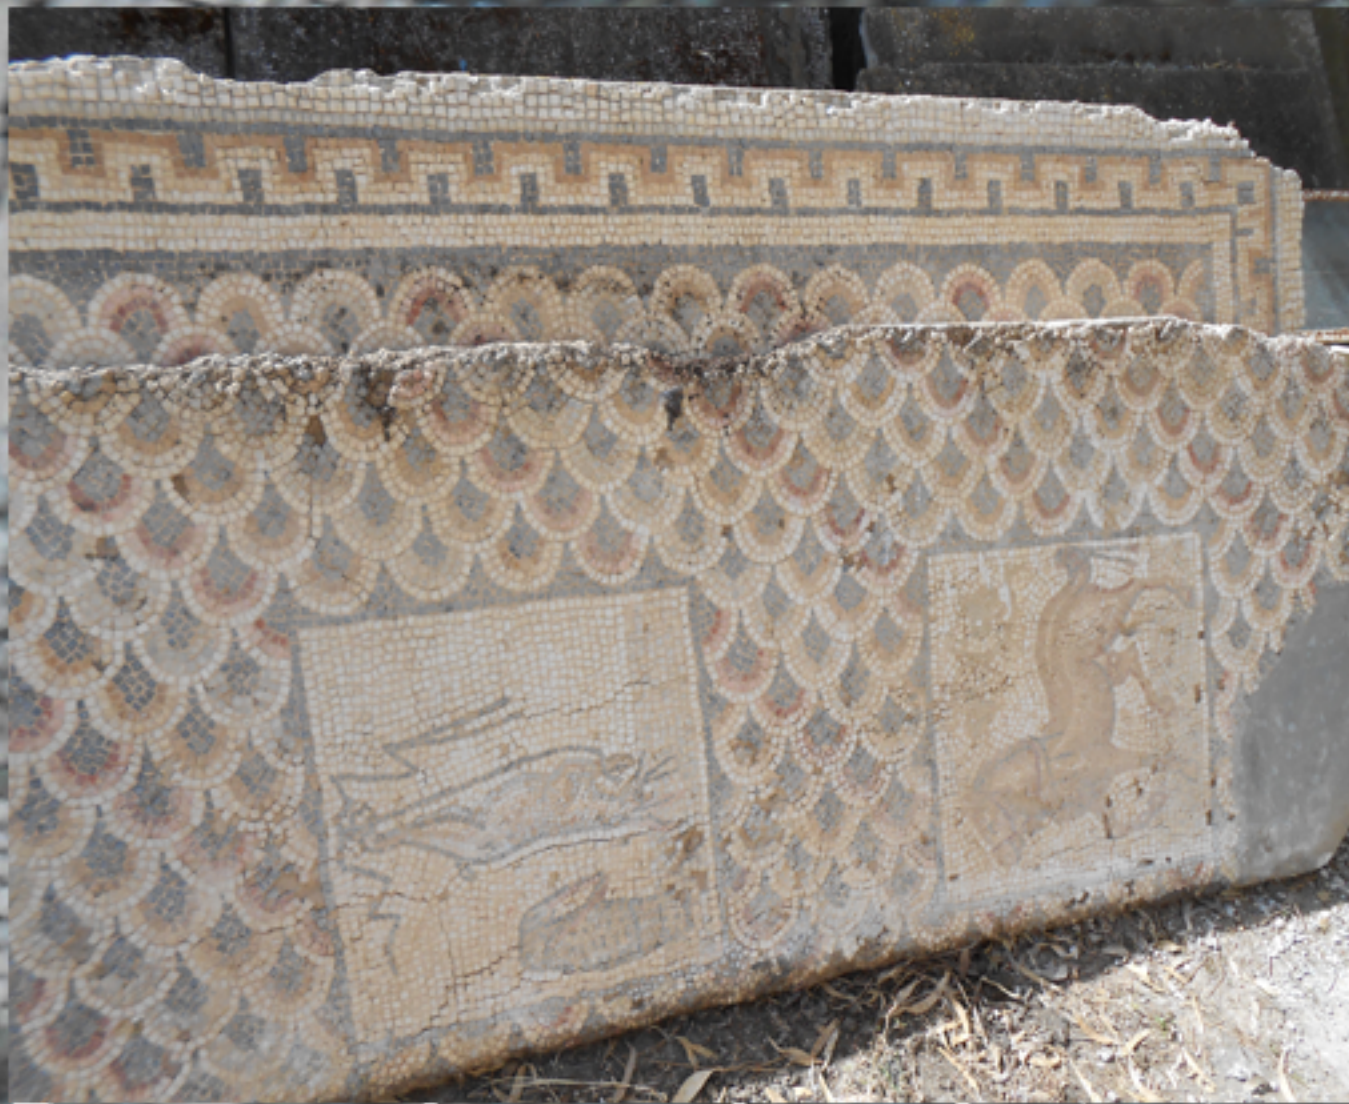
A large, heavy detached Mosaic

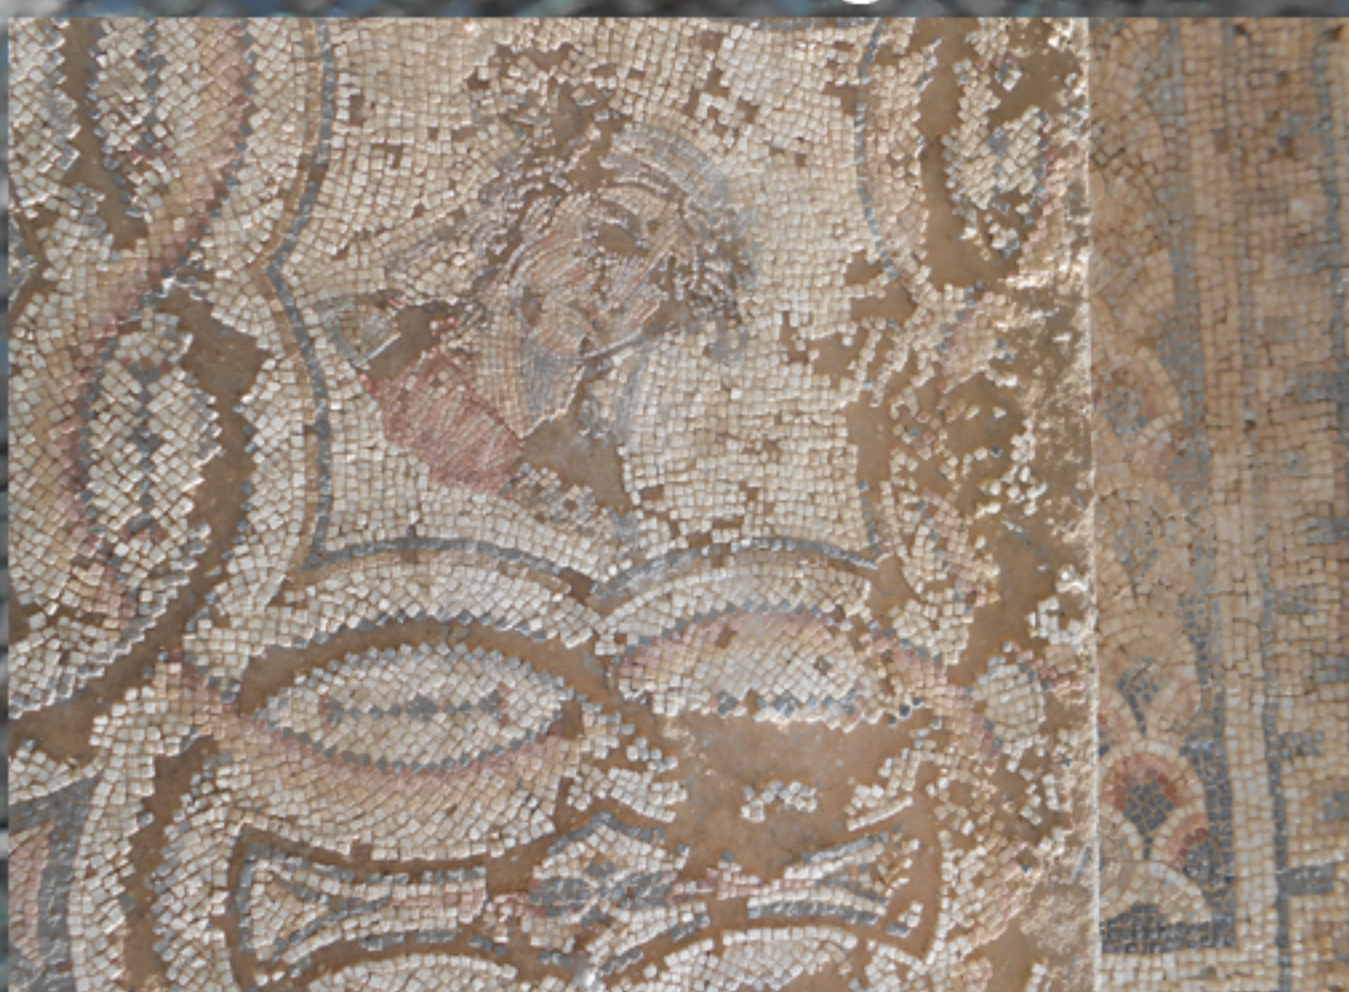
Damaged mosaic substrate, made of cement and iron: a mosaic in storage

The main problem of Mosaics placed on reinforced concrete still remains with many of them currently detached from their bedding layers. Unless immediate action is taken to stop the worsening of their condition, the result will be further damage and finally their extinction.

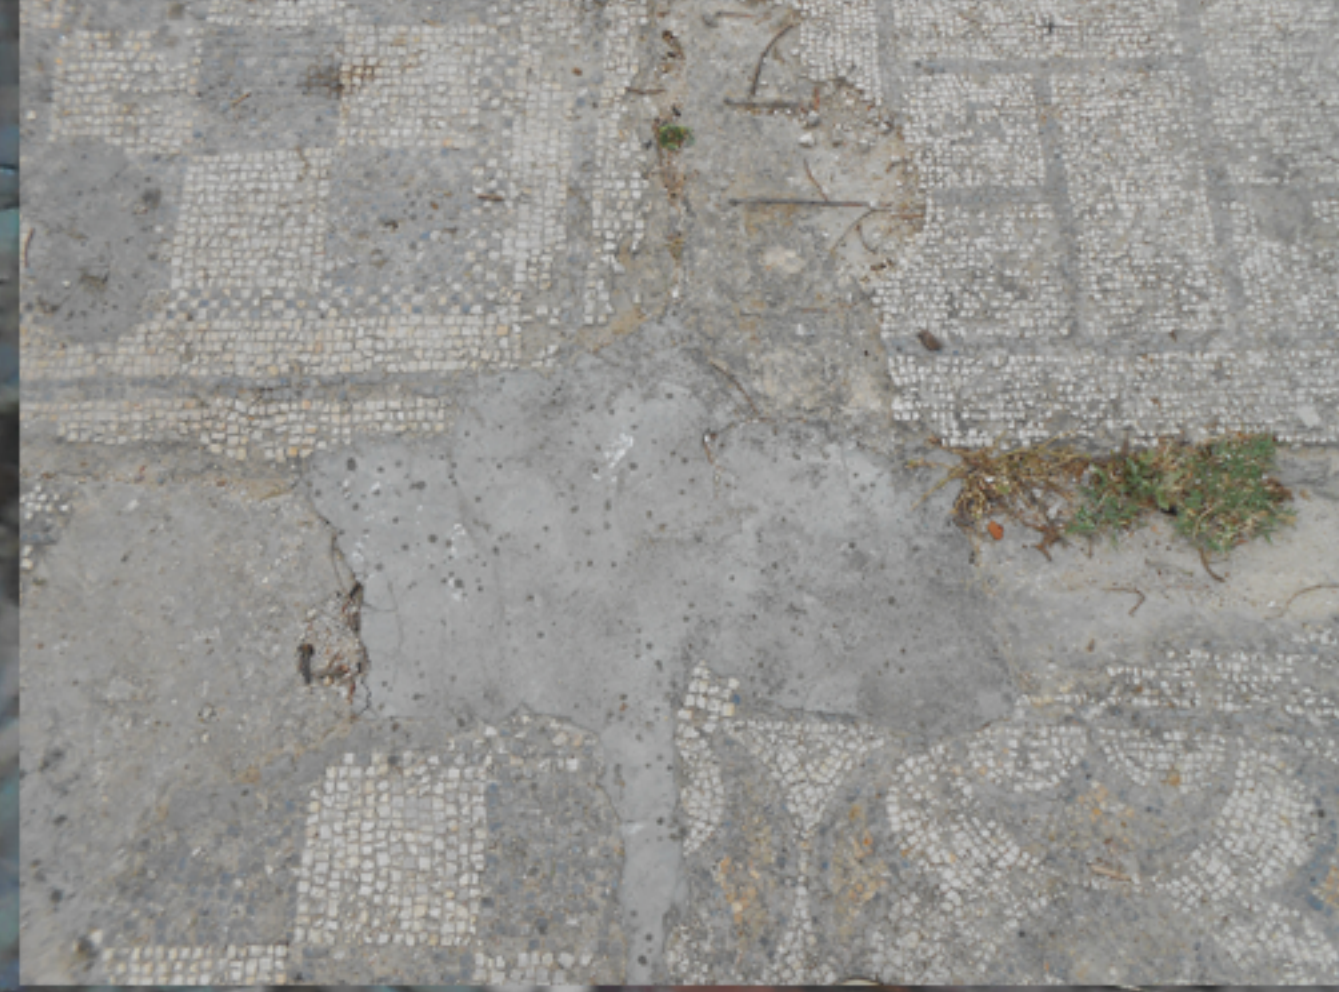
a mosaic in situ

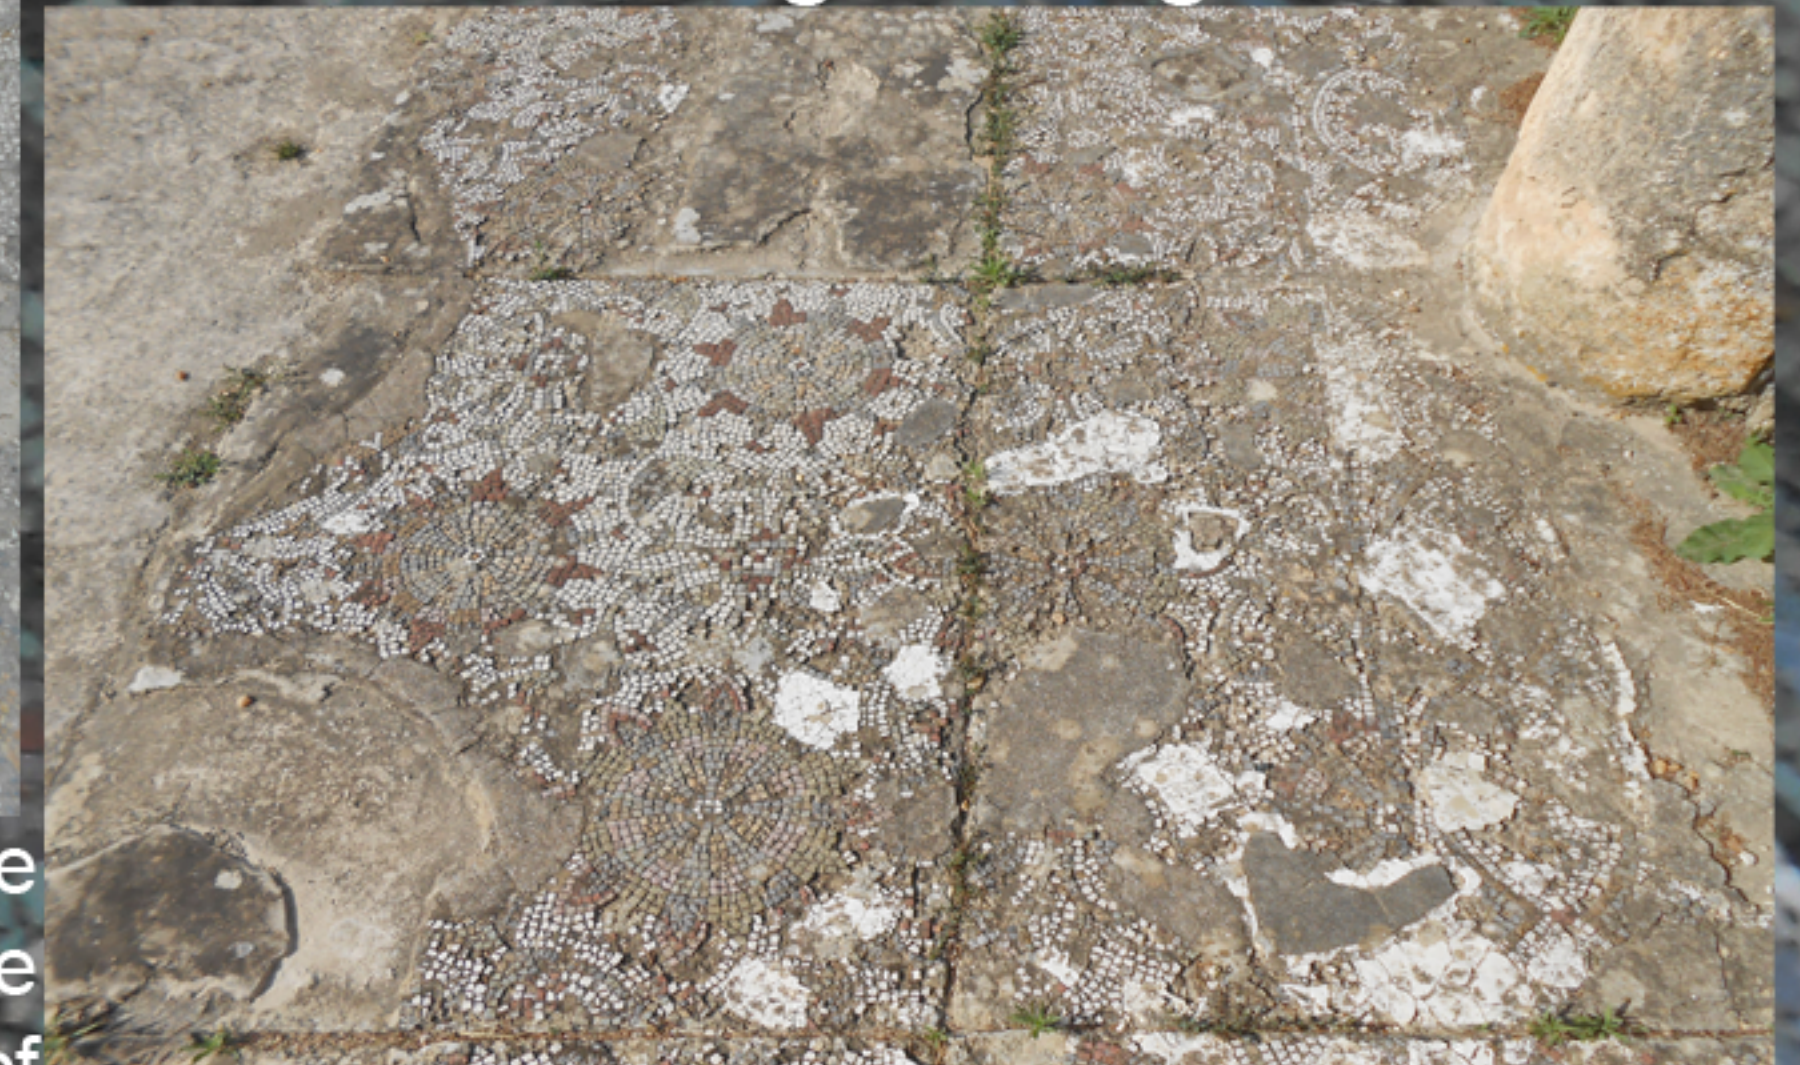
Detached mosaic in several pieces and poorly reassembled showing cut edges
