# Restoring mosaics in Lebanon: evaluation of earlier decision and propositions of further action based on the examples of two case studies

Anna Tomkowska  
Departametrn of Conservation and Restoration  
of Works of Art

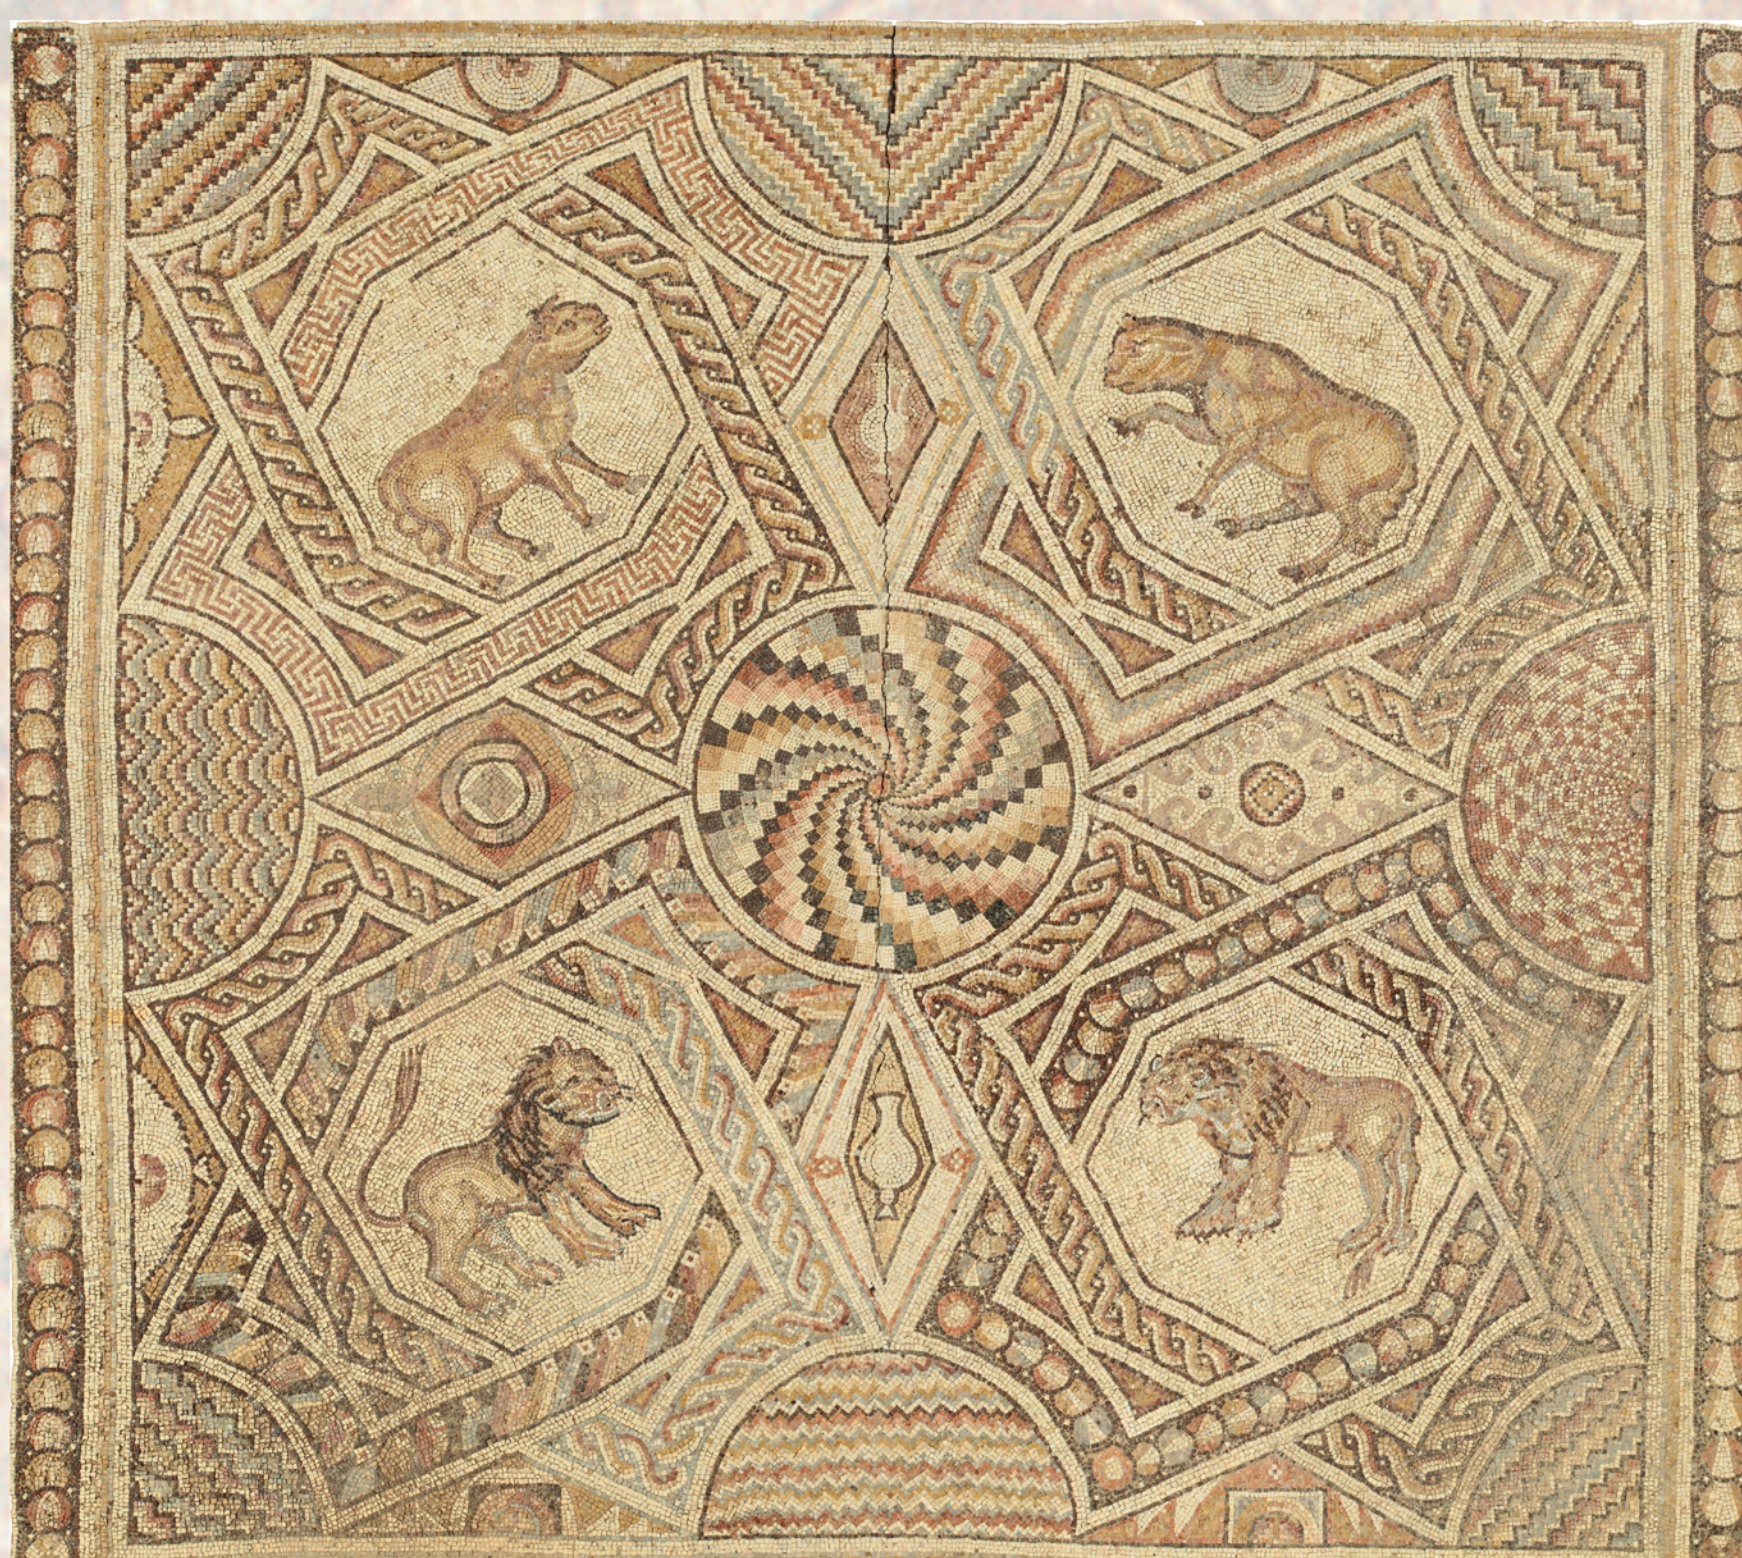
## Early byzantine mosaic from the basilica in Jiyeh.

In late 80's during the Civil War early byzantine church with rich mosaics was found accidentally at the coastal archaeological site Jiyeh.

Mosaics were removed from site and placed in Beit ed Dine museum. Most of them were relaid on reinforced concrete. Conservation of mosaics have place probably at the museum's workshop. From that period there is no photo or written documentation about conservation process.

Mosaics from Jiyeh are dated by the inscription for the 572 AD

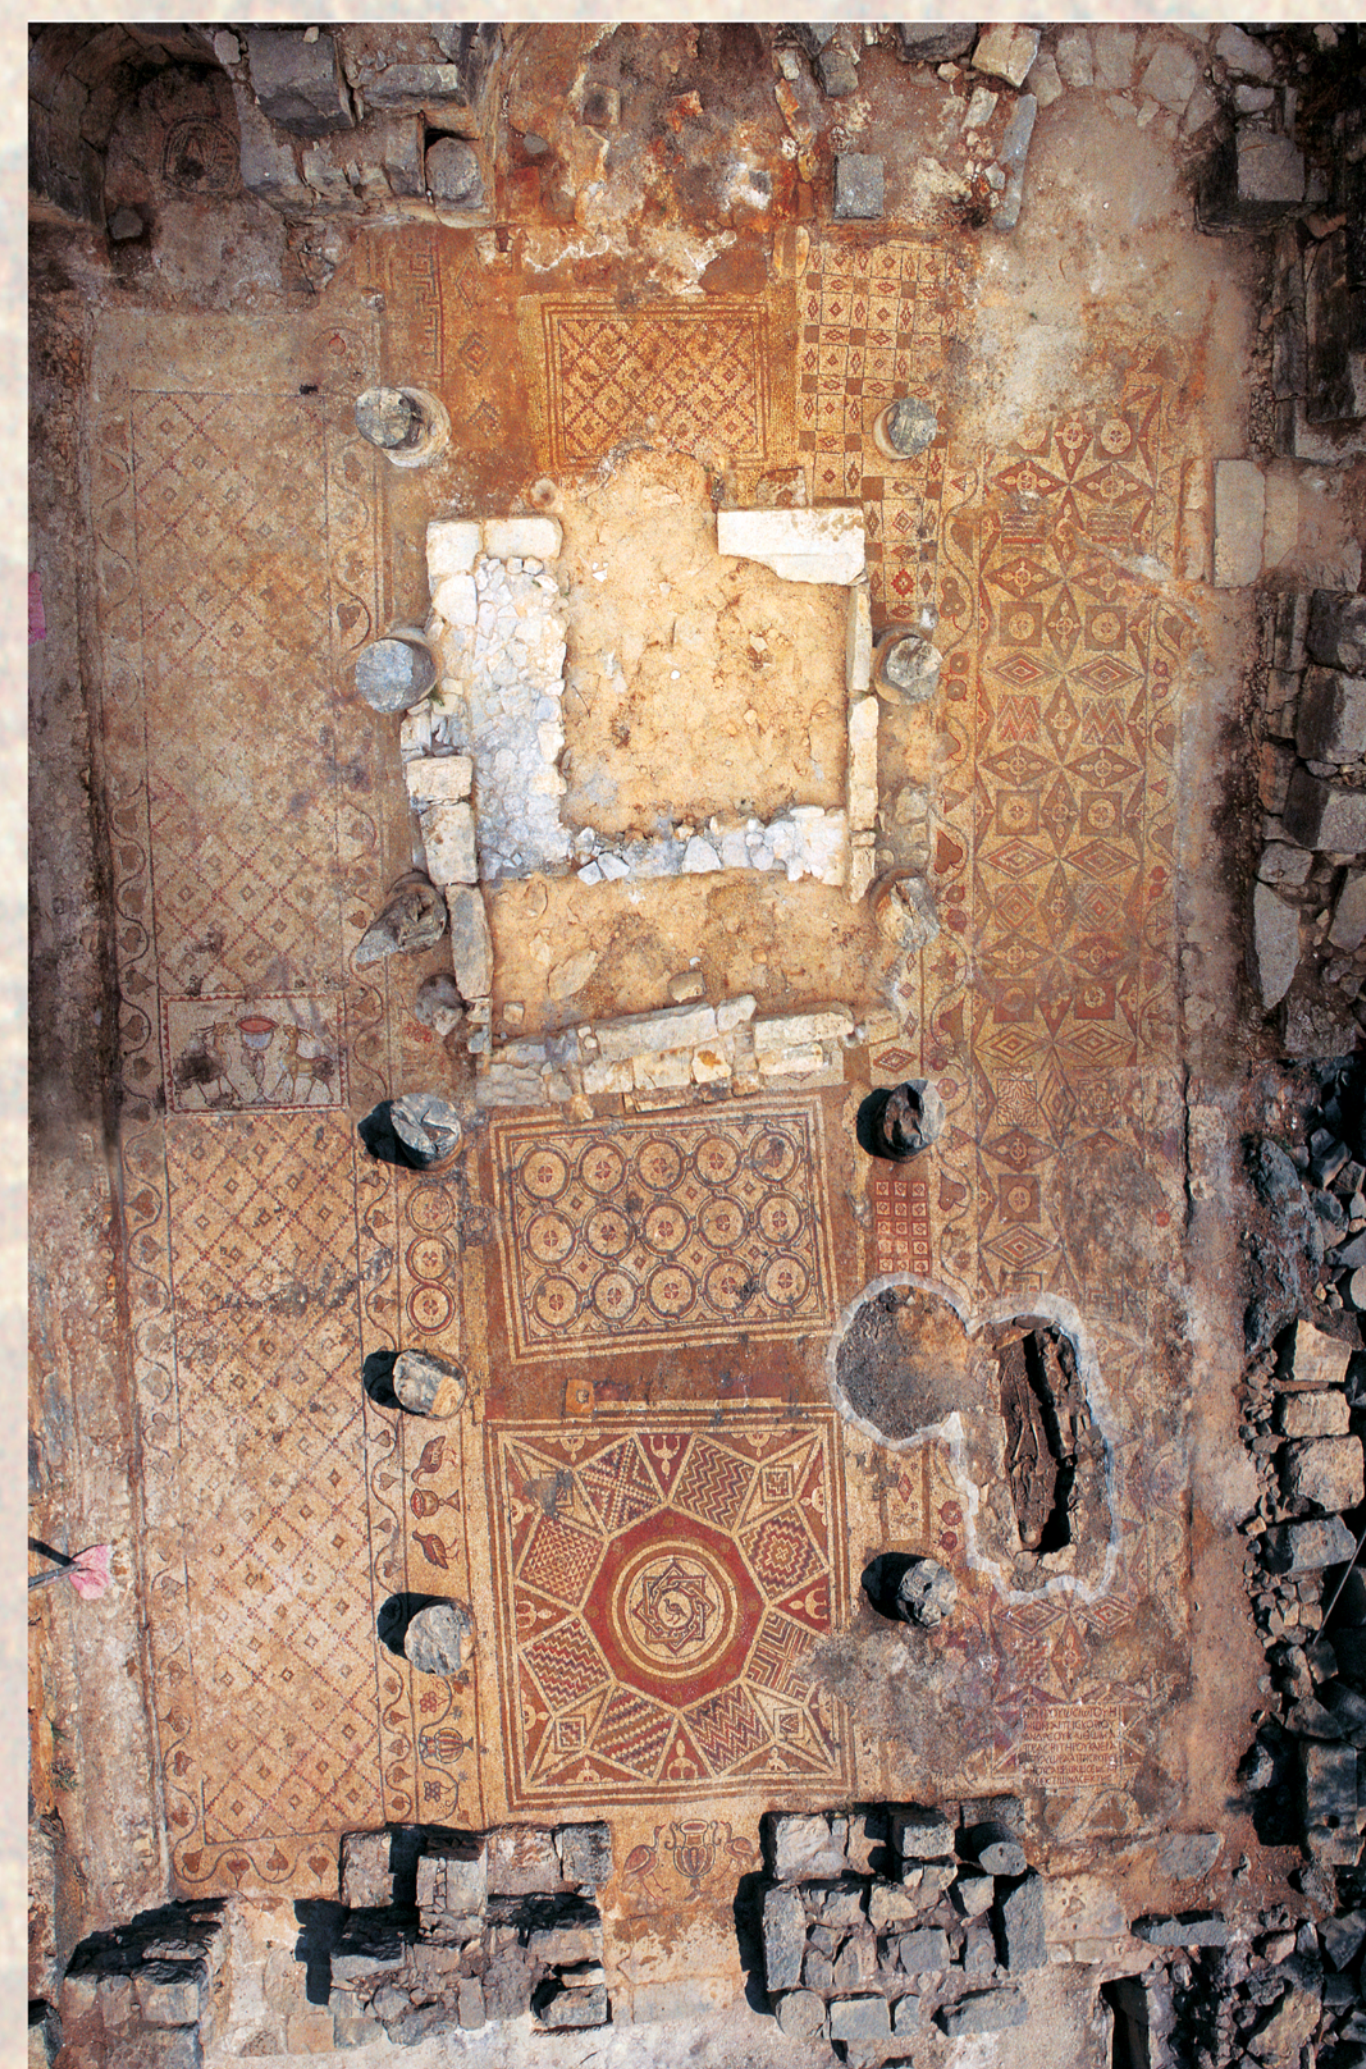
## Early byzantine mosaic from the basilica in Chhim

In 1996 Polish - Lebanese archaeological expedition uncovered floor mosaic in the basilica in Chhim. On the basis of the Greek inscription the mosaic was dated for the 498 AD.

Mosaic was conserved „in situ” by polish conservators from Academy of Fine Arts in Warsaw. After the excavation and conservation season the whole mosaic was reburied with braided plastic foil and covered with small pebbles and sand. The height of entire reburial was at around 12 cm.

In 1999 the mosaic from the central nave and the part of the inscription were stolen. Stolen mosaic from central nave was found. It was cut and rolled by thieves. Current condition of mosaic from central nave is unstable. Since the fragment was found it is kept in the storage in Saida. The part with the inscription has not been retrieved.

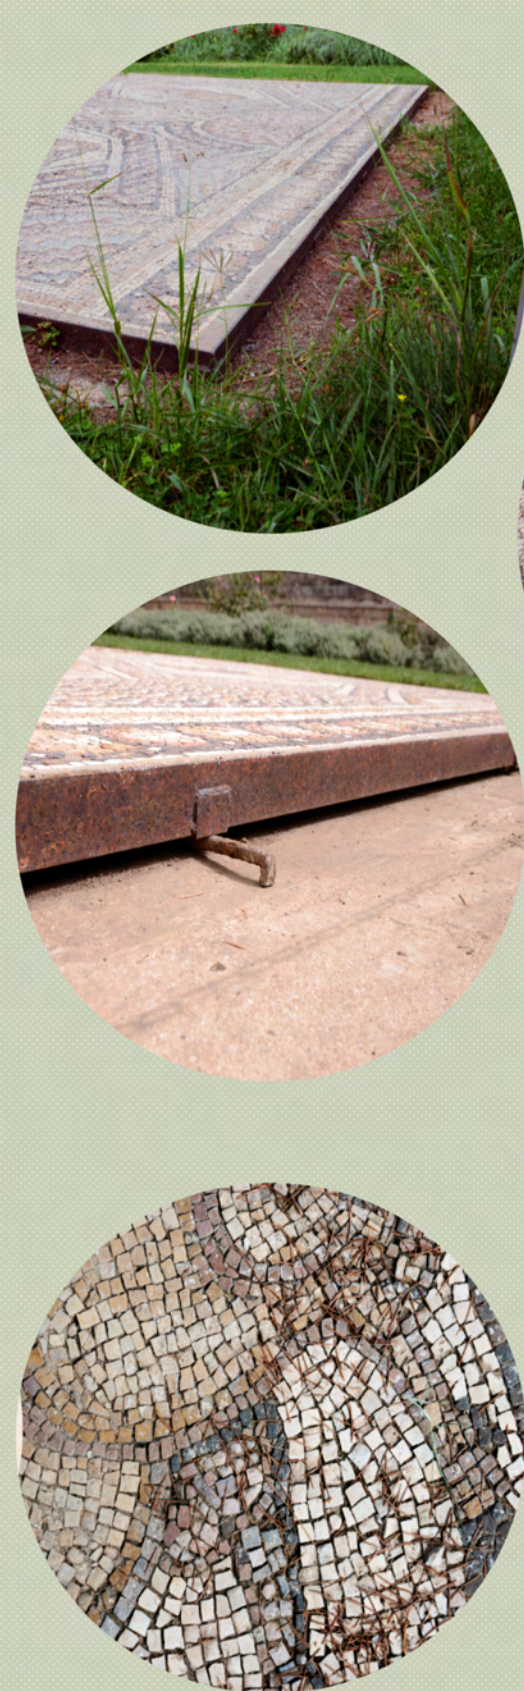
**Re-laid on concrete** Main cause of destruction was mosaic's transfer onto a reinforced concrete. Strong cement-based mortar caused mechanical damage (cracked and fractured), mostly of ceramic tesserae.

**Location** The mosaic is exhibited in the museum's gardens. Presence of grass seed and soil (carried by the rainfall) in the place of exposition causes further cracks in the concrete backing. Current location of the object prevents it's straightforward transfer to the workshop.

**Steel hooks** For exhibition purposes steel hooks were slid under the reinforced concrete backing, causing a gap under the mosaic. In time soil and grass seed began to accumulate in the empty space. The hooks removal caused a collapse resulting in a crack in the central part of the object.

**Lack of prevention** The mosaic is not sheltered nor reburied. It has a tremendous impact in the autumn-winter season (characterised by heavy rainfalls). This leads to surface accumulation of leaves and needles which in turn causes amassing of organic agents causing bio-degradation of the tesserae.

**Lack of documentation** No readily available or archived documentation concerning past works on an object.

**Grass removal** To prevent further mosaic's damage caused by grass, a steel frame system was put in place, separating the mosaic from the lawn.

**Drainage system** To stabilise the mosaic, a drainage system has been developed. This type of protection allows easy draining of rain water and prevents soil and seed transfer under the mosaic.

**Conservation** The main purpose of conservation was reinforcing the weakened tesserae (mostly ceramic ones). Second stage consisted of cleaning tessellatum surface and protecting from the negative effects of microorganisms.

**Shelter** There is a plan to design a shelter above the mosaic after the conservation process has concluded. Considering especially harsh climate during the autumn-winter season there is a choice between a free-standing roofing and yearly reburying.

**Documentation** The aim of the project is also documenting most recent works and noting any that were carried out in the past.

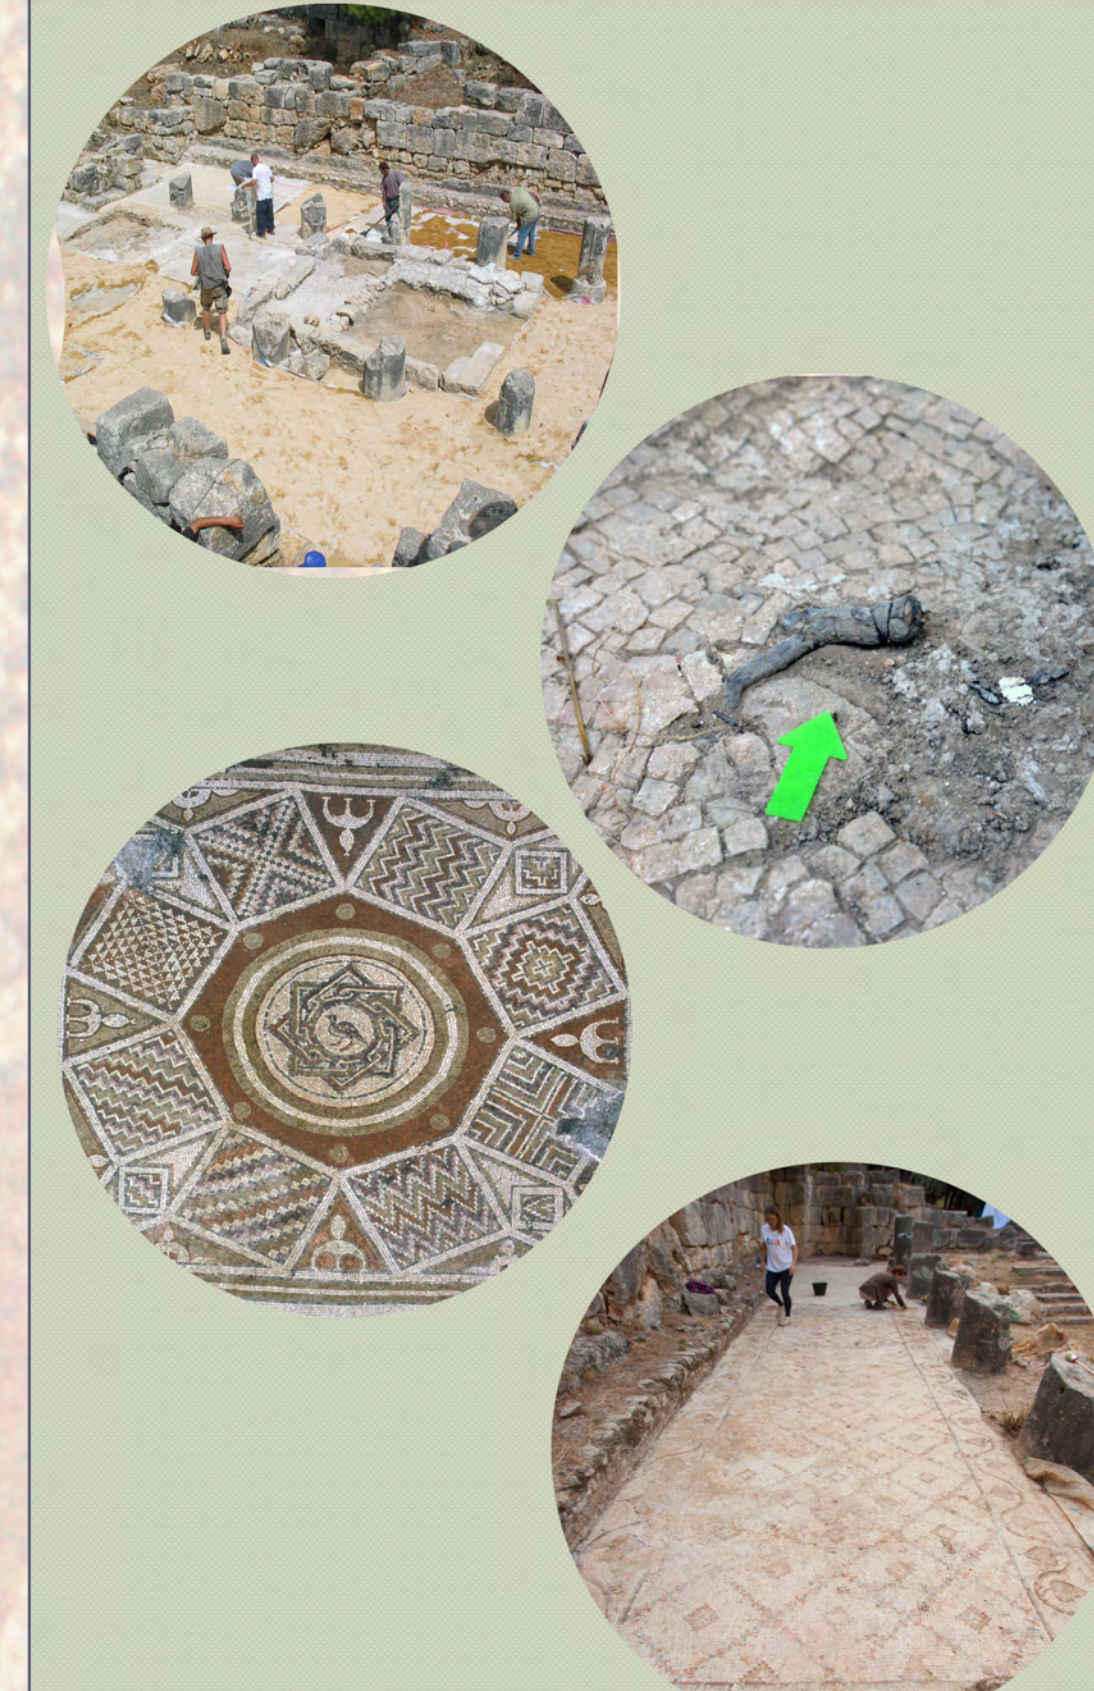
**Low reburial** Although carried out at a high level, the lack of funding during the 90's conservation works resulted in the mosaic's reburial not being high enough.

**Lack of fencing** Until 2000 the site was not fenced and sufficiently secured, which resulted in the theft of mosaic's most valuable parts in 1999.

**Lack of prevention care** For a long time there were no prevention works carried out on the site. This resulted in the mosaic being covered by thick vegetation growth. Roots of shrubs (mostly of the *inula viscosa*) and grasses overgrew the reburial protection layers causing further damage to the tessellatum.

**Most unstable parts** The north nave which was mostly secured but not restored during the 90's is in worst condition. Most commonly observed issues are surface deteriorations, early edging repair degradation, new lacunae caused by insects underground nests and roots.

**Conservation** Conservation works were carried out mostly on parts of the northern nave. During the works the main objectives were to remove the vegetation roots and to stabilise detached tesserae, new edging application, tessellatum lacunae refilling with mortar.

**Reburial** Braided plastic nets were exchanged for geotextile in the parts of the church where the conservation works took place. The new reburial is also higher and consists of multiple layers.

**Prevention** Thanks to the local authorities (Directorate General of Antiquities) constant prevention works are taking place on site. Those are mainly mowing of vegetation growing on reburial outer layers and guarding the site itself.
