The Location

This site is located in the village of Al-Shabtiya in the northern part of the city of Latakia in Burj Salam region. This site is located at the top of 12 meters cliff above sea level and directly overlooking the sea.

It is a monastery dating back to the first Christian period, As result of the discovery of a large Baptismal font, and the translation of the written part of the mosaics

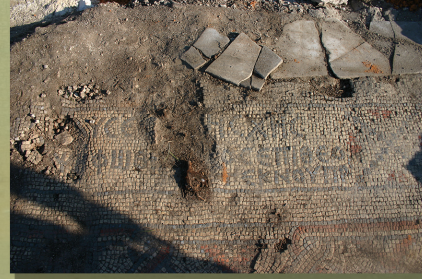
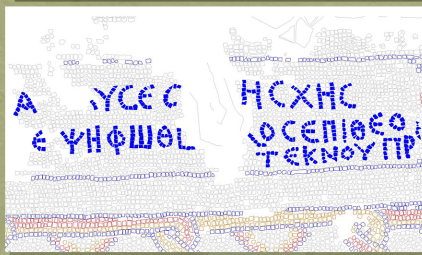
A translation of it, which is very incomplete is: "For the of the peace sake of Esheses, this mosaic was paved during the reign of Theotkenus the priest." Phid. Malatus Jaghnon

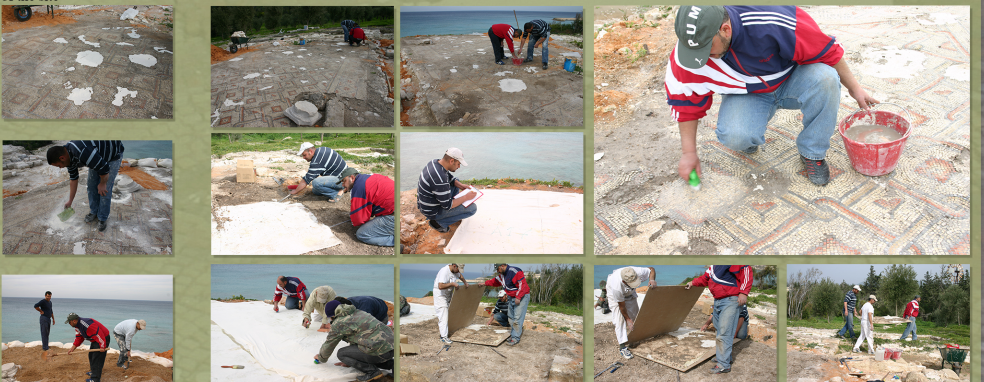
1-Documentation:

Condition assessment through a technical study to determine the mosaic layers and dimensions of cubes and colors and types of decoration and was documented through pictures and plans

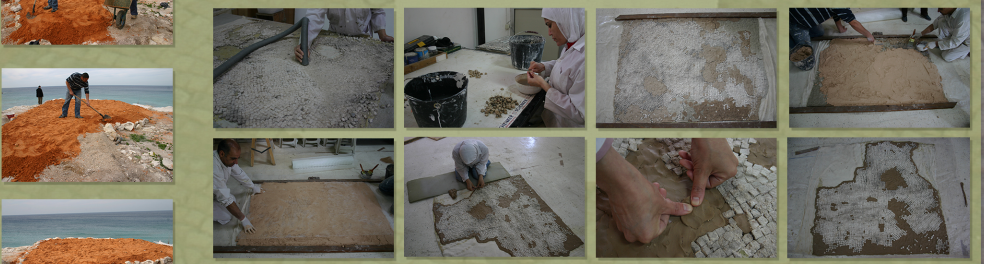
3-Lefting:

conservate the mosaic by extracting it from the original mortar and transporting it to the mosaic laboratory in the city of Damascus. and a layer of fabric had been pasted on the surface of the cubes to save them during the extracting process .
