# RESTORING THE TRENCADÍS MOSAIC ON THE INNER FACE OF THE PARK GÜELL BENCH, BARCELONA.

Anna Cusó Recasens<sup>1</sup>, Margarita Alcobé Domínguez<sup>2</sup>

<sup>1</sup>ECRA SL(Specialized in Conservation, Restoration, Archeology), Barcelona, Spain. [ecra@ecra.es](mailto:ecra@ecra.es).

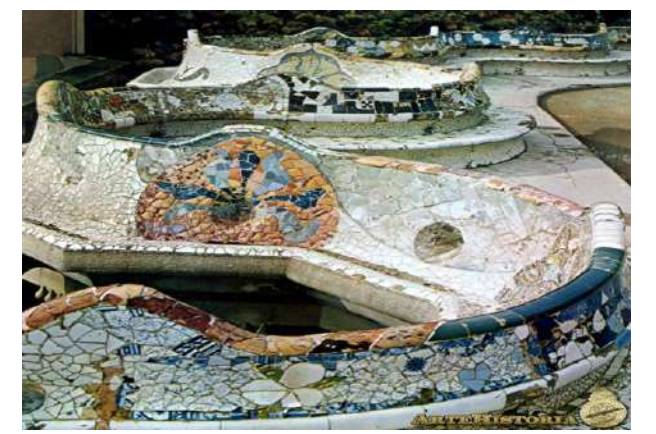
Ever since Park Güell has been open to the public, it has had an important flow of visitors, which has even been exaggerated during the past decade. The ceramic of the Trencadís has degraded due to the quality of its materials, its usage and the fact that it is outdoors. The most common damage is the loss of glazing parts and sometimes also the biscuit.

Deterioration state before replacement of pieces

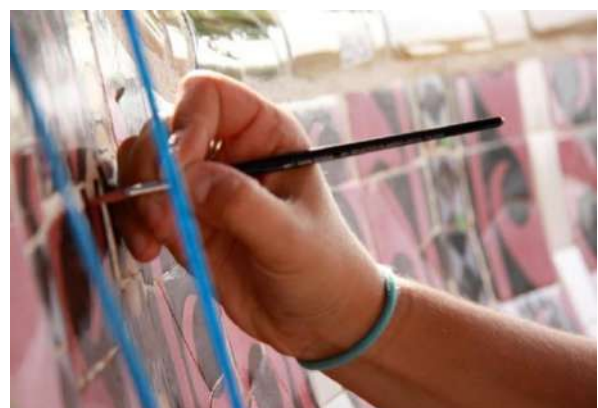
Section 20-21, detail pictorial retouch

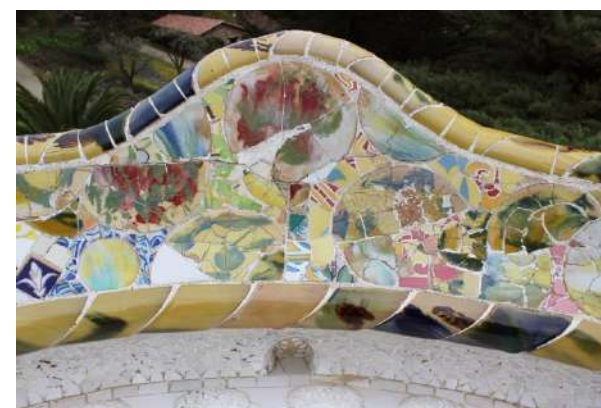
Section 17, before the restoration

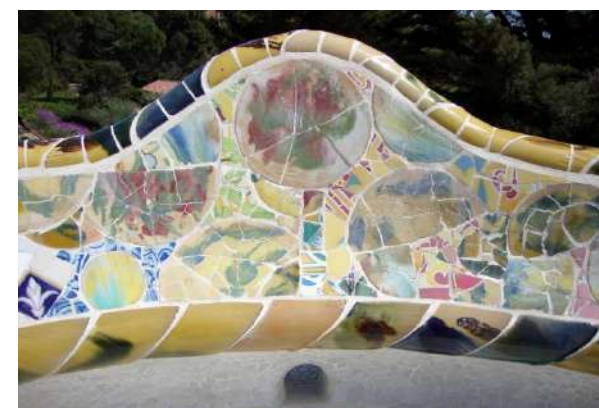
Recuperation of volume and color

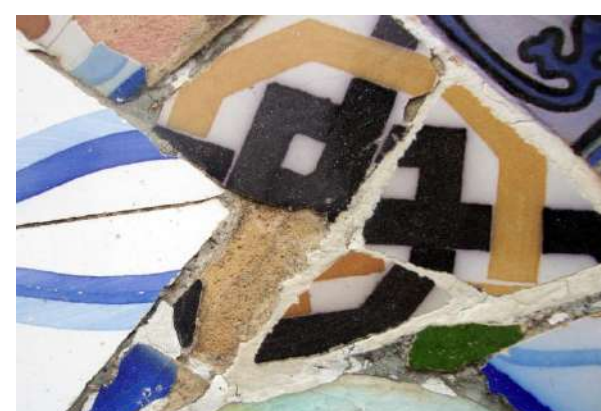
Section 58, Cleansing process of the inner moss

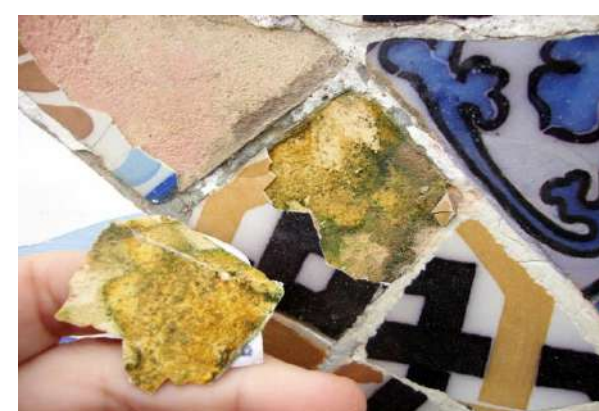
Biological affection

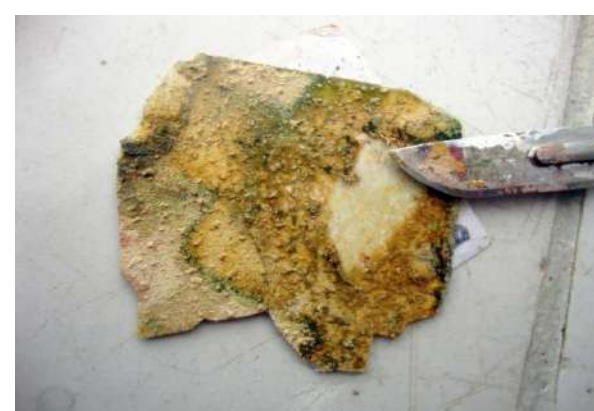
Deep cleaning

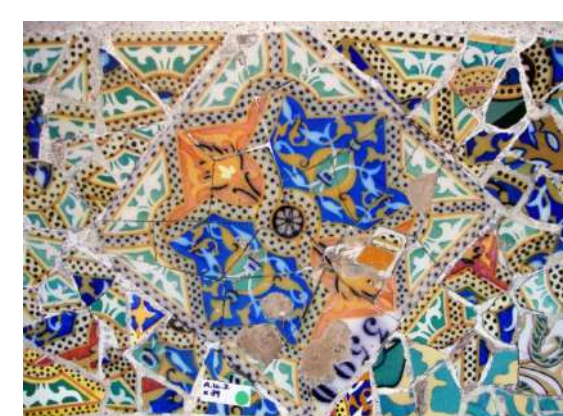
Section 35-36, deteriorated trencadís

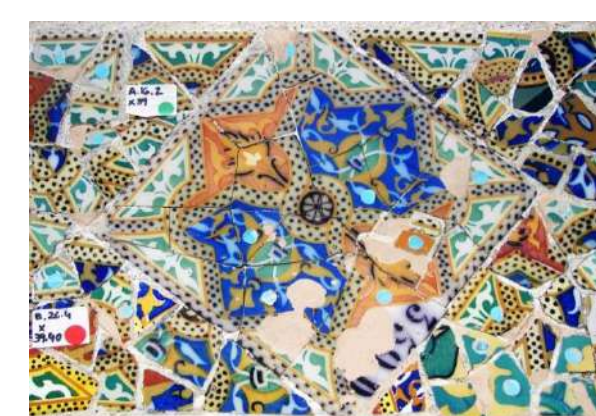
During the restoration

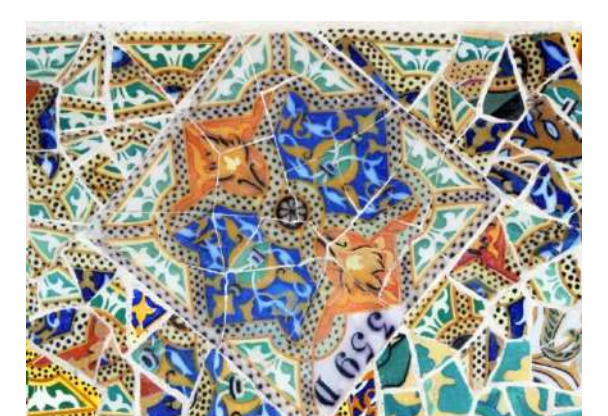
After the restoration

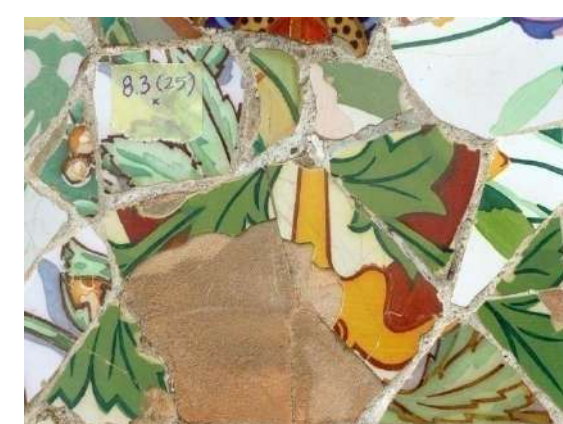
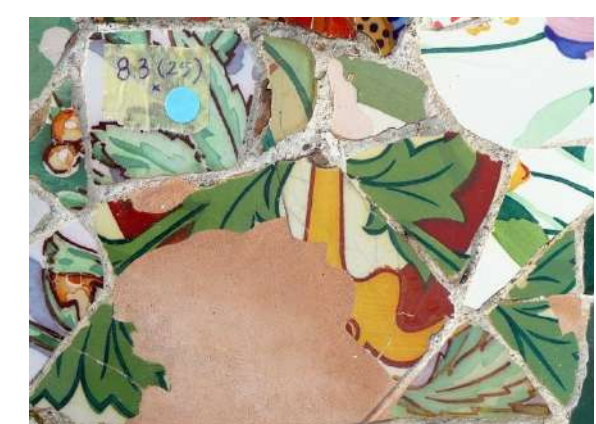
Section 50, detail recuperated according to original models

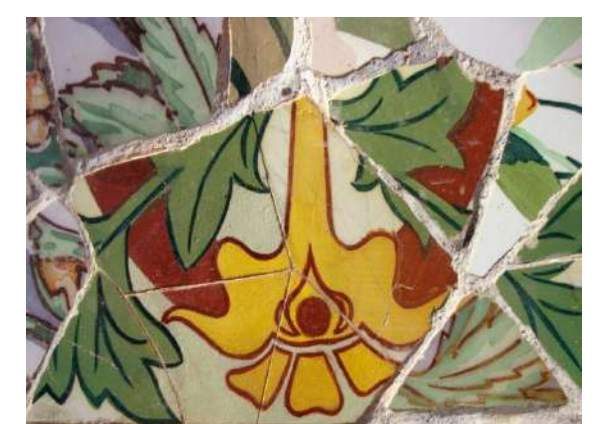
After the restoration

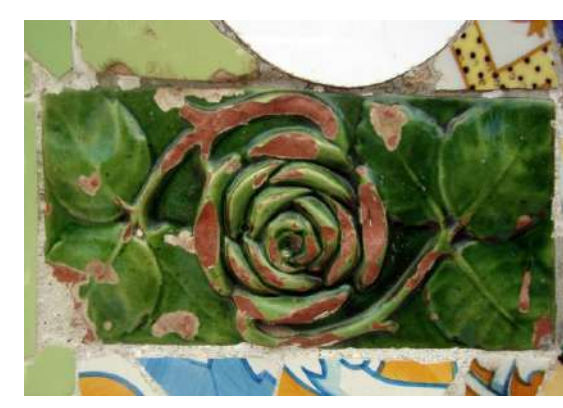
Section 53, tile with volume

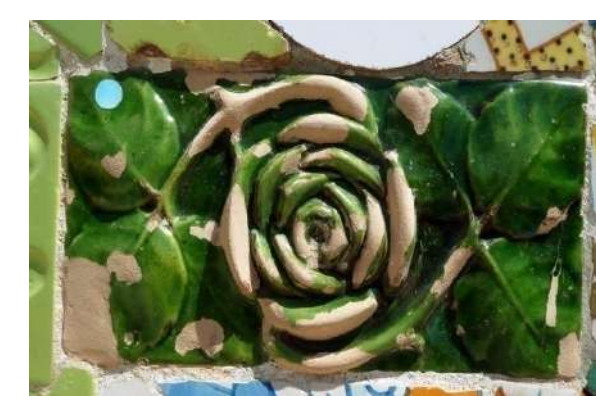
During the restoration

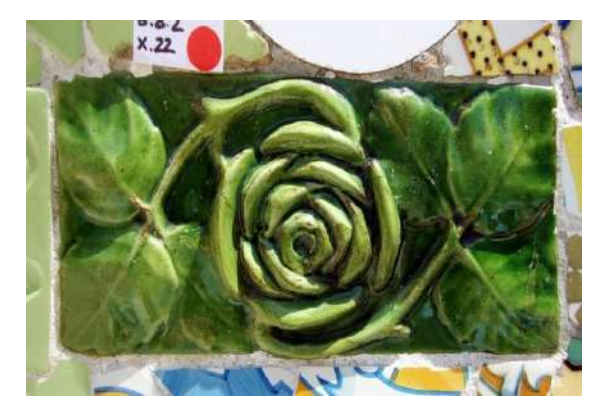
After the restoration

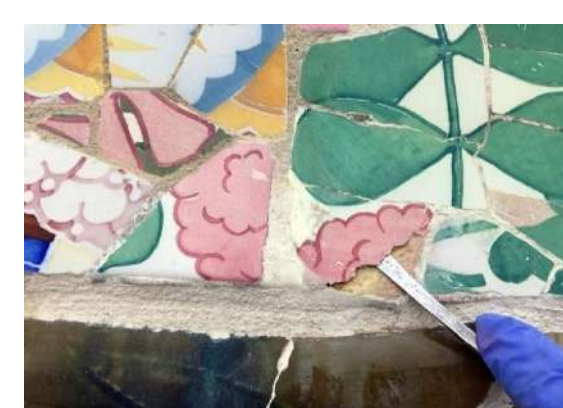
Section 44, separation of glazing elements

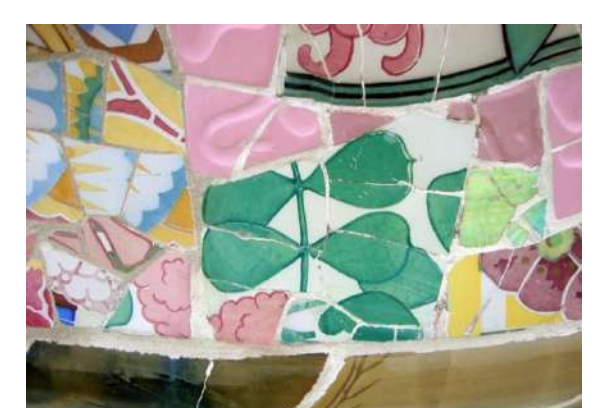
Final result

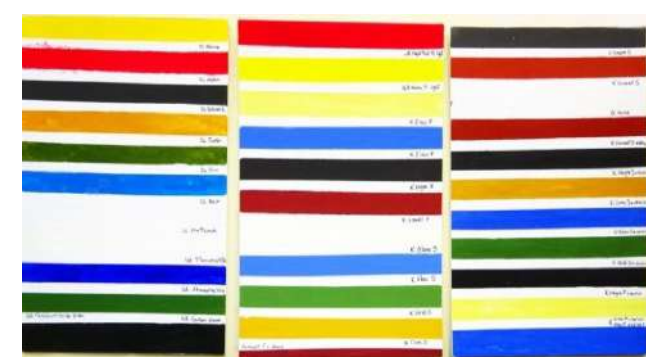
After the application of induced aging conditions on the acrylic based colours, in general white, yellow and red colours darken, changing the  $\Delta E^*$  category. Parameters  $\Delta a^*$   $\Delta b^*$  tend to green, while green, blue and black colours tend to get lighter, with a slight tendency to yellow. Blue and black colours lose resistance to  $\Delta E^*$ , substantially getting lighter. For the silicate based colours, even though some colours have varied in  $\Delta E^*$  without changing their category, the visual perception is minimum, since the chromatic layer of these paints is the most concentrated one in the pigment-binder relation, obtaining a more dense and matte visual appreciation of the colour.

Test tubes table, acrylic colours

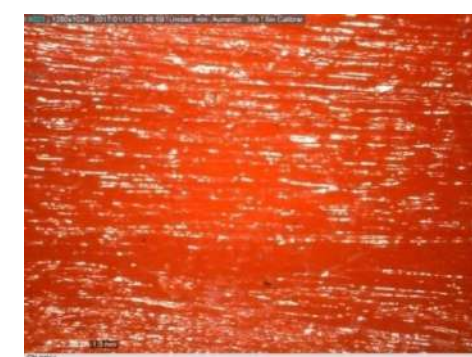
Digital microscopy for the analysis of superficial texture. Digital microscope AM413M-FVT. UV.

Microscopy. Acrylics texture

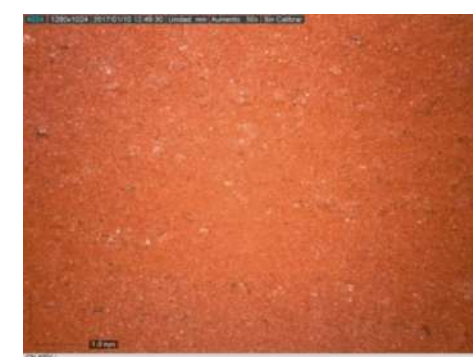
Microscopy. Silicate texture

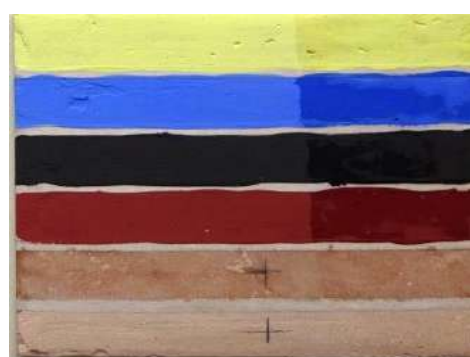
Table of silicated colours

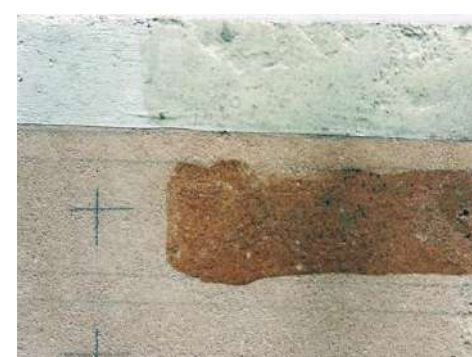
Addition of UV varnish protection

As for the varnishes, UV protection acrylic has an outdoors curing time of hours, during which it traps suspended particles that break the polymer chain of coverage. With time, it gets yellow and dirty. Other silicate superficial protections can crystallise in the surface, creating a whitish glaze or a micro scaled effect of the paint applied.

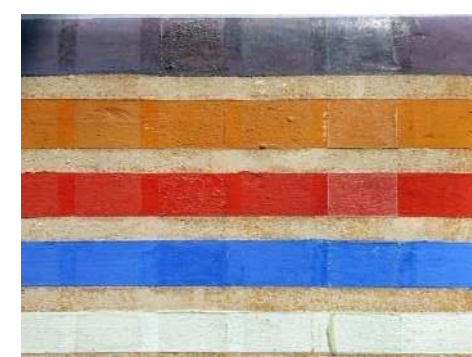
Addition of silicates protection

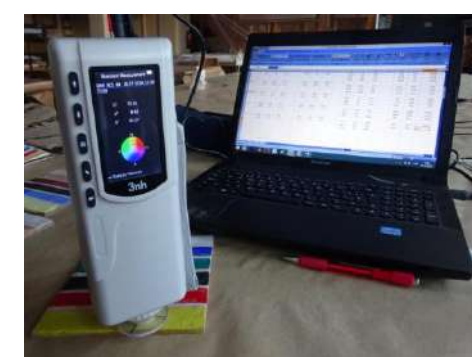
Chromatic study of the samples before and after inducing the aging processes. Colorimetre RN 110, Nh3 Quantotech. Colorimetric space CIELAB.

Measurements colorimetre

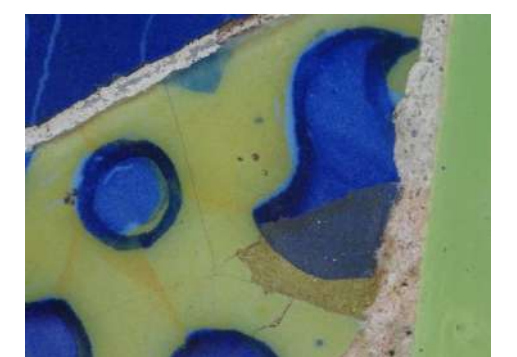
Trapped dirt on surface
