MANAGING ARCHAEOLOGICAL SITES WITH MOSAICS: FROM REAL PROBLEMS TO PRACTICAL SOLUTIONS

THE 11TH CONFERENCE OF THE INTERNATIONAL COMMITTEE
FOR THE CONSERVATION OF MOSAICS, MEKNES, OCTOBER 24-27 2011

edited by
Demetrios Michaelides and Anne-Marie Guimier-Sorbets

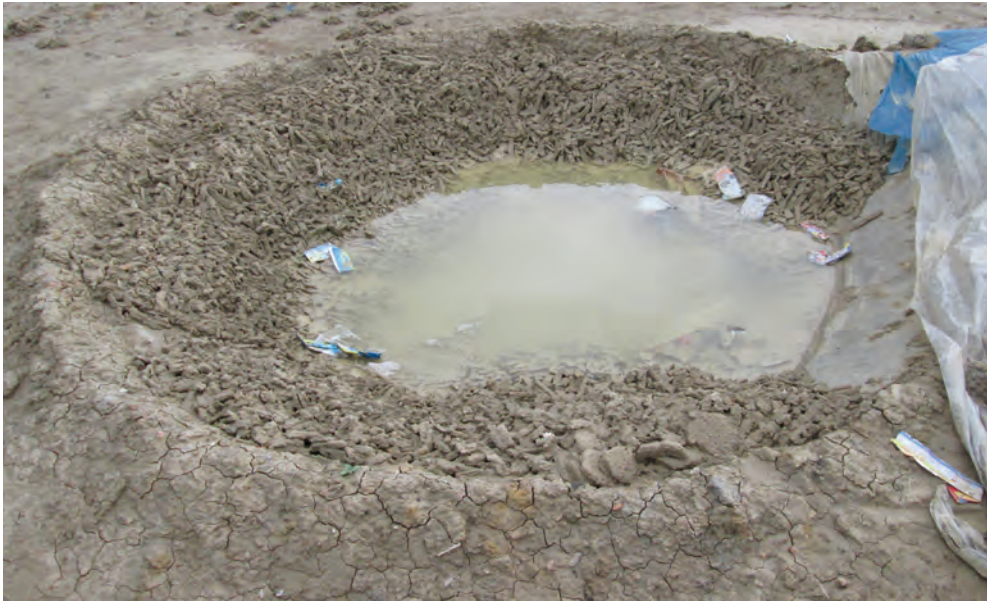
Fig. 3. Fosse (*zūba*) destinée au trempage de l'argile servant à la fabrication de la brique, du zellij et de la poterie : Nouveau quartier d'al-Fakhārīn à Meknès. (al-Rmīka) (cliché : A. El Khammar)

La préparation des pièces de zellij comporte plusieurs opérations. Tout d'abord, les ouvriers brisent les gros blocs d'argile et les découpent en petits morceaux qui sont jetés dans des fosses (*zūba-s*), dont les bords sont incurvés et non maçonnés (Fig. 3). Après quoi, on verse l'eau dans la fosse jusqu'à ce que celle-ci soit pleine, et on laisse l'argile se déliter et se désagréger durant un ou deux jours. Ce délai passé, un ouvrier descend dans la fosse et procède au malaxage de la pâte afin qu'il puisse la débarrasser des impuretés, telles que les galets ronds, les cailloux et les particules dures. Si le

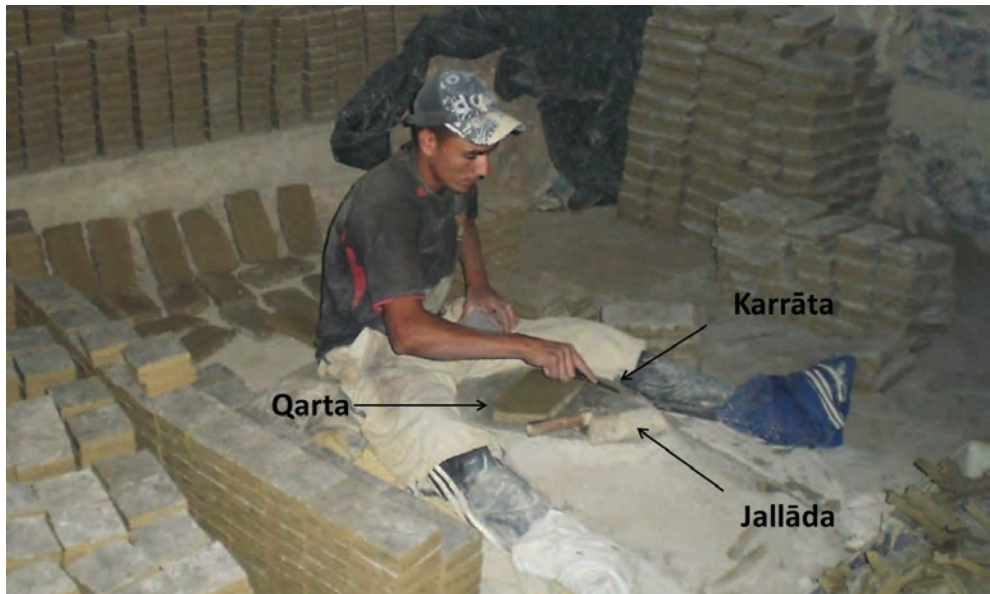
Fig. 4. Un jeune apprenti fabrique des pièces rectangulaires de zellij (*bajmāt*) : Il se sert de la *qarta*, de la *jallāda*, du *qāla* et de la *karrāta* (nouveau quartier d'al-Fakhārīn à Meknès : al-Rmīka) (cliché : Archives)

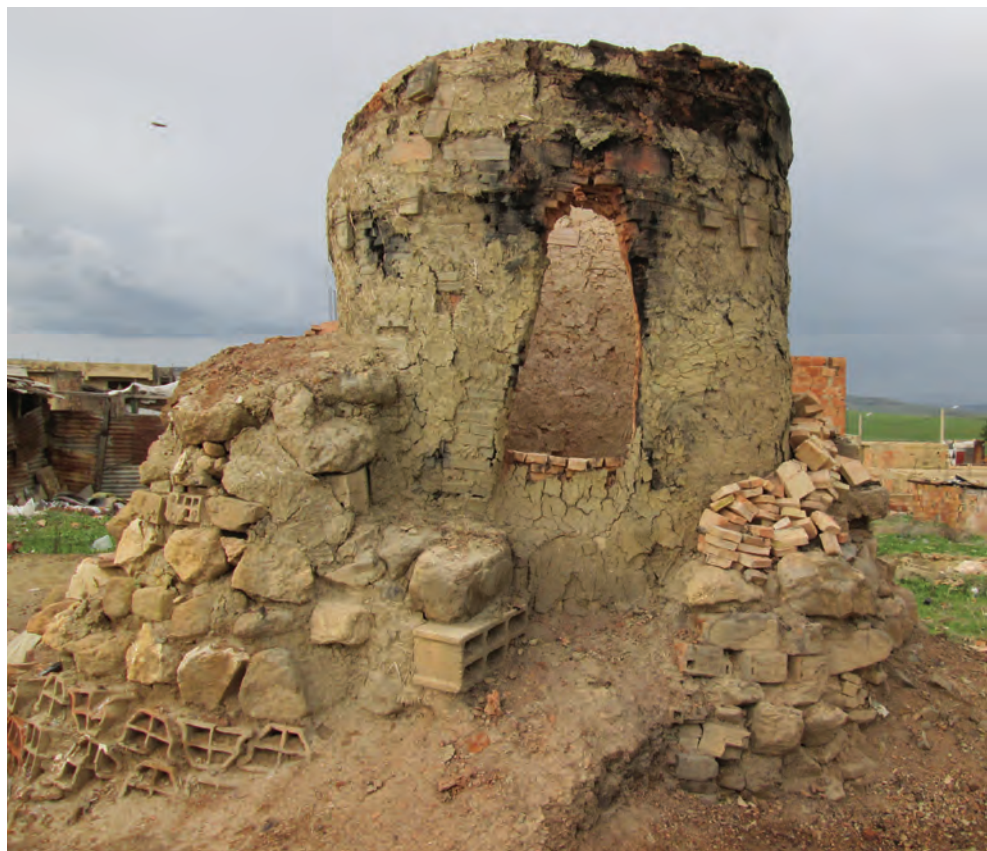
Fig. 5. Vue générale d'un four de zellij : Nouveau quartier d'al-Fakhārīn à Meknès (al-Rmīka) (cliché : A. El Khammar)

Les fours du quartier al-Fakhārīn (Fig. 5) sont tous bâtis en briques, liées avec un mortier de terre. L'enduit est constitué de l'argile rugueuse et une bonne quantité de paille. Ils se composent de deux parties superposées. La partie inférieure est une chambre à feu, destinée à recevoir le combustible : elle est la source de l'allumage du four (Fig. 6). Elle est enfoncée dans le sol, à une profondeur qui dépasse un mètre, et s'ouvre par une petite baie arquée qui est fermée au moment de la cuisson des briques. Cette chambre est pourvue d'une voûte très épaisse, permettant de supporter les centaines de briques posées au-dessus. La présence d'une voûte, comme l'a bien noté Armand Desbat (Desbat 1995, 17), n'est pas une nécessité pour obtenir des fours permettant des cuissons à température élevée. La voûte joue un rôle plus important pour le refroidissement de la fournée, en conservant la chaleur et évitant le choc thermique d'un refroidissement trop rapide, que pour l'obtention des températures de cuisson élevées. La partie supérieure (*frīna*) est de section circulaire et reçoit les plaques de zellij à cuire (Fig. 7). Sa partie inférieure est munie d'une sole (*ghurbāl*) de section circulaire (Fig. 8) qui repose sur la voûte de la chambre à feu et est creusée d'un ensemble de trous de sections et tailles variables qui permettent la communication entre la chambre à feu et la partie supérieure du four, ainsi que la circulation de la chaleur dans la partie supérieure du four. Le creusement en profondeur de la chambre à feu, et l'allongement de la partie supérieure du four contribuent puissamment aux performances thermiques et à l'obtention de températures de cuisson très élevées.

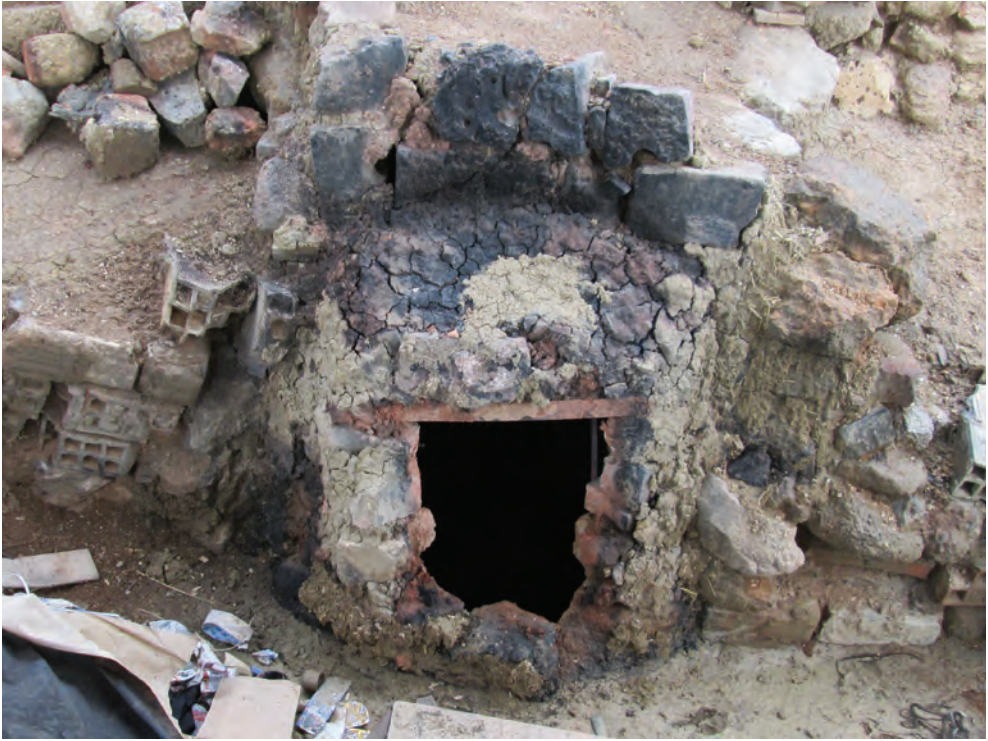
Fig. 6. Vue de la partie inférieure d'un four de zellij (*sjan*) : Nouveau quartier d'al-Fakhārīn à Meknès (al-Rmīka) (cliché : A. El Khammar)

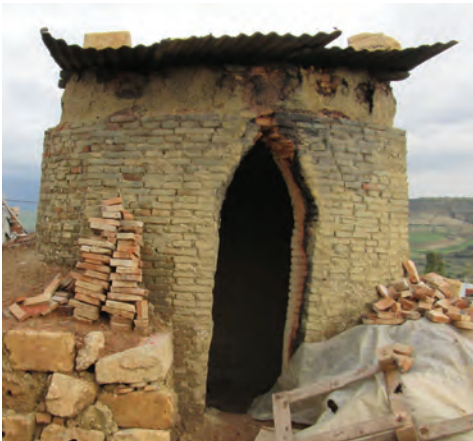
Fig. 7. Vue de la partie supérieure d'un four de zellij : Nouveau quartier d'al-Fakhārīn à Meknès (al-Rmīka) (cliché : A. El Khammar)

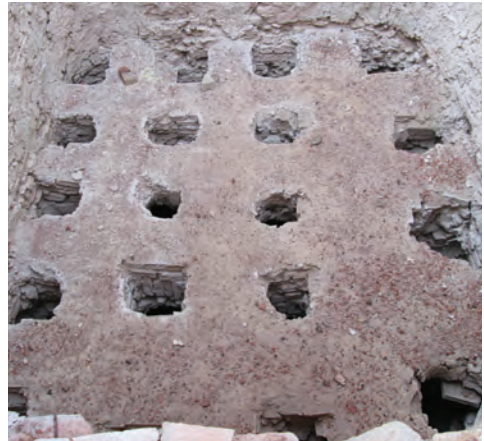
Fig. 8. Vue de la sole (*ghurbal*) d'un four de zellij : Nouveau quartier d'al-Fakhārīn à Meknès (al-Rmīka) (cliché : A. El Khammar)

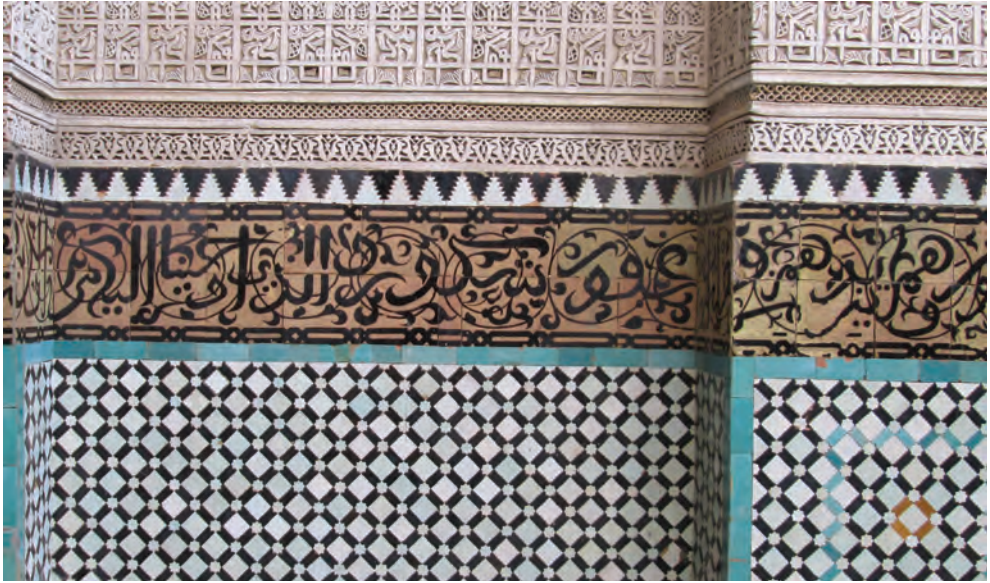
Fig. 11. Inscription coranique champléevée dans une plaque de zellij à tonalité noire ; elle est inscrite dans un encadrement rectangulaire à base d'un entrelacs d'étoiles polygonales : façade sud de la cour de la madrasa al-Bū'nāniya à Meknès (cliché : A. El Khammar)

des marches d'escalier et des terrasses. Son emploi est également attesté dans le revêtement des lambris des murs, des piliers, des quatre façades des minarets (Fig. 9 et 10), et des piédroits des portes d'entrée. Les panneaux de zellij servent également de support pour l'excision des inscriptions historiques ; celles-ci sont découpées selon la technique du zellij excisé ou champlevé qui consiste à écorcher au burin des carreaux monochromes (Fig. 11 et 12).

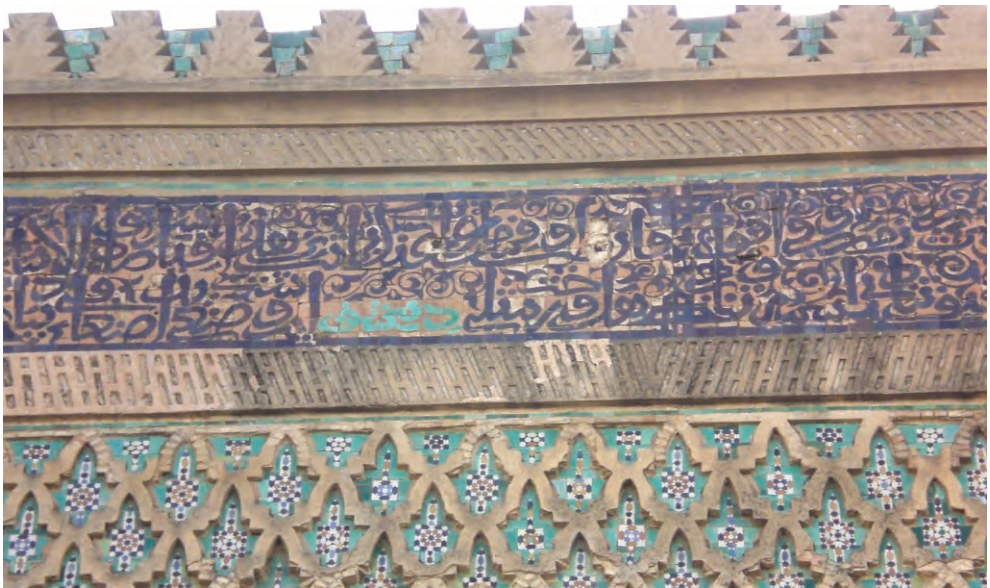
Fig. 12. Inscription historique excisée dans une plaque de zellij de couleur noire : Partie supérieure de la porte de Bāb Mansūr la'laĵ à Meknès (cliché : A. El Khammar)

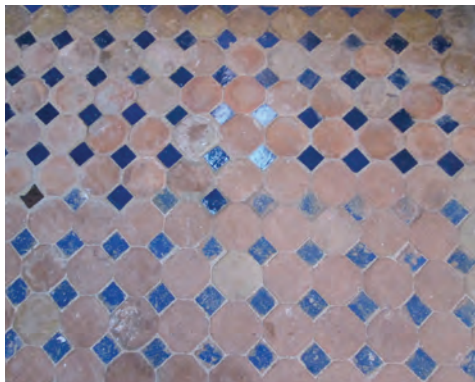
Fig. 15. Ouvrage transparent (*Shghal bān*) : Pièces octogonales (*Kūra*) bordées aux quatre côtés par des carrés étoilés (pavage du vestibule d'entrée de Fondouk al-Hanna à Meknès) (cliché : A. El Khammar)

- Composition en *Shghal bān* (ouvrage transparent) : elle est constituée par la répétition d'un décor de pièces octogonales dont les quatre côtés sont occupés par de petits carrés étoilés (Fig. 15).

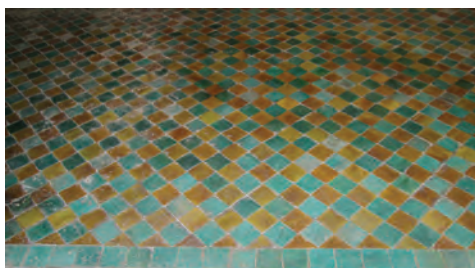
Fig. 16. Schéma en petits carrés étoilés (5,5x5,5 cm) : Pavage de la salle de prière de la madrasa al-Bū'nāniya à Meknès (cliché : A. El Khammar)

- Schéma en carrés étoilés polychromes (*mjaddaj 'alā harfū*).
- Schéma en petits carrés étoilés : il est fait de pièces carrées (5.5x5.5 cm), disposées sur leurs bordures (Fig. 16).
- Combinaison géométrique en *mdaw-dab balqtib maqsum baldrihm* : elle est faite de carrés (10x10 cm) disposés sur la pointe, bordés par de petits carrés (5.5x5.5 cm), disposés également en pointe (Fig. 17).

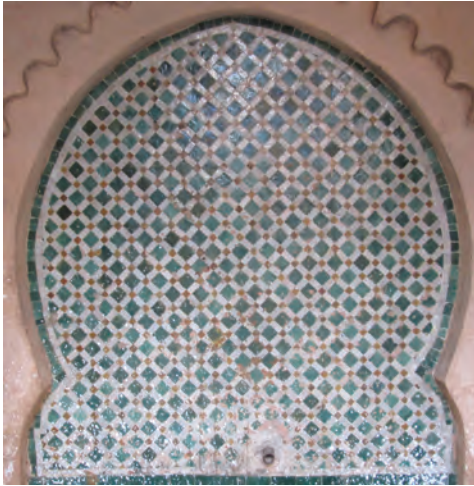
Fig. 17. Schéma en carrés étoilés (10x10 cm) bordés sur les quatre côtés par des petits carrés étoilés (5,5x5,5 cm) (*mdawdab balqtib maqsūm baldrihm*) : fontaine murale (saqqāya) de Sīdī Qaddūr al-‘Alamī à Meknès (cliché : A. El Khammar)

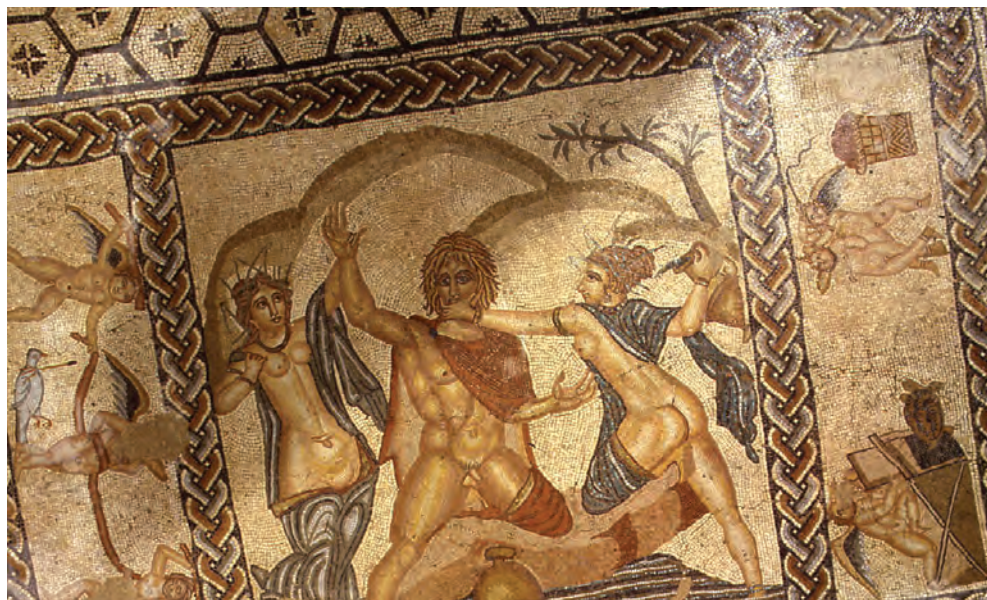
Fig. 6. Rapt d'Hylas, Maison de Vénus, Volubilis (cliché : Centre Henri Stern)

C'est une mosaïque en tapis juxtaposés en rallonge. Hylas y figure au centre, assailli par deux nymphes qui le tiennent par le bras et le menton. La scène est empreinte de violence transparaissant dans la position des bras et des jambes des personnages et l'hydrie lâchée dans l'eau par Hylas. Le paysage stylisé est évoqué par des arcs qui représentent les collines et un arbre à feuilles qui représente la végétation. La relation

nymphes/eau est soulignée par les plantes aquatiques qui ornent leurs cheveux. La nymphe de droite tient un vase d'où coule un filet d'eau qui évoque l'eau de source.

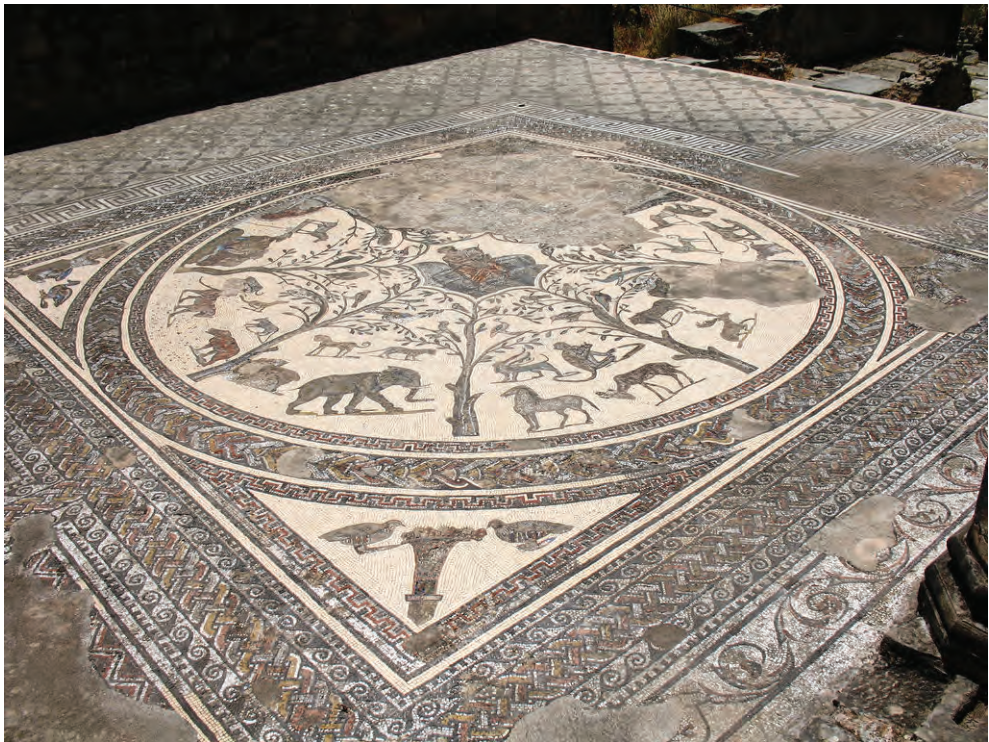
Fig. 7. Orphée, maison homonyme, Volubilis (cliché : www.google.com.cy/search?q=orpee+volubilis&source=lnms&tbm=isch&sa=X&ved=0ahUKEwiYqZ6m_5TTAhUB1xQKHb-47Cf4Q_AUIBigB&biw=1286&bih=718&dpr=1.25#imgrc=WdL-13ZPn6BP6M :)

Elle est traitée selon un schéma circulaire concentrique qui la place parmi les pavements du type III (Qninba 1998, 196-197) qui regroupe les pavements de Grande Bretagne et de Salone (Split) en Yougoslavie. L'éloignement géographique et chronologique des pavements de ce groupe ne permet pas de préciser l'influence des uns sur les autres. C'est pourquoi

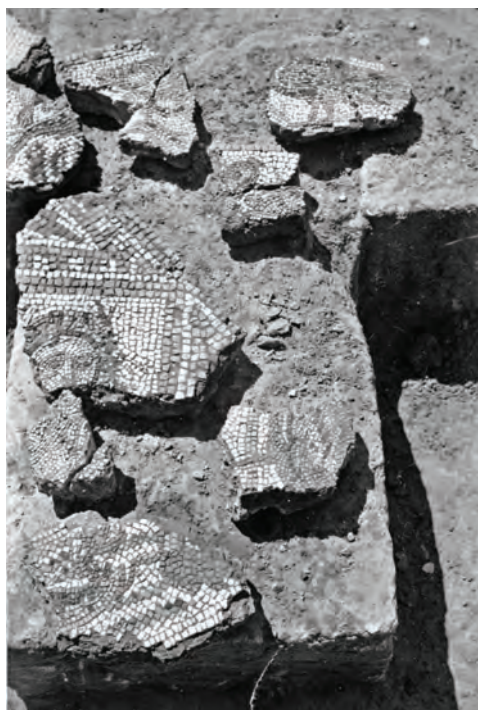
Fig. 3. Fragments d'une mosaïque figurée découverte à Chellah en 1968 (copyright : Centre Camille Julian, MMSH, Aix en Provence, France)

fragments d'une mosaïque figurée polychrome, actuellement mis en dépôt, furent collectés en 1963. On y distingue une partie de la tête d'une néréide, le front parée d'un diadème, la partie inférieure d'un volatile et des éléments de bordures tels les lignes de triangle et les tresses à deux brins (Fig. 3). Nous ne possédons aucune indication sur l'emplacement originel de ces fragments à l'exception d'une mention de N. Khatib-Boujibar (1964, 367) qui a signalé leur découverte par J. Boubé dans l'une des douze boutiques au nord du Capitole, sans toutefois préciser dans quel contexte archéologique ces fragments ont été retrouvés.

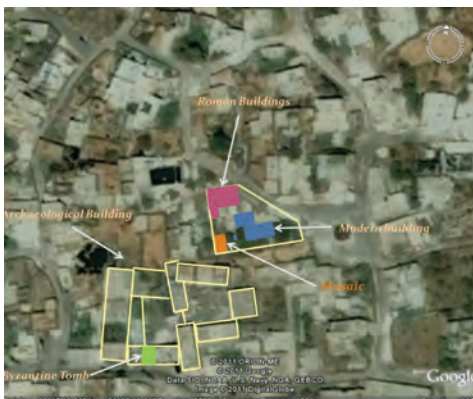
Fig. 1. Location and plan of the house (Google; Plan: Nesreen Bouza)

This property is composed of a Roman basalt house containing two inhabited arched and roofed rooms and a long stable behind them. It is close to an archaeological complex, which consists of Roman and Byzantine buildings (Fig. 1). The mosaic room which measures 4×4 m is located at the west limit of the property and to the southwest of the two ancient rooms. It is a modern structure of basalt stones and cement blocks built on ancient foundations and roofed with sheets of corrugated iron, and was, until recently and before the mosaic was discovered, used as a barn (Fig. 2).

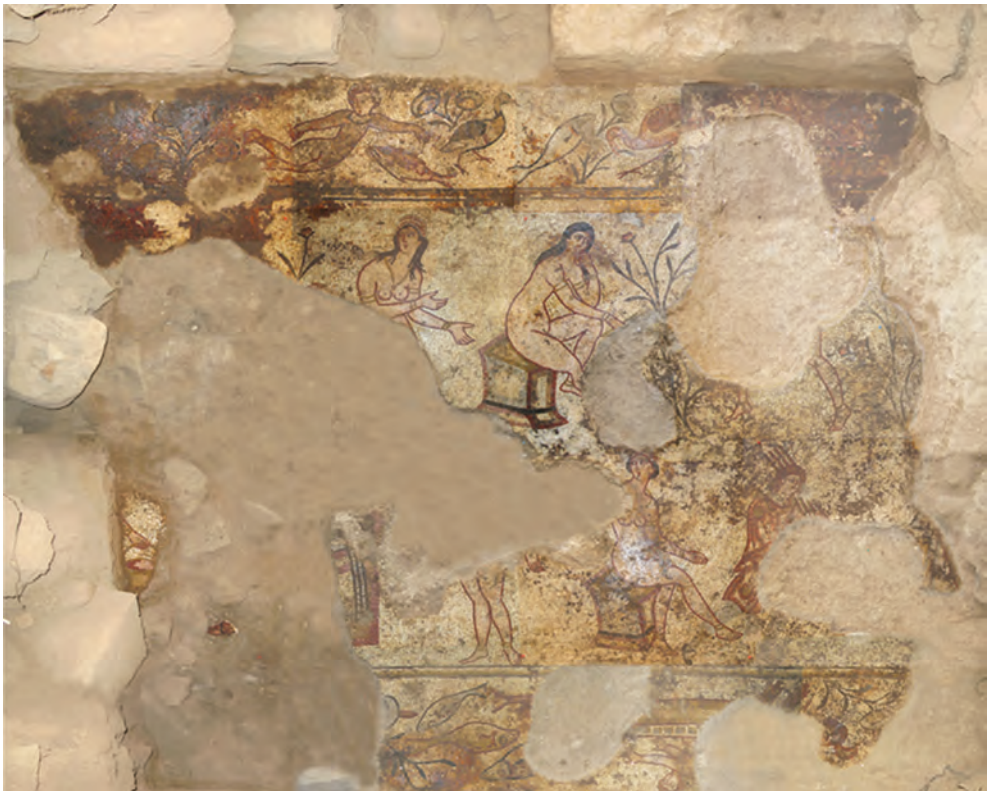
Fig. 4. The mosaic (Photo: the team)

the present dimensions of the mosaic are 3.75×3.30 m (Fig. 4).

About 50% of the mosaic survives and the major scene represents naked women. The mosaicist has arranged the persons in two parallel rows where we can see in the centre of the upper row a naked woman with black hair hanging down onto her shoulders. She is seated on a stool, her left hand supporting her left cheek, while her right hand hangs over her left knee. She is wearing an armlet and a bracelet on each hand, and an anklet on her left leg, all khaki-coloured and made of two rings. Her right foot has been destroyed. There are another two women on this register,

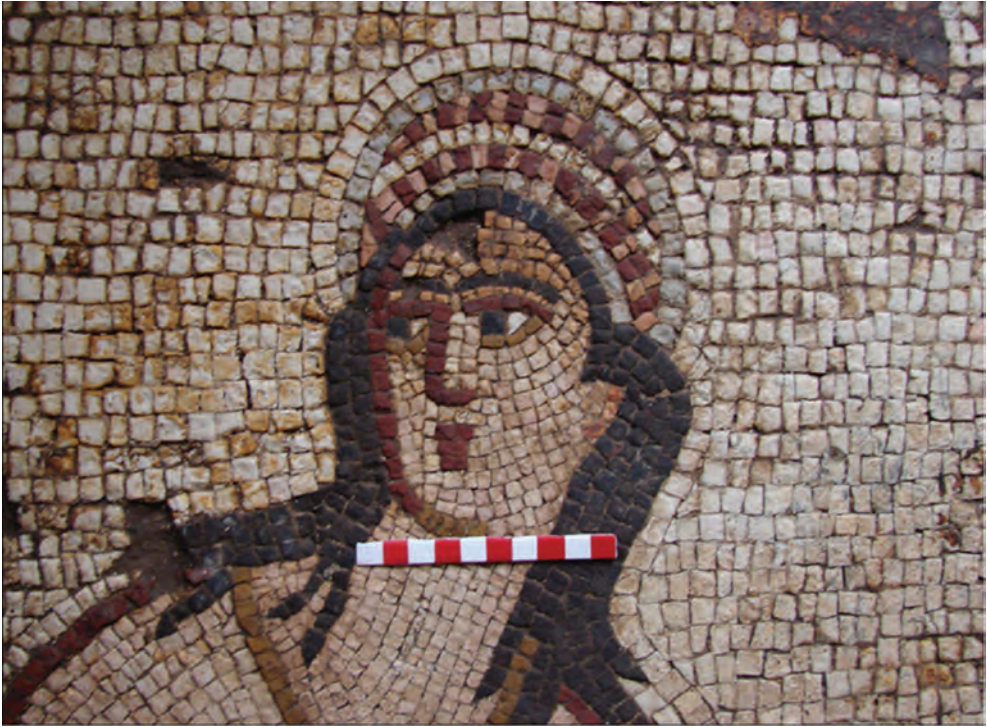
Fig. 6. Typology, size, materials and colours of tesserae (Photo: the team)

The pavement is made of *opus tessellatum* and the tesserae that have been used are of limestone, marble and red brick. They measure from 5 to 10 mm and are of various colours: white, black, yellow, red, rose, khaki, grey and coral (Fig. 6).

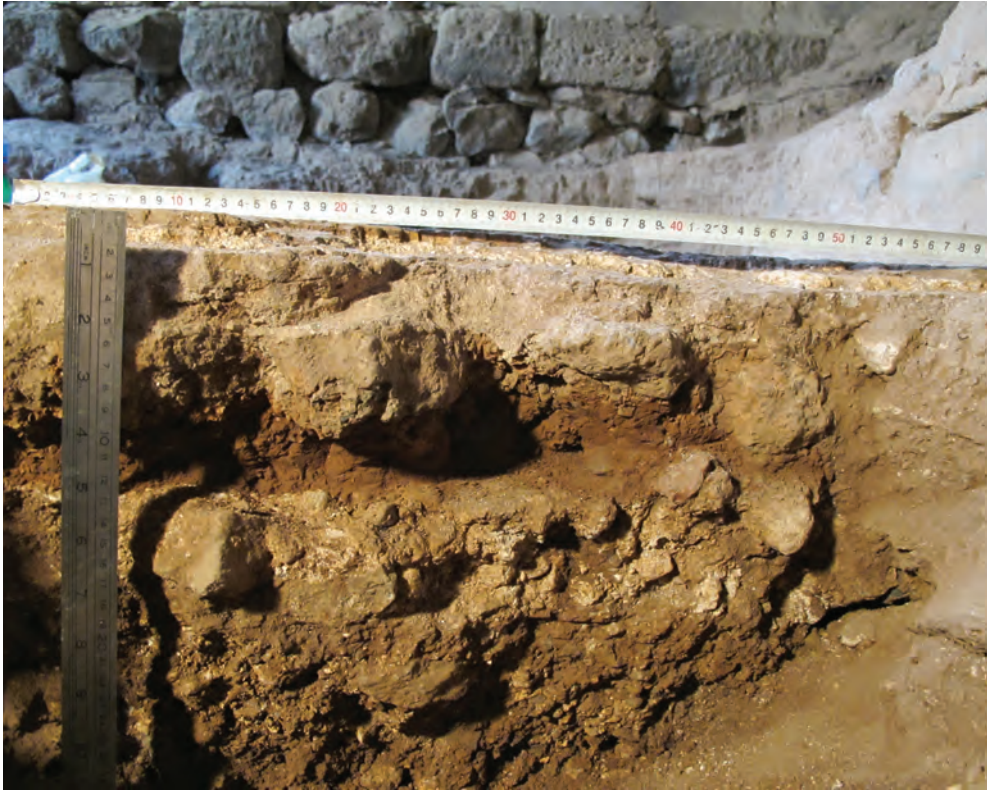
Fig. 7. Stratigraphy of the mosaic (Photo: the team)

We bore a hole in one of the big lacunae of the mosaic in order to check its stratigraphy and discovered that this consists of *statumen*, *nucleus*, bedding layer and the *tessellatum* (Fig. 7).

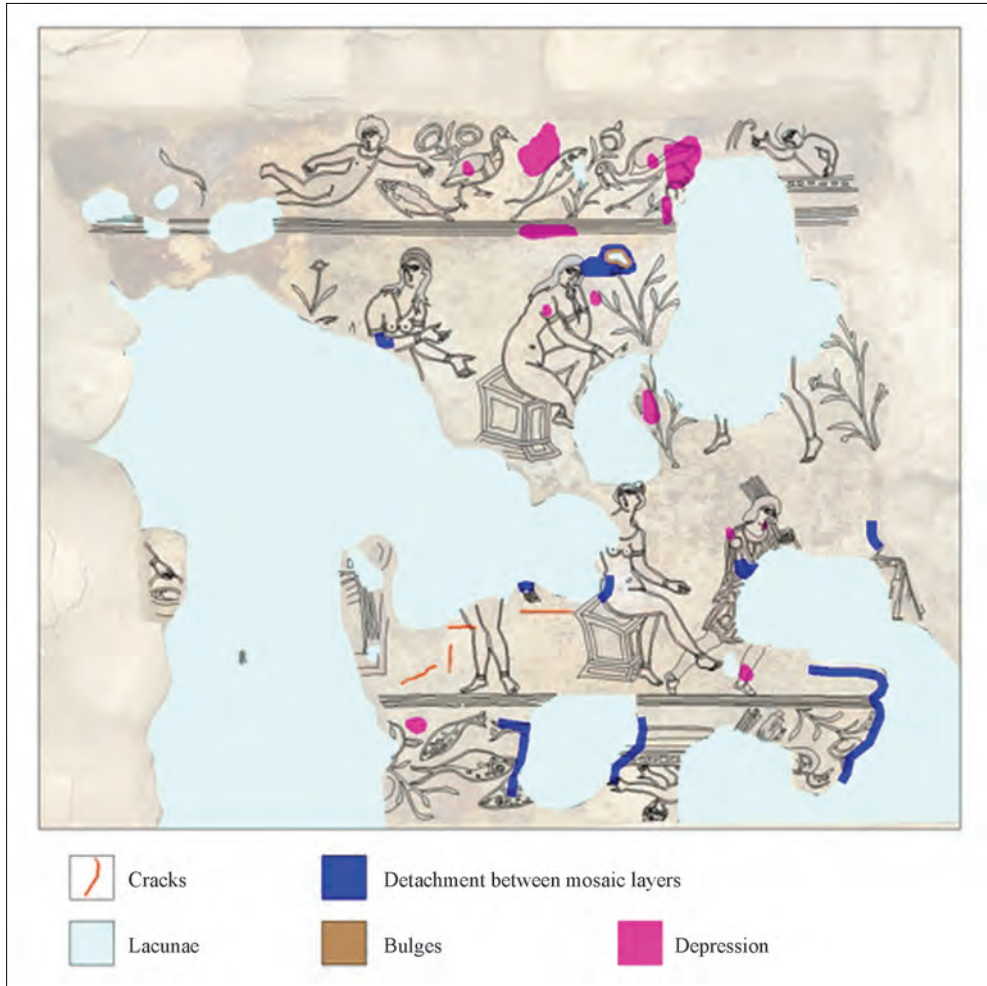
Fig. 10. Documentation work (Drawing: the team)

Some of the tesserae exhibited erosion and exfoliation and a few others have been lost (Fig. 10 and 11). There were also detached tesserae near the edges and, in a few areas, deteriorated mortar between the tesserae. Moreover, the surface has stains caused by the oxidized water mentioned above. But the main problems of the surface were the numerous damaged tesserae and the stains, which, with time, had often turned into incrustations, especially in the north-western and the north-eastern areas of the mosaic.

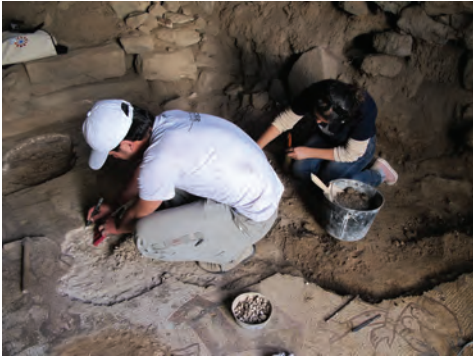
Fig. 12. Preparing the edges of the mosaic (Photo: the team)

We started by cleaning and preparing the mosaic edges in order to repair them using mortar (Fig. 12). Then, we prepared mortar that was composed of 1 part hydraulic lime, 1 part powdered limestone, $\frac{1}{2}$ part yellow sand (grain size less than 4 mm), $\frac{1}{4}$ part volcanic sand (pozzolana) (grain size less than 6 mm) and $\frac{1}{4}$ part red sand (grain size less than 4 mm). For this mixture we took into consideration many factors, such as hardness, coherence, porosity, colour harmony and reversibility. Regarding our choice to use yellow, red and black (volcanic) sand, this was done in order to achieve harmony between the mortar and tesserae colours. The use of volcanic sand which is rich in minerals has given the mortar a good porosity and more rigidity. After that, we protected all edges of the mosaic, we filled the small lacunae and reset the detached tesserae using the same mortar (Fig. 13). We have found one detached piece of mosaic (the left open palm of the standing woman in the lower row of the panel), so we reset it using mortar composed of 1 part hydraulic lime, 1 part limestone powder and 1 part marble powder. Then, we cut the vine roots and covered them with petrol to prevent growth. Finally, we reburied the mosaic (Fig. 14) with a first layer of 20 cm of sieved sand free of salt. We then put a net as a separation layer and 25 cm of soil on top (we preferred to make the layers of reburial deeper in order to protect the mosaic in case of collapse of the walls) (Fig. 15).

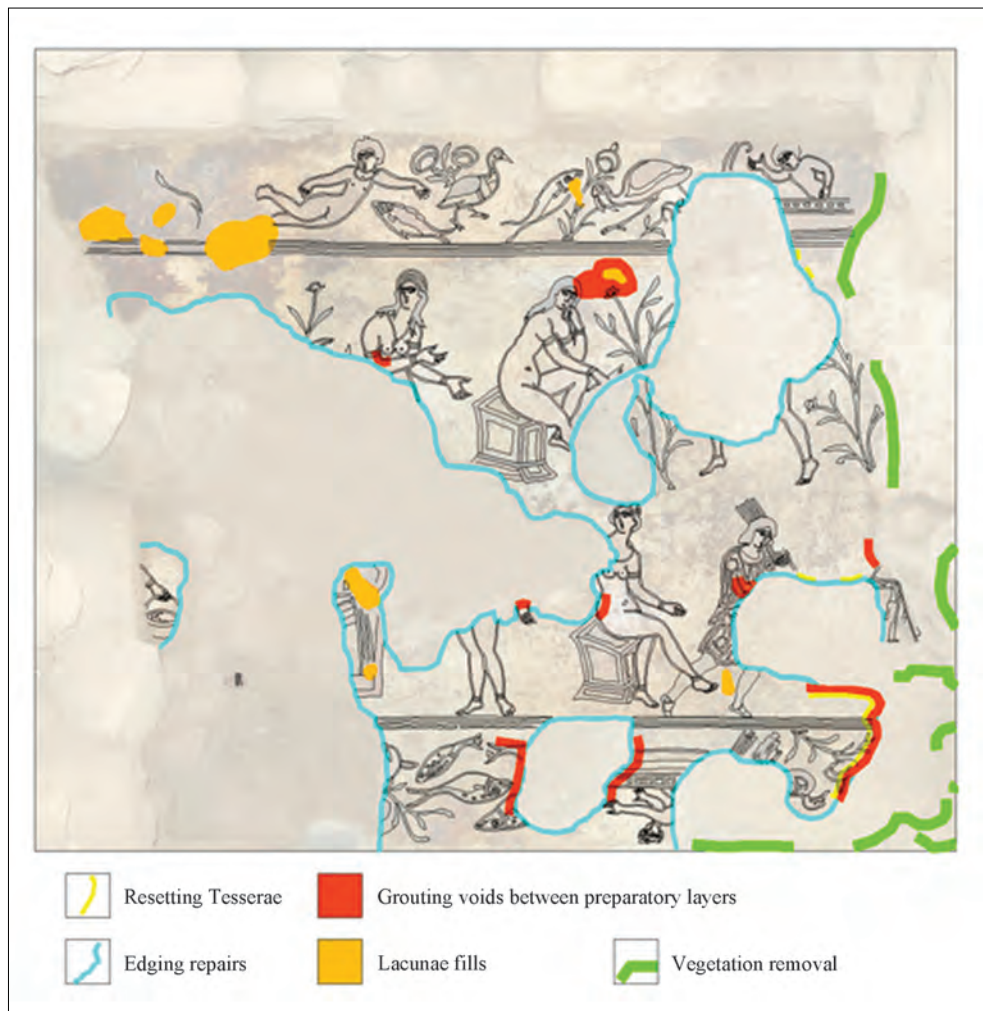
Fig. 13. Condition assessment-surface and biological deterioration (Drawing: the team)

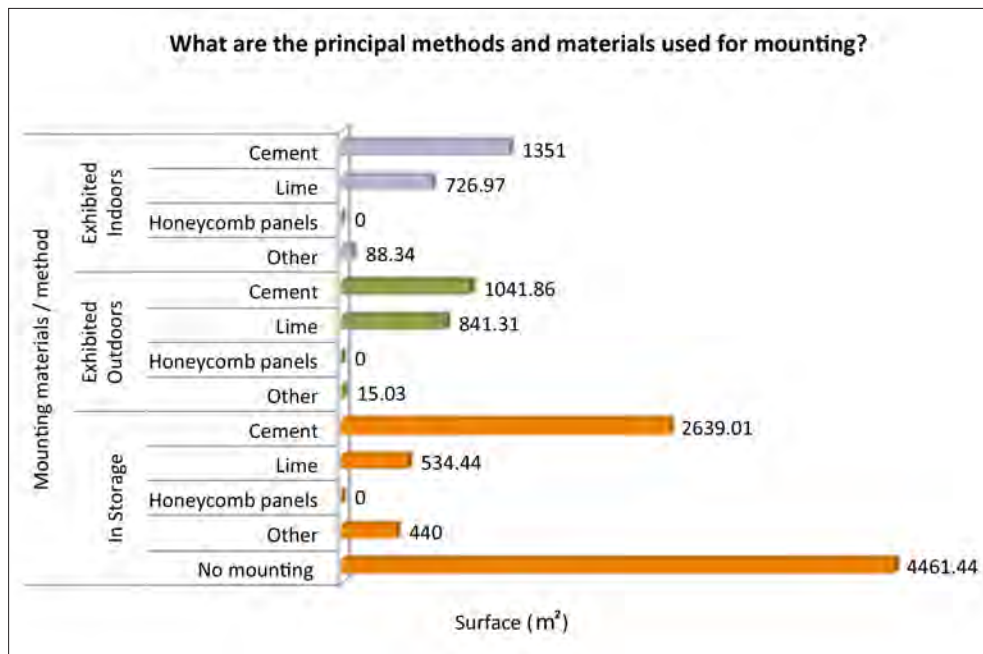
Fig. 6. The main materials used for mounting mosaics are lime and white cement in various mixtures and reinforced with aluminum and stainless steel frames. Honeycomb panels have not been used at all and the mosaics in storage are not mounted

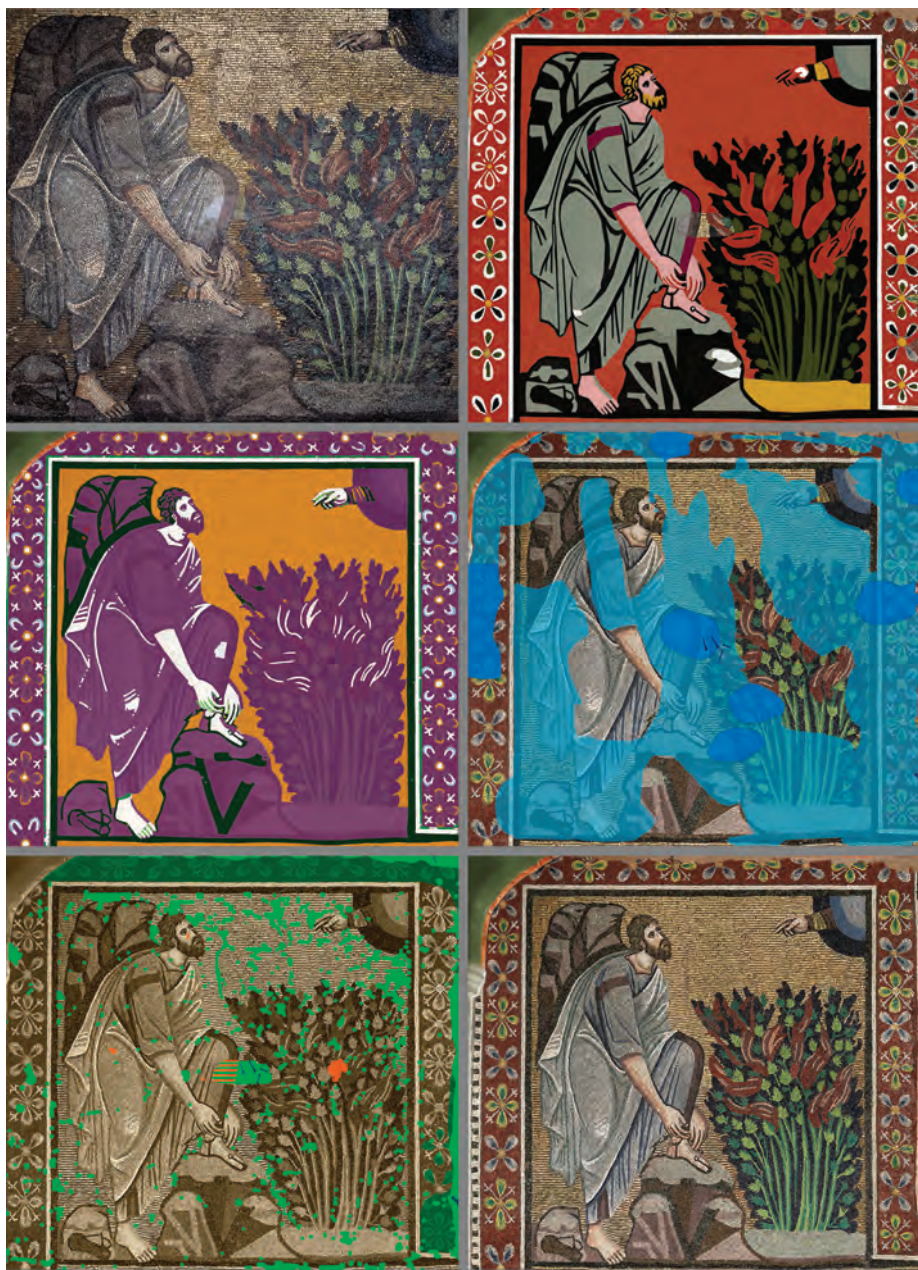
Fig. 6. Monastery of Saint Catherine, Sinai. Mosaic of the Transfiguration. Moses removing his sandal in front of God by the Burning Bush. An example of 6 plates reporting the state of conservation of the mosaic and the treatment implemented. From top left: detachments; colours detected under the tesserae; materials composing the tesserae; deep consolidation; 1847 restoration; 2005-2016 restoration

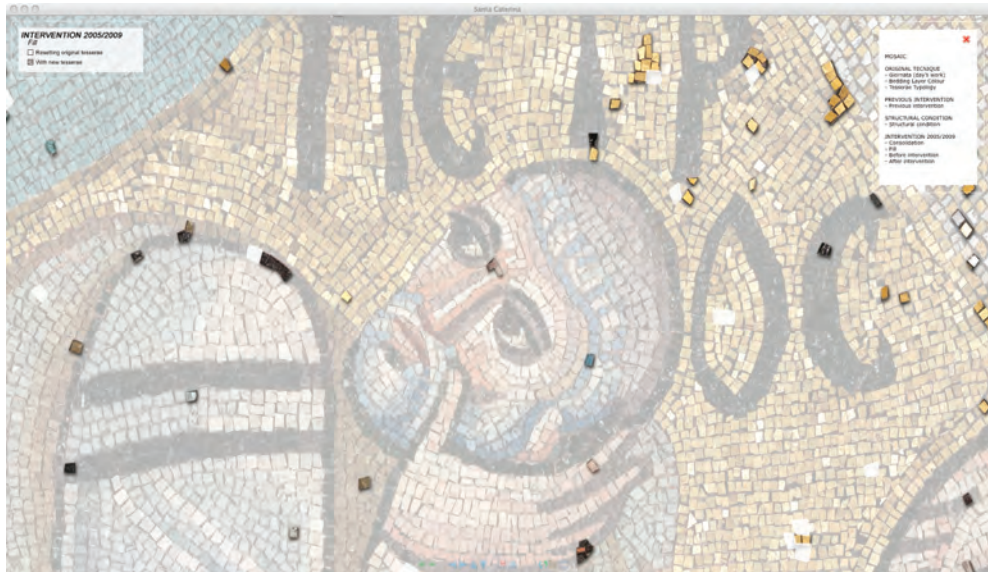
Fig. 8. Monastery of Saint Catherine, Sinai. Mosaic of the Transfiguration. Example of screen shot referred to the lacunae filled with tesserae during the treatment of 2005-2009. Documentation is accessible at 1:1 scale

showing the true appearance of the mosaic. The software was designed for input of the collected data, in graphic form using semi-transparent colours, thus permitting reading of the mosaic by a vast public, beyond those present on site.

<p>TREATMENT 2005/2009 Consolidation The treatment performed by the CCA aims to highlight areas to be monitored during future maintenance.</p>			<p>TREATMENT 2005/2009 Fill All the lacunae (gaps) filled with new tesserae were documented so they can always be distinguished from the old.</p>
<p>TREATMENT 2005/2009 Photos 2005 You can see some photos of before the 2005-2009 conservation-restoration treatment. Photos Araldo De Luca.</p>			<p>TREATMENT 2005/2009 Photos 2009 You can see some photos of after the 2005-2009 conservation-restoration treatment. Photos Araldo de Luca.</p>

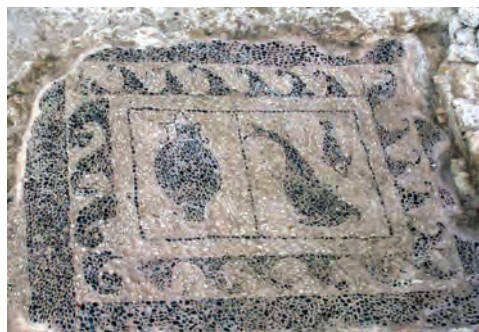
Fig. 2. Kourion, pebble mosaic under the “House of Eustolios” (photo: E. Charalambous/ Department of Antiquities of Cyprus)

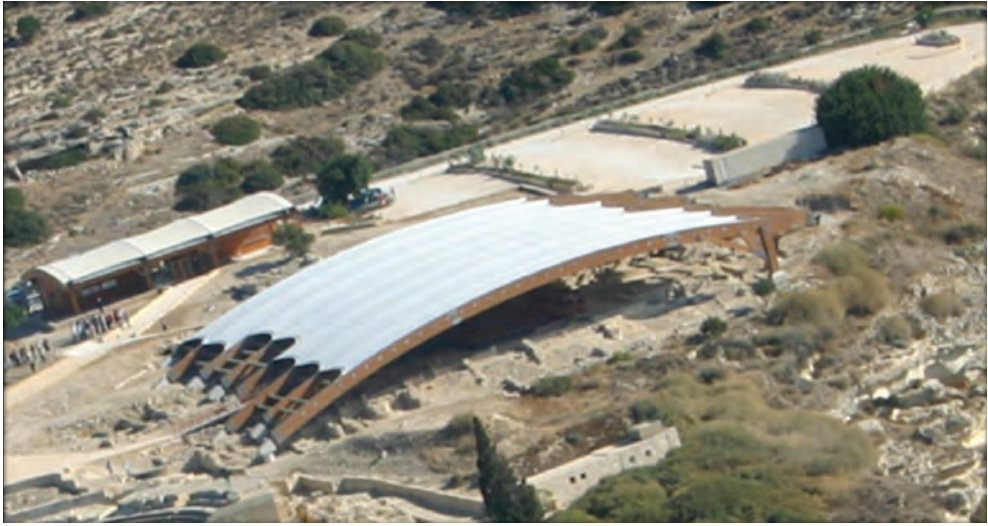
Fig. 4. Kourion, the shelter over the “House of Eustolios” (photo: E. Charalambous/ Department of Antiquities of Cyprus)

It would be quite an omission not to refer to the shelters which were constructed above three *domus* that have mosaic pavements at the site of Kourion (Fig. 4). These shelters offer general protection from the main corrosive factors, climatic or other, which, however, should be improved in certain ways. Nonetheless, one needs to take into consideration the fact that a pioneering work of this type and scale has never before taken place in Cyprus and

thus, it is possible that it had weaknesses that should be judged accordingly. A first evaluation of the maintenance situation of the mosaics at the “House of Eustolios” according to the corrosion diagrams gives encouraging conclusions. Soon a second large project for the sheltering of the archaeological site of Nea Paphos (Fig. 5) will be initiated, where the vast majority of the mosaic floors will be covered. It is our belief that the problems occurring on this site will also be successfully dealt with. Another measure, that concerns the mosaic pavements that are not situated under the shelters, and is practised for the last two years by the Department of Antiquities, is the reburial of these floors (Fig. 6) during the winter period (see Charalambous and Lysandrou 2017). The reburial starts at the beginning of November and the uncovering at the beginnings of April, always depending on the weather conditions. Reburial protects the mosaics as much as possible, mainly from

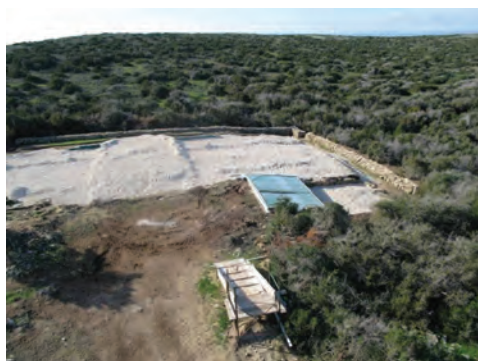
Fig. 6. Limassol, Akrotiri, Early Christian basilica, reburial of mosaic pavement (photo: E. Charalambous/ Department of Antiquities of Cyprus)

the frost and gives the chance to the team of experts to control and protect the pavements that are not buried during this same period. The aim of this reburial is to decelerate the corrosion procedure. The reburial consists of two layers: the first layer consists of a geotextile with a 90% covering, with which all the floors are covered. The purpose of this layer is to allow the drainage of the floor from rising humidity, to limit the excavated area from the protection layer and to obstruct, in a low grade, the development of vegetation. The second layer consists of ten to 20 centimetres of river sand; its function is to protect the monument from direct contact with and the action of rain water, to give stability to the work, to help it to adapt to the weather changes and to allow its drainage. An important factor in choosing the river sand is its purity. It should be without seeds and with low salt consistency. The Department of Antiquities has also reburied all the pavements that are located in archaeological sites that

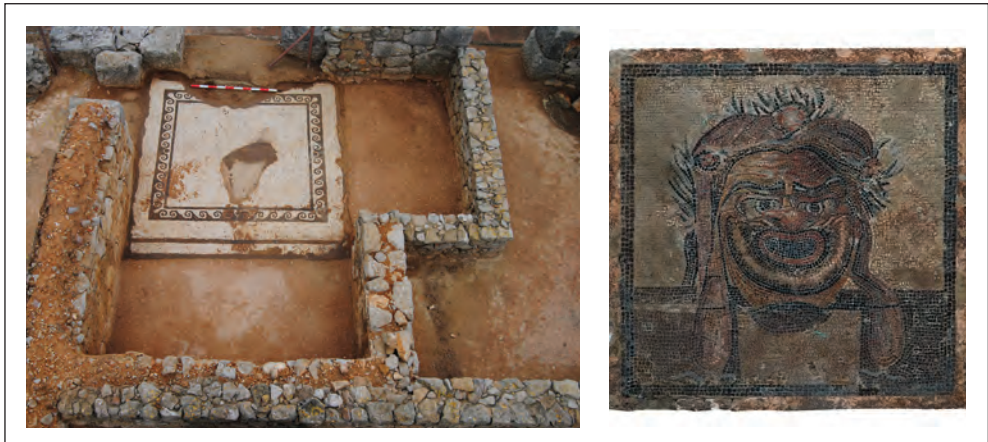
Fig. 3. Close-up of area 23 of *Domus* 1, where the theatre mask *emblema* was discovered in situ in the 1940s (photos: MAC-Empúries Archives)

Other restoration activities were also performed at this time. Reports indicate that in 1944, the *emblema* depicting the theatre mask, discovered in situ in a room of *Domus* 1, was lifted and restored in the Barcelona workshop (Almagro 1945, 110). The original limestone support, however, was preserved. The partridge, the cat attacking a bird and the fish *emblemata* – all discovered out of context, the first two in *Domus* 1 and the third in Neapolis – were also likely restored at this time, likewise preserving their original supports. In all the above instances, the lacunae were integrated with the same techniques that the Museum’s Barcelona workshop, headed by Francisco Font, used on the Iphigenia *emblema*. Lastly, we must also mention that the majority of *signina* from the Roman city and Neapolis also underwent a treatment that included cleaning and consolidating and reintegrating missing parts with cement. The next documentary reference takes us to 1971, at which point the initial team had dwindled down to Adolfo Maragliano and Domingo Gamito. At this time, thanks to the latter’s testimony and the significant photographic archives he provided, we know that several bichrome mosaics from *Domus* 1 were displaying signs of bulging and had to be treated. Aside from this, they used this occasion to integrate with tesserae lacunae that had been filled with Portland cement during the lifting and re-laying process. A new conservator from the Barcelona branch of the Archaeology Museum of Catalonia named José Pedro began working at Empúries in the early 1970s. He would work on a number of campaigns during

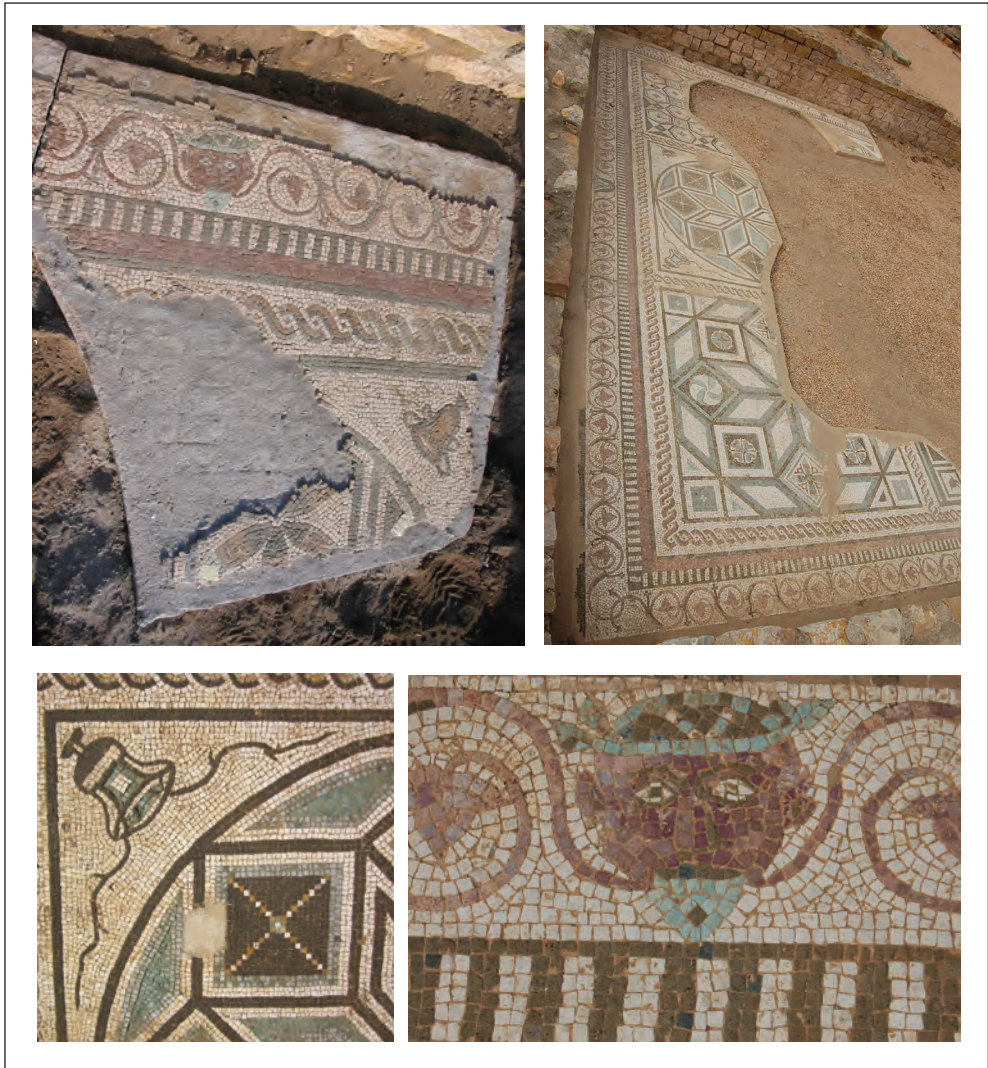
Fig. 5. The polychrome mosaic from the Forum in Ampurias: the new reinforced cement support installed in the 1990s; its condition after being re-laid in 2005; and a close-up of its decoration (photos: MAC-Empúries Archives, Sílvia Llobet)

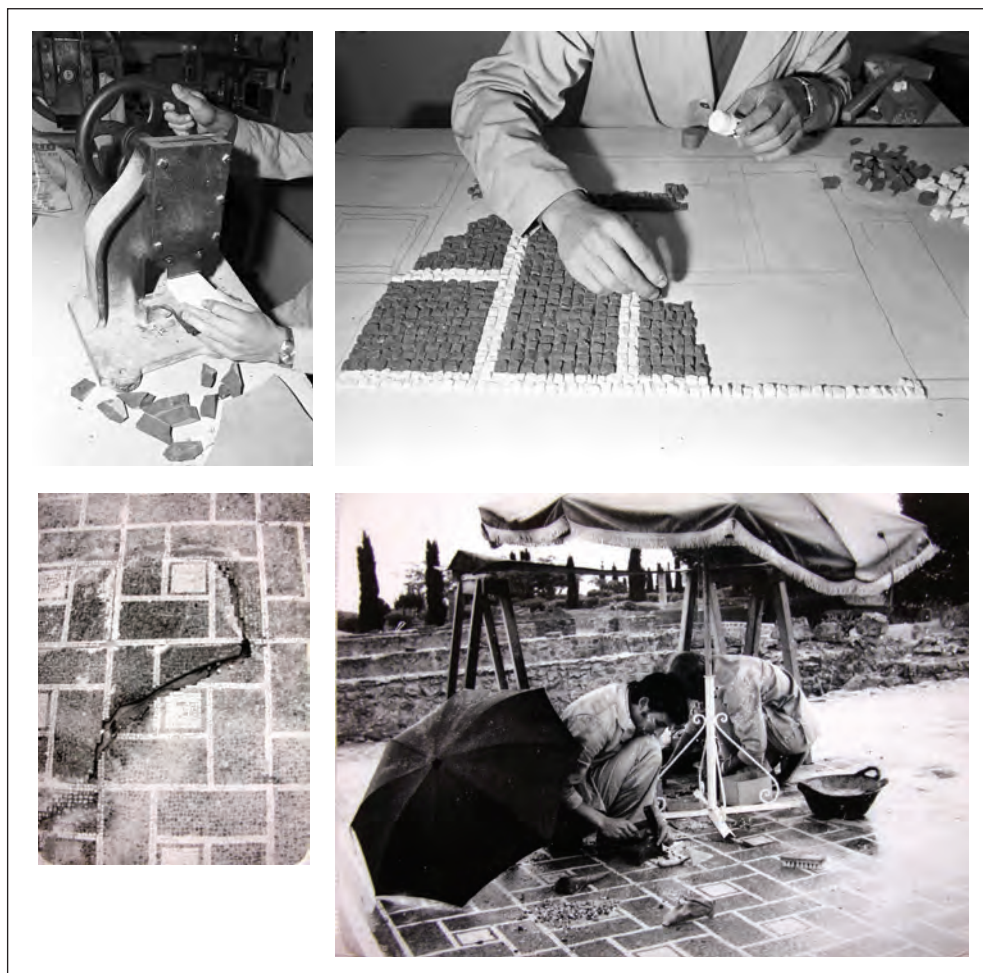
Fig. 7. Lacunae reintegration (in the 1970s) in area 9 of *Domus 2A* in the Roman City (photos: Mac-Empúries Archives)

his 40 years at Empúries and inherited his knowledge of mosaic restoration from the, by that point, aged Adolfo Maragliano. He continued to integrate the preserved bichrome mosaic from *Domus 2A* (Fig. 7) with tesserae, and lifted the polychrome mosaic from the Forum, the only mosaic with a new support reinforced with an iron mesh (Fig. 5). José Pedro coordinated the restoration works of the EMPORI-
