MANAGING ARCHAEOLOGICAL SITES WITH MOSAICS: FROM REAL PROBLEMS TO PRACTICAL SOLUTIONS

THE 11TH CONFERENCE OF THE INTERNATIONAL COMMITTEE
FOR THE CONSERVATION OF MOSAICS, MEKNES, OCTOBER 24-27 2011

edited by
Demetrios Michaelides and Anne-Marie Guimier-Sorbets

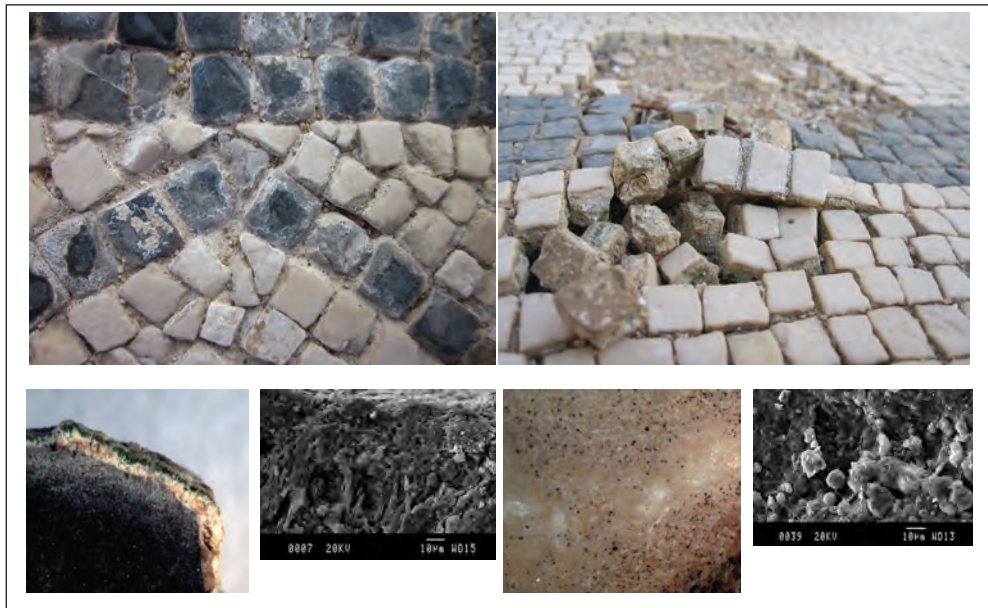
Fig. 8. Areas affected by microbiological growth and the resulting bulging issues; and close-ups of the microbiological growth and scanning-electron microscope photomicrographs of both a white and black affected tessera (photos: Sílvia Llobet, Patrimoni 2.0 Consultors SL)

Initial results reveal the serious condition evidenced by all bichrome mosaics in *Domus* 1, with obvious bulging problems resulting from microbiological growth (today in an advanced stage) caused by years of conservation stagnation and a high degree of moisture. One has to remember that the mosaics are exposed to harsh climatic conditions and are located near the coast. Aside from this, we have identified other commonplace pathologies among unsheltered mosaics in the open air, such as lacunae, detached tesserae and detachment between layers, which lead to structural instability, along with disaggregated tesserae and damage from earlier interventions, many of which have become obsolete or no longer serve a purpose. In addition to the latter, an analysis of the pathologies by professionals from other fields has also been performed. Although these assessments have already begun, they must be redefined as conservation moves forward. The initial analyses from 2011 have already provided us with a number of initial conclusions:

Firstly, with Patrimoni 2.0 Consultors SL, we analysed four tesserae (two of white marble and two of limestone) from areas where bulges had been identified in *Domus 1* (Fig. 8). In these cases, the mortar between the interstices and in the bedding layer has been colonized by microbiological organisms (fungi, algae and lichens). The mortar's microbiological growth also affects the tesserae, as the microbiological organisms secrete acids which attack the mortar and alter it through corrosion. With respect to the formation of bulges, which affect a large number of *tessellata*, we have confirmed that this phenomenon is induced by the stress that the growth process of the microbiological organisms (particularly lichens) exerts on the mortar between the interstices: given the large number of interstices, the sum of the

stress produced in each joint is enough to expand the mosaic's surface, pushing the tesserae upwards. Secondly, we have analysed samples of black tesserae which show highly advanced disaggregation (Fig. 9). This highly porous sandstone contains variable amounts of clay. The clay content makes them susceptible to water, the cause behind this visible degradation. The distinct types of clay experience wet-dry cycles that lead to changes in volume, producing stress inside the stone which eventually causes granular disaggregation and material loss. Aside from studying and documenting the state of conservation, appropriate graphic documentation must be made during mosaic intervention. We plan on producing orthophotographs and tracings, which will form the basis for plotting data on maps and drafting a

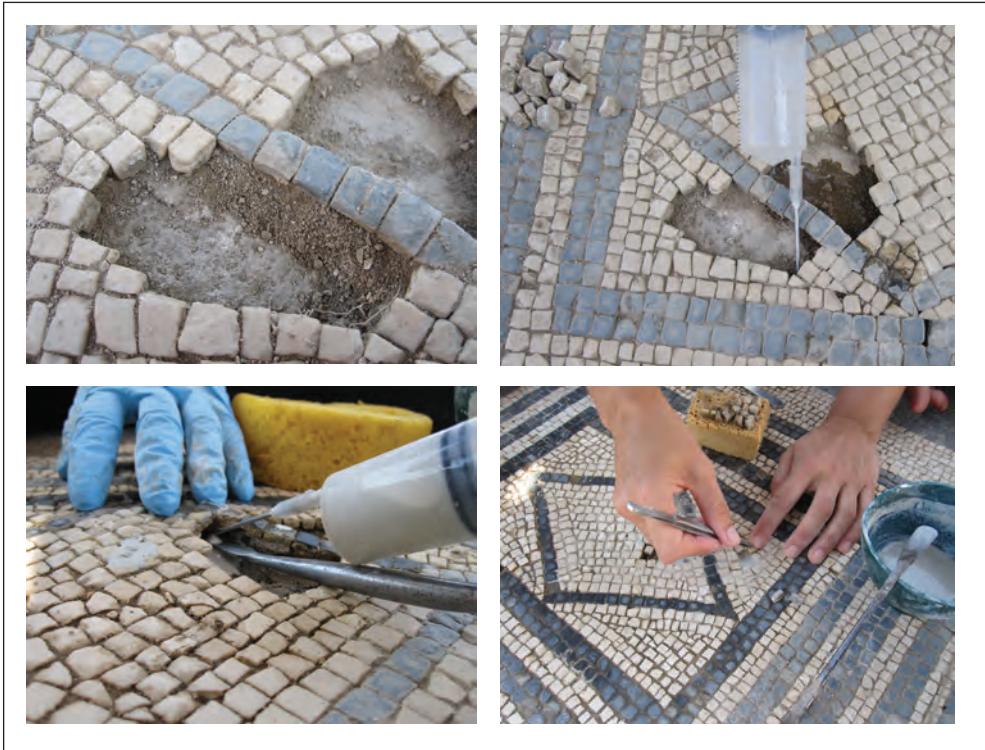
Fig. 11. Conservation work from 2011 on a black and white mosaic from *Domus 1*: application of a biocide, setting bulged areas with natural mortars and re-laying detached tesserae (photo: Sílvia Llobet)

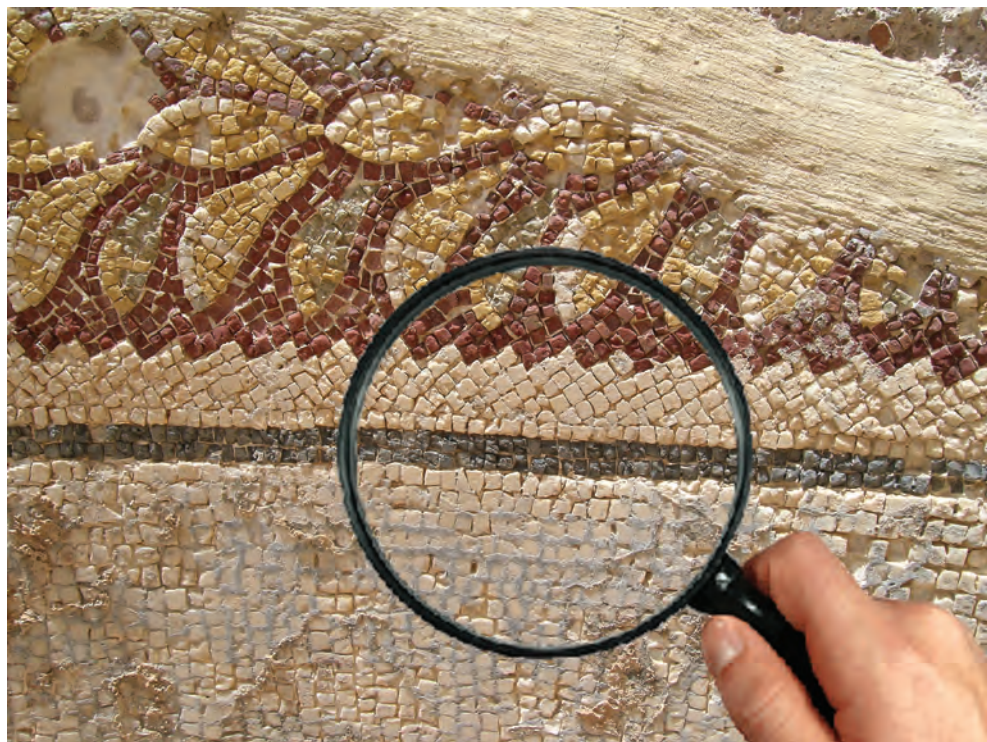
Fig. 1. The level or depth of inspection of a mosaic condition survey depends on specific circumstances and objectives. The amount of survey information previously gathered, the significance of the mosaic, its condition and risk environment all inform the level of survey that is appropriate for a particular case (© John Stewart)

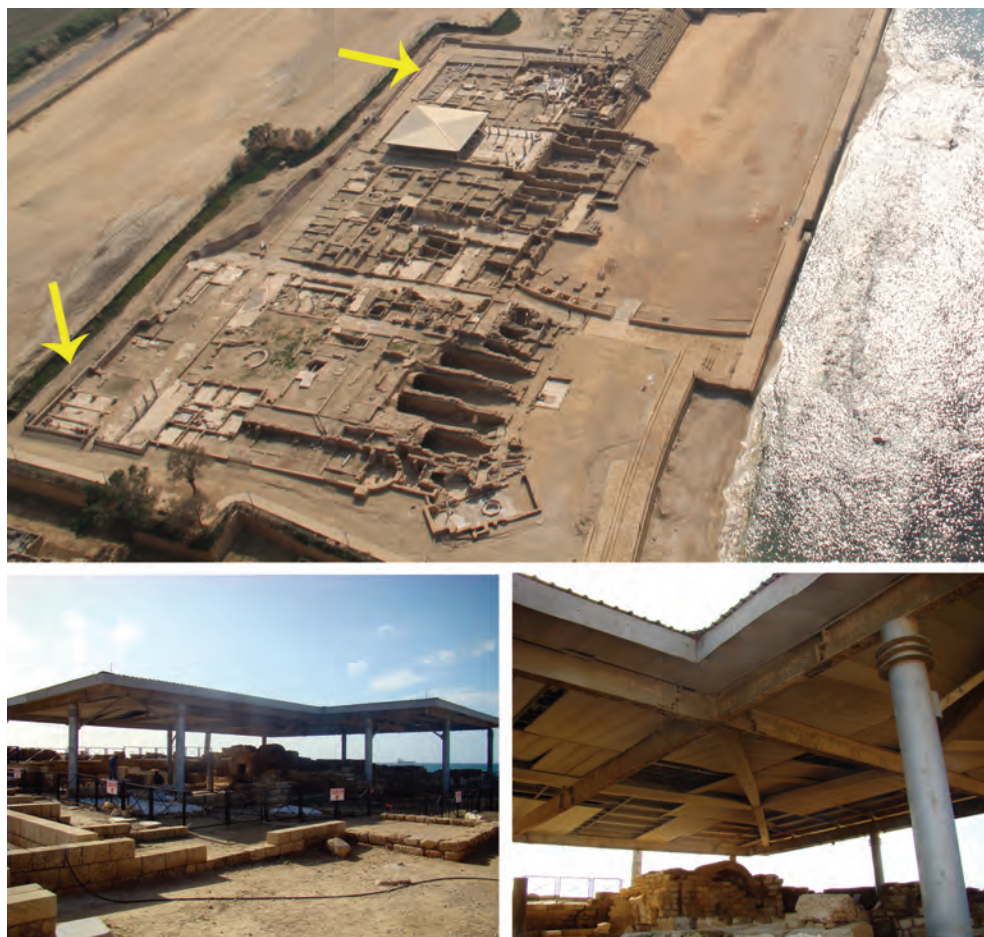
Fig. 4. Top: Aerial view of Caesarea after dismantling the bathhouse shelter and the Ibex mosaic shelter. Out of three permanent shelters constructed on the site, only the villa shelter remained. Courtesy of P. Gendelman, archaeologist; photography performed by Skyview (2010). Bottom: Photos taken during the dismantling of the bathhouse shelter. Photographer: A. Gilad (2010)

strate the need to establish a hierarchy of risks by a cause-effect analysis, with the aim of defining specific criteria for mitigating the risks. From this, performance expectations and design criteria could be established for the planning of the shelter. In the maritime environment of Caesarea, aerosols have been found to be a major risk for the mosaics. The aerosols are a greater

risk than rain, which is usually regarded as a major risk factor in other environments. In fact, in the case of Caesarea, the rain actually washes and reduces the destructive effect of the aerosols that accumulate on the surface of the mosaics (Neguer and Alef 2008). This understanding, among other reasons, led to the dismantling of the shelter over the bathhouse nine years after

its construction! (Fig. 4). Another option in a maritime environment may be the erection of an enclosure with a controlled air system to filter out the aerosols. In any case, the mosaics in those enclosures will probably need more maintenance than the mosaics left exposed in the open air in the maritime environment.

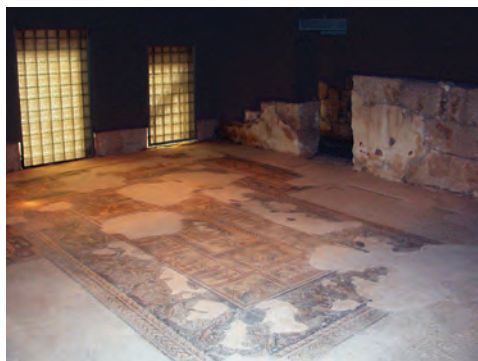
Fig. 5. The Dionysus mosaic, Zippori, interior view of the enclosure. The design responded to security concerns, emphasis on the artistic value, and human comfort needs. The mosaic is presented in museum conditions regarding lighting and climate control, isolating it from the architectural and archaeological context. Photographer: Y. Alef (2006) © IAA

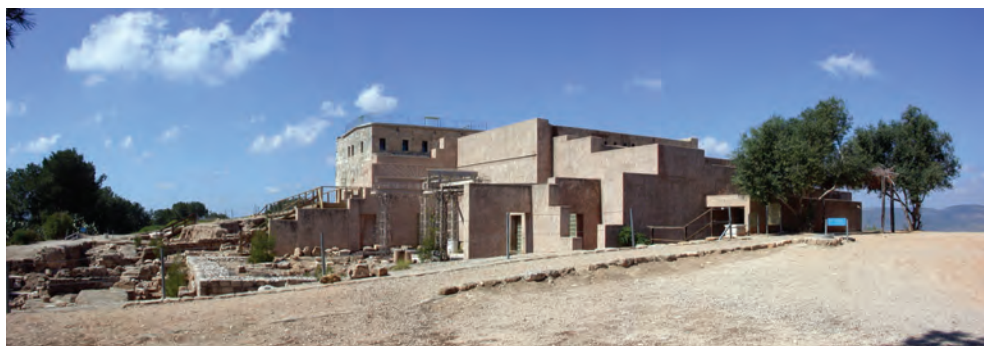
Fig. 6. The Dionysus shelter Zippori, exterior view of the enclosure in the archaeological context. Photographer: Y. Alef (2006) © IAA

Lary Belkin, the architect of the enclosure, recalls that the planning took place soon after the Tyche mosaic in Beit She'an was vandalized (Alef 2002). The alarming incident caused extra sensitivity to security matters in National Parks and in particularly over the "Mona Lisa of the Galilee". Security became a main priority in the planning of the shelter, and every measure was taken to ensure its efficiency. The north and west sides of the shelter are buried in the slope and the shelter has massive walls with only two openings for the doors that are locked overnight; windows and skylight were eliminated from the design. In the interior, elevated walkways were installed to separate the visitor from the remains (Fig. 6).

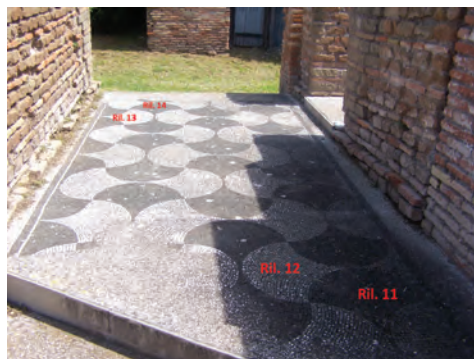
Fig. 1. Areas sampled in order to analyse the effects of light on the biological cover (photo: G. Caneva)

In order to verify the influence of the constituent material of the tesserae on the biological colonization in the area of the Casoggiato dei Lottatori, samplings were taken from two areas composed exclusively of black tesserae (survey 11 and 14) and two areas consisting of white tesserae (reliefs 12

and 13), making sure that samples 11 and 12 came from an area in the shade for most of the day, and samples 13 and 14 from an area of the floor always in full sun (Fig. 1).

The data obtained (Table 2) show how the surveys with an equal index of light exposure are much more similar to each other, as compared to the findings with the same substrate; it seems that light here is more important than the type of substrate, probably in as much as it also affects more or less the water stagnation and in the end the xericity of the area. Also to help demonstrate this, no obvious differences in colonization can be observed in the white and black tesserae with the same light exposure in survey 1. Only in the “stanza dei ventagli”, we could note how the lichen *Aspicilia calcarea* (L.) Mudd has a slight preference for black tesserae. Since it is not plausible that this is related to the chemical nature of the substrate (being a basophilous species, even if it is also true that the mortars are lime based) it is probable that this phenomenon is due to the more intense warming up of the black tesserae, which favours the xerophilous lichen species.

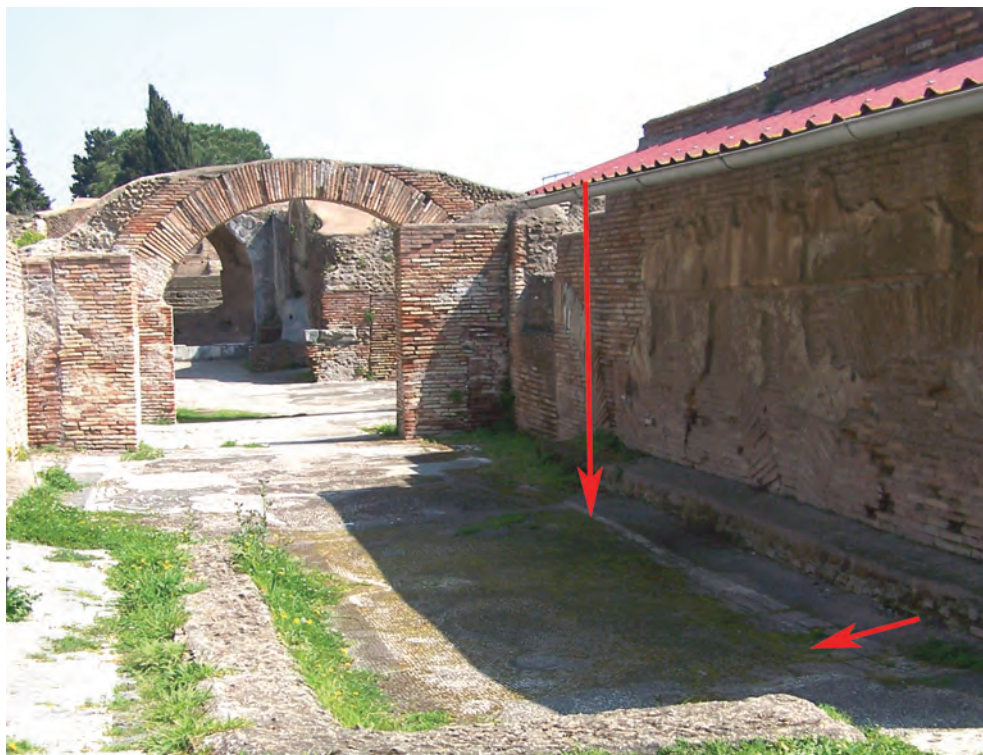
Fig. 2. Increase of the biological cover linked to a higher input of water and earth arising from a nearby shelter (photo: G. Caneva)

onto the mosaics, the biodeteriogens are virtually absent. The parallel effect of light reduction is to be considered negligible in as much as the more shaded but moist parts still showed growth of photoautotrophs. It should be observed that in areas adjacent to shelters the effects may increase biological growth, especially if there are clogged gutter drains, which can generate a local increase in the input of water and earth with synergistic effects on growth (Fig. 2).

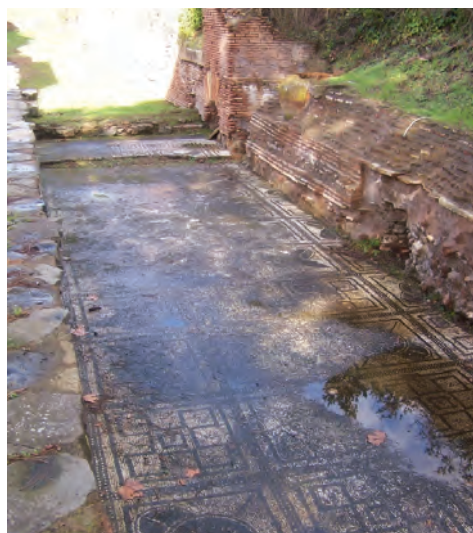
Fig. 3. High growth of algae and cyanobacteria in humid conditions (photo: S. Brignocchi)

The Terme delle Province site, which is about 1.30 m above the average ground level of Ostia Antica, was selected to evaluate the effects of uneven gradients in the terrain (Fig. 3).

with particularly high humidity, even if they were not underground as many of the others were. Once again water shows itself to be the determining factor. This, even if expected, reduces the potential influence of other factors, such as the nutrients, for example, which potentially could have an important role. No effects due to the eutrophication of the substrate were observed, except on one site (survey 23) where there is a conspicuous colonization by *Caloplaca aurantia* (Pers.) Hellb., a lichen species with a rather high eutrophication index, which can be explained by the close contact of this small section of the mosaic floor with the ground.

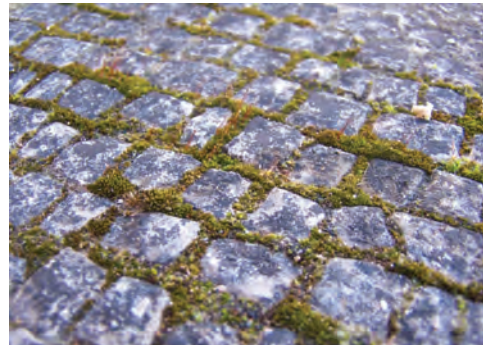
Fig. 4. High moss colonization in the interstices between the tesserae (photo: S. Brignocchi)

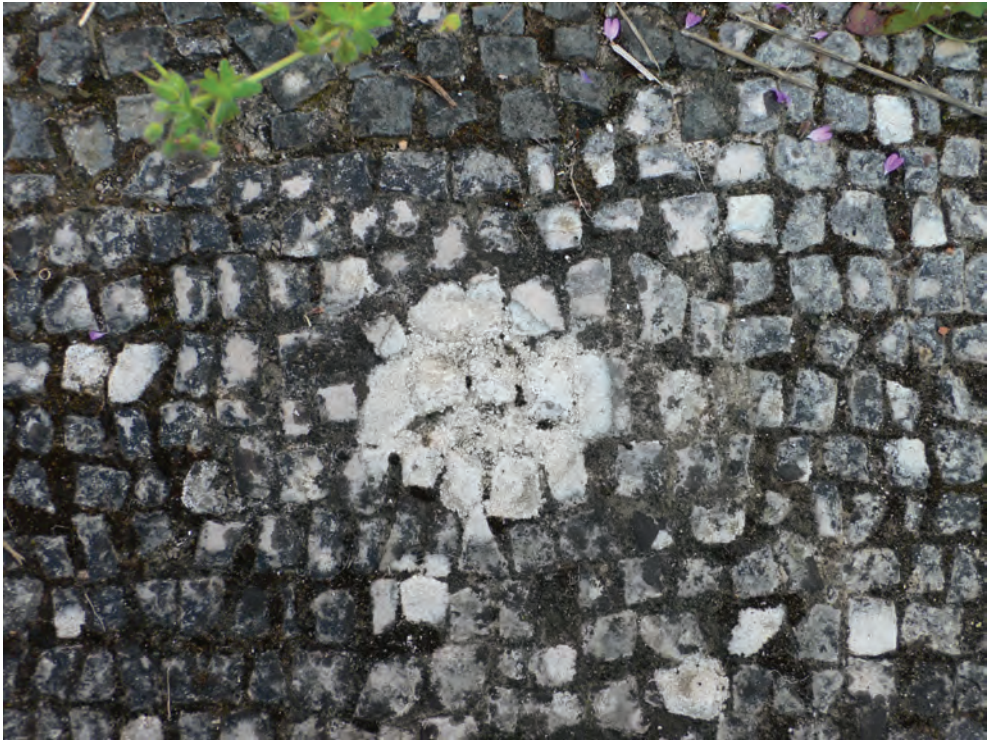
Fig. 5. Extensive lichen cover (*Aspicilia calcarea* (L.) Körber and *Caloplaca aurantia* (Pers.) Hellb.), which sometimes can surpass the space between tesserae (photo: G. Caneva)

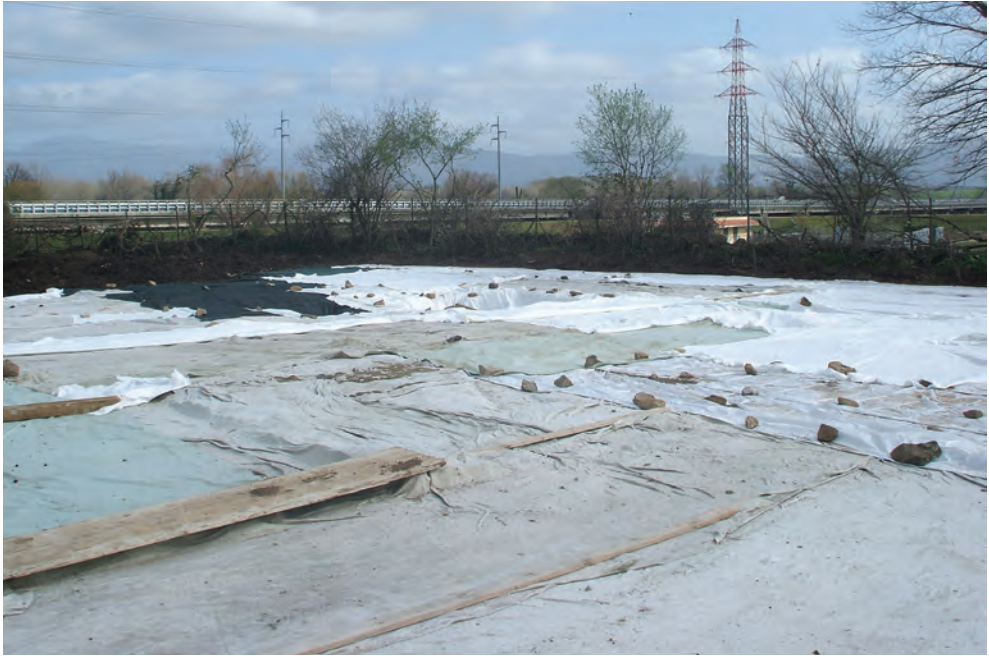
Fig. 1. Covering mosaic floors with nonwoven fabric, Villa Fontana Amara, Rome (photo: A. Lugari)

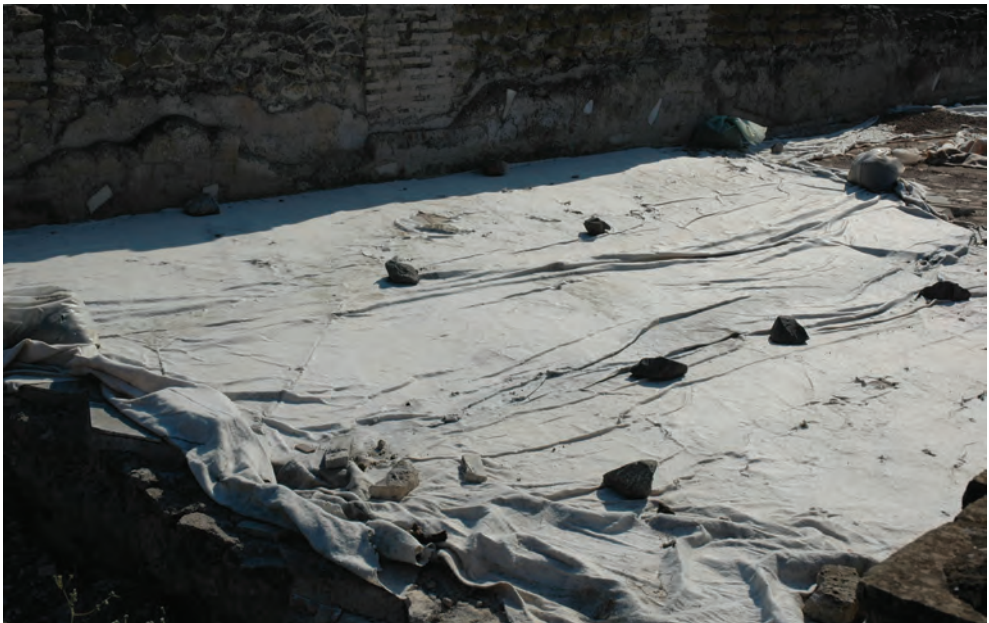
Fig. 2. Covering mosaic floors with nonwoven fabric, Villa dei Quintilii, Rome (photo: A. Lugari)

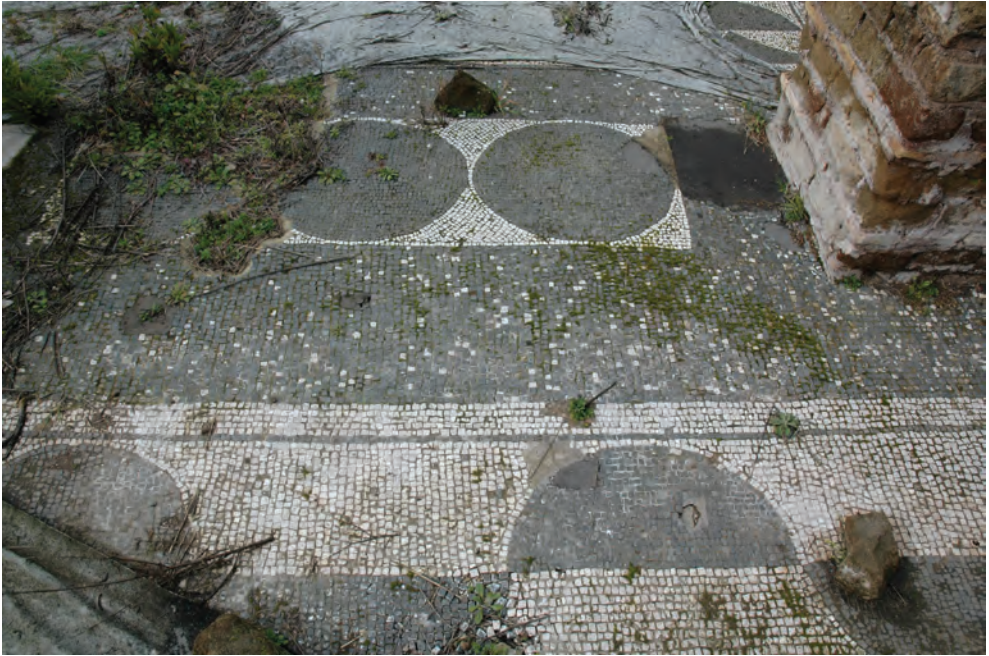
Fig. 3. Condition after one year of covering with nonwoven fabric, Villa di Via Carciano, Rome (photo: A. Lugari)

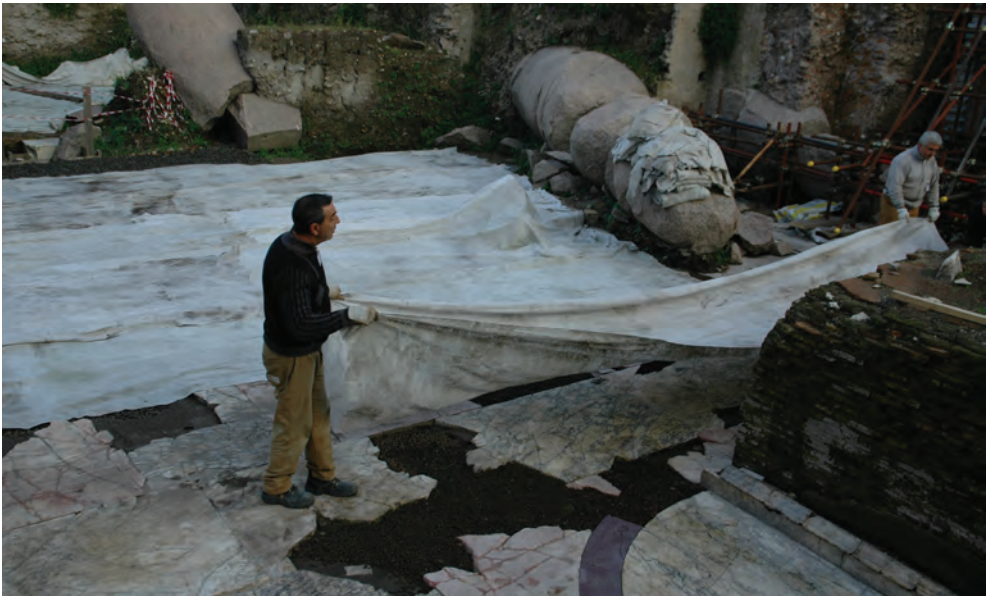
Fig. 4. Daily covering with nonwoven fabric, Forum of Peace, Imperial Fora, Rome (photo: A. Lugari)

In the conservation project for the *Templum Pacis* (Temple of Peace) in the Imperial Fora in Rome (Lugari and Schievano 2010), during the excavation a nonwoven fabric was used, and every day the sections in which work had to be done, were uncovered, to be covered again at the end of the day (Fig. 4). Once the intervention was completed, the big problem to solve was how to preserve our hard and long work. So, we go back, for a moment, to the beginning of this paper, and mention that, at this point, we had an unstable thermodynamic situation with rapid variation of environmental parameters. There are many options for reducing the effects caused by these phenomena: The first, and perhaps the best, is the building of a shelter (Laurenti 2006) and, associated with this, the drawing up of a maintenance program. An alternative would be to cover the pavements at least seasonally and organize ordi-

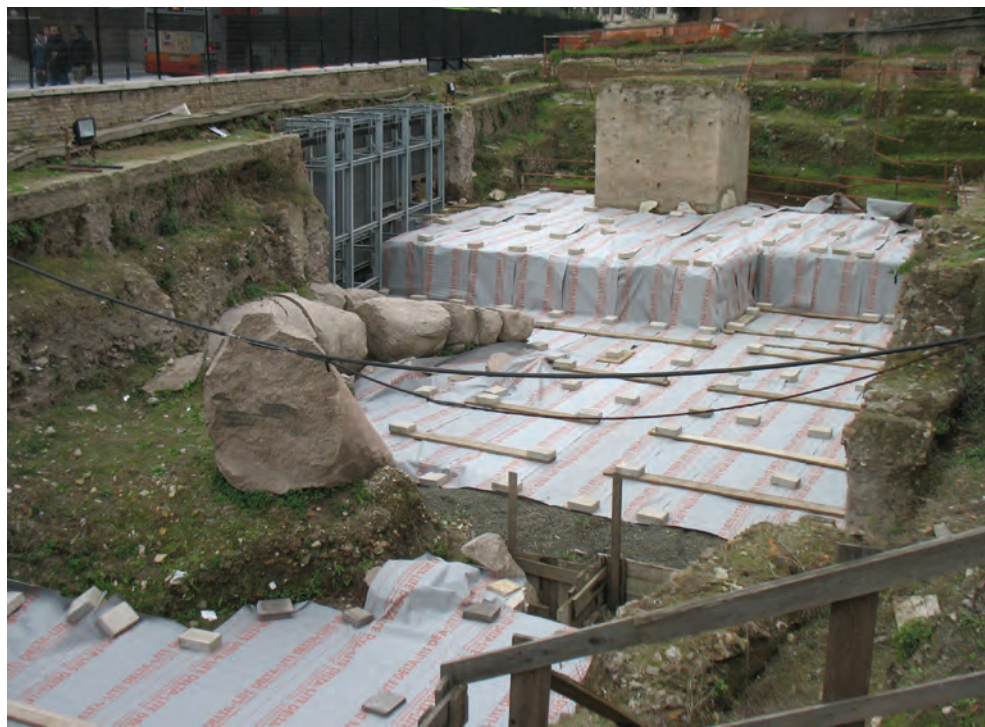
Fig. 5. Covering with Delta-Lite fabric, Forum of Peace, Imperial Fora, Rome (photo: A. Lugari)

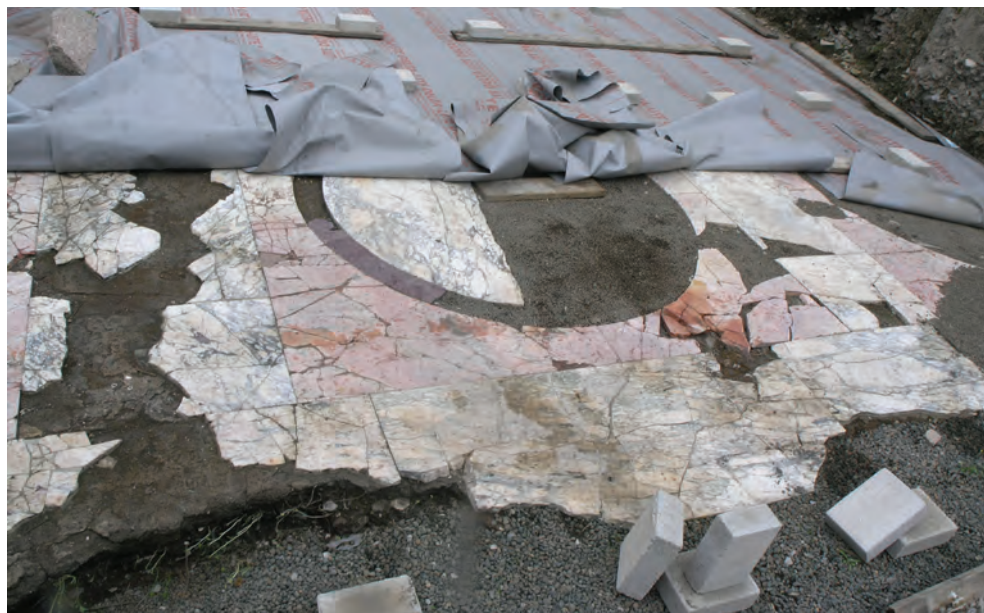
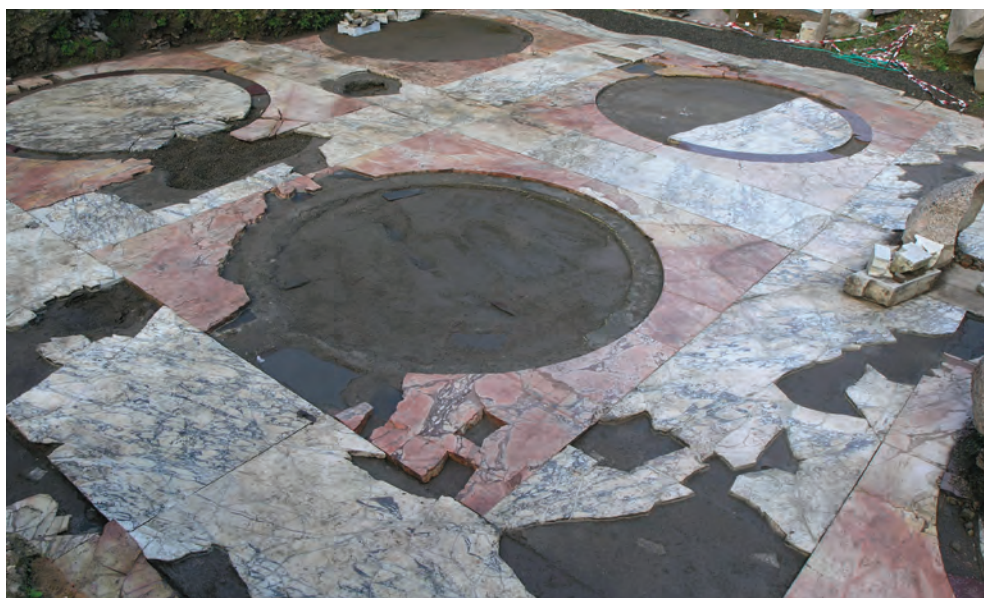
Fig. 6. Condition after one year of covering with Delta-Lite fabric, Forum of Peace, Imperial Fora, Rome (photo: A. Lugari)

Fig. 7. Condition after one year of covering with Delta-Lite fabric, Forum of Peace, Imperial Fora, Rome (photo: A. Lugari)

(Colombi 1995). After 20 years we can say that the best option for a temporary covering is gore-tex. The one and only, and the big problem with this material is its cost: it is very expensive (about 300 euros per square metre). Our research was to look for a material with the same characteristics as gore-tex (is waterproof, transpires, and is UV resistant) and, at the same time, cheaper. Eventually we found Delta-Lite, a material for construction works, used for the water-proofing of shelters. As an experiment, we tested it for covering the entire pavement (Fig. 5). When, after six months, we removed it in order to check the condition of the pavement, we got a surprise. The conservation of the floor was perfect, apart from small problems: the material was sold in rolls and at the junctions

of the sheets there was some infiltration of water, but all the same the results were good (Fig. 6 and 7). To face this inconvenient we asked for a solution from the Delta-Lite factory. The expedient was the application by the factory itself of strong-glue stripes on the edges of every roll. Thus, a 'single' composite sheet is obtained (Fig. 8), which hinders water infiltration. Today, after five years of experimentation, we are completely satisfied with the Delta-Lite covering. It has the same characteristics as gore-tex, but costs only about three euros per square metre! A 'single' sheet is easy to apply and remove, and the conservation of the pavement is excellent; and we use it in many archaeological sites all over Italy (Fig. 9).

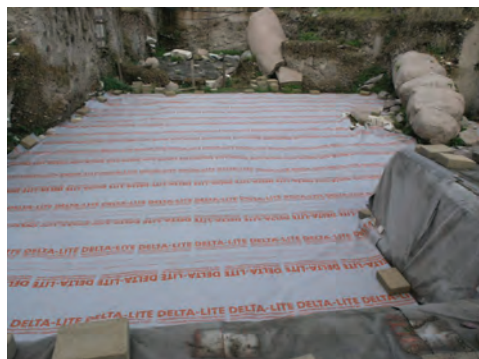
Fig. 8. Covering with a 'single' sheet of Delta-Lite fabric, Forum of Peace, Imperial Fora, Rome (photo: A. Lugari)

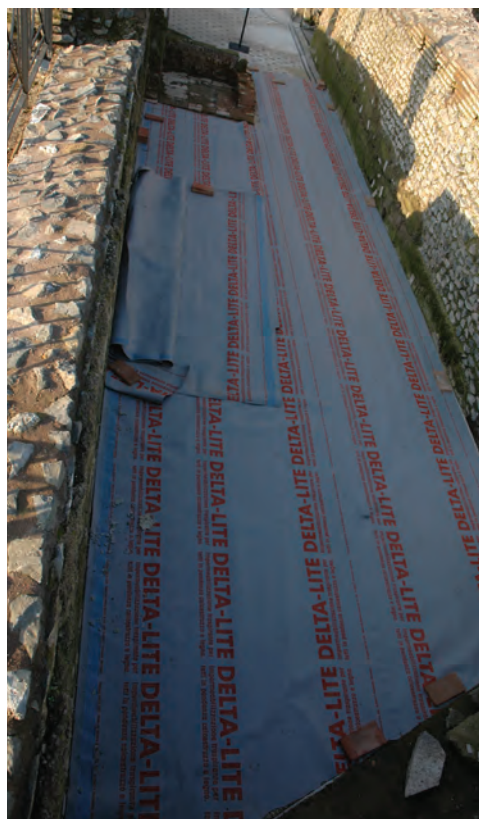
Fig. 9. Covering with a 'single' sheet of Delta-Lite fabric, Villa dei Quintilii, Rome (photo: A. Lugari)

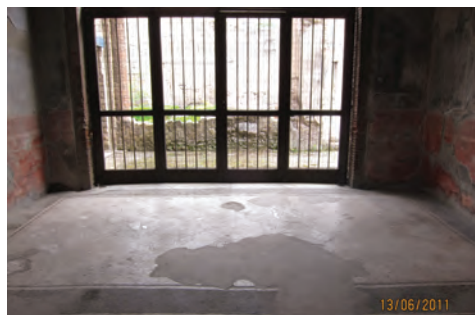
Fig. 3. Plain bi-chrome, black-on-white mosaic, *tablinum*, Casa del Tramezzo di Legno, Herculaneum (photo: Niki Savvides)

Among these features are the mosaic floors, which decorate the houses and public baths of the Forum, along with other types of flooring such as *opus sectile* and *battuti*. Made predominantly with volcanic, calcareous stone and marble, their surfaces have plain (Fig. 3) or geometric decoration (Fig. 4 and 5) except for the two figural mosaics in the baths (Fig. 6). A total of 34 mosaics are currently directly accessed by thousands of visitors every day (Fig. 7). Their numbers peak in the months of March to May, when most school groups come to the site, along with organized groups and independent visitors (Fig. 8). Visitor numbers have been on the increase at the site, and they are expected to continue doing so as more areas re-open to the public in the near future. This is partly due to the Herculaneum Conservation Project (HCP), which improved the state of conservation of the site since 2001 (Court, Thompson and Biggi 2011). The Herculaneum Conservation Project is a Packard Humanities Institute initiative in collaboration with the Soprintendenza Pompei (at the time

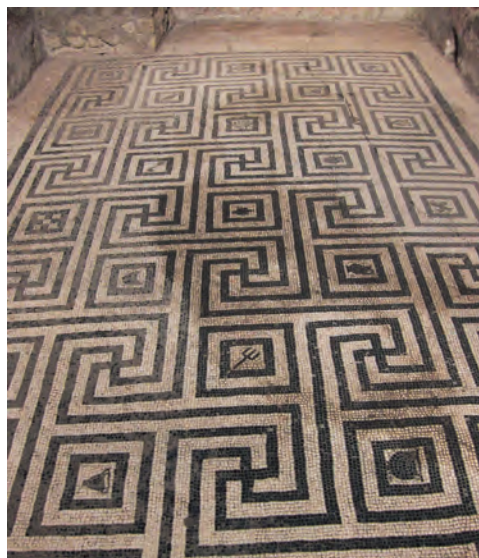
Fig. 4. Geometric bi-chrome black-on-white mosaic, *tepidarium*, Terme Centrali Femminili, Herculaneum (photo: Niki Savvides)

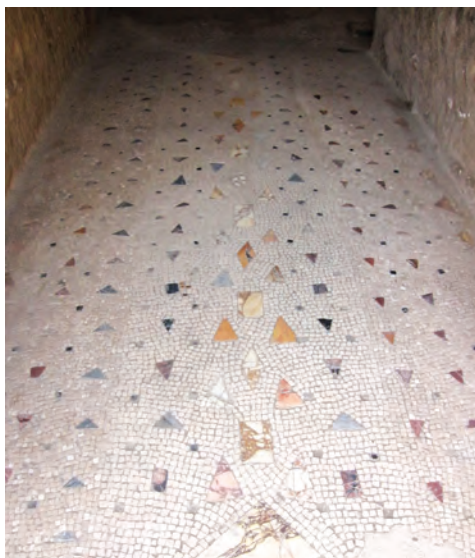
Fig. 5. Geometric polychrome mosaic, vestibule, Casa dei Cervi, Herculaneum (photo: Niki Savvides)

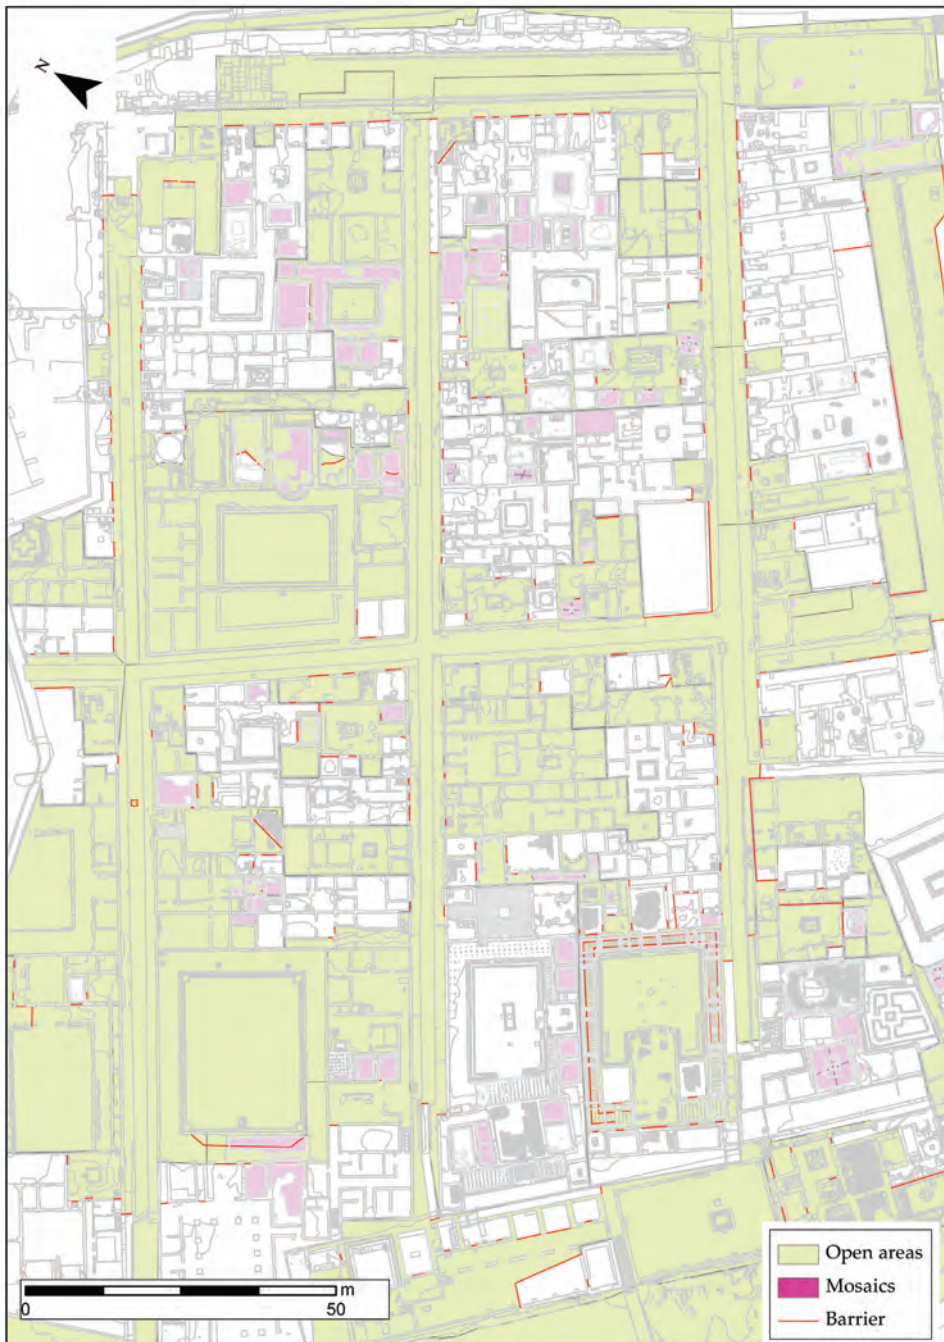
Fig. 7. Mosaics at Herculaneum open to public access and included in the visitor impact assessment (image: Herculaneum Conservation Project)

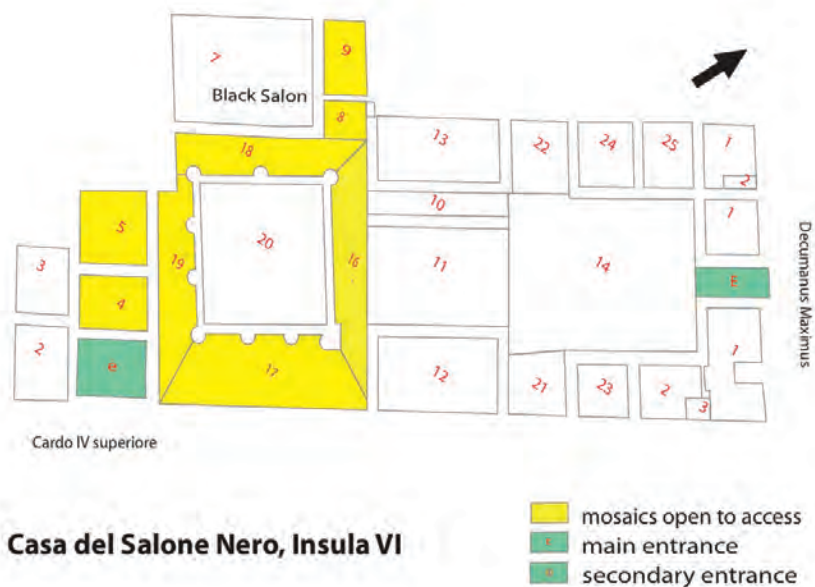
Fig. 11. Map of Casa del Salone Nero (map: Studio Brizzi/Herculaneum Conservation Project, with additional modifications by Niki Savvides)

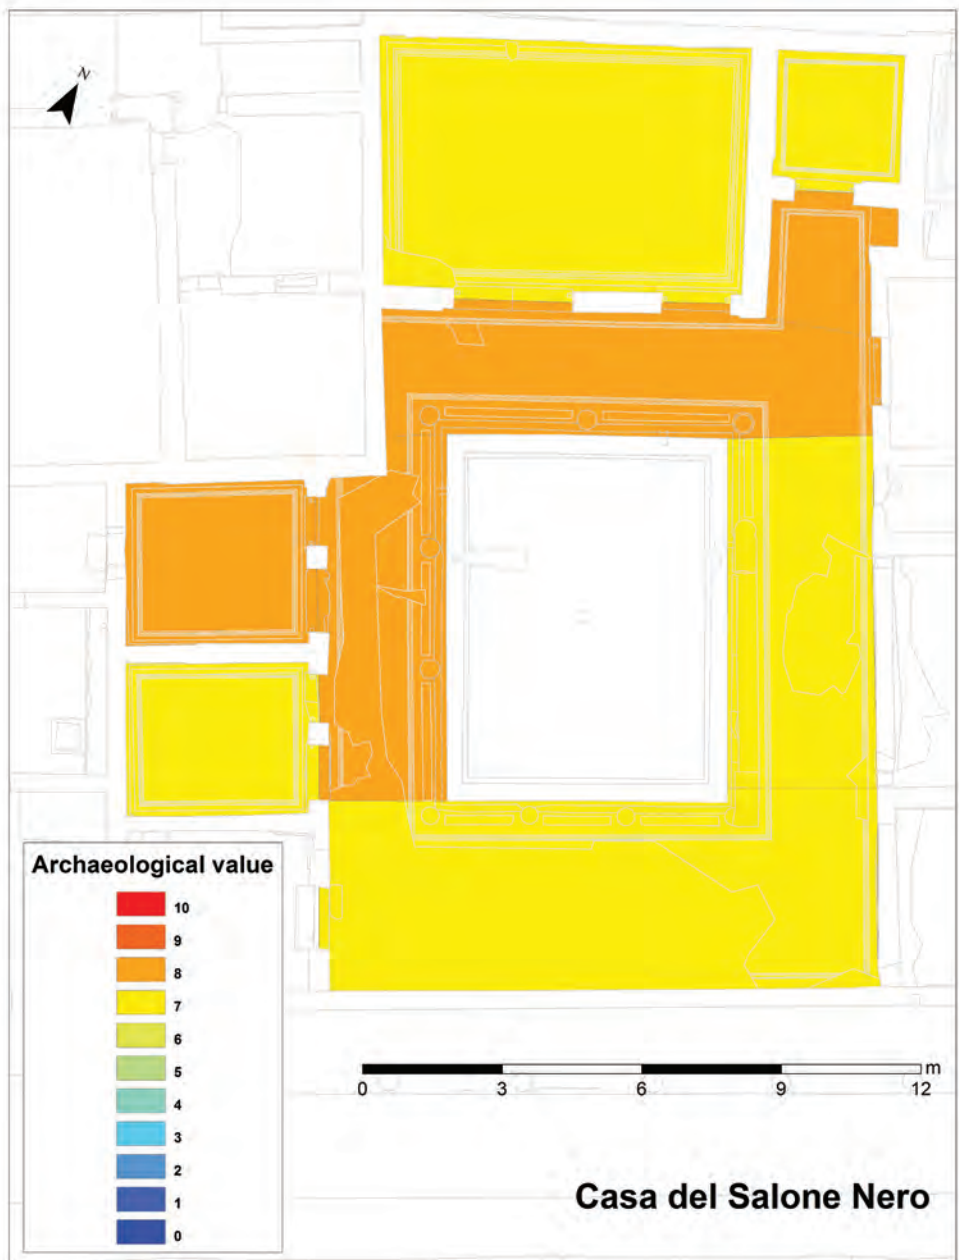
Fig. 14. Map of the Casa del Salone Nero, Herculaneum, with the mapped archaeological values for the mosaics (photo: Sosandra/Herculaneum Conservation Project)

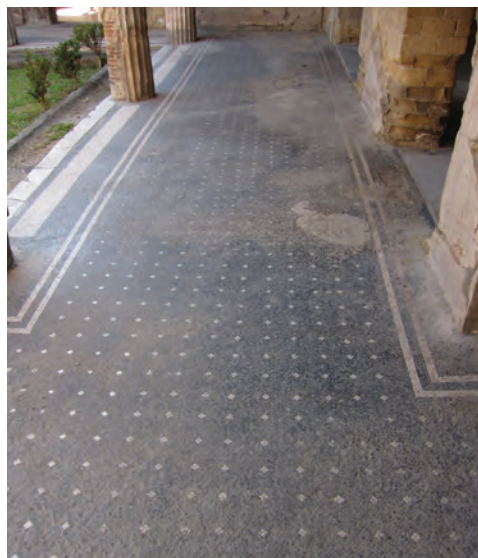
Fig. 16. Mosaic floor of the peristyle corridor 18 with extensive abrasion and mortar repairs, Casa del Salone Nero, Herculaneum (May 2011) (photo: Niki Savvides)

The tesserae of the peristyle are extensively abraded as opposed to mosaics 4, 5 and 9, where this condition affects mainly the borders made with volcanic stone (Fig. 12). The peristyle mosaics are further affected by soiling (Fig. 19). All peristyle floors have extensive mortar repairs (Fig. 13). These exhibit severe decay on mosaics 8 and 18 (Fig. 16 and 17). Other structural conditions recorded on these floors are detachment and to a lesser extent lacunae and loose tesserae along their central panels and their borders towards the peristyle (Fig. 12 and 13 respectively).

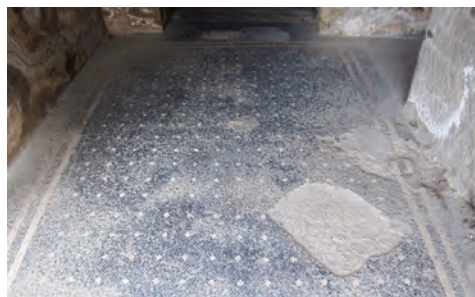
Fig. 17. Mosaic floor of corridor 8 with extensive abrasion and mortar repairs, Casa del Salone Nero, Herculaneum (May 2011) (photo: Niki Savvides)

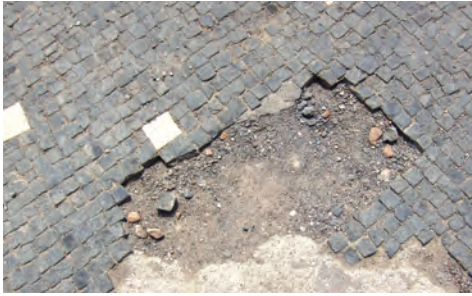
Fig. 18. Lacuna on peristyle corridor 16, Casa del Salone Nero, located close to the *tablinum* with a deteriorated *battuto*, from where gravel is transferred onto the mosaic and may be related to the losses affecting the floor (May 2011) (photo: Niki Savvides)

Gravel and loose aggregates deposits on mosaic 16, and especially on areas recorded with lacunae (Fig. 18), suggest that gravel may contribute to the instigation and possible growth of existing losses. Their source is the deteriorated *battuto* of the *tablinum* that connects the peristyle with the atrium.

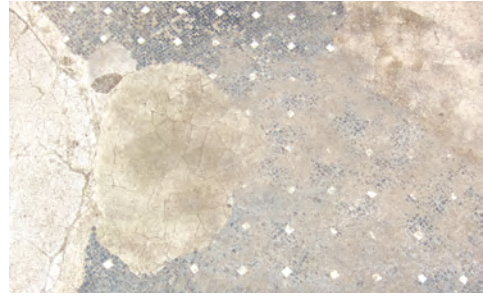
Fig. 19. Soiling affecting the surface of the peristyle mosaic 16, Casa del Salone Nero, Herculaneum (May 2011) (photo: Niki Savvides)

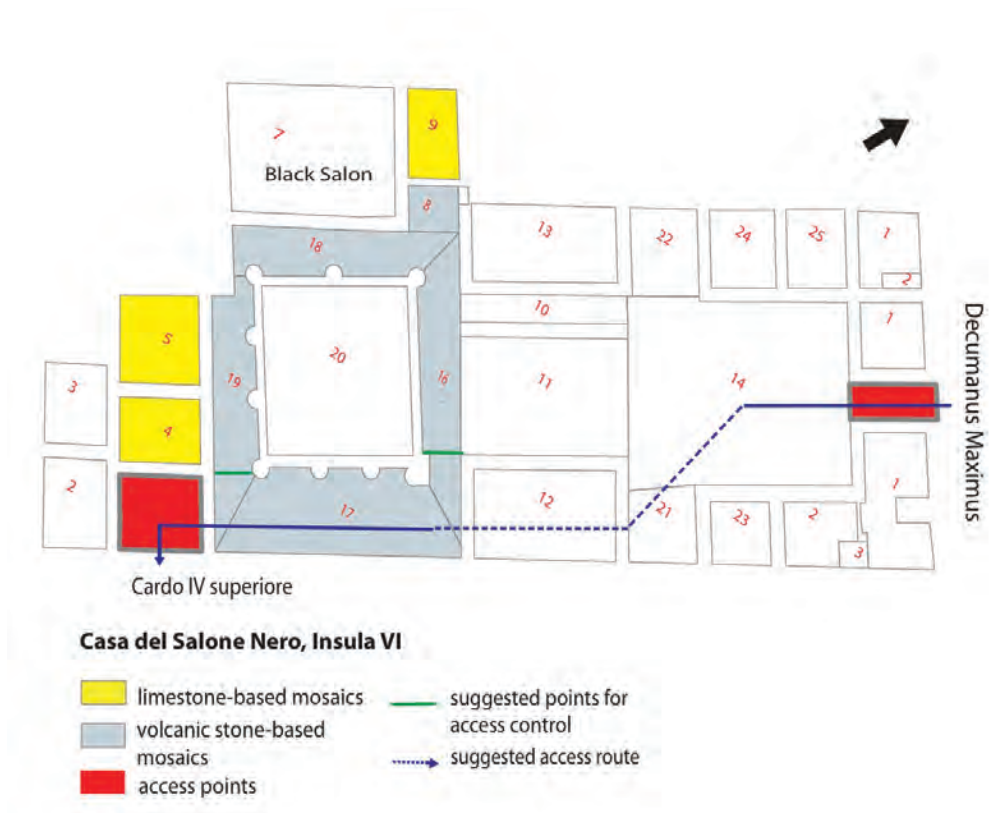
Fig. 20. Suggested itineraries for the Casa del Salone Nero for controlling visitor access

3. For the rest of the opening hours of the site, establish one-way itineraries to and out of the building by using both access points, so that visitor flow is controlled and less pressure is placed on tessellated areas (Fig. 20). The suggested itinerary considers the original access point into the house, which would enable visitors to get a better understanding of the function of the house in antiquity.

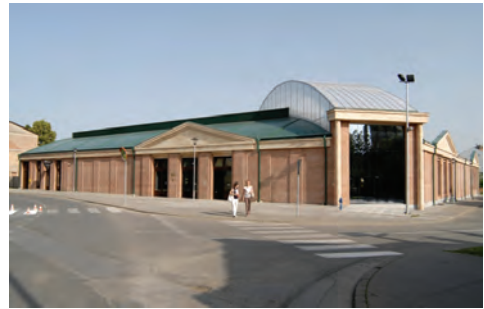
Fig. 8. Model of the external appearance of the building (Institute for the Protection of Cultural Monuments of Sremska Mitrovica)

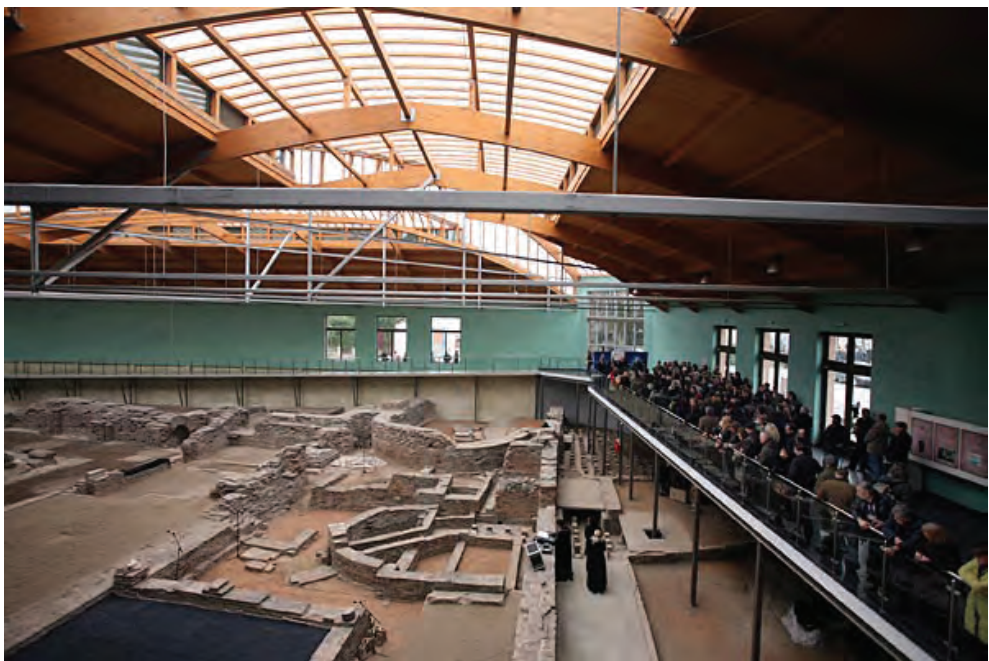
Fig. 9. Final appearance of the interior (photo: Institute for the Protection of Cultural Monuments of Sremska Mitrovica)

ramps allow easy access to the lower level (Škorić 2008) (Fig. 9 and 10). Visitors are allowed to walk not only on the ramps but also to go down and walk through the

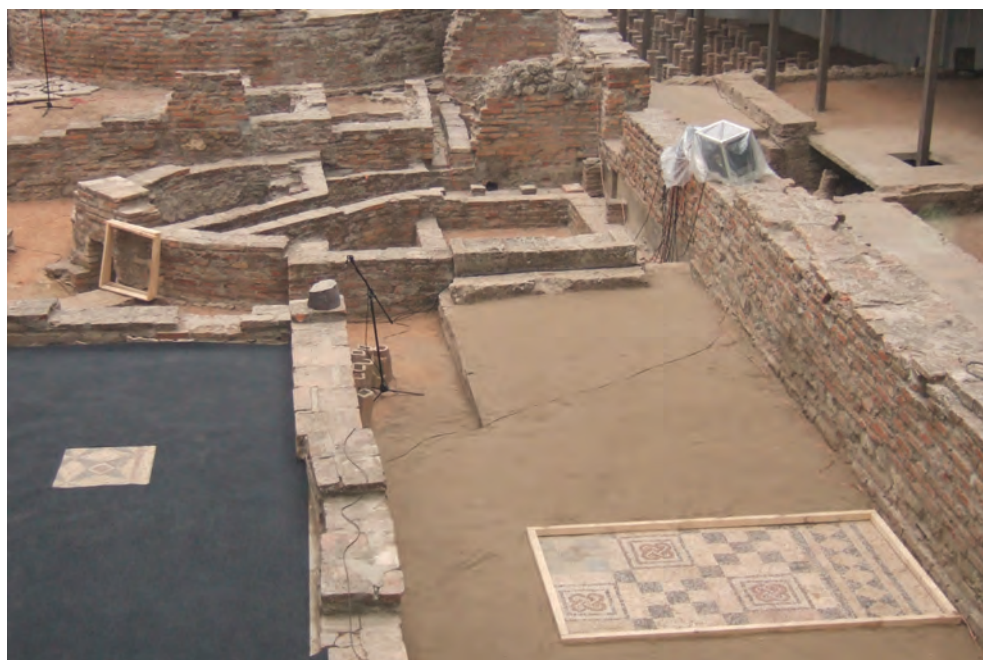
Fig. 11. View of the mosaic presentation (photo: Institute for the Protection of Cultural Monuments of Sremska Mitrovica)

entire '1a Site'. Therefore, the mosaics are still covered with sand, with only small sections presented since this is all at an experimental phase (Fig. 11). The project was funded by the Ministry of Culture, the Ministry of Economy and Regional Development and the city of Sremska
