MANAGING ARCHAEOLOGICAL SITES WITH MOSAICS: FROM REAL PROBLEMS TO PRACTICAL SOLUTIONS

THE 11TH CONFERENCE OF THE INTERNATIONAL COMMITTEE
FOR THE CONSERVATION OF MOSAICS, MEKNES, OCTOBER 24-27 2011

edited by
Demetrios Michaelides and Anne-Marie Guimier-Sorbets

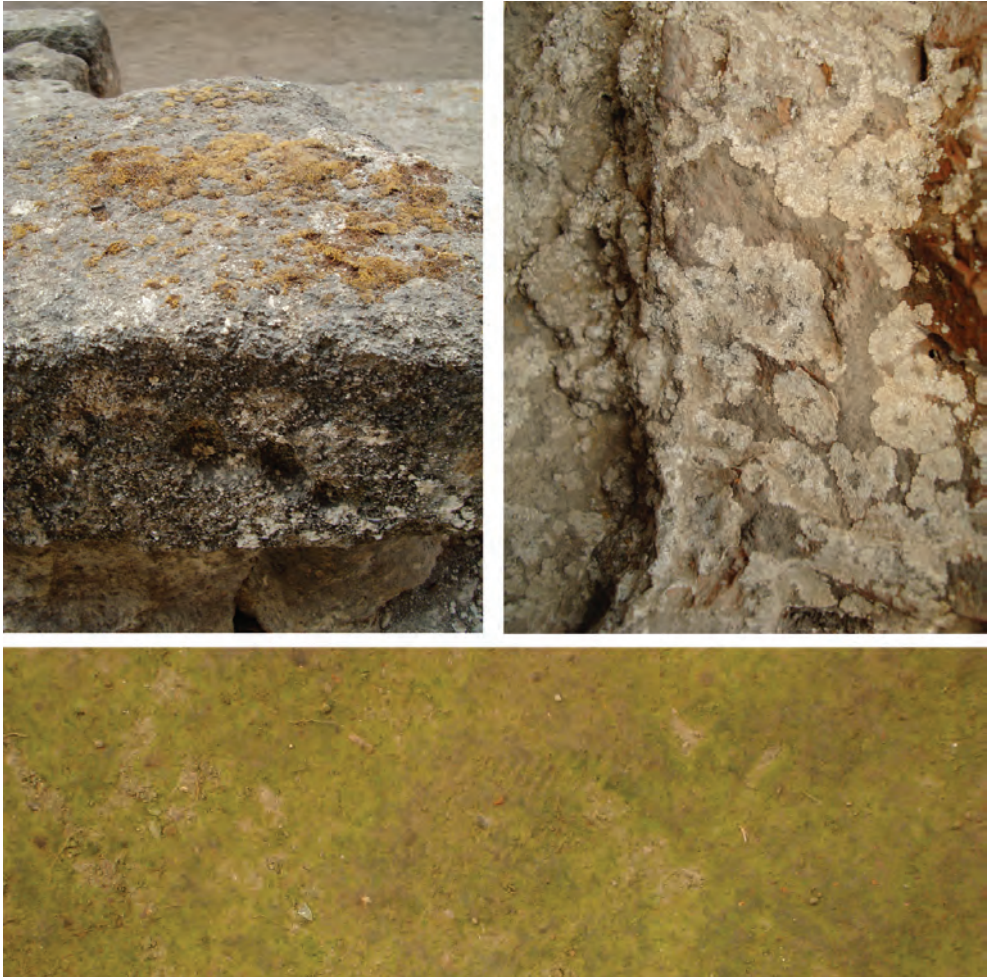
Fig. 12. Development of micro-organisms and certain types of low vegetation (photos: N. Smiciklas, Institute for the Protection of Cultural Monuments of Serbia, Belgrade)

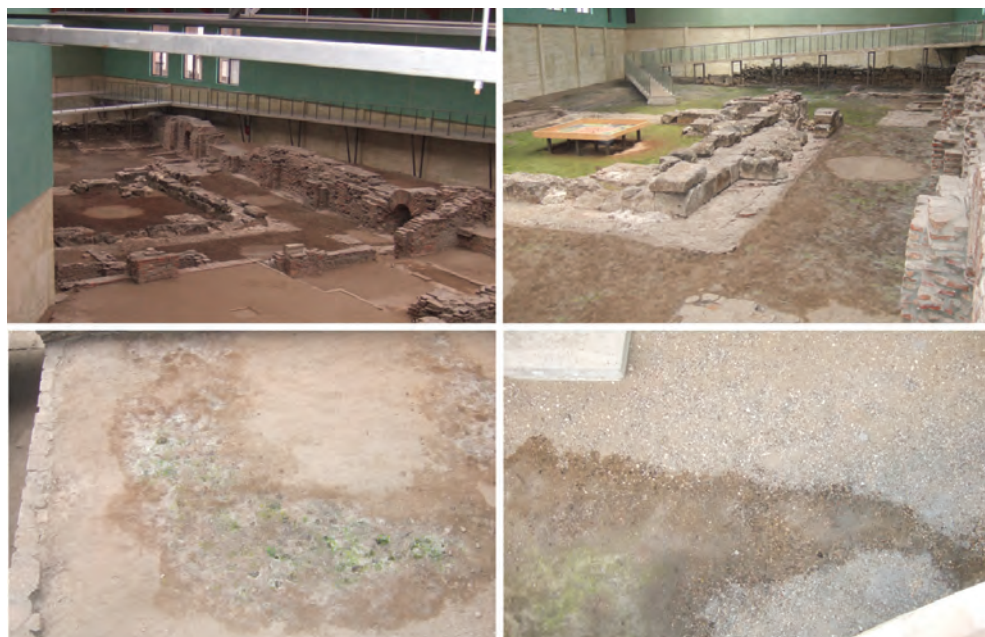
Fig. 13. Examples of rising damp (photos: N. Smiciklas, Institute for the Protection of Cultural Monuments of Serbia, Belgrade)

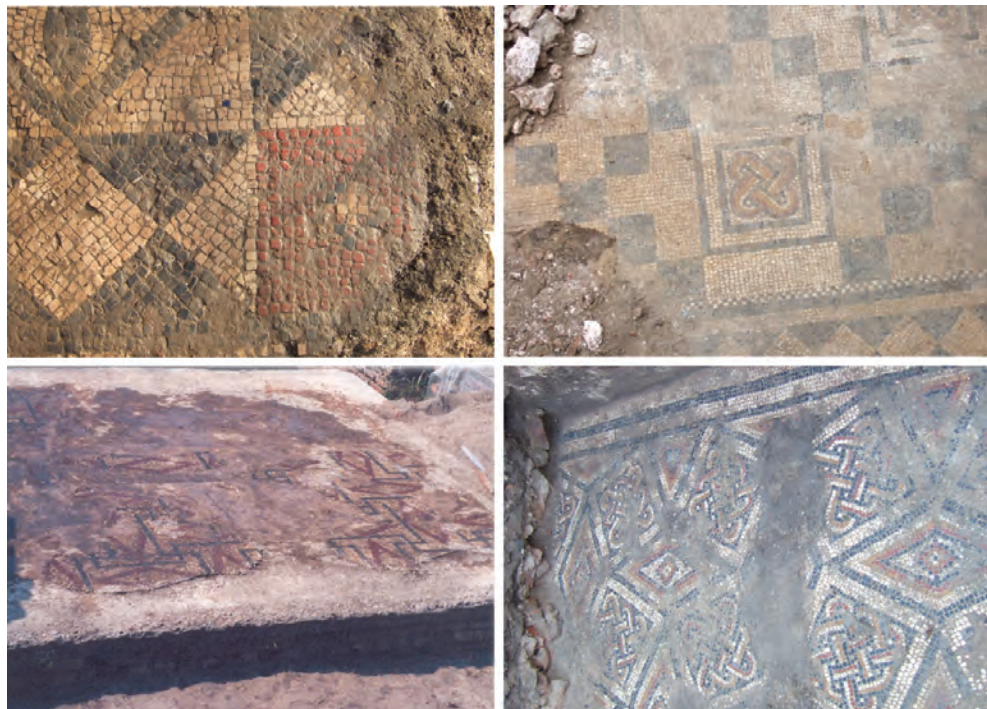
Fig. 19. Current condition of the mosaics (photos: Institute for the Protection of Cultural Monuments of Sremska Mitrovica)

tesserae, deteriorated preparatory layers, detachment between mosaic layers, incrustation, cracks, lacunae, etc. (Fig. 19). The mosaic floors of the imperial palace are made in the *opus tessellatum* technique, and with clay tiles, and are decorated with a variety of geometric patterns. The size of the variously coloured stone tesserae ranges between 0.5 and 1.5 cm (Fig. 20, 21 and 22), and the brick tiles are hexagonal. During the 1970s, over 200 m² of mosaic revealed at that time were conserved. In rooms 14, 16, 23, 2-upper level and 34, the mosaics were lifted and placed on reinforced concrete supports. For the main bearing layer of the previously cleaned segments of mosaics, a 3-4 cm thick mortar was made as follows (the amounts given are for about 10 m²):

The fragments were re-laid after treatment and joined with cement mortar. This cement mortar surfaced through the lacunae and the edges where the mosaic was cut into pieces, and covered tesserae in these areas. After this major intervention was performed, only minor maintenance took place (change of the protective layer of sand and removal of vegetation) which revealed more and more defects in the underlying layer of mosaic, where tesserae were deteriorating and separating from the substrate. The lacunae are filled with cement mortar to the level of the tesserae, which, over time has become darker and cracked, and thus spoils the whole visual impact and stability of the tesserae, and also undermines the mosaic as a whole. The edges of the lacunae and the mosaics are extremely unstable, and the tesserae

are detached and fall out of their sockets. Minor damages are retouched with tesserae of inappropriate colour, size and tone, which, instead of being functional, impair the visual experience of the mosaics. Given the weight of the fragments after the conservation and restoration of the 1970s, which used reinforced concrete in some places, the soil has settled, cracking and deforming the original hypocaust (*suspensura*) and its supporting pillars (*pillae*). Consequently, bumps and cracks are visible on the entire mosaic surface. The network of cracks spreads mainly through joints, but individual tesserae are also damaged. The surface of the mosaic itself is covered with a thin layer of incrustation and salt efflorescence. This greatly affects the visual impact, since the incrustation appears as a light coating on the tesserae. The efflorescence found especially in the interstices between the tesserae appears as a white crystalline powder. Given that this is a product of efflorescence, it is very destructive. Salt crystallizes in the micro-cracks of the mortar and the tesserae, and with expansion leads to cracking and major damage to all layers of the mosaic. This occurs because of the ability of concrete to attract and retain moisture. Visual inspection of the tesserae established various types of damage. On the larger mosaic surfaces there are traces of disaggregation, loss of adhesive properties and pulverization, and lamination of the tesserae. Many of them have separated from the underlying layer of mortar, but are still in their original place, although there are some parts of the mosaic where they are lost. A large number of broken tesserae are still in their proper place, complete or in fragments. Although, after conservation and restoration the mosaics

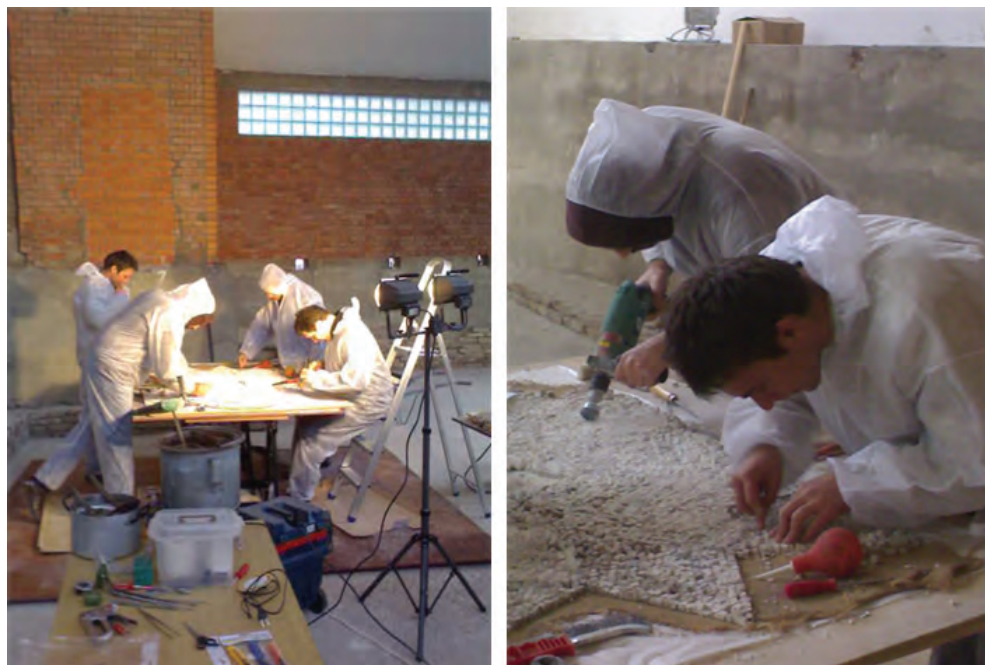
Fig. 23. Conservation and restoration work on mosaic fragments (photo: N. Smičiklas, Institute for the Protection of Cultural Monuments of Sremska Mitrovica)

Some of the mosaics, mainly the large fragments, are lifted using conventional *colletta*, while the smaller ones are lifted using Movilith. Using such methods is dictated by the weather conditions that have adversely affected the traditional drying of *colletta*. After lifting, the back of the fragments is cleaned of sediment contaminants, with care being taken to preserve, where possible, the stability of the original, ancient mortar (Fig. 23). After cleaning, a layer of mortar made using quartz sand and hydraulic lime is applied. A second layer is made of lime mortar reinforced with glass fibre and plastic mesh. A glass fabric

is glued with epoxy resin to the back side of the fragment. Thus prepared, the fragments are placed on custom-made trays of a reinforced aluminium honeycomb grid. The panel surface which is in contact with the mosaic, as a finishing layer, is coated with a special film that increases the quality of the connection between the panel and the mosaic fragment. Bonding was made with the use of an epoxy resin with the addition of fillers. We thank the team of the COMPOSITE TECHNOLOGY TEAM DOO and the BG Model Shop, which developed and improved panels for our purposes. Their experts helped in testing different types of epoxy resins and fillers in order to choose the best combination for our needs. Along with that, adhesives based on polyurethane were tested as

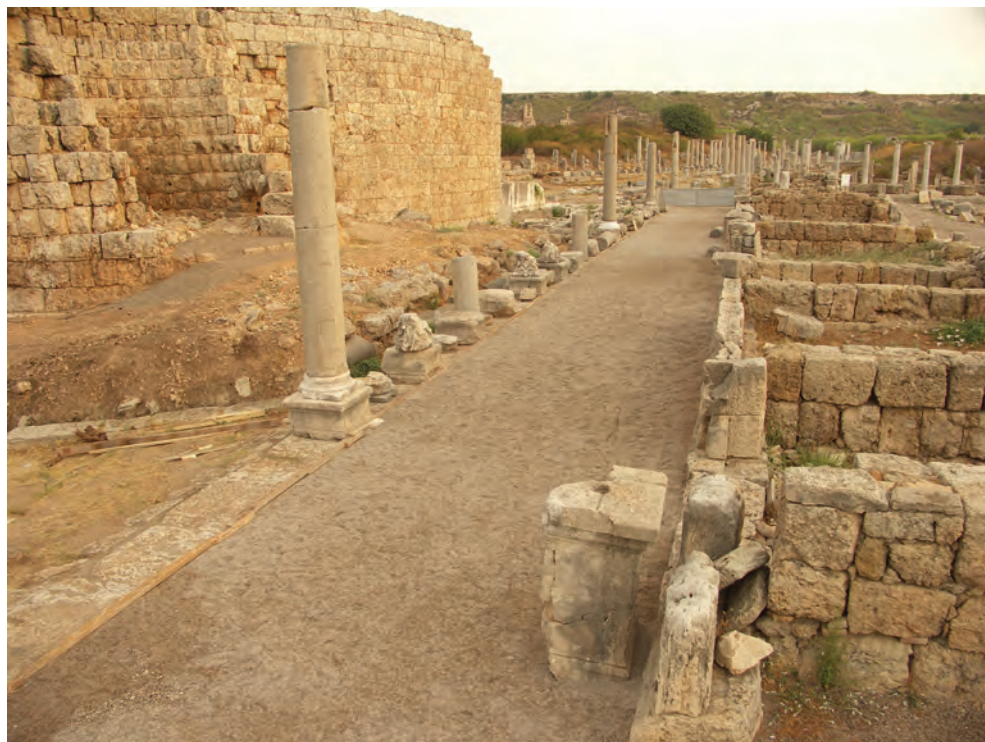
Fig. 2. Reburied mosaics in Perge (photo: I. Işıklıkaya, from the Perge Archives, İstanbul University. Courtesy of Prof. Dr H. Abbasoğlu)

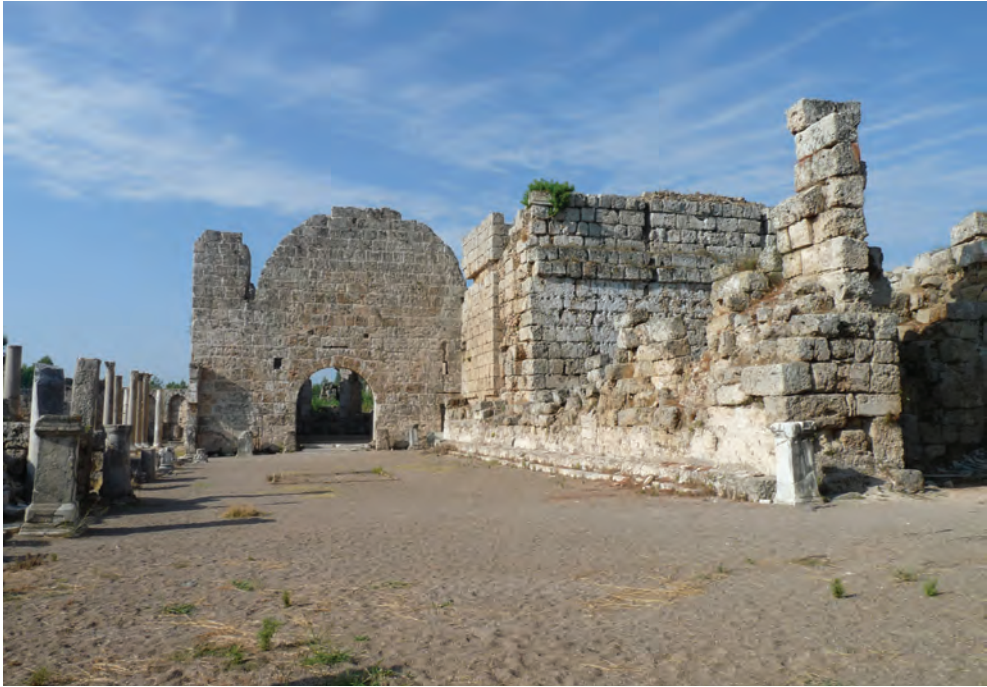
Fig. 4. Plant intrusion on the reburied mosaic in the South Baths (photo: I. Işıklıkaya, from the Perge Archives, İstanbul University. Courtesy of Prof. Dr H. Abbasoğlu)

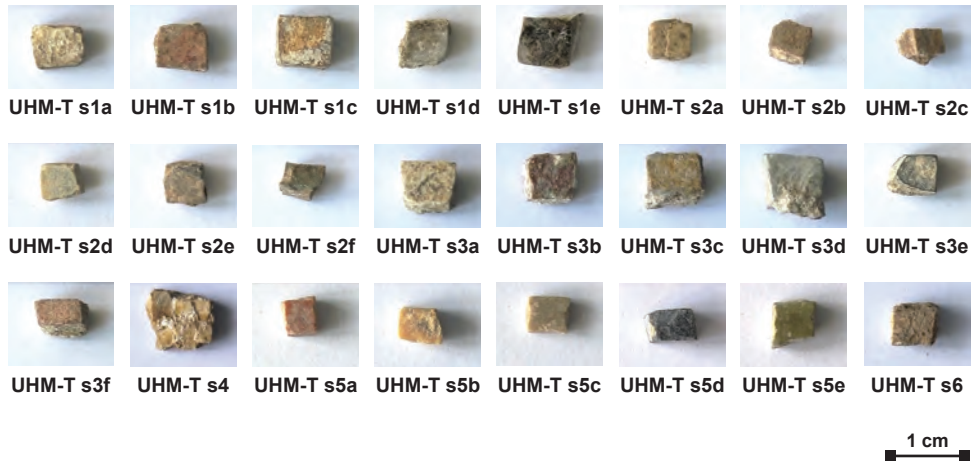
Fig. 4. Tessera samples from the mosaics of the Amazons Villa in Haleplibahçe (Photos: Gazi University, Faculty of Fine Arts, Department of Conservation and Restoration of Cultural Properties, Historical Material Research & Conservation Lab Archive – Ali Akin Akyol)

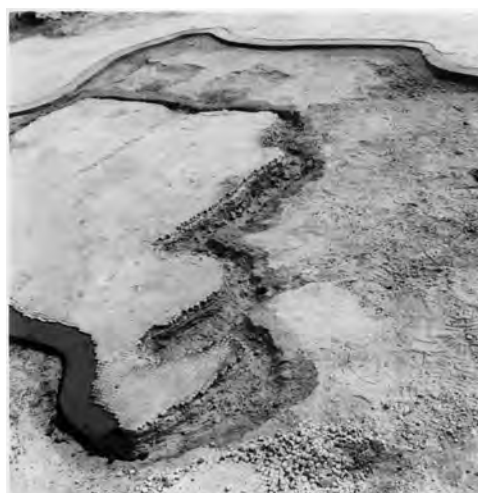
Fig. 2. The interventions carried out in the past (20th century) (Photo: Pasquino Pallecchi)

mosaics in order to fix the tesserae in their original position (Fig. 2). After more than 20 years since the second intervention, the state of conservation of the mortars (original and restoration) seems good in some cases, while in others it is rather precarious. The reasons are the capillary rise of more or less salty water, the bulging of the substrate made of sandy clay, and the biological growth (Fig. 3a, 3b, 3c). The main goal of this work was the formulation of

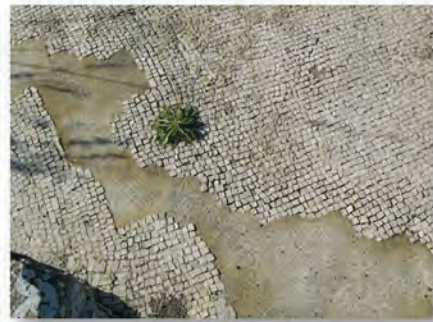
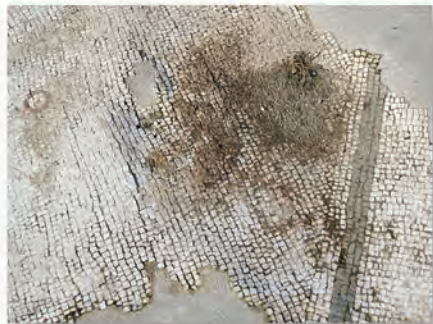
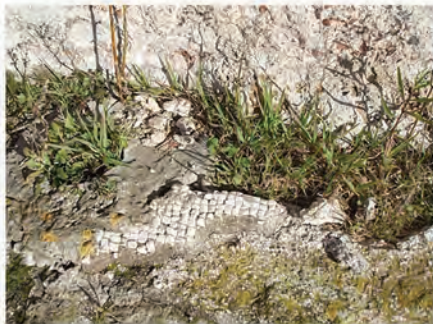
Fig. 3a, b, c. The different decay phenomena observed in the mosaic of the archaeological site (Photos: Mara Camaiti)

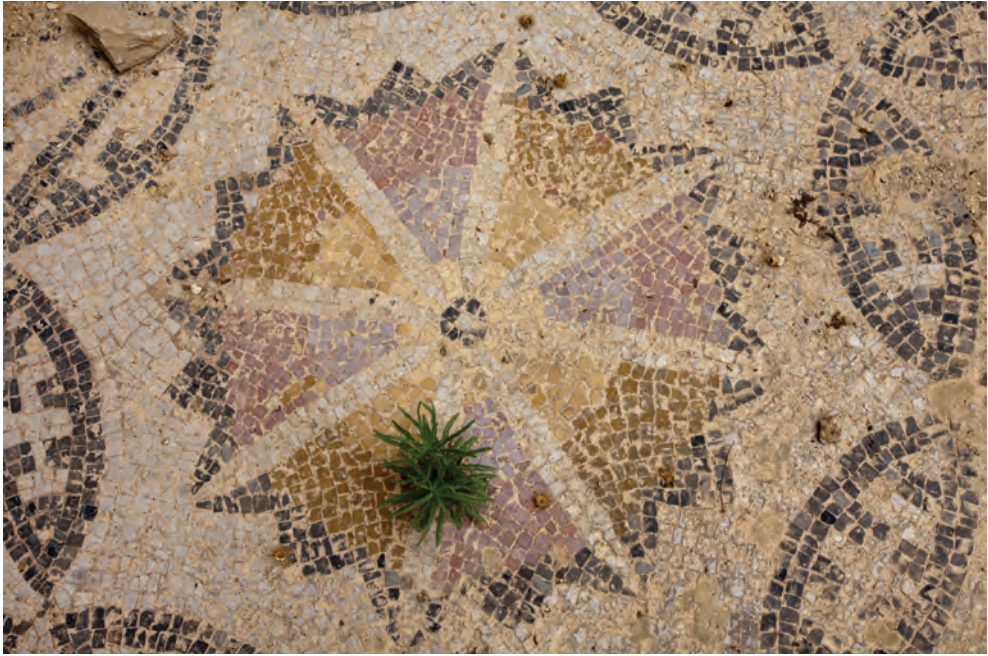
Fig. 2. Végétation qui pousse autour des mosaïques, Augusteum, Bulla Regia (cliché : GCI)

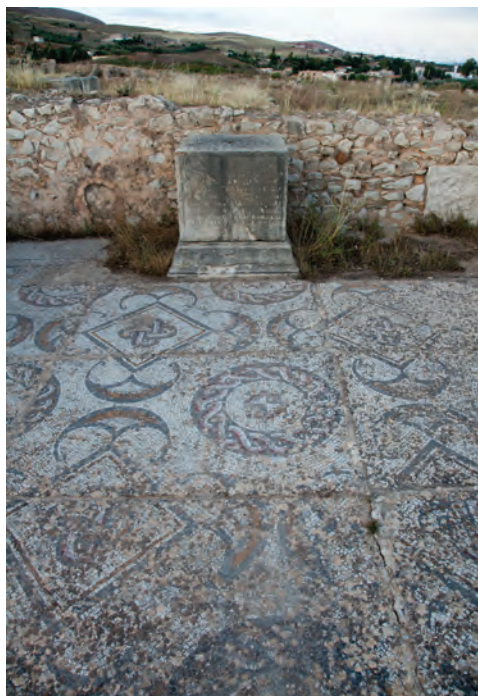
Fig. 3. Gorgées d'eau en hiver, les mosaïques sont de plus en plus sensibles au développement de lichens au printemps, Maison de la Nouvelle Chasse (cliché : GCI)

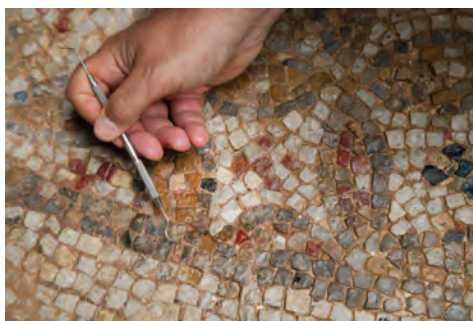
Fig. 4. Intervention sur un pavement conservé *in situ*, Bulla Regia (cliché GCI)

Les interventions sur les pavements conservés *in situ* sont multiples : nettoyage du pavement qui consiste à retirer les poussières, concrétions et micro-organismes en vue de rendre au pavement sa lisibilité (Fig. 4), protection des bords, consolidation des matériaux et supports avec le renforcement de l'adhérence des tesselles aux couches préparatoires par injection de mortier liquide, bouchage des lacunes etc. Toutes les opérations de stabilisation nécessitent obligatoirement l'usage des mortiers à base de chaux. Plusieurs œuvres ont ainsi pu faire l'objet d'un traitement complet dans les maisons de la Chasse, la Maison des Poissons et les basiliques chrétiennes. Pour des raisons financières autant que déontologiques, les restaurations doivent être légères, les plus discrètes possibles. Mais il nous arrive parfois aussi d'opter pour le réenfouissement certains panneaux de mosaïques mis au jour depuis des décennies sont au

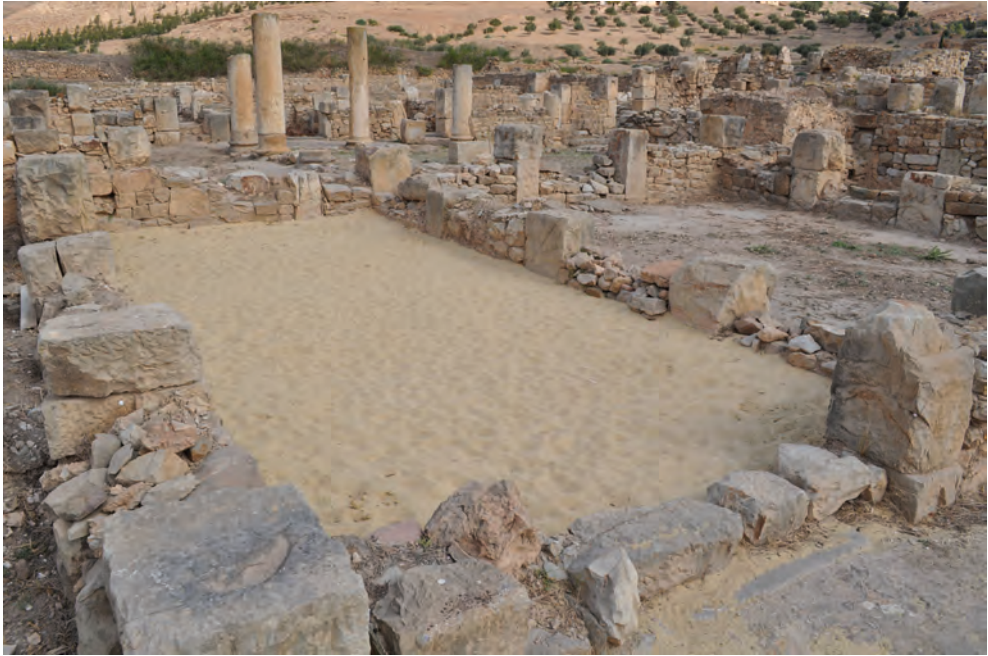
Fig. 5. Réenfouissement dans la Maison no. 9), Bulla Regia (cliché : Moheddine Chaouali)

aujourd'hui de plus en plus fragiles. Leur état de dégradation s'accroît sensiblement. Le choix est alors porté sur des actions de réenfouissement (opération menée récemment, par exemple, dans la Maison no. 9) (Fig. 5). Faute de moyens financiers et humains, l'équipe est obligée de recourir à une telle solution qui assure une protection temporaire.

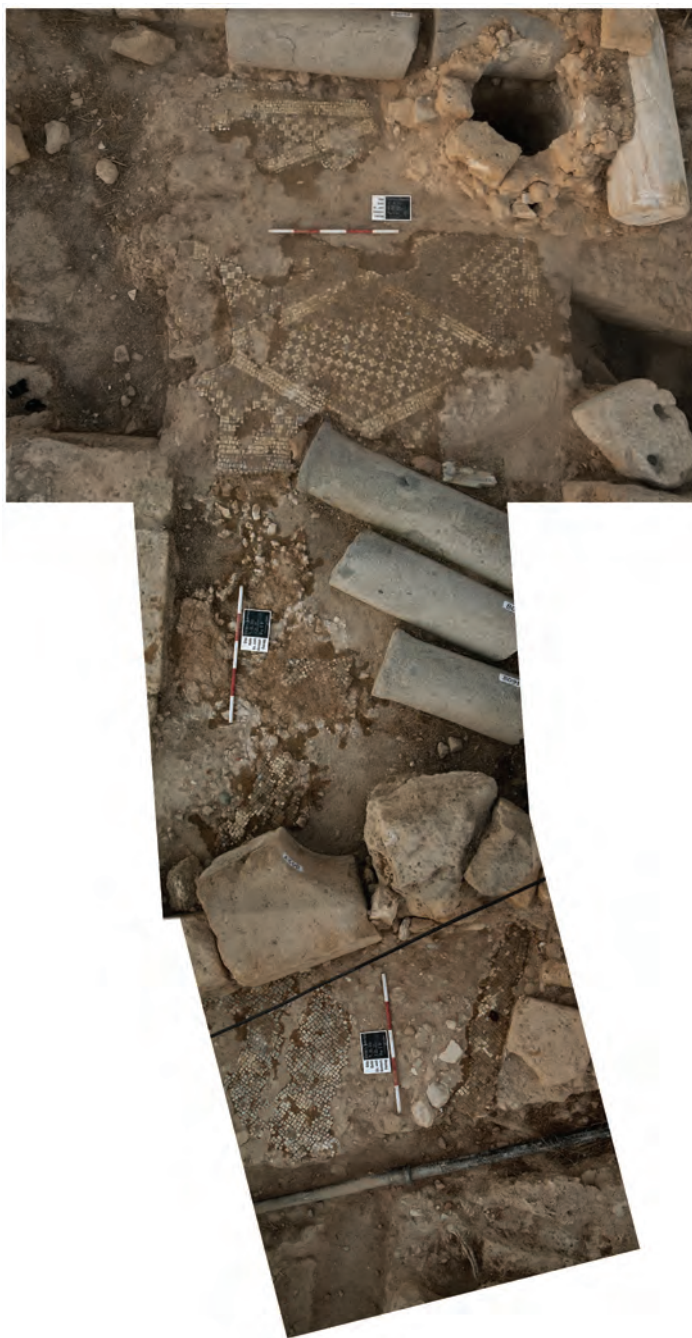
Fig. 2. The fragmentary mosaic on the floor of the eastern *parodos* and its southern entry. The damage caused by later activities is clearly demonstrated (photo: Bob Miller, 10 November 2010)

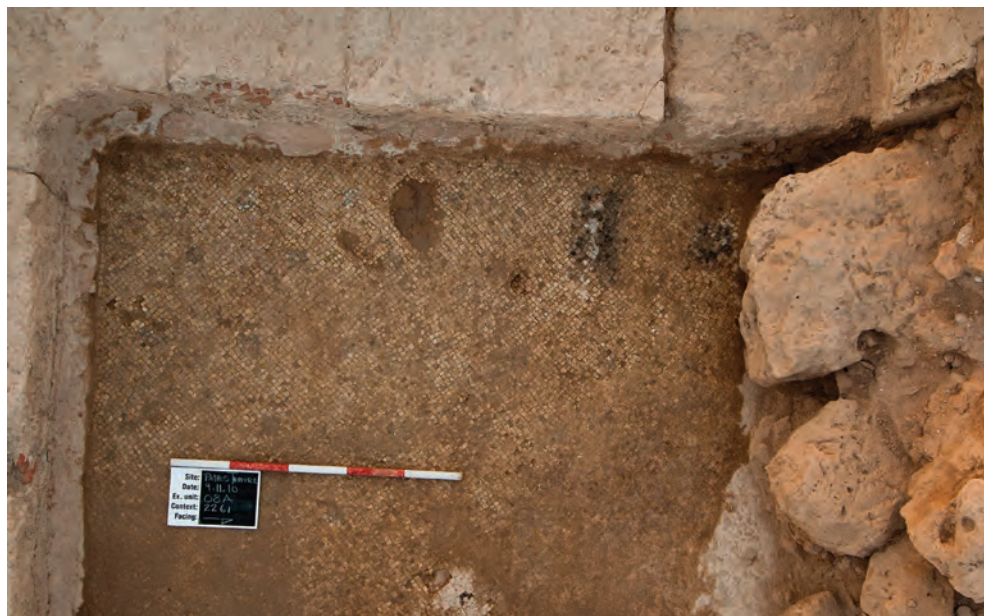
Fig. 3. South-west corner of the poorly preserved nymphaeum floor mosaic. Edges are chamfered and there are patches of burning (photo: Bob Miller, 10 November 2010)

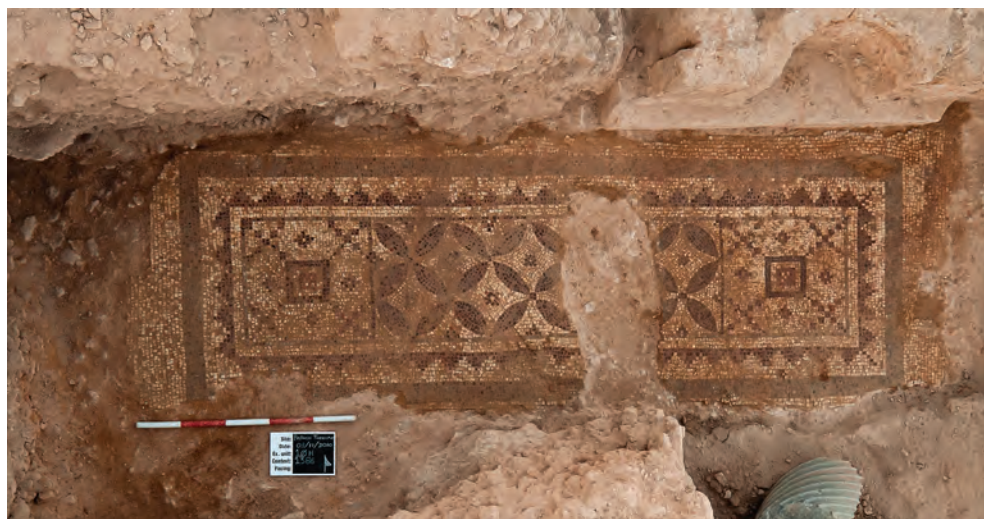
Fig. 4. The room to the south-west of the western *parodos* patterned with intersecting circles and octagons. The damage was caused by smashing columns for the lime kilns after the theatre had been abandoned and was used as a quarry (photo: Bob Miller, 10 November 2010)

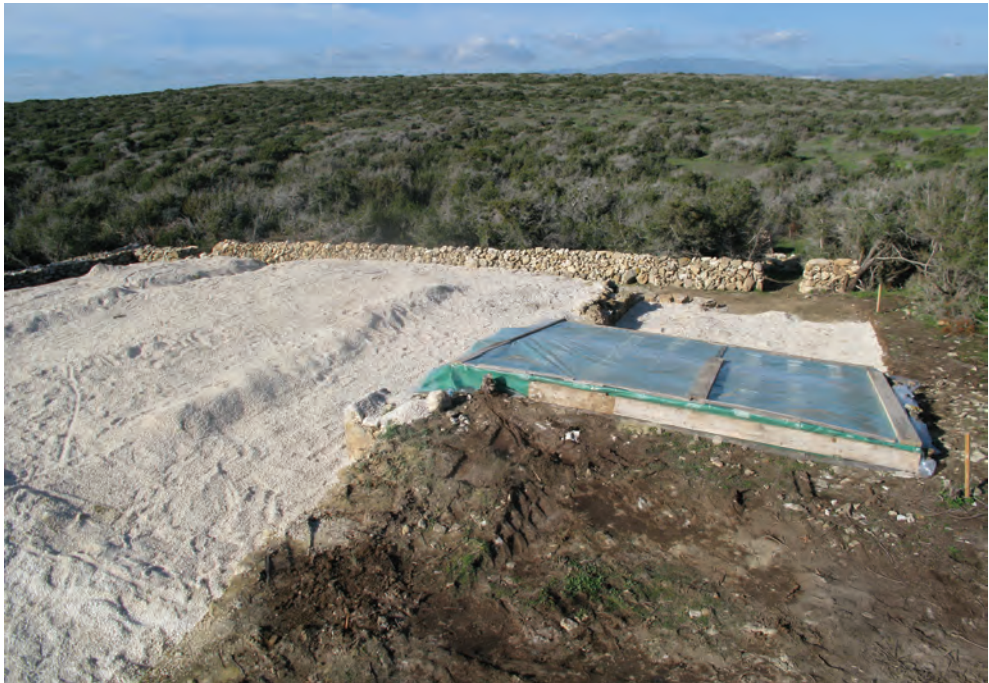
Fig. 4. Akrotiri, locality *Plakota*. Limassol District. The third covering layer for long-term reburial (photo: E. Charalambous for the Department of Antiquities)

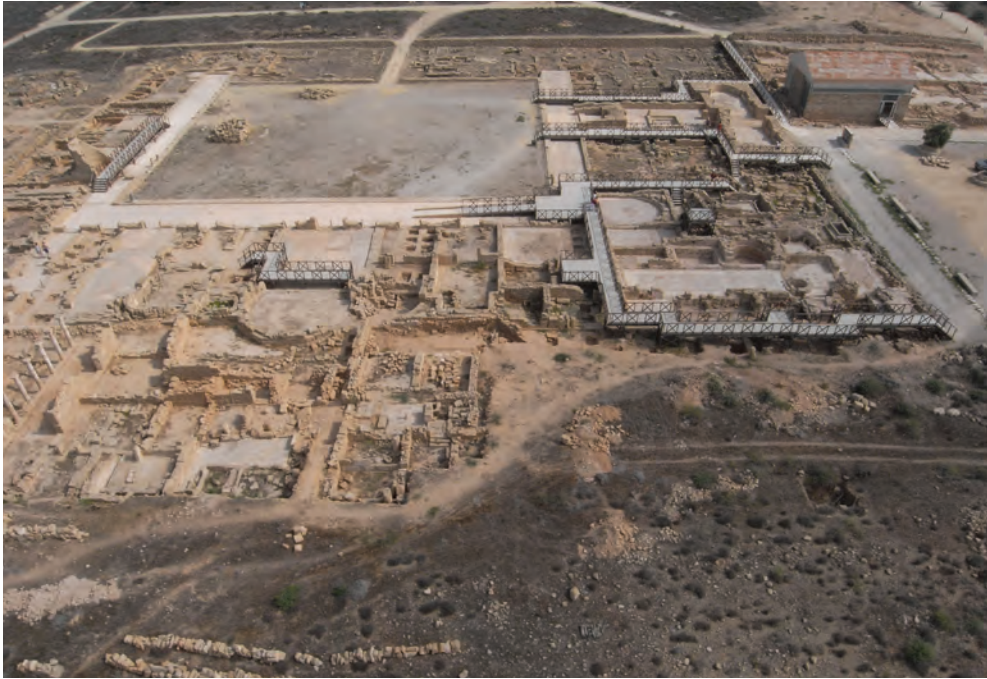
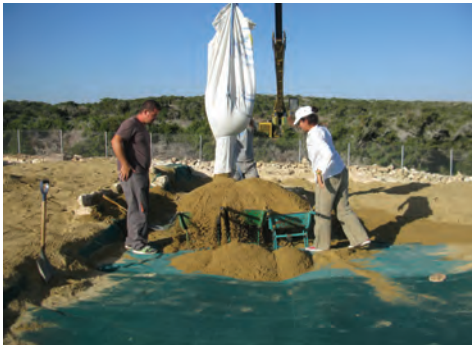
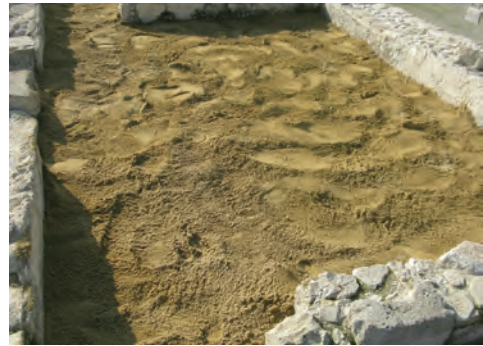
Fig. 5-7. Nea Paphos, aerial photograph of the House of Theseus and adjacent structures. Reburial of mosaics during winter (photos: A. Charalambous for the Department of Antiquities)

The above-mentioned reburial method has a lifetime of about four to seven years. During this period, it is recommended to uncover the mosaics periodically, in order to avoid the formation of salt incrustations. The reburied monument should also be periodically controlled by the conservation team, in order to arrest vegetation growth. The Cypriot Department of Antiquities applies this reburial method for three different cases. The first is that of newly excavated floor mosaics (Fig. 1), where both periodical and long-term methods are applied, accompanied by drainage and other auxiliary structures. The second case concerns floor mosaics situated in areas not accessible to visitors; and here, long-term reburial is applied (Fig. 4). Lastly, the third case concerns mosaics that are unprotected by shelters or other structures, even though they are accessible to the public. In this case, a periodical reburial is applied for the winter season only (Fig. 5-7).

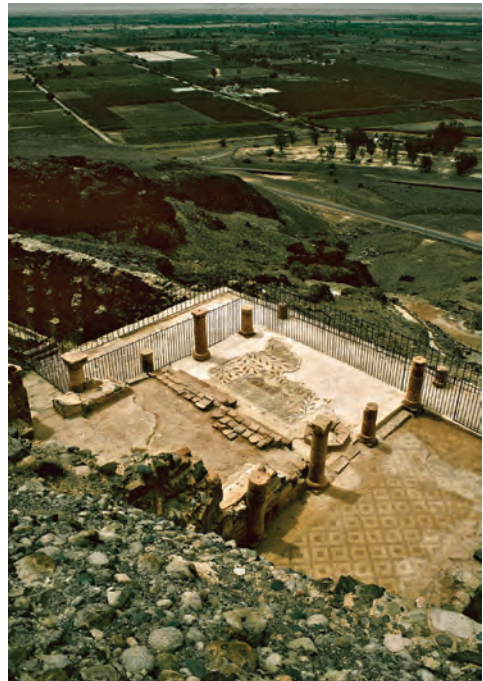
Fig. 1. View from above the Church of Aghios Lot showing conserved mosaics and security fence (photo: K.D. Politis)

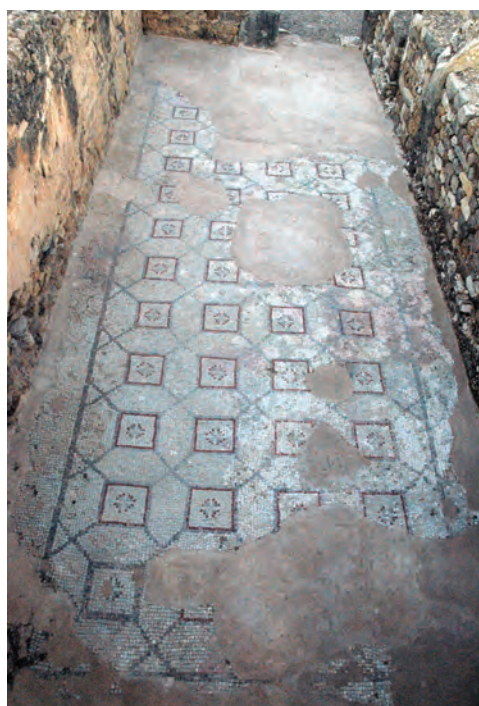
Fig. 3. A mosaic after recent maintenance treatments by INP technicians based at the site (photo: Ermanno Carbonara © 2011 The J. Paul Getty Trust)

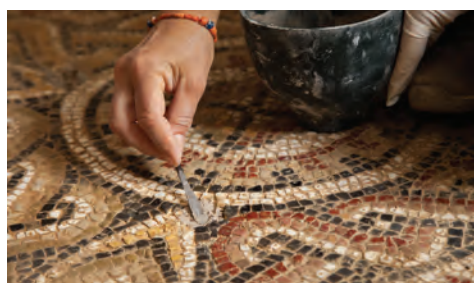
Fig. 4. Infilling of a lacuna using lime mortar, a common maintenance operation (photo: Scott S. Warren © 2011 The J. Paul Getty Trust)

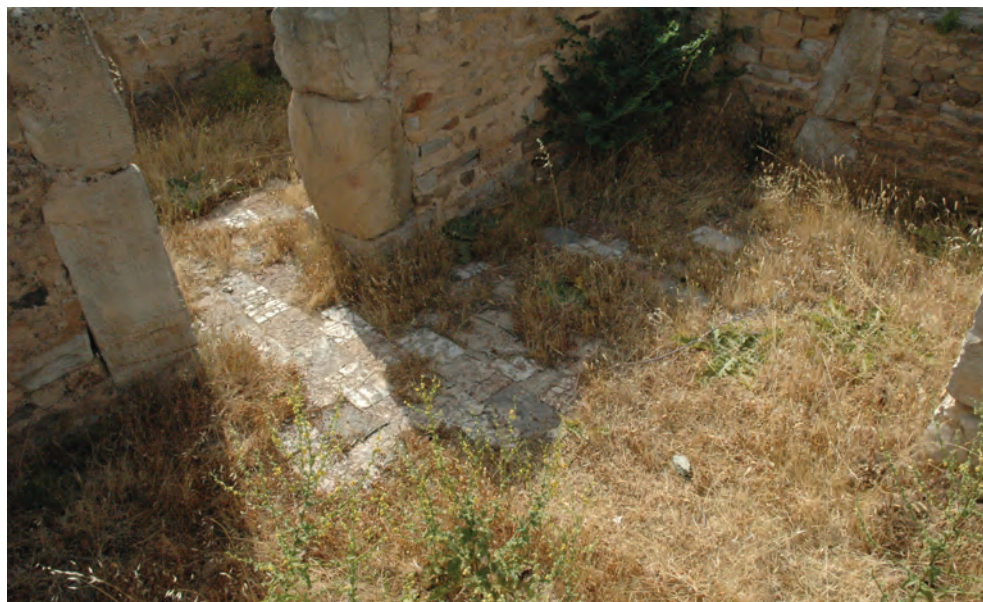
Fig. 5. One of many neglected mosaics in very poor condition throughout the site of Bulla Regia (photo: E. Carbonara © 2012 The J. Paul Getty Trust)

Another major aim of the Bulla Regia project is to develop a conservation plan for the almost 400 excavated mosaics at the site. Many of these, after decades of being left exposed and walked on, are in very poor condition, and some are already beyond repair (Fig. 5). Given the resources of the site, both human and financial, the survival of hundreds of mosaics at Bulla Regia depends on developing and carrying out a prioritized plan of action to stabilize and protect through reburial many mosaics at the site, while conserving and presenting to the public only a selected number. The condition, significance and exposure data collected for each mosaic through the survey will provide the basis for decision-making about how best to preserve all the mosaics of the site, through a combination of reburial, protective sheltering and maintenance programs (Fig. 6). The resulting conservation plan will provide a much-needed management tool for Bulla Regia, and potentially a planning example for other sites in Tunisia and in the Mediterranean region with significant collections of in situ mosaics.

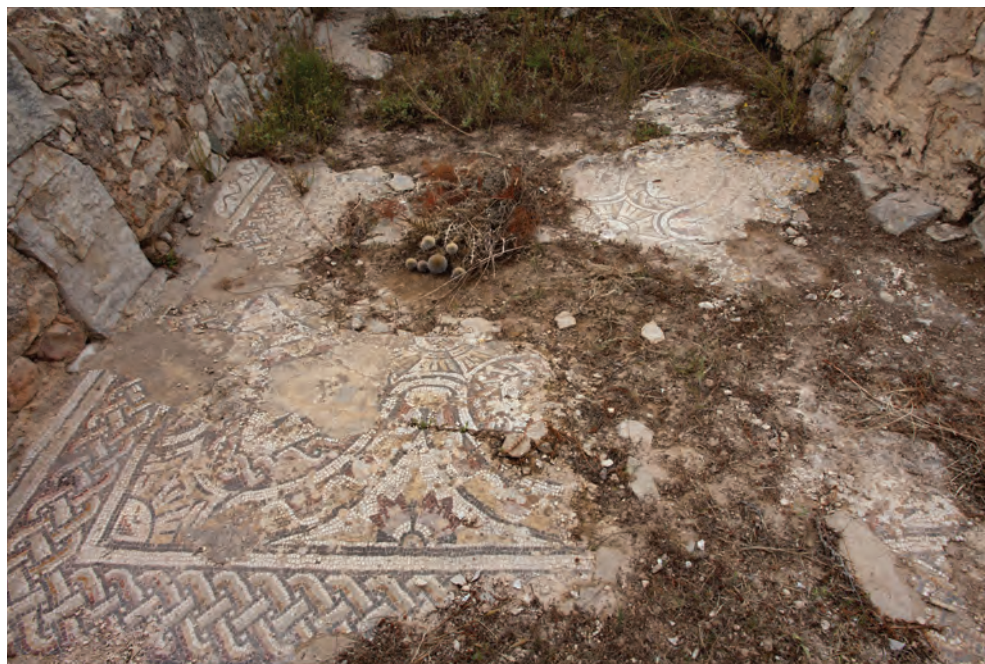
Fig. 1. Near loss of mosaic at the site of Bulla Regia, Tunisia (photo: The J. Paul Getty Trust)

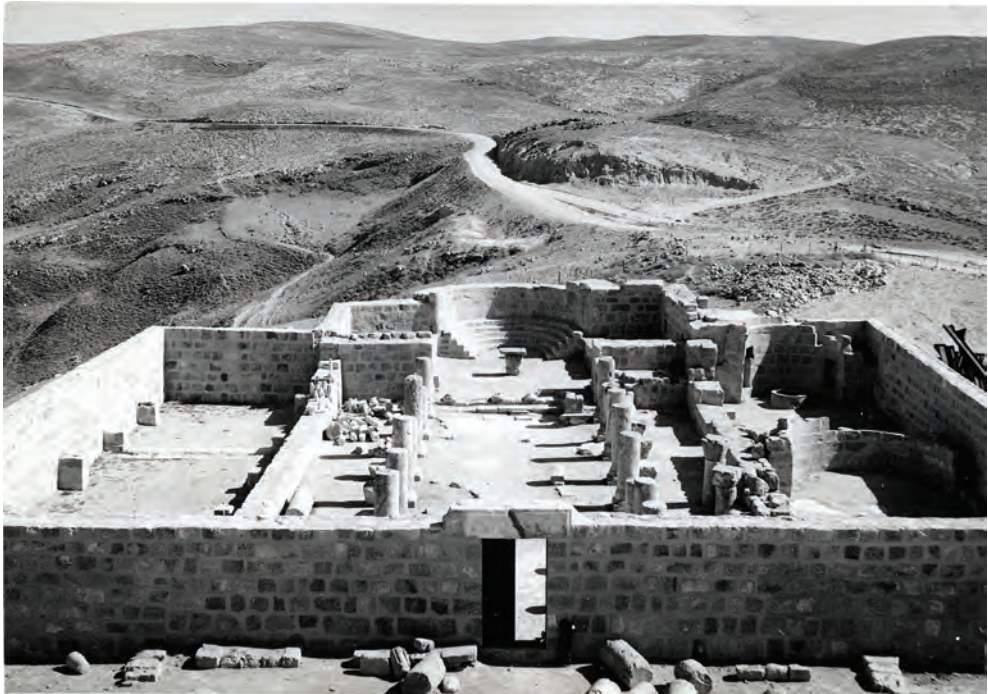
Fig. 3. The perimeter walls of the Memorial repaired to be reused for the shelter, 1964 (© SBF, Jerusalem)

In 1963, after the decision of Custody of the Holy Land to restore the original pavements of the Basilica in order to exhibit them. Virgilio Corbo was appointed as the person in charge of the project. A metal shelter designed in Oxford, was put in place by personnel of the workshop of St Saviour in Jerusalem under the direction of Nazareno Moretti (Piccirillo 2004, 15; Cf. Corbo 1967; 1970) (Fig. 3 and 4). The 1967 Arab-Israeli war prevented the completion of the work.

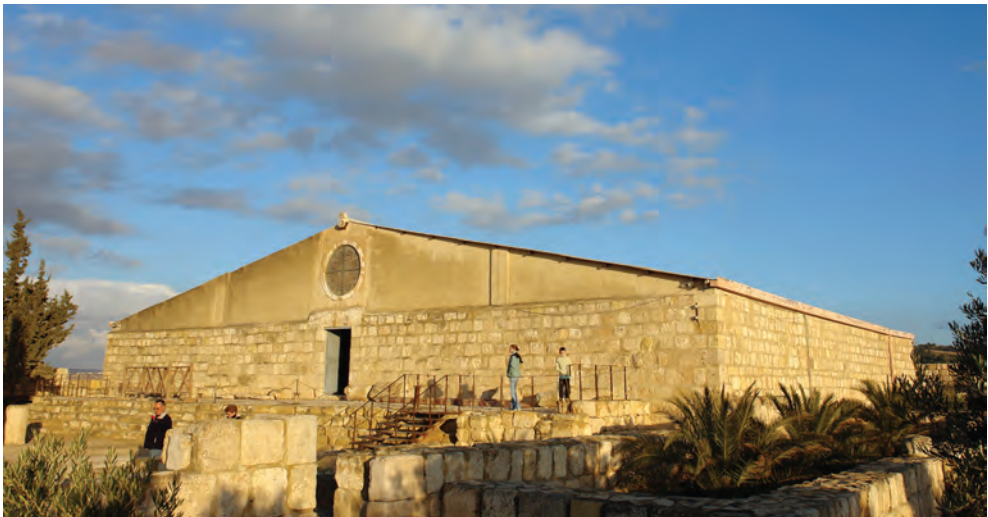
Fig. 4. The Memorial and its shelter as they were until December 2007 when work for the new shelter began (© C. Pappalardo)

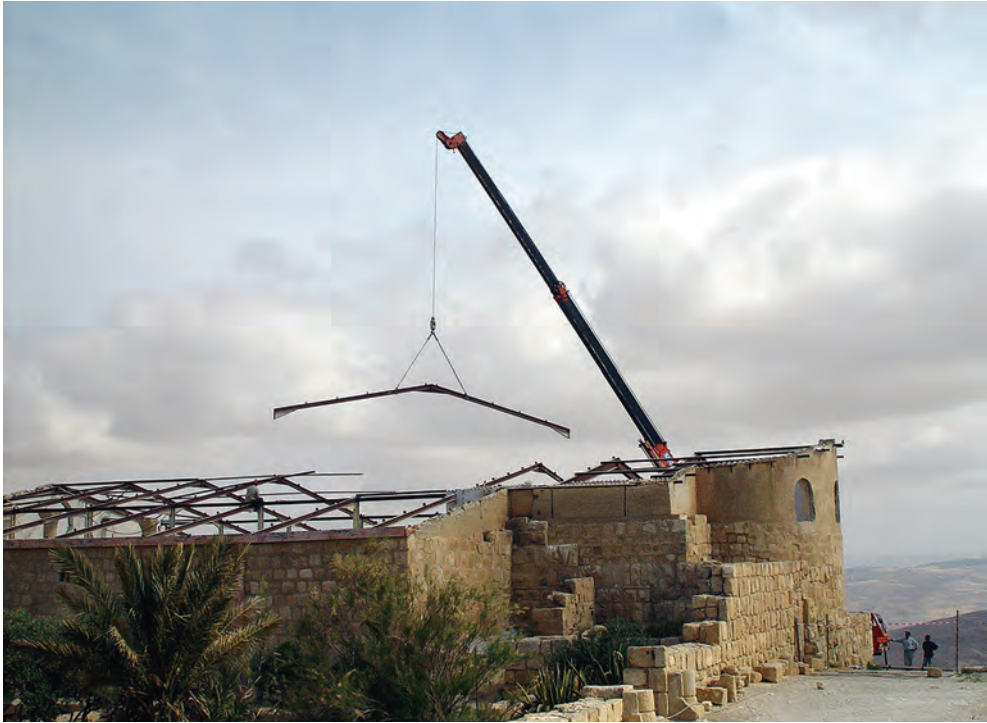
Fig. 5. The dismantling of the iron structure of the old shelter, April 2008 (© C. Pappalardo)

Meanwhile, the demolition of the old shelter (Fig. 5), along with all the walls

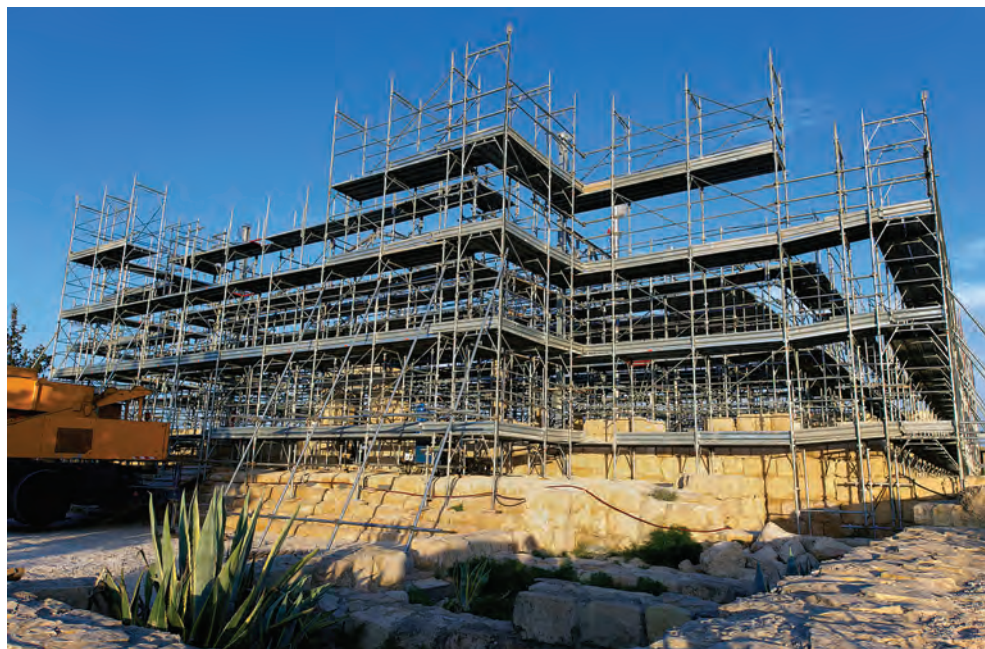
Fig. 6. The scaffolding on the Memorial's perimeter for the building of the new shelter, March 2010 (© C. Pappalardo)

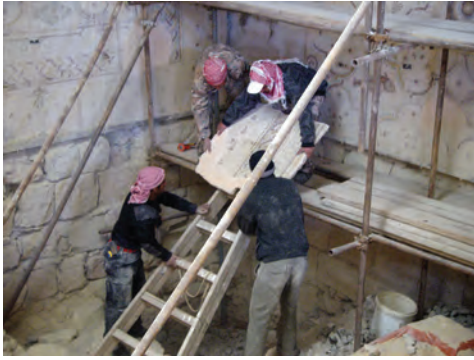
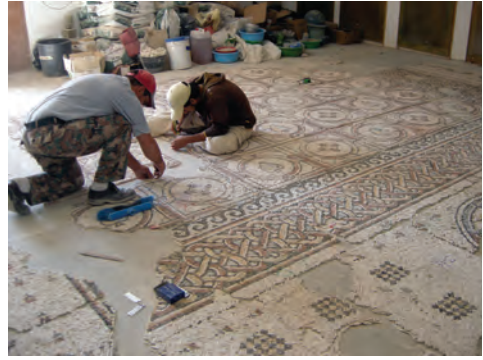
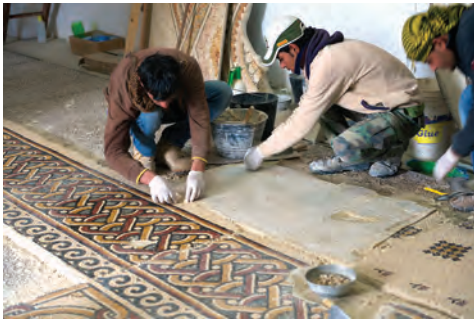
Fig. 7. The removal of the mosaics for their restoration, February 2008 (© C. Pappalardo)

Fig. 8. The mosaics being restored, October 2009 (© C. Pappalardo)

Fig. 9. The mosaics being restored, March 2010 (© C. Pappalardo)

Meanwhile the restoration of the mosaic floors of the Sanctuary is in progress (Fig. 7-9). After removing them from the walls and the pavements – except for the superb mosaic of the Diaconicon-Baptistry which was found intact – the mosaics were detached from their old cement supports, cleaned and consolidated, in order to proceed, in the near future, with placing them back on the pavements on a mortar bedding or setting them on light panels which will be reassembled on ad-hoc structures and fixed on the walls of the restored building.

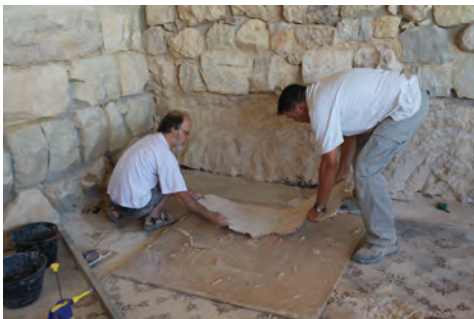
Fig. 10. The restorers A. Vaccalluzzo and F. Sciorilli while they are repositioning the restored mosaic in its original location in the sacristy, July 2009 (© C. Pappalardo)

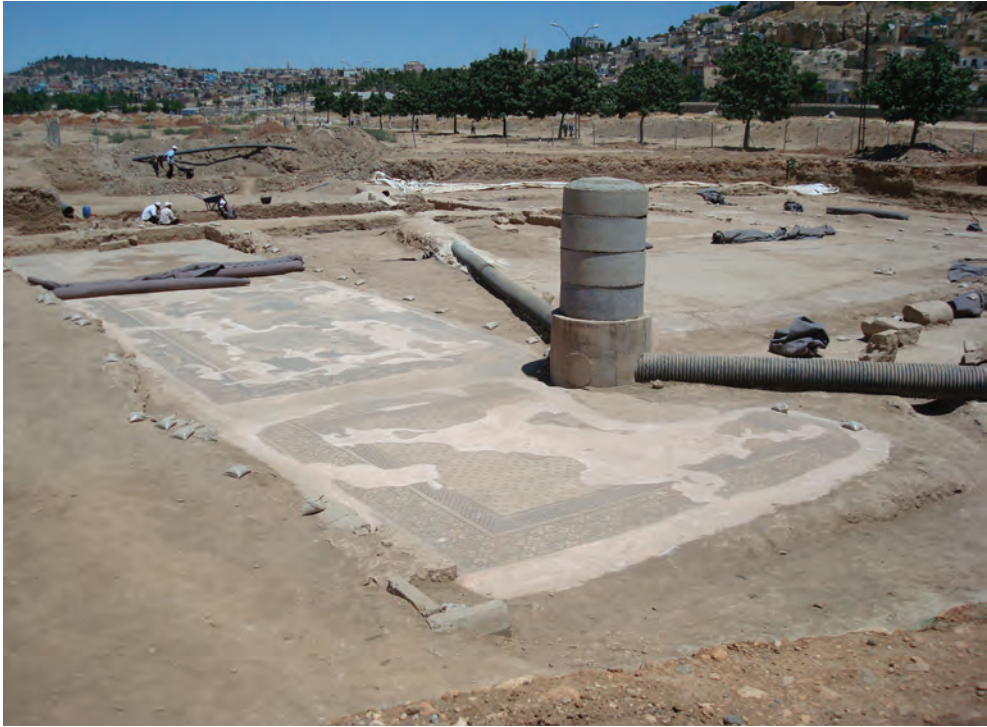
Fig. 2. State of repair before the rebuilding the walls of the Amazons Villa (photo: Y. Selçuk Şener, 2008)

parts of the walls that were under the level of the mosaic were raised so as to surround the mosaic flooring with at most one course of stones; parts of the missing walls were reconstructed taking into consideration measurements close to this level. Stones of a size close to those of the original walls were used for the restoration. In order to easily distinguish the newly built walls from the original ones, grout of different colour and texture was used. Thanks to the wall restoration, we both delimited the boundaries of the spaces necessary for the preservation of mosaics, and were able to better perceive the building, at least in terms of its layout (Fig. 2 and 3).

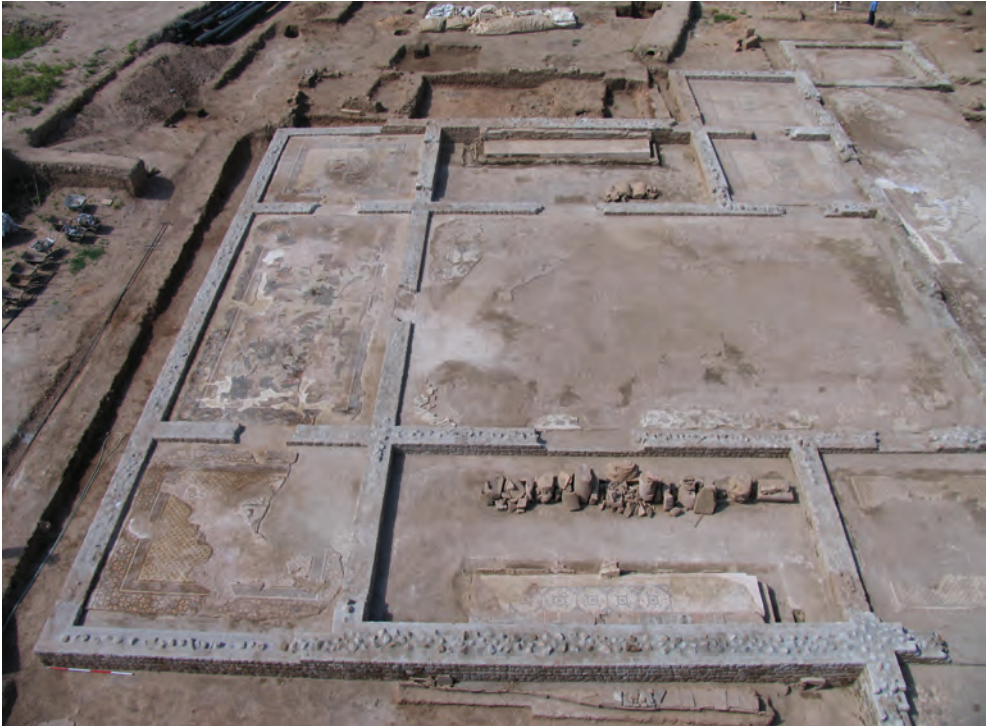
Fig. 3. Restoration and resetting of walls (photo: Y. Selçuk Şener, 2009)

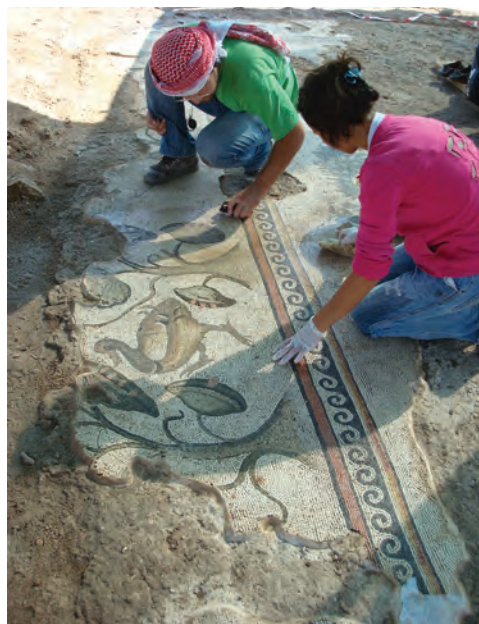
Fig. 4. The cleaning of mosaic surfaces (photo: Y. Selçuk Şener, 2008)

The layer of soil from the mosaic surfaces was first carefully removed with trowels, spatulas and brushes. To clean away remnants of mud adhering to the surface a “washing procedure” was carried out, which involved wet scrubbing and wiping the surface with a sponge (Fig. 4).

For cleaning away the hard and adhering deposits on the mosaic surfaces, mechanical methods were used. The dense layers of limestone were thinned down, first with diamond-pointed thin steel chisels; and the cleaning was completed using a scalpel, which gave us more control, and also by washing with brushes of medium firmness (Fig. 4). Surface cleaning was carried out more delicately on areas where bulging, depression and lacunae had formed. To expose the boundary between mosaic and lacunae we used a portable steam cleaner which provided low pressure hot water steam. The steam cleaner softened the soil that had filled the lacunae, thus facilitating its removal.

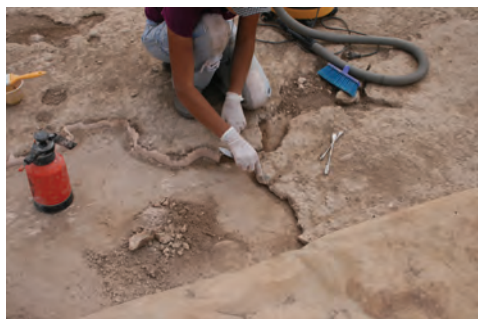
Fig. 5. The repair of the edges of the mosaics (photo: Y. Selçuk Şener, 2008)

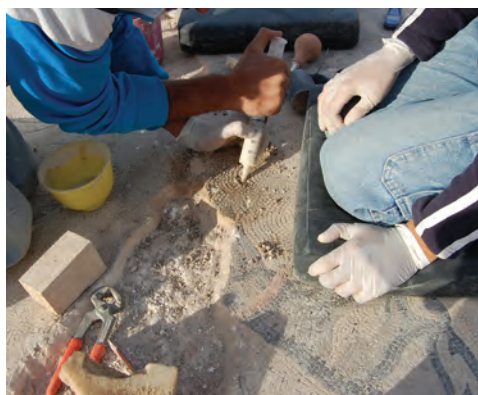
Fig. 6. Consolidation of the mosaics (photo: Y. Selçuk Şener)

This involved the different procedures carried out with the aim of repairing and/or improving the poor condition of the layers constituting the mosaics.
