MANAGING ARCHAEOLOGICAL SITES WITH MOSAICS: FROM REAL PROBLEMS TO PRACTICAL SOLUTIONS

THE 11TH CONFERENCE OF THE INTERNATIONAL COMMITTEE
FOR THE CONSERVATION OF MOSAICS, MEKNES, OCTOBER 24-27 2011

edited by
Demetrios Michaelides and Anne-Marie Guimier-Sorbets

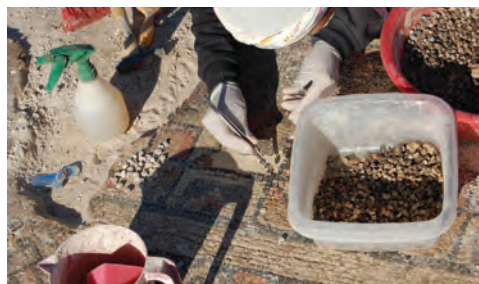
Fig. 7. Reintegration of the *tessellatum* with tesserae (photo: Y. Selçuk Şener, 2008)

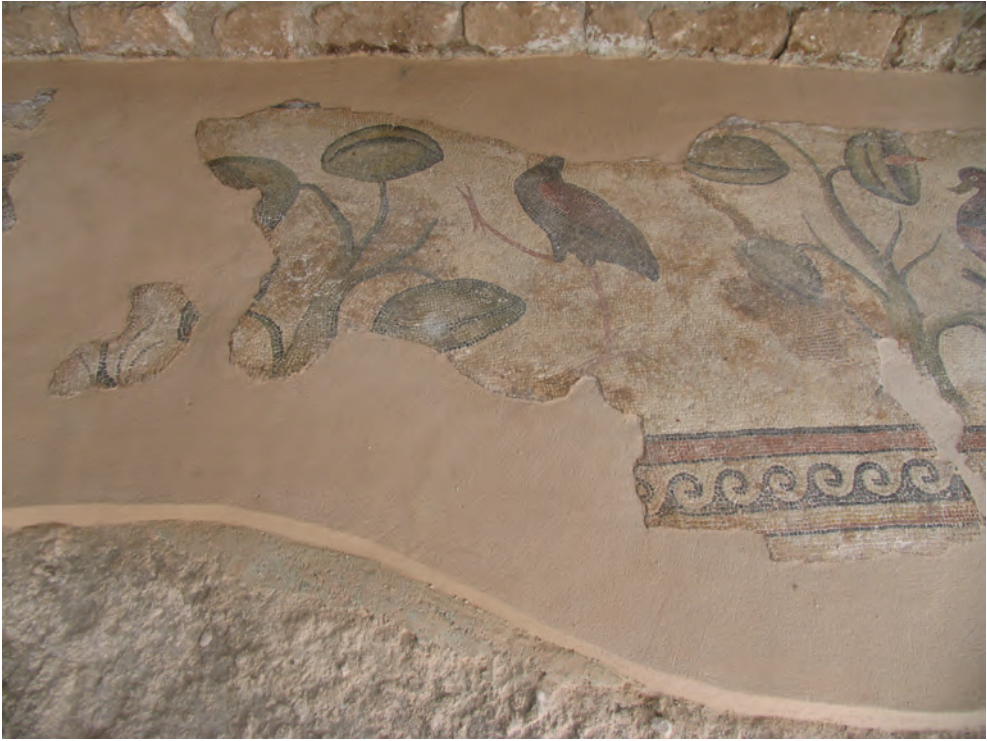
Fig. 8. Reintegration of the *tessellatum* with aesthetic mortar (photo: Y. Selçuk Şener, 2009)

Deep areas were first filled with pebbles in such a way as to remain 5-6 cm below surface level. Then a lime mortar prepared with coarse sand and lime (grey mortar) was spread and levelled after filling the areas so that, in general, it remained 2-3 cm below the surface (Fig. 8). The aesthetic mortars

to be used on the uppermost reintegration layer were selected from among a great number of trials prepared so as to match all the mosaics and in compliance with the colour texture of the *tessellatum* layer. The mortars were prepared with a mixture of finely sifted sand, stone powder, brick powder, and hydraulic lime; and pigments were used to colour the mortars. Care was taken to leave the aesthetic mortar fills about one millimetre below the *tessellatum* layer.

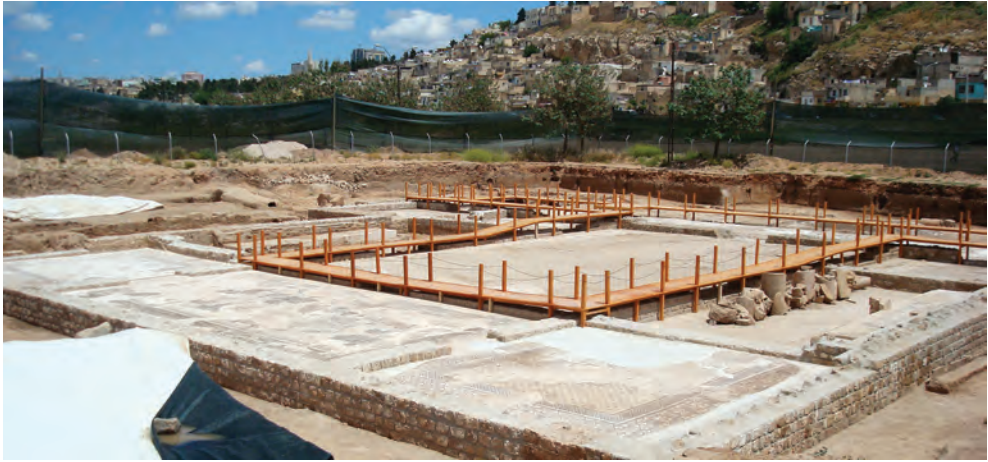
Fig. 9. Haleplibahçe, the walkway and the building of the temporary cover (photo: Y. Selçuk Şener, 2009)

Preventive conservation measures were planned so as to include a walkway to ensure controlled visits of the building and the mosaics; to build a temporary cover to protect them from environmental conditions; and to install a drainage system around the building in order to prevent moisture. The walkway was built at the final stage of active conservation work. Thanks to this walkway, made of wood and set on the walls, the area was opened to visitors (Fig. 9). Thus, thanks to the restoration work performed, we accomplished the first and second phases of the objective to “transform the area into an archaeopark” through in situ conservation,

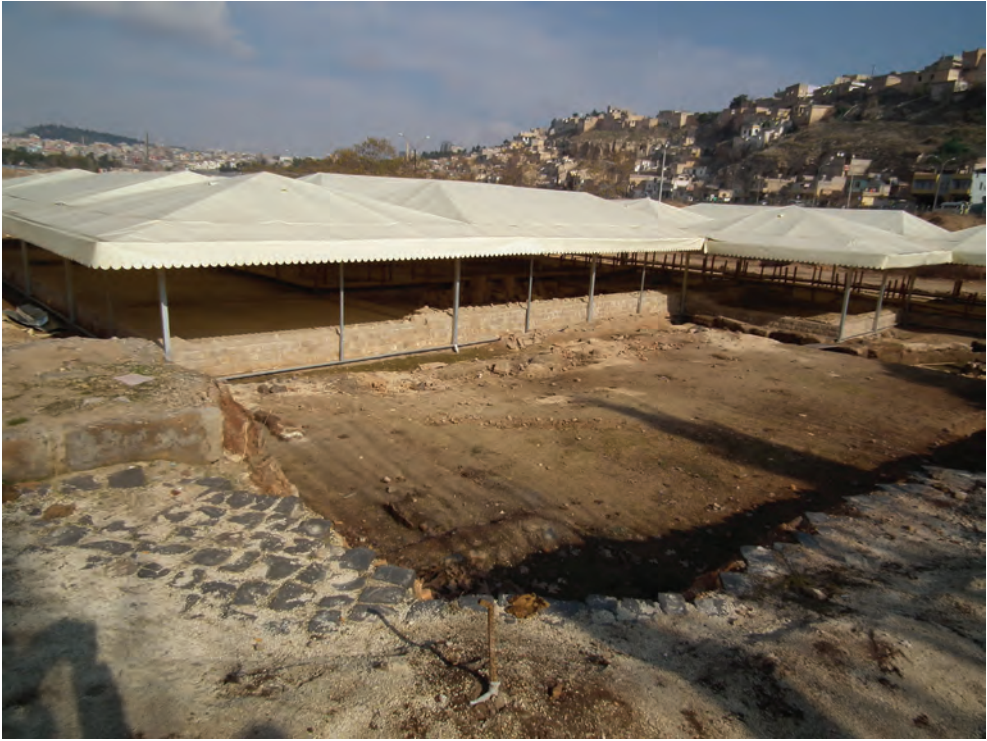
Fig. 10. Haleplibahçe provisory cover, after restoration (photo: Y. Selçuk Şener, 2009)

as was envisaged at the outset. The task of building the temporary cover was carried out by the museum authorities in the autumn following completion of the conservation work. Though its appearance is not so attractive, it can be said that it does fulfill its duty of protecting the site against environmental conditions until the permanent cover is built (Fig.10).

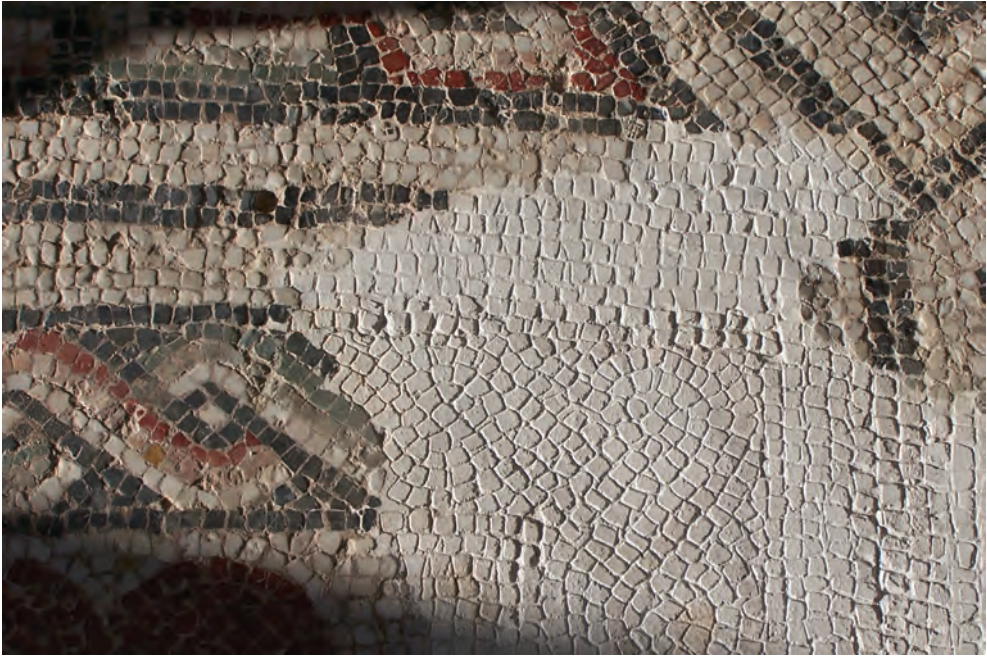
Fig. 3. The staccato technique in progress in the Villa Romana del Casale, Piazza Armerina, Sicily (photo S. Chlouveraki, 2007)

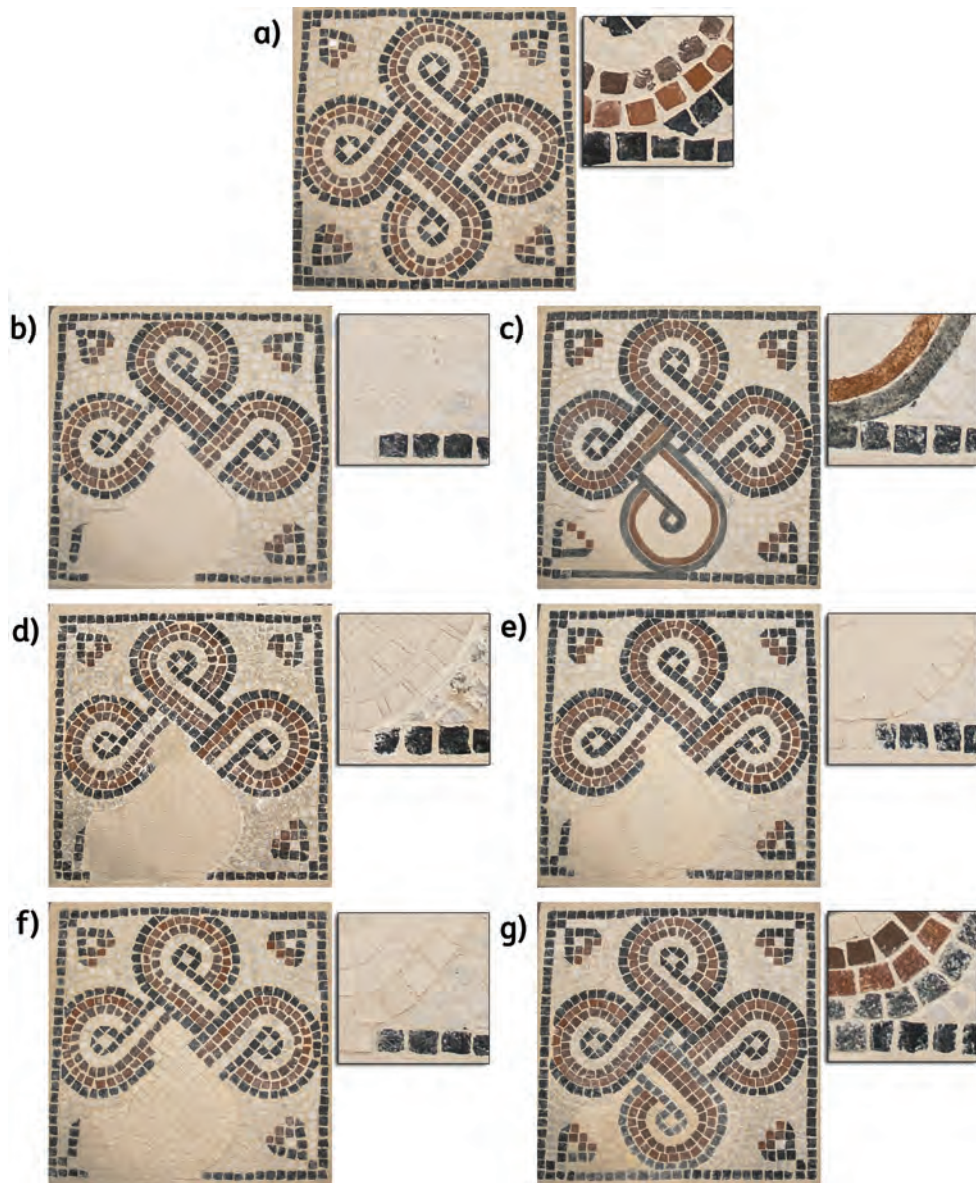
Fig. 4. a) original mosaic, b) mortar: reintegration by applying mortar in the lacuna, at same or lower level than the original surface; c) mortar + colour: reintegration by applying mortar in the lacuna and then painting the missing parts of the design; d) *staccato*: a three-dimensional effect is created by engraving the shape of tesserae in mortar without colour; e) mortar + off-white tesserae: reintegration by applying mortar in the lacuna and then adding off-white stone tesserae on the outline of the design; f) off-white tesserae: reintegration of the entire lacuna with new off-white stone tesserae; g) new tesserae: reintegration with new stone tesserae in colours close to the original ones, usually lighter in tone, Athens, Greece (photo M. Kindt, 2012)

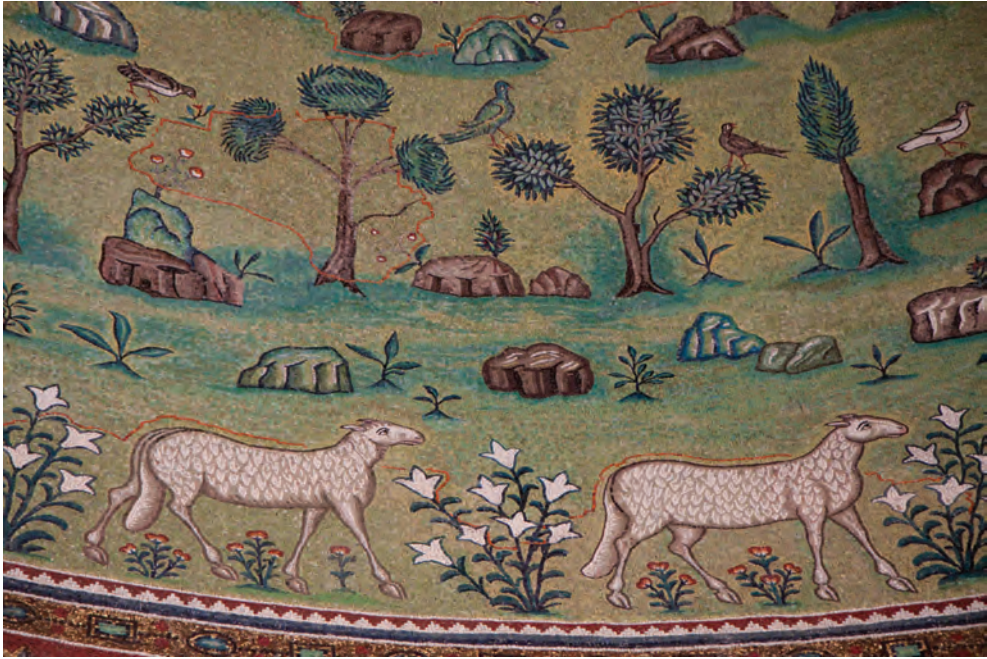
Fig. 5. Reintegration indicated with a single line of tesserae, red line around the lacuna in the Basilica Saint Apollinaire in Classe, Ravenna, Italy (photo M. Kindt, 2012)

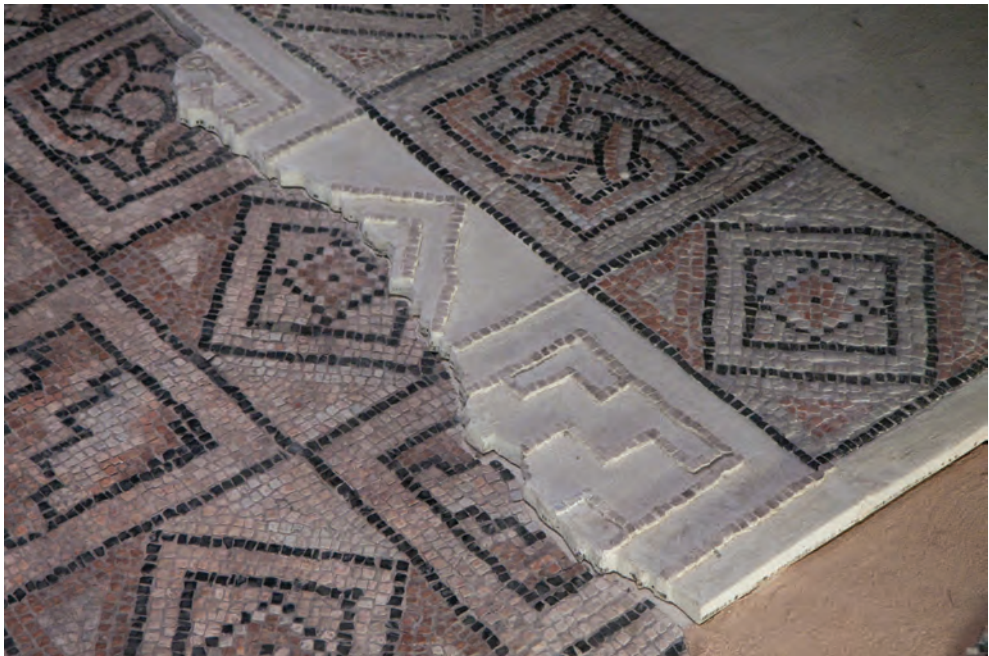
Fig. 6. This reintegration technique in the Domus dei Tappeti di Pietra, Ravenna, Italy, is at a higher level than the mosaic surface. Looking at the mosaic from above it seems as if they are at the same level (photo M. Kindt M., 2012)

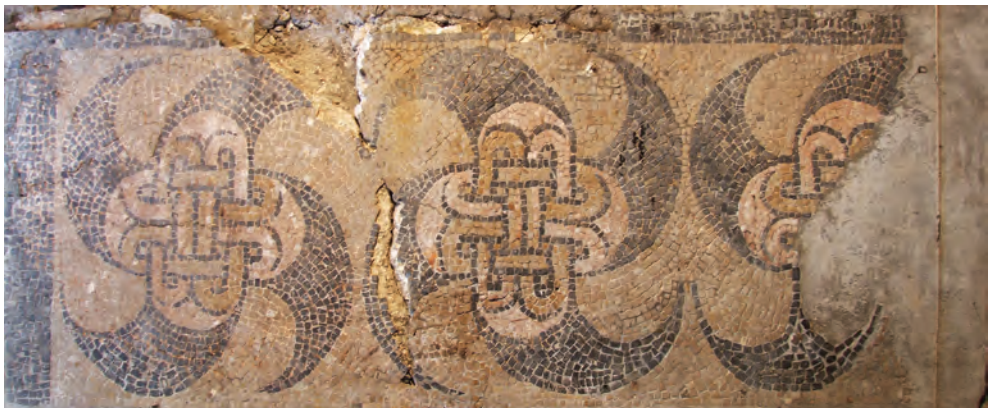
Fig. 3. Condition of the mosaic in 2008 (photo: Brigitta Maria Kürtösi)

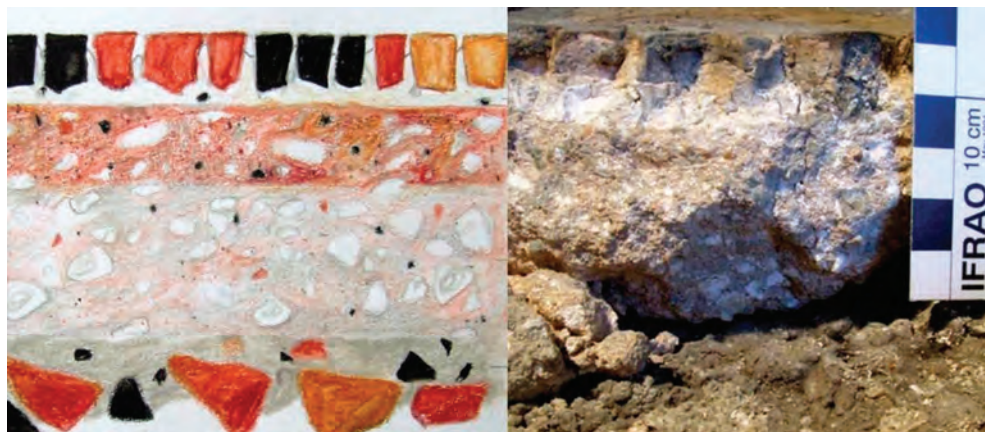
Fig. 6. The stratification of the fragment (Reconstruction drawing and photo: Brigitta Maria Kürtösi)

Nucleus – There are two layers made 'wet in wet'. The 5 cm thick lower one is richer in lime than the upper 1 cm thick part, where the quantity of powdered brick is significant. That is why this stratum has a pinkish hue. The crushed brick was used as filler. The use of a quantity of brick dust in a mortar can be one of the causes

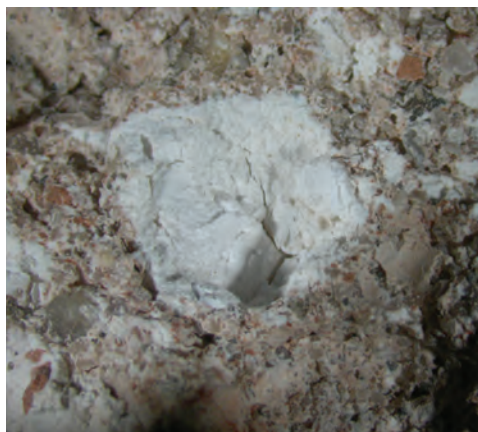
Fig. 7. 'Kalkspatzen' - detail of the first layer of *nucleus* (Photo: Brigitta Maria Kürtösi)

The slaking of the quicklime happens on the premises. The presence of chalk-like kernels in the lime, called 'Kalkspatzen' in German, is quite extensive. These kernels are reserves of binder and can be activated by moisture. The binder obtained from them migrates and can bind the micro-cracks all over the matrix of the preparatory mortar layers (Fig. 7). The traditional division of the preparatory layers can be found in this mosaic:

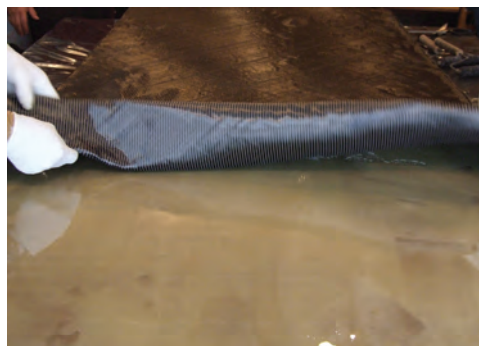
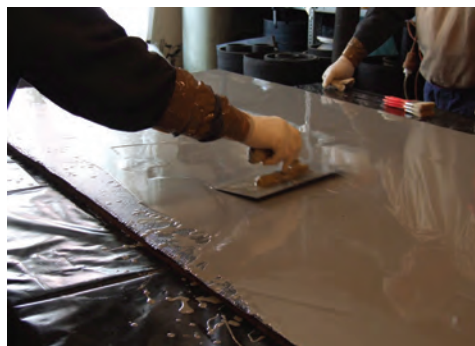
Fig. 9. The preparation of the new support with woven carbon fibre and 3PSP2 resin (Photo: Brigitta Maria Kürtösi)

Fig. 10. The preparation of the new support with woven carbon fibre and 3PSP2 resin (Photo: Brigitta Maria Kürtösi)

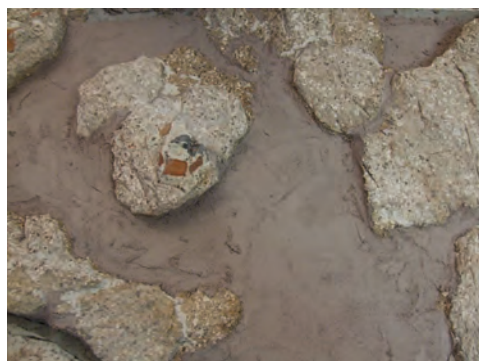
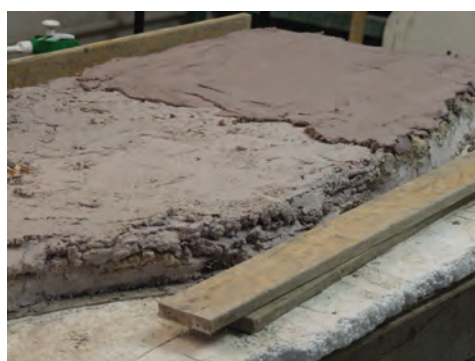
Fig. 11. The leveling of the backside of the mosaic was made by the lightweight lime-based mortar (Photo: Brigitta Maria Kürtösi)

Fig. 12. The leveling of the backside of the mosaic was made by the lightweight lime-based mortar (Photo: Brigitta Maria Kürtösi)

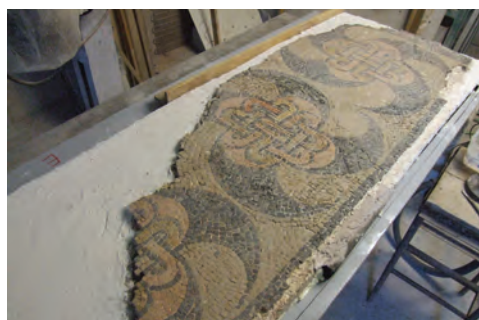
Fig. 13. The place of the missing parts (Photo: Brigitta Maria Kürtösi)

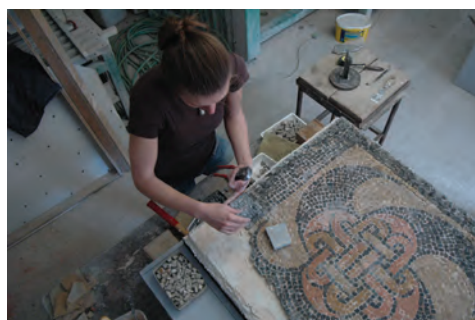
Fig. 14. The preparation of the new tesserae supplements (Photo: István Bóna)

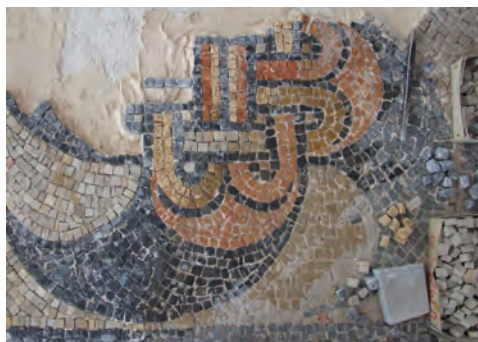
Fig. 15. The material of the new tesserae supplements was a geologically similar massive limestone. The lime-based VAPO inject 01 was used as bedding mortar (Photo: Brigitta Maria Kürtösi)

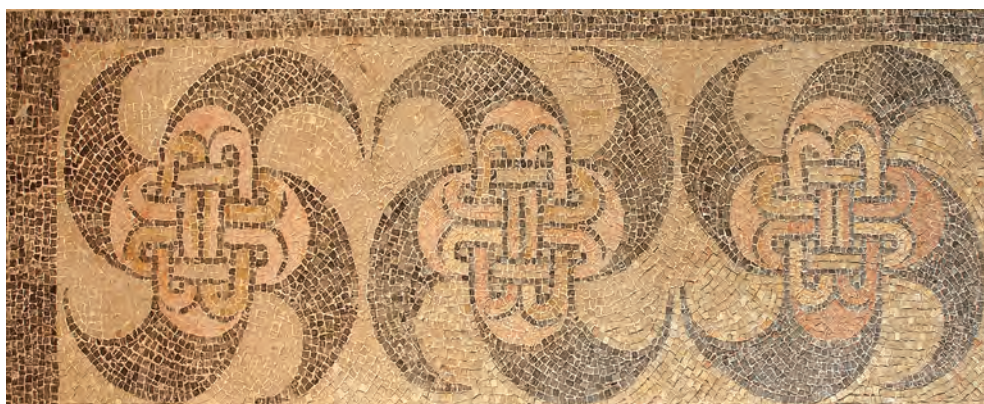
Fig. 16. The state of the threshold mosaic after conservation in 2010 (Photo: Brigitta Maria Kürtösi)

um, and then at the temporary exhibition of the Museum of Aquincum entitled *There is something new under the ground, old sites – new results 2011* (Fig. 16).

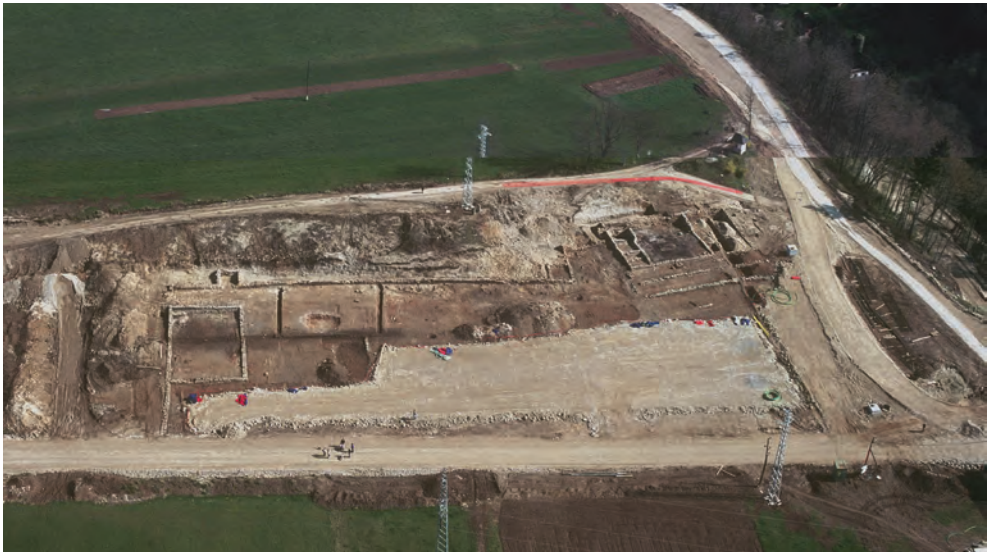
Fig. 1. Air photograph of the archaeological site of the *villa rustica* near Mošnje (photo: Jože Hanc, archive IPCHS)

The Roman mosaic was discovered during the archaeological excavations in 2006 and 2007 of a *villa rustica* near Mošnjje in the northwestern region of Slovenia. The villa is dated to the 1st and 2nd centuries AD on the basis of small finds (coins, jewellery, pottery etc.). The villa consisted of five masonry structures, linked together into one whole by a supporting wall abutting the slope of the upper terrace (Fig. 1) (Lux and Sagadin 2012).

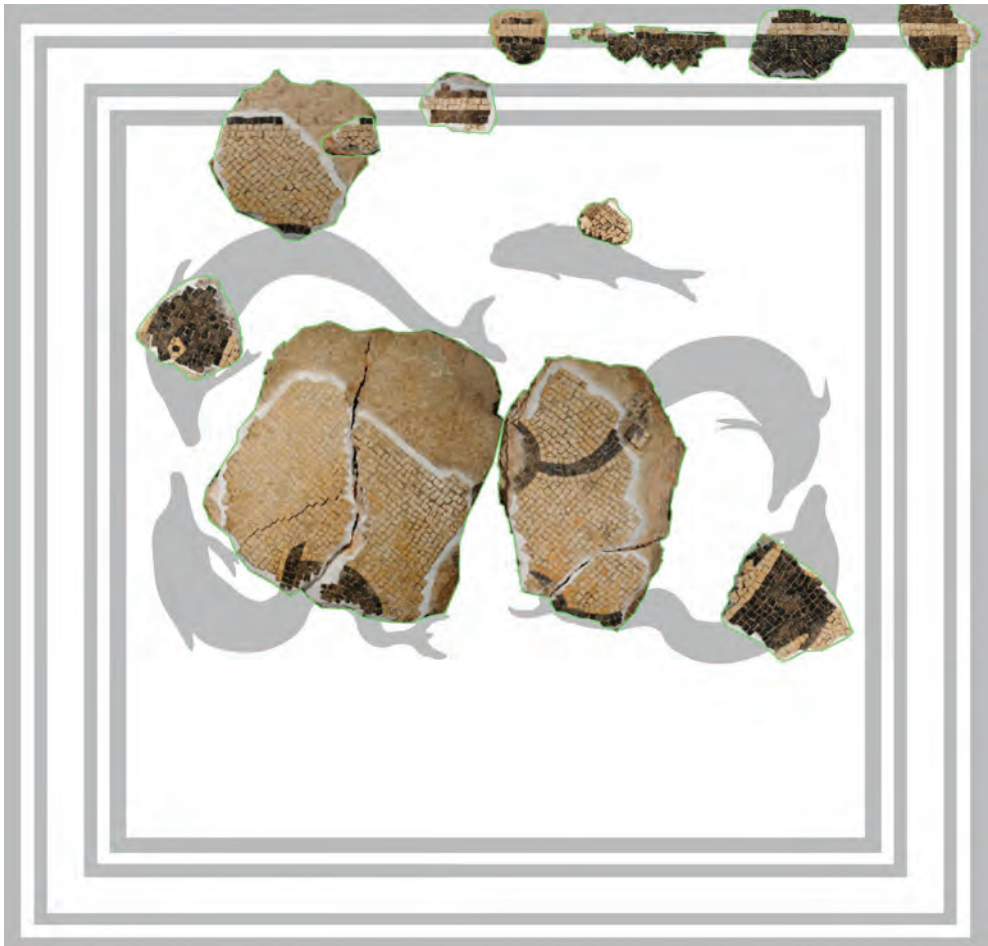
caution recommended is to put multiple screws simultaneously, in order to lift the fragment in parallel with the support.

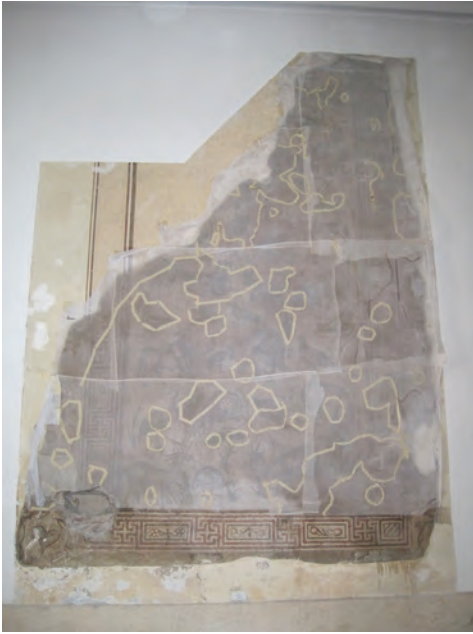
Fig. 6. Entoilage de la Mosaïque du Bon Pasteur et bandes adhésives utilisées pour délimiter les cloques

En 1995, lors de la réouverture du musée après la guerre civile, la mosaïque très fragilisée a dû être entoïlée en urgence à l'aide d'une gaze en coton et d'une colle vinylique blanche pour prévenir une perte de tesselles. Des bandes adhésives ont été collées sur l'entoilage pour délimiter les clo-

Nous avons démonté le coffrage en bois qui consistait de planches de contreplaqué vissées sur un châssis en bois. Nous n'avons pas décelé de traces de moisissures ni d'humidité sur la surface de la mosaïque toujours entoillée (Fig. 6). Les travaux de réfection du bâtiment effectués en 1997 notamment sur la partie extérieure du mur est ont contribué à son renforcement et, par le fait même, à la stabilité du pavement créant ainsi une bonne isolation thermique et structurelle.

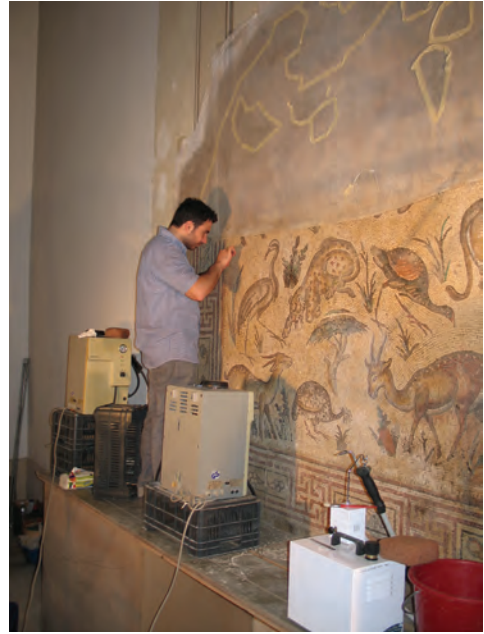
Fig. 7. Nettoyage de la surface à la vapeur d'eau

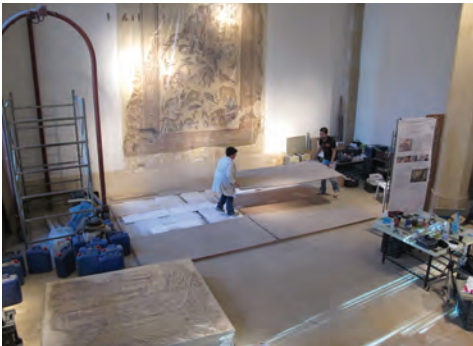
Fig. 8. Dégagement des panneaux de bois et de polystyrène sur la mosaïque aux oiseaux

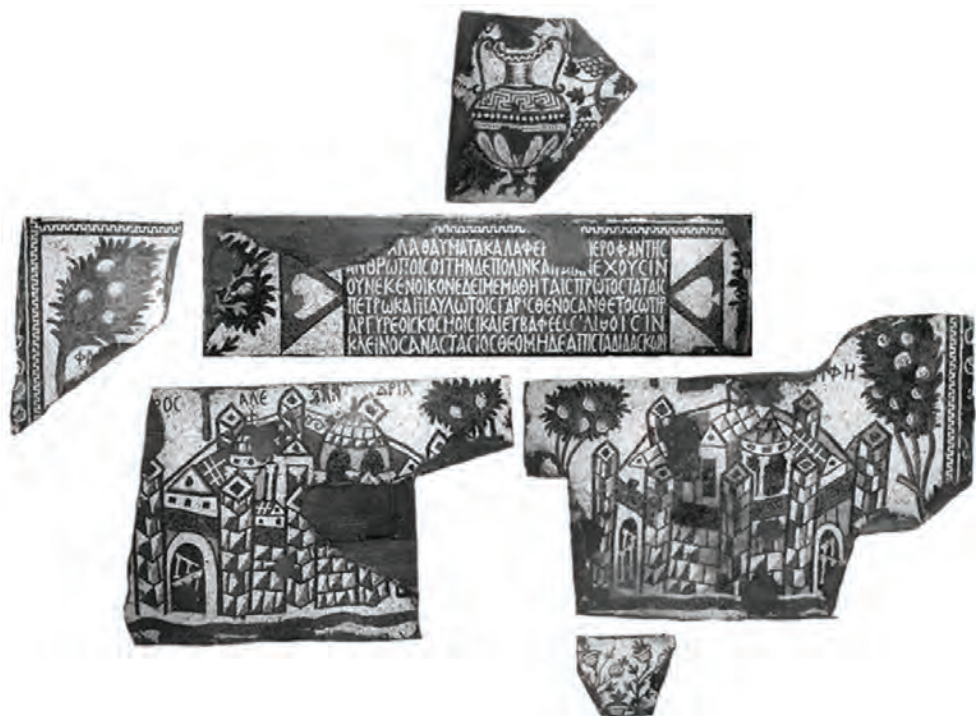
Fig. 1. Yale Gerasa city mosaic (#1932.1735) panels in Jordan in 1931 (photo: Yale University Art Gallery)

Excavation photographs show that the condition of the mosaic when first unearthed was fragmentary with overall dimensions of approximately 4x6 m (13x20 ft). The floor mosaic was divided into six sections ranging in size from less than 1 m² to approximately 4 m² as shown in a composite of 1931 photographs (Fig. 1). They are: 1) an upper panel of a wine amphora with grapevines pouring from its mouth, 2) a corner with a fruit tree bearing what appear to be pomegranates, 3) a Greek dedicatory inscription that identifies the church as being built by Bishop Anastasios and dedicated to Saints Peter and Paul, 4) the city of Ale-

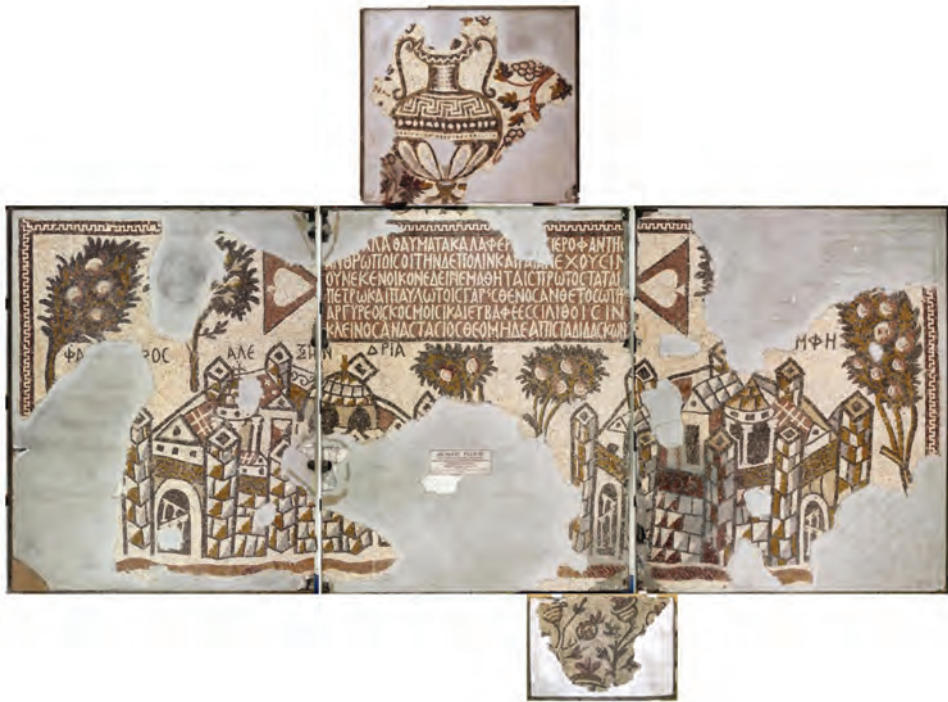
Fig. 2. Yale Gerasa city mosaic panels after 1933 (digital reconstruction) (photo: Yale University Art Gallery)

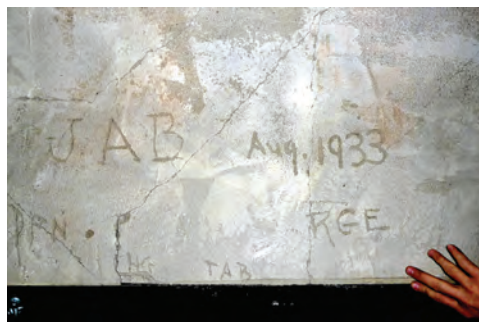
Fig. 3. Date and initials found in concrete on reverse of panel (photo: Yale University Art Gallery)

ing the date ‘August 1933’ and initials of those involved in the project (Fig. 3). ‘RGE’ is most likely Yale Art School Department of Sculpture Professor Robert G. Eberhard. Close examination of the 1933 materials provided a better understanding of the methods used at that time. The six polygonal mosaic sections from Jordan were reconfigured into five rectangular panels: three side-by-side measuring approximately 2 m in width by 2.5 m in height (78x98 in), one on top measuring approximately 1 by 1 m (46x43 in), and one at the bottom measuring 0.8 by 0.6 m (32x23 in). The backing applied in Jordan was replaced by a lime plaster mortar containing varying amounts of sand that

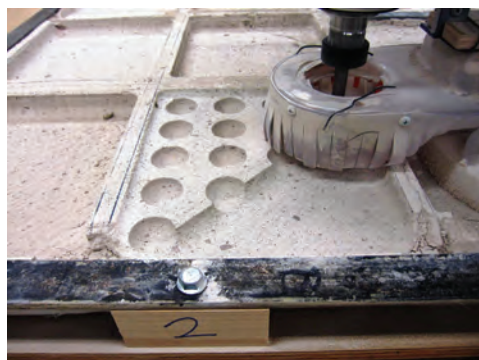
Fig. 4 Initial cutting patterns to mill concrete within steel grids (photo: Yale University Art Gallery)

The first round of milling was done by cutting a series of circles within the squares defined by the interior steel grids, in order to give cooling intervals during the milling process. The next round of milling cut diagonally through the circular holes, as shown in Figure 4. Any concrete remaining between the squares was chiselled off and the exposed interior steel bars and exterior frame were easily removed due to bond failure between the concrete and the steel. A finish round of milling was done using diagonal passes to achieve a surface to which new composite materials would be bonded, leaving a 5 mm layer of the 1933 plaster and exposing the score lines from that treatment. Figure 5 illustrates a mosaic panel after milling down to a consistent thickness of approximately 2 cm and prior to its removal from the cutting bed while still on its torsion box. The actual process of milling by the CNC cutter was done in approximately two weeks for each 2x2.5 m panel.

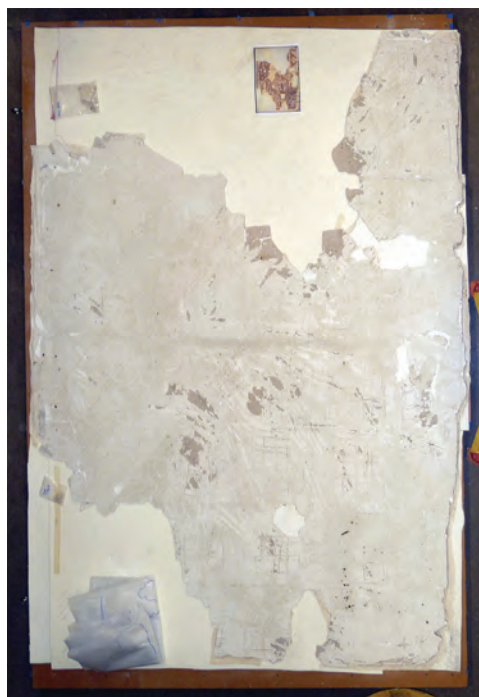
Fig. 5 Mosaic panel after concrete backing removal (photo: Yale University Art Gallery)

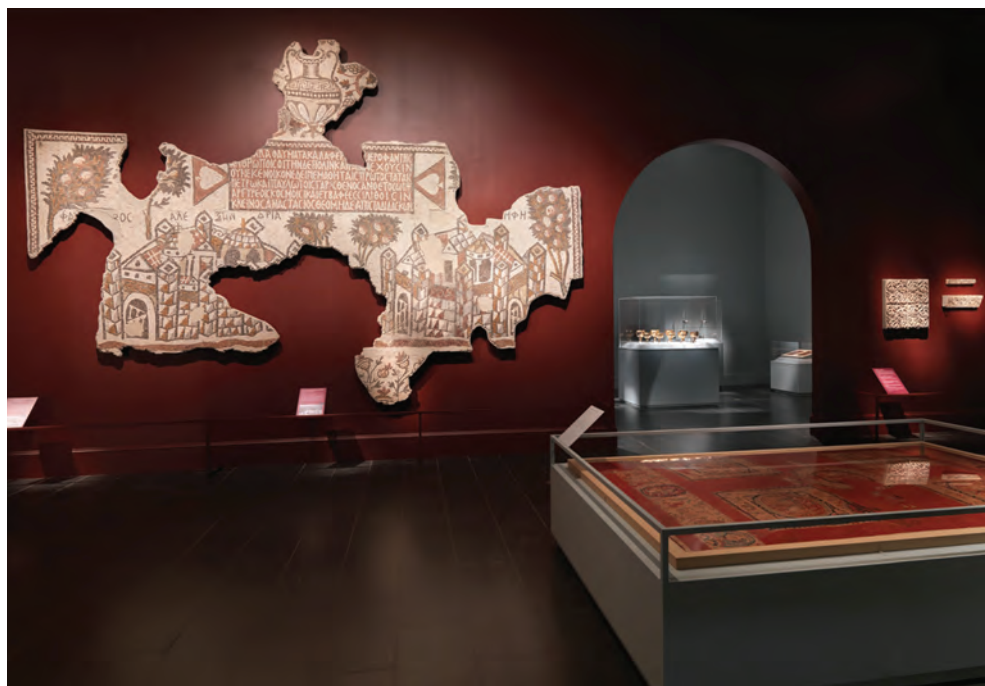
Fig. 7 Installation of the Yale Gerasa mosaic at the Metropolitan Museum, New York, 2012 (photo: Metropolitan Museum of Art)

For the joins between the panels tubular aluminium was used as both a support and a guide for proper alignment. Losses between panels were filled with cushioning inserts of Ethafoam® polyethylene foam, which was carved and painted to replicate the missing tesserae then attached to the aluminium with hot melt adhesive. Auxiliary tubular aluminium frames were bolted to the stainless steel inserts in the composite panels to strengthen the panels and to ease stresses by minimizing handling during crating, transport, uncrating, and installation on gallery walls by art handlers and exhibition staff. The system also allows the mosaic to travel to other museums for temporary exhibitions (Fig. 7) (Brody 2012, 11-12; Brody and Snow 2015, 20-29).

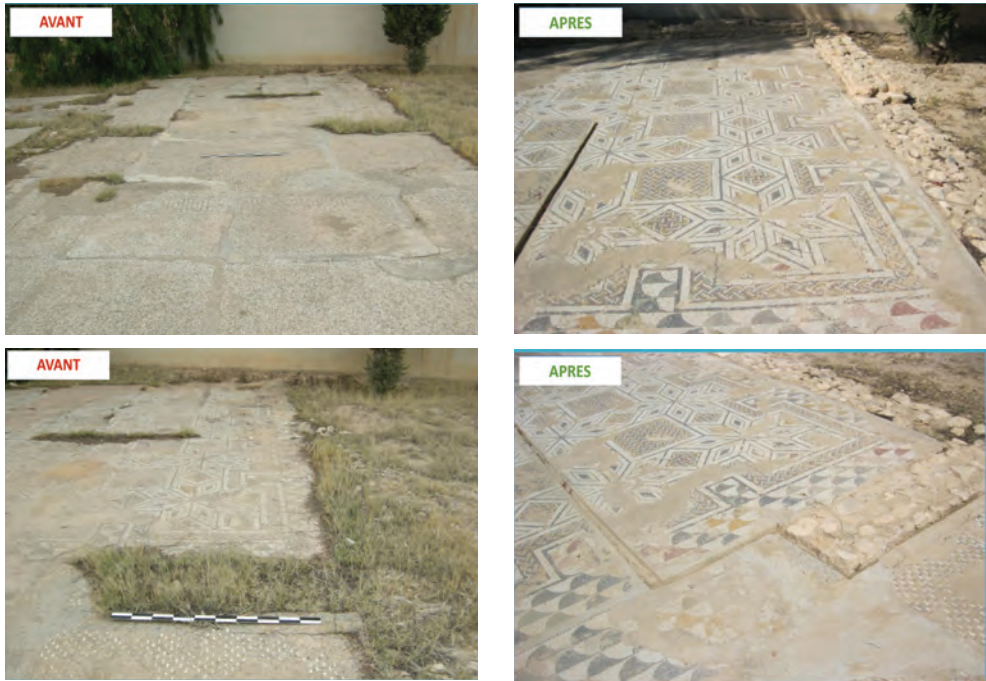
Fig. 1. Travaux de consolidation des mosaïques et drainage des eaux à El Jem (Photo : L. Belhouchet)

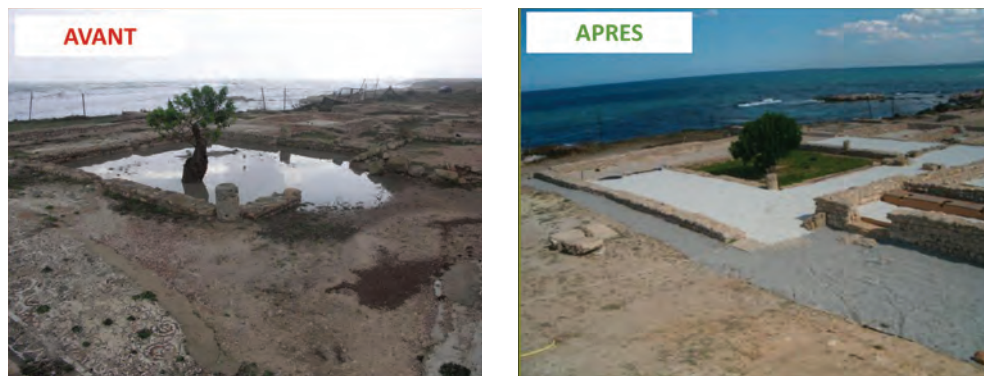
Fig. 2. Réenfouissement après consolidation des mosaïques de la Maison aux Deux Péristyles à Hergla (Photo : L. Belhouchet)

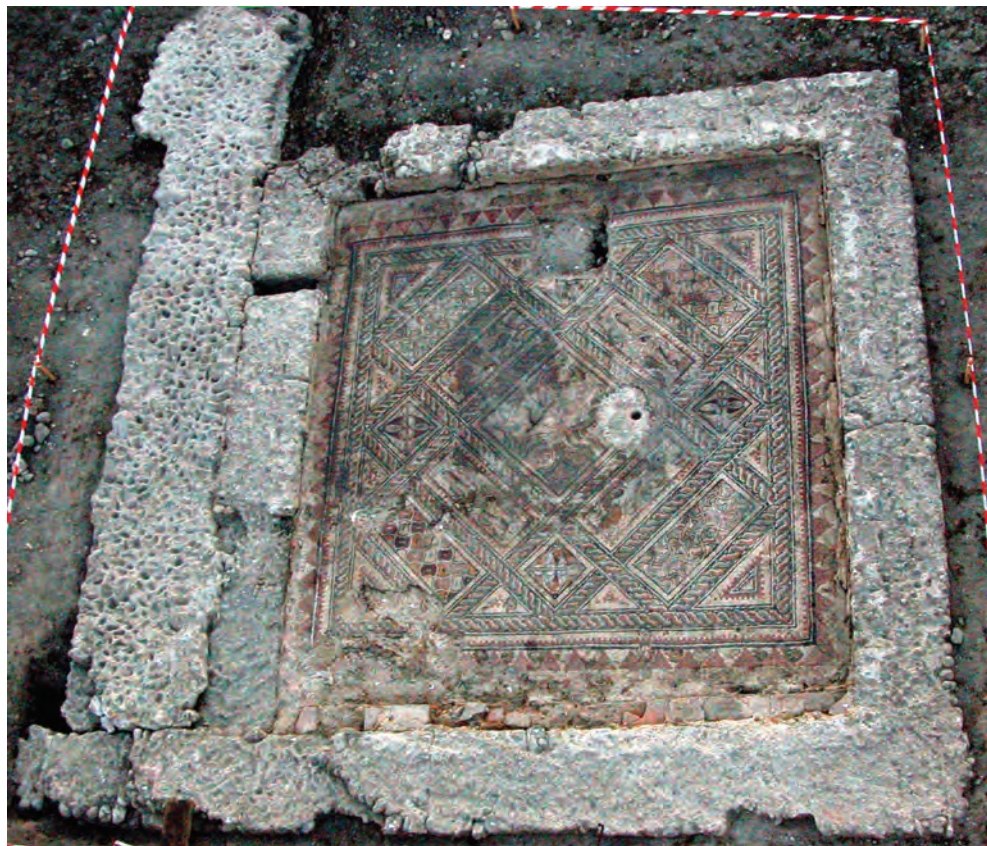
Fig. 1. La mosaïque *in situ* (Cliché : HADÈS)

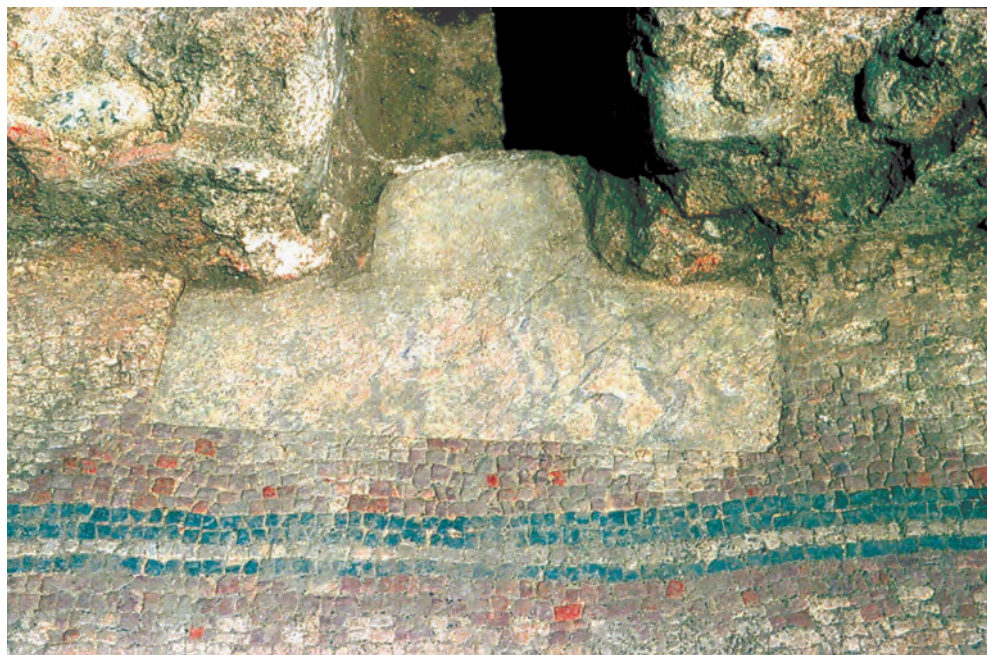
Fig. 3. Détail de la rigole d'évacuation et plaque de marbre encastrée dans le *tessellatum* (Cliché : Atelier)

Le pavement présentait une pente de 20 cm, d'un point haut dans l'angle sud-ouest vers une cuvette d'écoulement située dans l'angle nord-est, conduisant à une rigole d'évacuation percée dans le mur nord et revêtue par une plaque de marbre violet en forme de T, encadrée dans le *tes-sellatum* (Fig. 3). Par ailleurs, les vestiges d'une assise de maçonnerie bâtarde (briques et pierres) formant une banquette de 25 cm de largeur doublaient l'intérieur du mur ouest : ces deux aménagements, ajoutés au décor aquatique du pavement et à l'absence de seuil attesté ont conduit

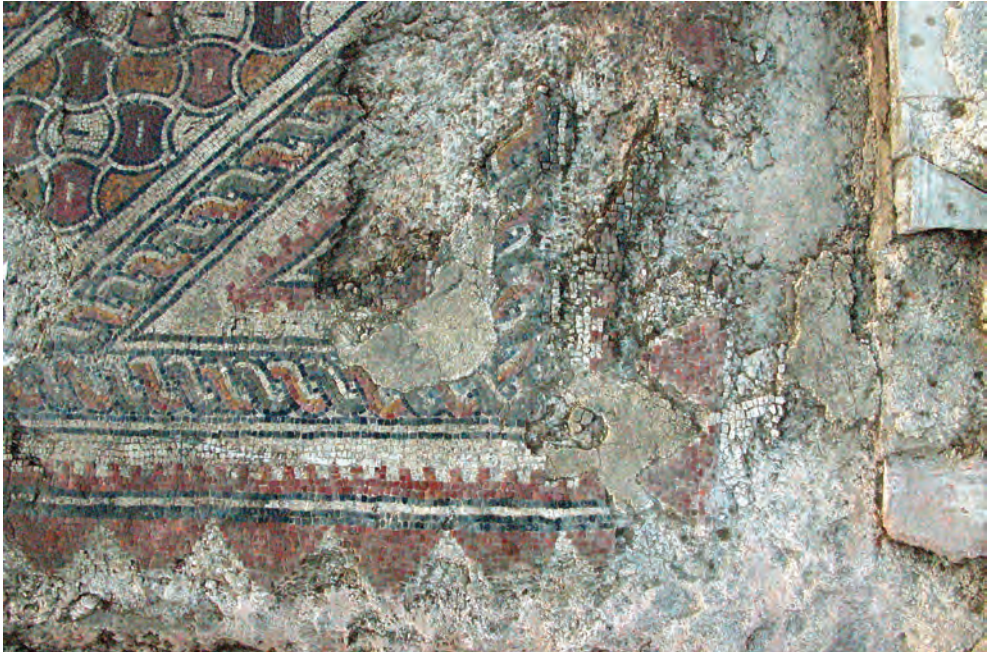
Fig. 4. Détail de la zone lacunaire et usée devant la tombe tardive du mur nord (Cliché : HADÈS)

nord ; ce secteur présentait des réfections antiques en mortier de chaux qui colmataient partiellement des îlots de tesselles réduites à quelques millimètres d'épaisseur (Fig. 4). La seconde lacune était centrée sur le côté est de la mosaïque (Fig. 5). De format grossièrement carré, elle se démarquait des autres lacunes par sa profondeur : alors qu'ailleurs seul le *tessellatum* avait disparu, laissant apparent le lit de pose ou le *nucleus*, la partie détruite occupait ici l'épaisseur du *nucleus* et du *rudus*, une partie descendait même sous le *statumen*. Sa première interprétation comme un creusement tardif – peut-être un sondage archéologique –, a pu être reconsidéré après l'étude de l'organisation du décor autour de ce « trou », ultérieurement précisée au cours de la restauration de la mosaïque.

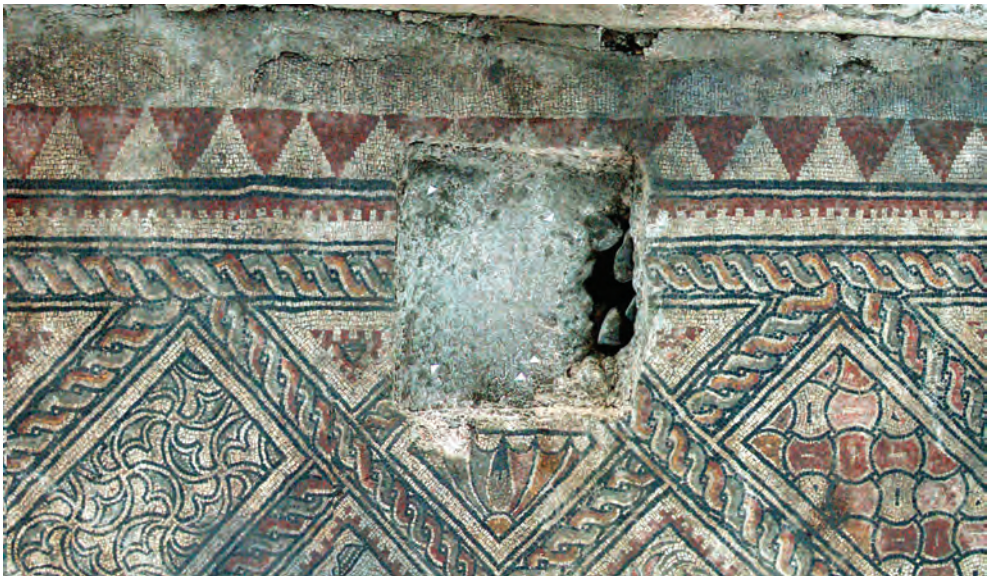
Fig. 5. La lacune carrée centrée sur le côté est de la mosaïque (Cliché : HADÈS)

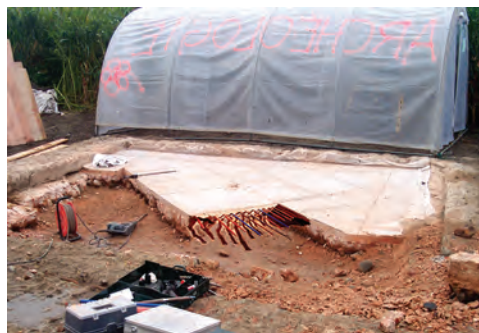
Fig. 6. La dépose en cours ; les plaques sont délimitées suivant la trame géométrique du décor (Cliché : Atelier)

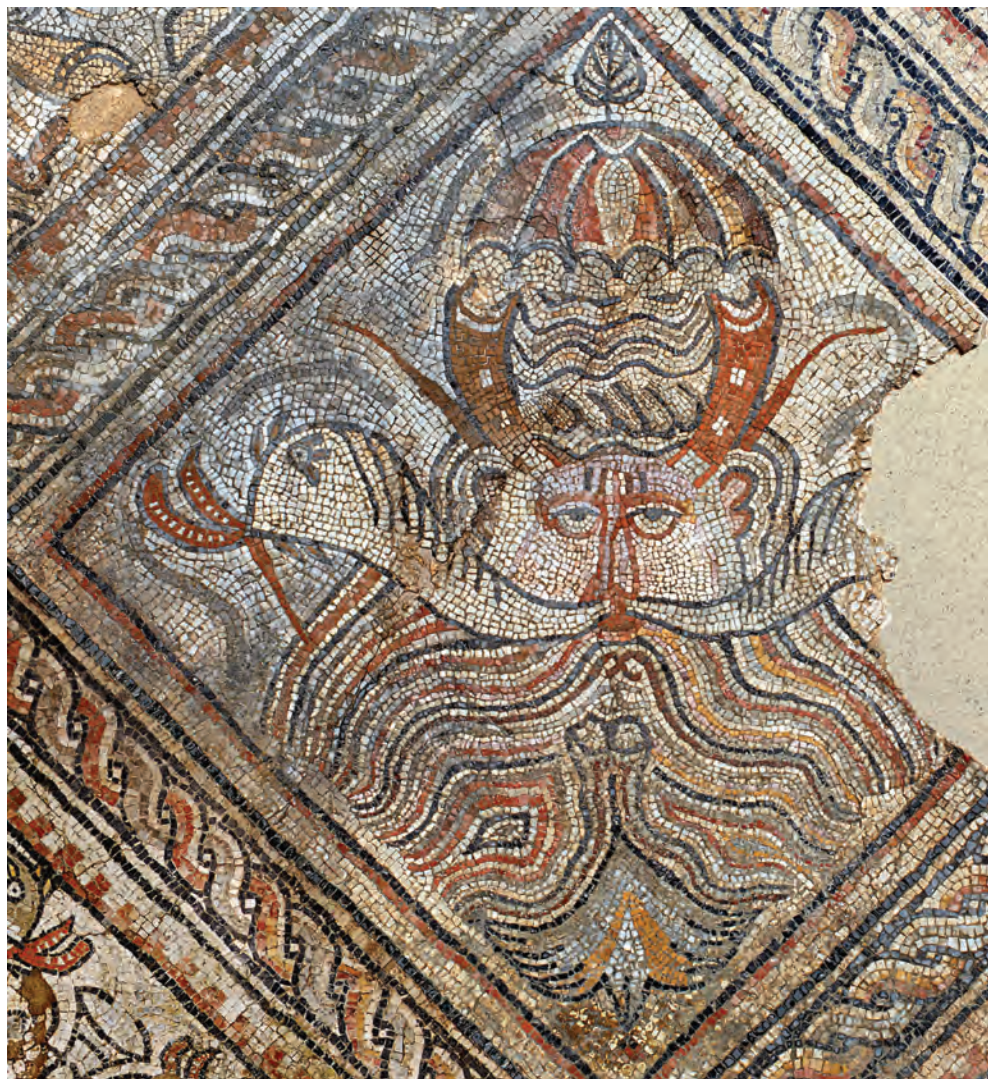
Fig. 8. Le dieu Océan après nettoyage (Cliché : Paul Veysseyre)

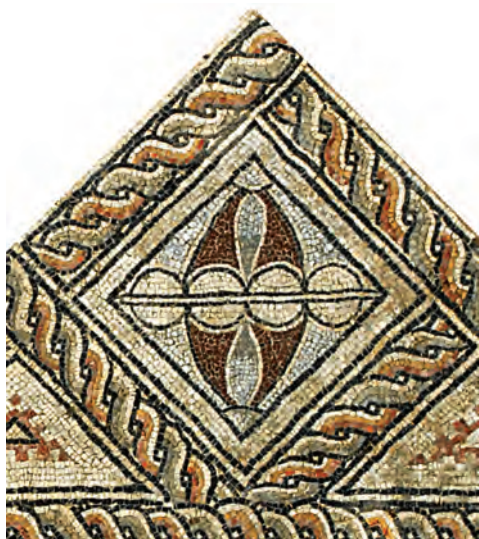
Fig. 9. Carré sur la pointe situé sur le côté nord : le motif de coquille se développe de manière symétrique de part et d'autre d'un axe déterminant deux triangles égaux. C'est le cas également pour les autres carrés sur la pointe que présente la mosaïque (Cliché : Paul Veysseyre)

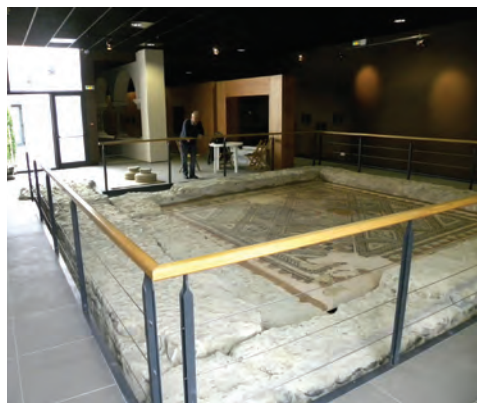
Fig. 11. La mosaïque et les murs installés dans l'espace muséographique de Maubourguet (Cliché : Atelier)

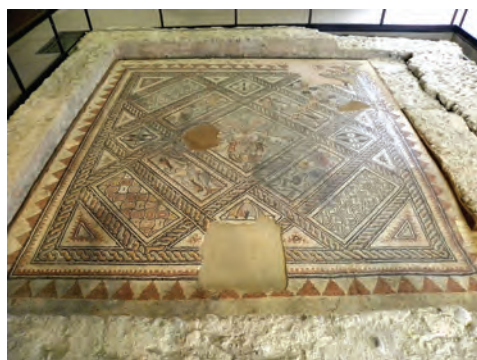
Fig. 12. Détail de la mosaïque après sa mise en place (Cliché : Atelier)

bourguet (Fig. 11 et 12) (Doussau 2010). Elle y a retrouvé son cadre d'origine : ses quatre murs et l'amorce de l'abside qui doublait le mur nord, démontés en blocs et remontés dans la salle d'exposition avant la mise en place du pavement. Les opérations finales de présentation ont consisté à appliquer un enduit de chaux dans les lacunes ; l'opération a été réalisée *in situ* pour masquer les limites des sept panneaux constitutifs du pavement : le traitement de la lacune carrée, revêtue d'un enduit lisse et terreux, la différence des autres parties lacunaires, comblées par un mortier plus grossier chargé de tuileaux. Par ailleurs, les vestiges d'enduits partiellement préservés au bas des murs ont été remis en place et un mortier de tuileaux a été appliqué en périphérie du pavement pour le raccorder aux parois et en partie basse des maçonneries, selon la configuration d'origine (Fig. 13).

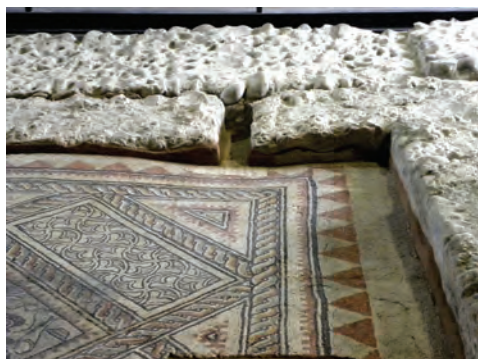
Fig. 13. Détail des enduits reposés en partie basse des murs (Cliché : Atelier)

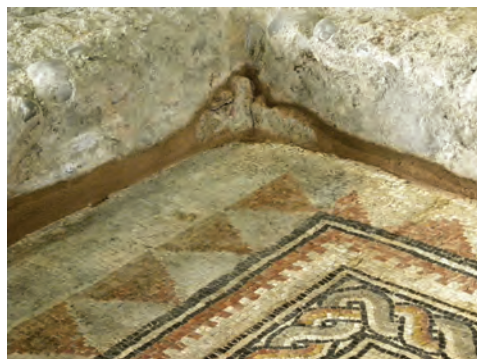
Fig. 14. Détail de la pente d'écoulement et de la rigole d'évacuation (Cliché : Atelier)
