MANAGING ARCHAEOLOGICAL SITES WITH MOSAICS: FROM REAL PROBLEMS TO PRACTICAL SOLUTIONS

THE 11TH CONFERENCE OF THE INTERNATIONAL COMMITTEE
FOR THE CONSERVATION OF MOSAICS, MEKNES, OCTOBER 24-27 2011

edited by
Demetrios Michaelides and Anne-Marie Guimier-Sorbets

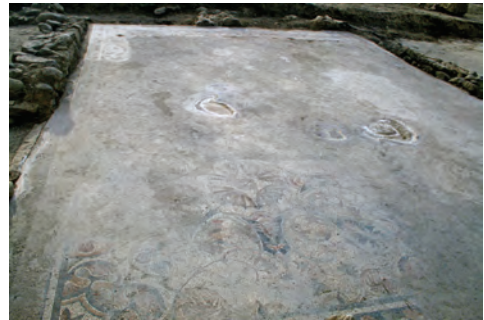
La mosaïque conserve encore son support original de bonne qualité, néanmoins, nous avons recensé de multiples altérations du *tessellatum* (Fig. 3) telles :

- La désagrégation des tesselles et leur détachement
- Des fractures et des fissures
- De nombreuses concrétions calcaires
- Des pertes d'adhérence entre les tesselles et leurs assises et révélées par les sonorités dégagées en « sonnant » sur le tapis
- Présence d'un nid de fourmis
- Tesselles calcinées sur une partie du *tessellatum*
- Altérations chromatiques

Fig. 3. Multiples altérations du *tessellatum* (cliché : S. Ferdi)

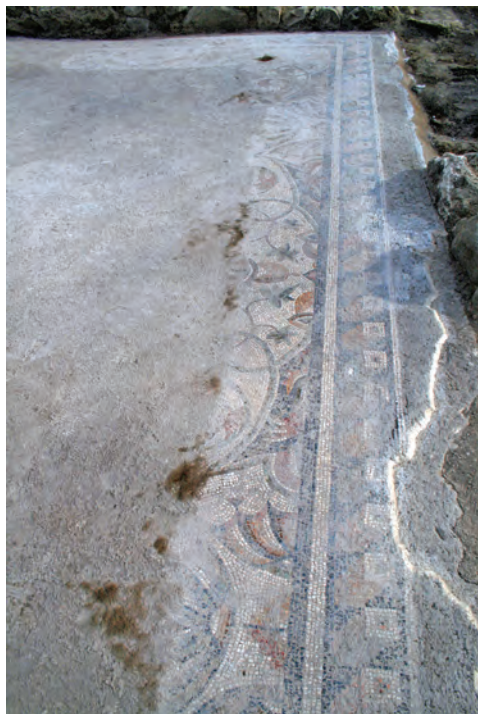
Fig. 4. Consolidation des bords du pavement par des solins de mortier de chaux (cliché : S. Ferdi)

- Le dégagement des bords et le nettoyage des poussières et de la terre.
- Collecte des tesselles désolidarisées.
- Consolidation des bords par la pose de solins à base de chaux hydraulique et de sable.
- Elimination mécanique des terres accumulées dans les lacunes jusqu'à l'apparition du lit de pose.

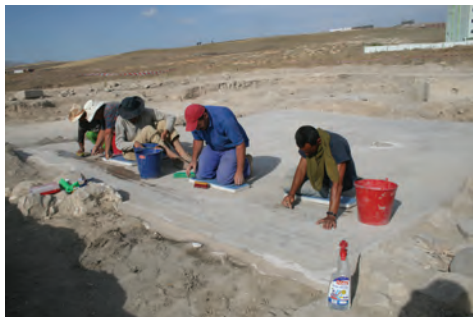
Fig. 5. Nettoyage général du pavement (brosses, eau, éponges) (cliché : S. Ferdi)

- Le nettoyage mécanique de la surface du *tessellatum* à l'aide de scalpels, bross-

es et aspersion d'eau afin d'éliminer les dépôts incohérents.

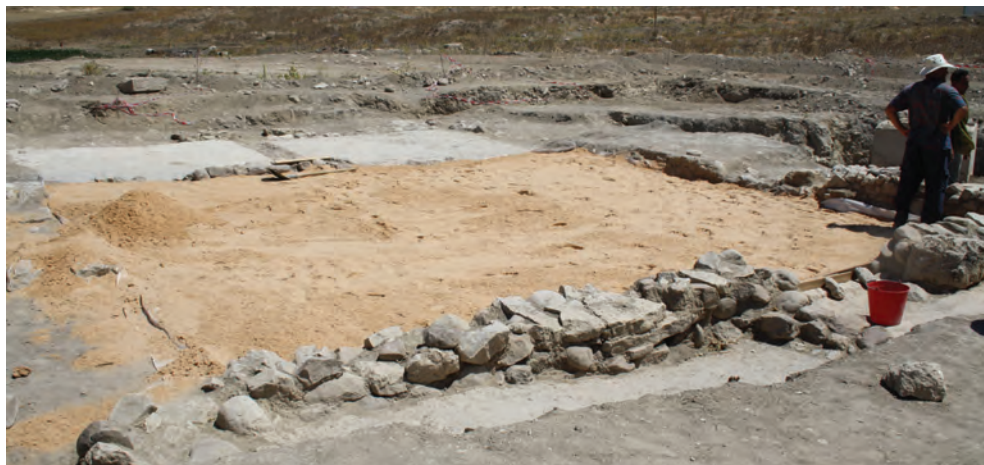
Fig. 6. Recouvrement de la mosaïque par du géotextile suivie d'une couche de sable et du gravier (cliché: S. Ferdi)

- Comblement des lacunes internes par l'application d'un mortier de renforcement à base de chaux et de sable.
- Remplissage des joints entre les tesselles par l'insertion d'un mortier hydraulique à base de chaux, sable et eau dans les interstices entre les tesselles.
- Consolidation des bords du pavement par des solins de mortier de chaux (Fig. 4)
- Nettoyage général du pavement (brosses, eau, éponges) (Fig. 5)
- Recouvrement de la mosaïque par du géotextile suivie d'une couche de sable (30 cm) et du gravier (10 cm) (Fig. 6).

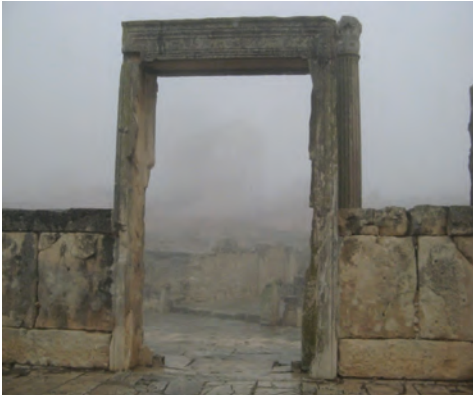
Fig. 2. Haute altitude et gel-dégel (cliché : Moudi Hani)

- Changements brusques de température : eau, humidité, ensoleillement, gel-dégel, etc. (Fig. 2)
- L'eau : stagnation (Fig. 3), infiltration, évaporation et cristallisation
- Les micro-organismes à la surface et à l'intérieur des tesselles
- Cristallisation des sels dans les tesselles
- Le nombre des visiteurs (Fig. 4) avec le manque de protections adéquates.

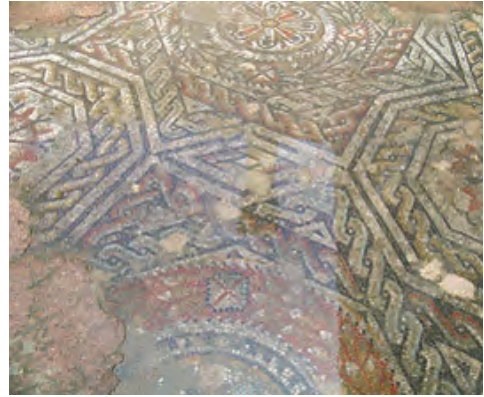
Fig. 3. Accumulation des eaux de pluie (cliché : Moudi Hani)

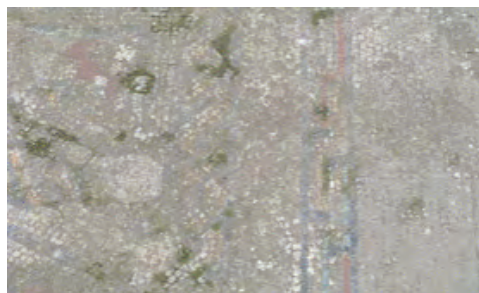
Fig. 5. Ternissement et décoloration (cliché : Moudi Hani)

Elles sont multiples : détachement de tesselles, micro-organismes, ternissement et décoloration (Fig. 5), poussée rapide d'herbes, craquelures, affaissements, gonflements et vides entre les couches d'un pavement, et interventions précédentes inadéquates (Fig. 6).

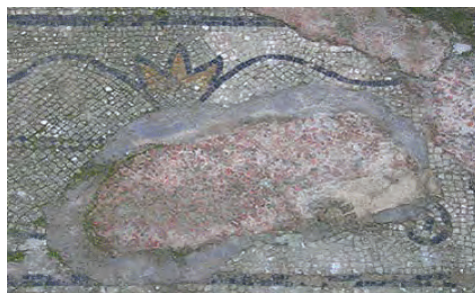
Fig. 6. Interventions précédentes inadéquates (cliché : Moudi Hani)

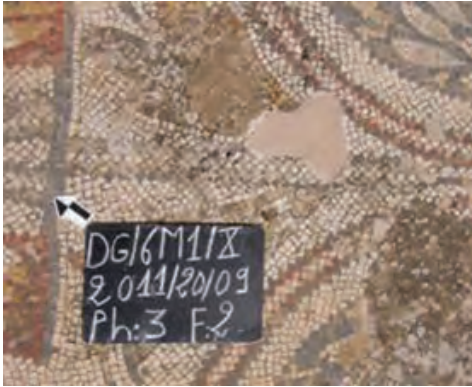
Fig. 8. Bouchage des lacunes (cliché : Moudi Hani)

- Nettoyage et désherbage
- Préparation des matériaux
- Bouchages des lacunes (Fig. 8)
- Protection de bords endommagés
- Remplissages des joints
- Traitement des panneaux déformés, des zones de soulèvement et des zones de dépression
- Traitement des problèmes liés à l'accumulation des eaux de pluie et au pié-

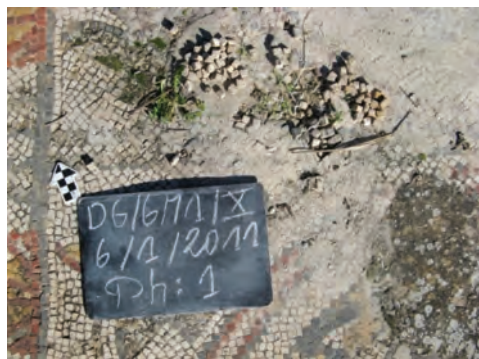
Fig. 11. Maison de Vénus : Tesselles détachés (cliché : Moudi Hani)

Dans la Maison de Vénus (Fig. 9 et 10), qui doit son nom à la fameuse mosaïque trouvée dans l'une de ses salles, nous sommes intervenus sur la mosaïque géométrico-florale polychrome de la salle rectangulaire située au fond nord de la maison. Celle-ci, souffre du détachement des tesselles sur les bords et à quelques endroits du *tessellatum* (Fig. 11) ; et ce à cause du passage des animaux. L'accumulation des eaux de pluie, dans cette salle, a provoqué des zones de gonflement.

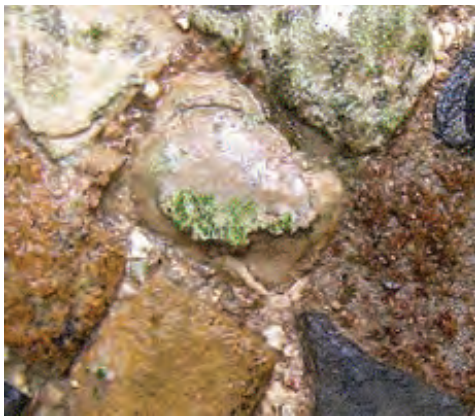
Fig. 13. Micro-organismes : dégâts structurels (cliché : Moudi Hani)

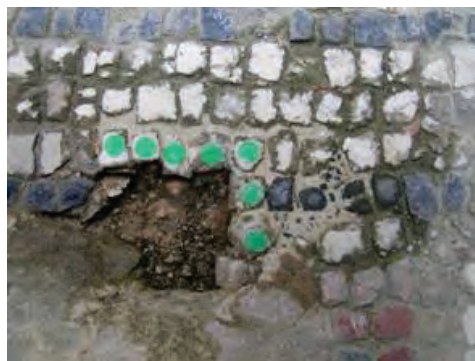
Fig. 14. Marquage des tesselles remises (cliché : Moudi Hani)

A la fin de l'opération, nous distinguons avec des étiquettes les tesselles remises en place afin de les marquer sur les plans des interventions réalisées (Fig. 14).

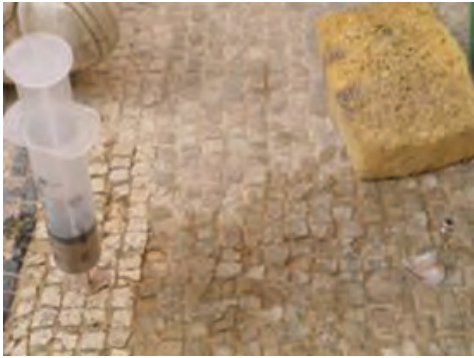
Fig.15. Traitement des décollements : Opérations préparatoires (cliché : Mouidi Hani)

LA STABILISATION DES DÉCOLLEMENTS (FIG. 15 ET 16)

On utilise pour cette opération un mortier liquide, appelé aussi coulis. Il s'agit d'un type particulier de mortier qui contient une proportion plus importante d'eau que les mortiers en pâte. La quantité d'eau ajoutée est juste

suffisante pour rendre le mortier fluide, mais sans excès, il est par ailleurs composé d'agrégats très fins. Le rapport liant/agrégat est de 1/1. Nous avons choisi un mortier hydraulique comme liant, car celui-ci devait pouvoir prendre sans être au contact de l'air comme nous allons le voir plus loin.

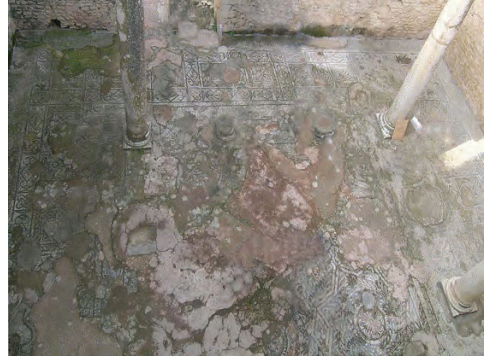
Fig. 17. Etat du pavement avant intervention (cliché : Mouidi Hani)

LA MOSAÏQUE DE LA SALLE D'ENTRÉE DES THERMES DE CARACALLA (FIG. 17 ET 18)

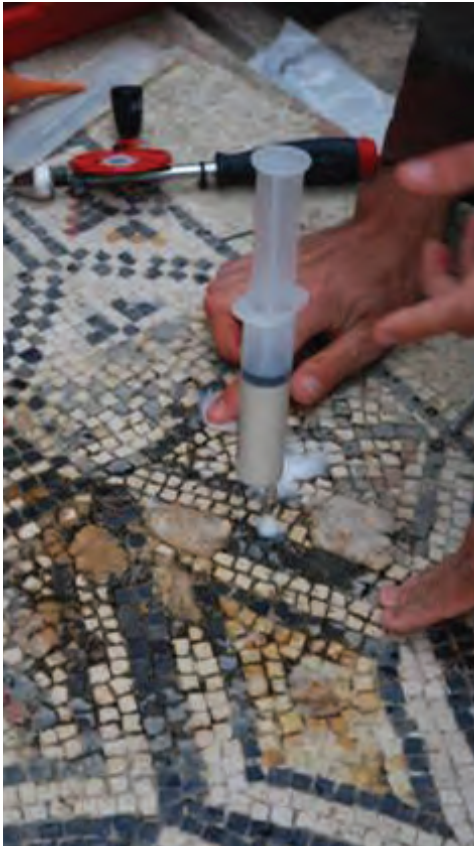
Fig.16. Décollement: remplissage de la cavité (cliché : Mouidi Hani)

Nous posons ensuite un poids (tel qu'un sac de sable) sur la zone stabilisée pendant une durée de trois jours afin de favoriser l'adhésion du mortier aux couches traitées.

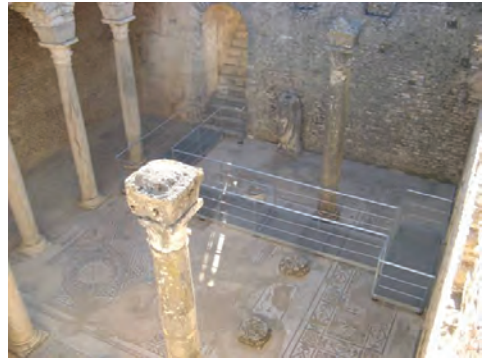
Fig. 18. L'état du pavement après restauration et mise en place de la passerelle (cliché : Mouidi Hani)

Pour préserver la mosaïque du piétinement des visiteurs, nous avons mis en place une passerelle en aluminium qui relie les deux accès. Elle est placée le long du passage des visiteurs, transformé avec le temps en des lacunes bouchées lors des interventions de conservation-restauration.

Cette solution qui dissimule les anciens dégâts, provoqués lors du passage des visiteurs entre les deux portes d'accès, protège la mosaïque de dégâts supplémentaires et permet aux visiteurs de contempler une grande partie, aujourd'hui bien conservée, de la mosaïque.

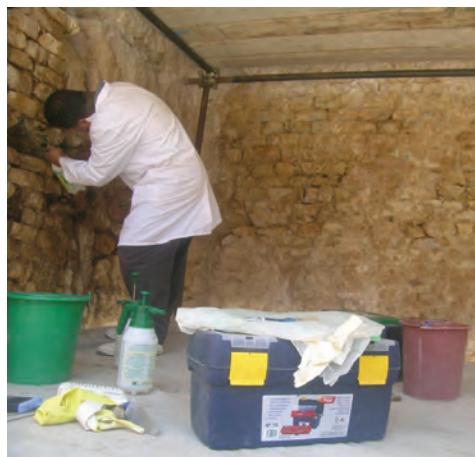
Fig. 20. Entretien des murs de la salle d'entrée des Thermes de Caracalla (cliché : Moudi Hani)

CONSERVATION DU CONTEXTE ARCHITECTURAL DU PAVEMENT (FIG. 20) ET MISE EN VALEUR DU SITE

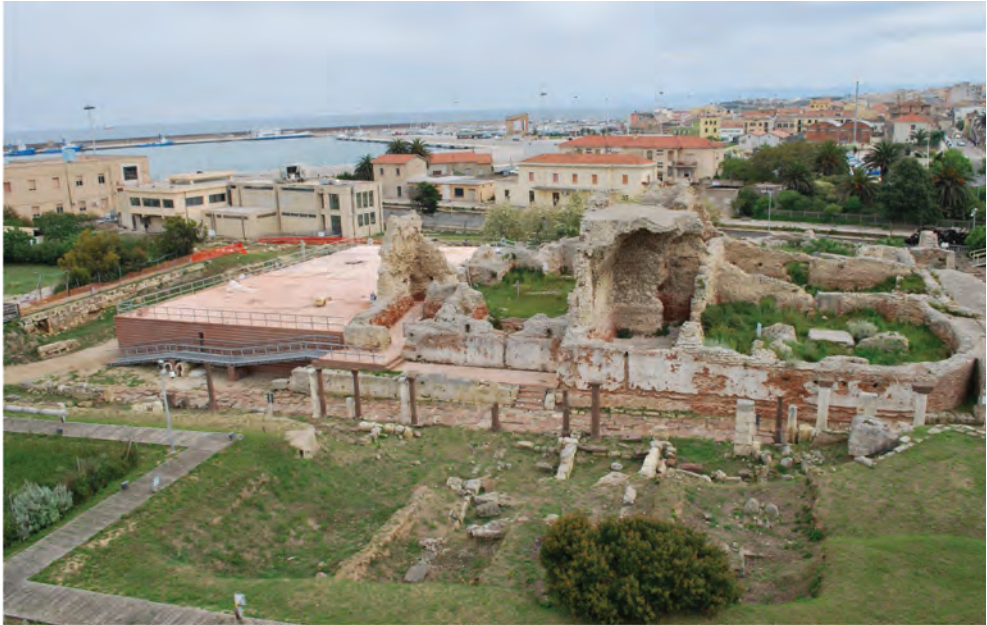
Fig. 7. The protective structure. View from the west (© Soprintendenza Archeologica per le province di Sassari e Nuoro)

tive structure (Fig. 7 and 8) is supported by metal piers set in the robber and foundation trenches on a layer of compact clay that covers the natural lime-bed. The entire construction is reversible in all of its parts and employs non-deformable materials, compatible with the monumental

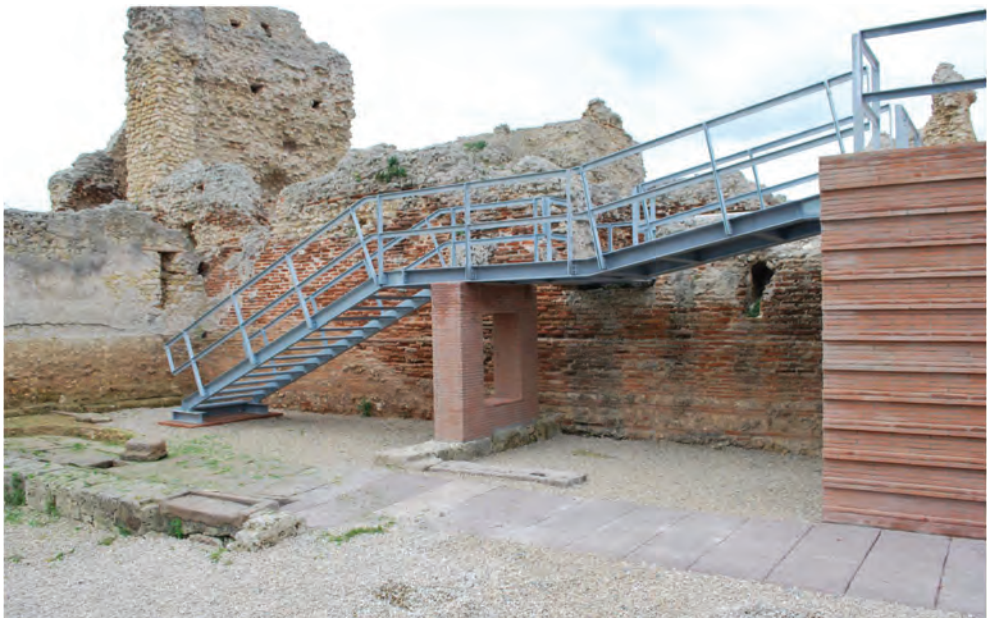
Fig. 10. The east entrance of the peristyle (© Soprintendenza Archeologica per le province di Sassari e Nuoro)

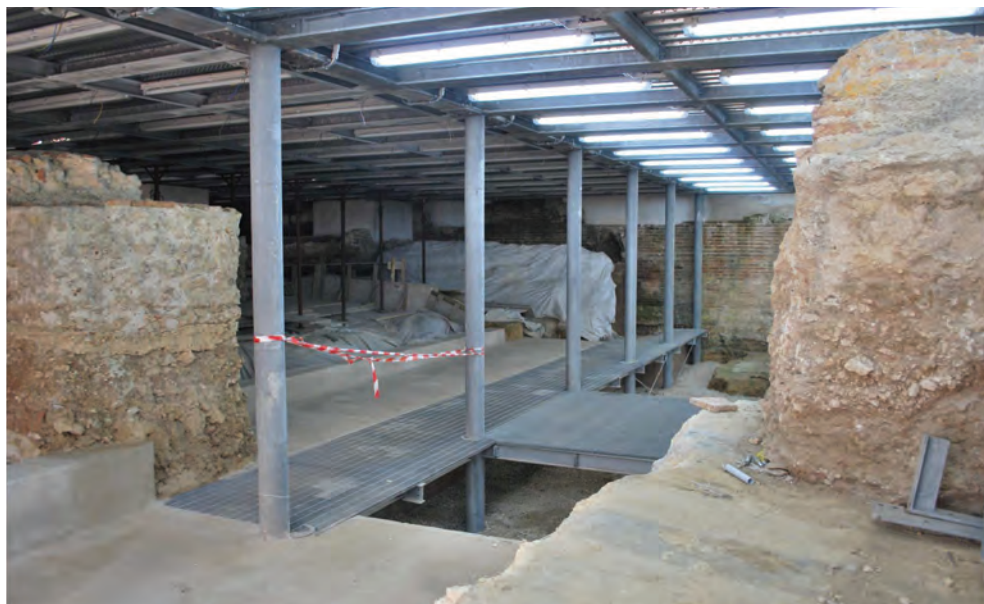
Fig. 11. Interior of the protective structure, west sector (© Soprintendenza Archeologica per le province di Sassari e Nuoro)

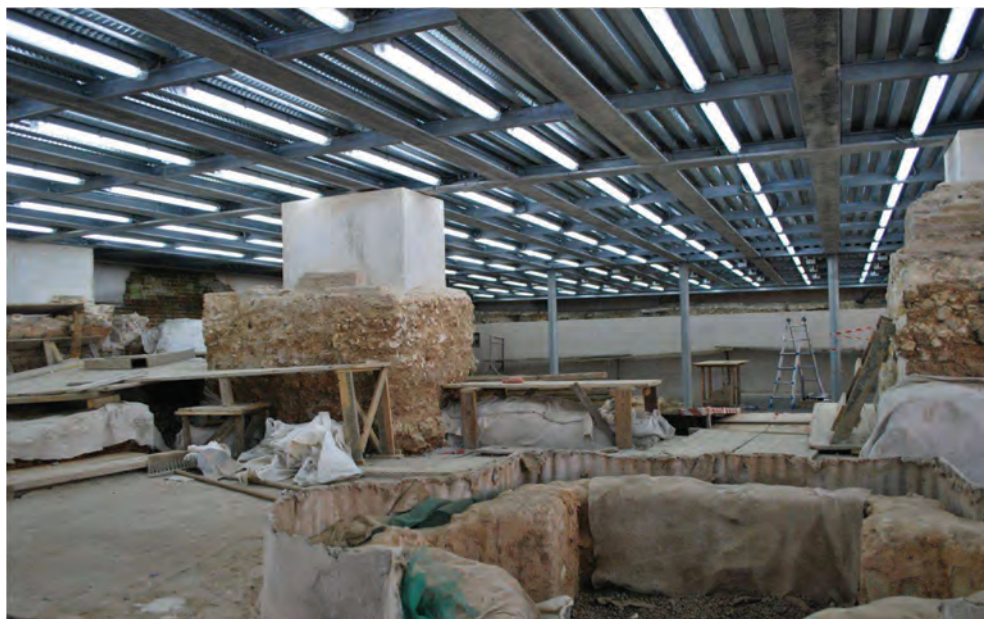
Fig. 12. Interior of the protective structure, east sector (© Soprintendenza Archeologica per le province di Sassari e Nuoro)

remains, characterized by moderate costs and low maintenance. There was no imposition or interference of any kind with anything pre-existing. Safe visiting is also ensured for the disabled. Moreover, excavation can be re-initiated in the areas which until now were not investigated due to safety and practical, economic concerns. The safeness of the restoration interventions on each mosaic is guaranteed and the surfaces are ready for the graphic completion of the decorative motifs of the mosaics. The current path around the mosaics can also be expanded with information and educational displays, to be placed on the large surfaces of the perimeter walls to the east and west. Having taken into consideration the large area of the peristyle (more than 600 m²), the regulatory measures for safe visits and the complex issues related to restoring access to the north sector, at the base of which there is a dense network of ruins and structures relative to the oldest phase of the city, the two original entrances between the northern entry rooms and the peristyle were deemed to be suitable, and a staircase and ramp were set up at the far south and far west (Fig. 9 and 10) of the protective structure. These are entirely reversible structures constructed on unexplored archaeological strata, which were isolated with the use of aggregate. The three large entrances into the covered space, made on the north and south perimeter walls, correspond to the visitor route, which can be followed in both directions. It is closed by double-grill metal gates, to ensure the natural ventilation of the enclosed space and so that the effects of fluctuations in and exchanges with the outside temperature and humidity can be kept to a minimum. The new structure,

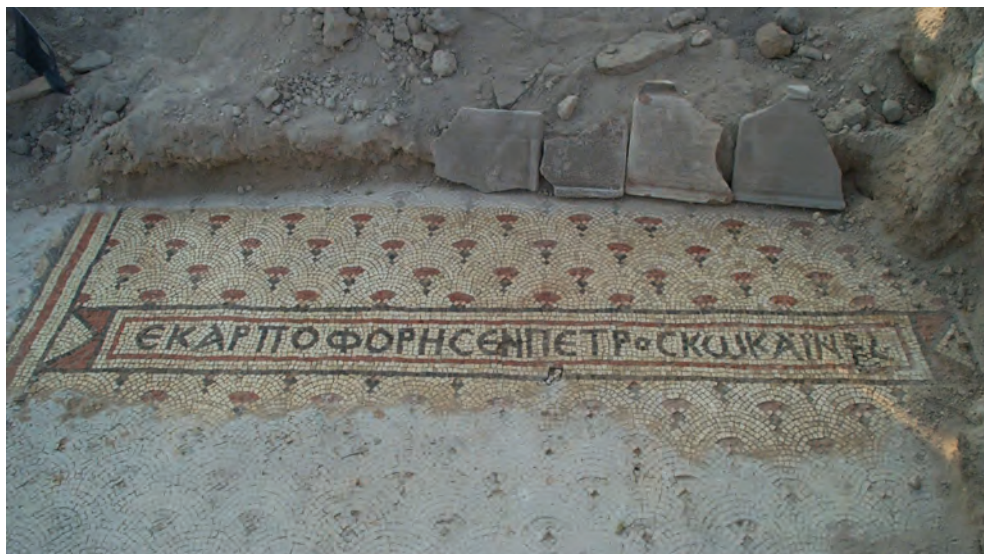
Fig. 5. The mosaic floor in the south aisle of the Church during exploration. Stabilization treatments had to be performed immediately after discovery (photo: J. Burdajewicz)

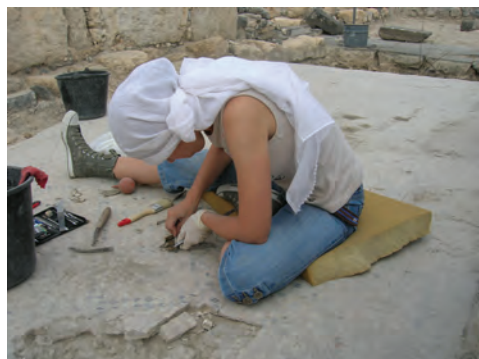
Fig. 7. Some minor aesthetic restorations were carried out in small lacunae. However, due to the character of the works, most treatments were focused on immediate stabilization and preservation (photo: J. Burdajewicz)

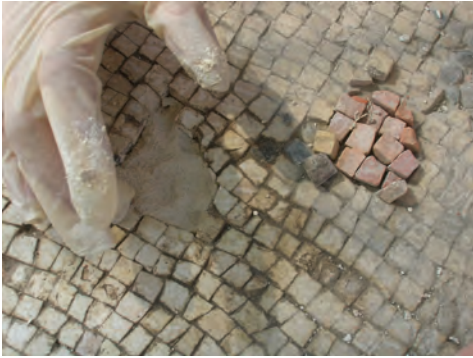
Fig. 9. One of the conservators preparing loose tesserae for replacement where the pavement was smashed by falling stones during the earthquake of AD 749 (photo: J. Burdajewicz)

the gap that appeared in the bedding and then placing the tesserae back with a new lime-based mortar binding. Cracked and smashed tesserae were replaced with loose ones collected on the site (Fig. 9). During the entire course of the conservation campaigns, documentation of the state of preservation and the treatments applied was being made and updated. The main means of documentation were photography and drawings, complemented with notes and reports. Again, due to the short length of the campaign and the difficult working conditions on the site, the drawn and written documentation was made with traditional methods and digitized later, after the end of the season. Also, throughout each season, previously discovered and treated areas were checked and any changes in their condition were recorded. The fact that the site is not properly guarded during eleven months of the year imposed the necessity of a very careful preparation of the mosaic floors for that period. Due to the character of the undertaking, the only available way of securing the mosaics for the rest of the

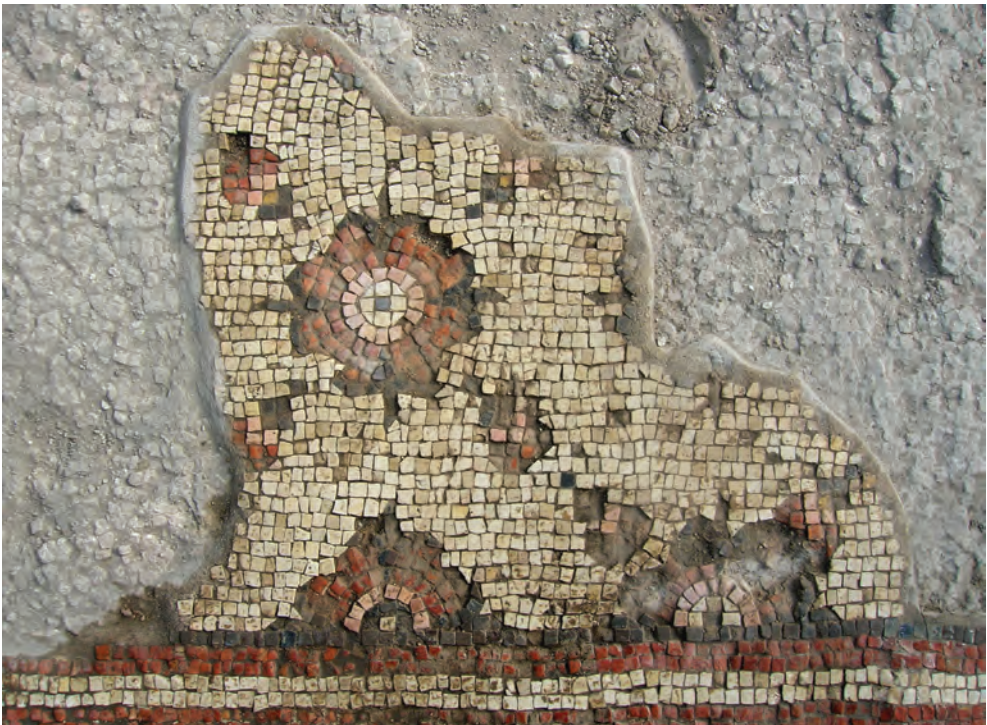
Fig. 8. Many of the colourful tesserae needed immediate consolidation. Particularly those made of soft red and yellow limestone, which were almost completely worn in many areas of the design (photo: J. Burdajewicz)

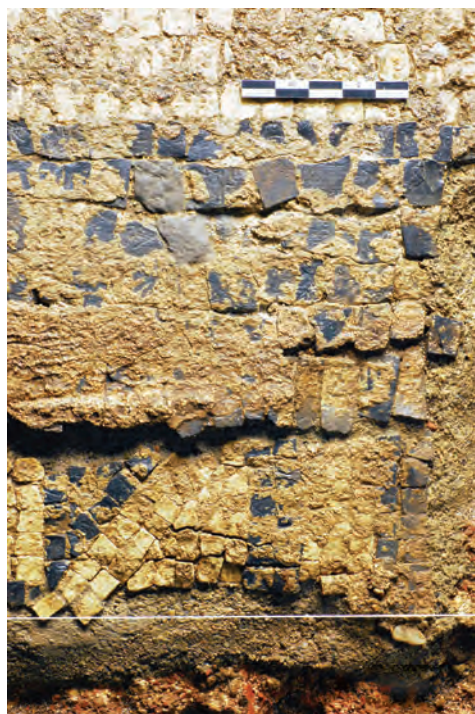
Fig. 4 a-b. La mosaïque est raccourcie en cours de pose: schéma géométrique (a) (Institut d'archéologie et des sciences de l'Antiquité (IASA) de l'Université de Lausanne), détail d'un fragment de la partie initiale et réfection de la bordure (b) (Site et Musée romains Avenches : SMRA)

est raccourcie pour faire place à une banquette ; sa bordure occidentale montre clairement une rupture, conséquence d'une adaptation du tapis original.

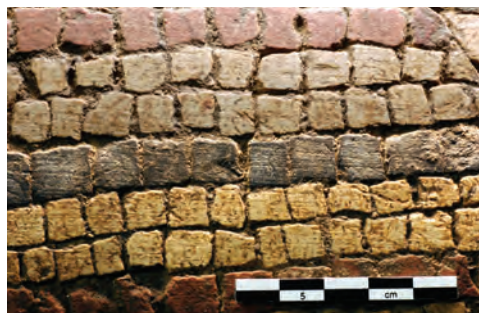
Fig. 5. Détail des traces de polissage antique (cliché : SMRA)

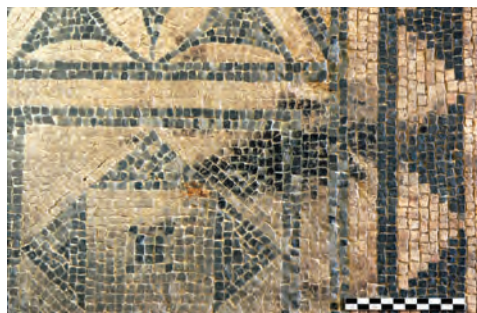
Fig. 6 a-b. Traces d'incendie sur les tesselles (a) et le lit de pose (b). (clichés: SMRA)

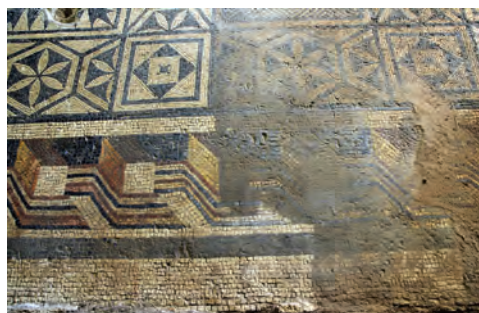
par endroits, obstrue une grande partie de la mosaïque : il s'agit de concrétions calcaires, probablement mélangées à des acides humiques et autres composants organiques (Fig. 7).

Fig. 7. Épaisse couche de concrétions calcaires dues à l'enfouissement de la mosaïque dans le terrain (vue au cours du dégagement mécanique) (cliché : SMRA)

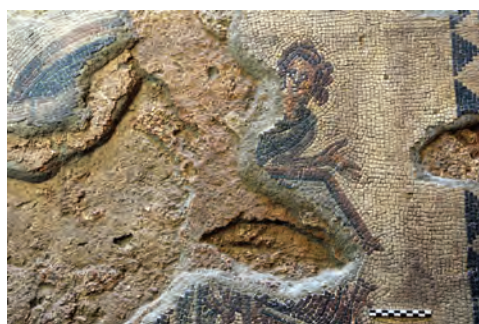
« blessures » livrent toutefois des informations précieuses sur le mode de construction du pavement (Fig. 8).

Fig. 8. Les labours en profondeur ont abîmé le tapis de la mosaïque (cliché : SMRA)

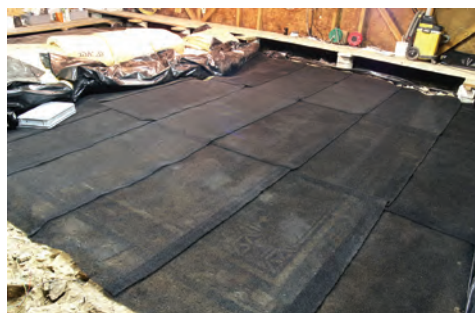
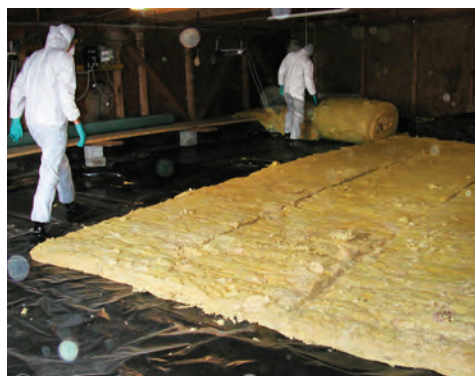
Fig. 9 a-b. Une couverture multicouche protège le pavement du dessèchement et des changements de température (clichés : SMRA)

En attendant sa mise en valeur pour le public, la mosaïque d'« Achille à Skyros » est protégée par un abri, sous couverture de conditionnement (Fig. 9 a-b).

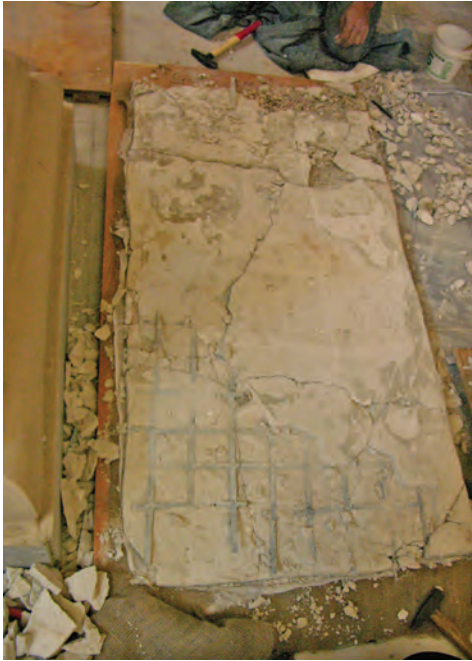
Fig. 2. Alexandrie, Musée gréco-romain : Pavement nilotique de Thmouis, plaque de ciment armé sous-jacente (en cours de restauration) (cliché : H. Tewfik, Archives CEALex)

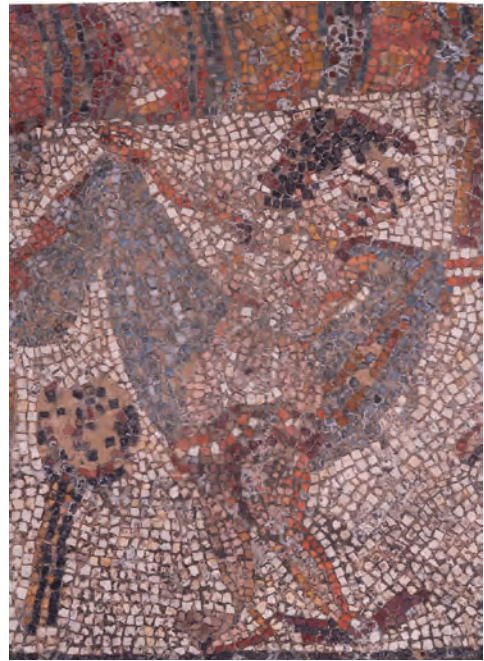
Fig. 3. Alexandrie, Musée gréco-romain : Pavement nilotique de Thmouis, détail de la danseuse avant le travail (cliché : A. Pelle, Archives CEALex)

qualités picturales dérivent des peintures d'époque hellénistique. Il convenait donc de nettoyer et de restituer le décor initial, dans la mesure du possible, tout en utilisant les tesselles du pavement (Fig. 3 et 4). Nous fûmes confrontés à deux problèmes majeurs : A/ le manque quasi complet de documentation relatif aux interventions précédentes : nous n'avons pu nous fonder que sur une photographie en noir et blanc, reproduite dans la publication initiale, et qu'il était difficile d'exploiter sous sa forme

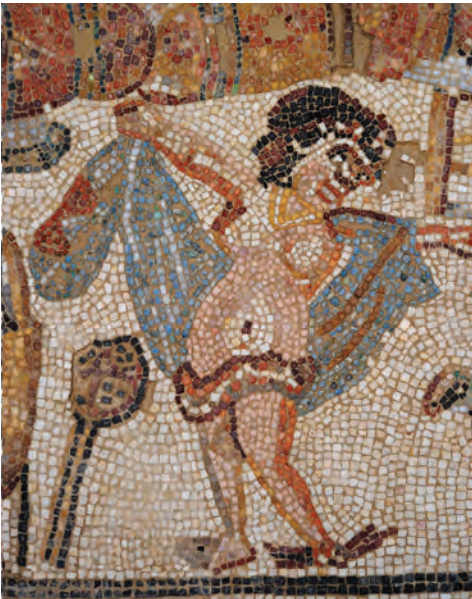
Fig. 4. Alexandrie, Musée gréco-romain : Pavement nilotique de Thmouis, détail de la danseuse (après restauration) (cliché : A. Pelle, Archives CEALex)

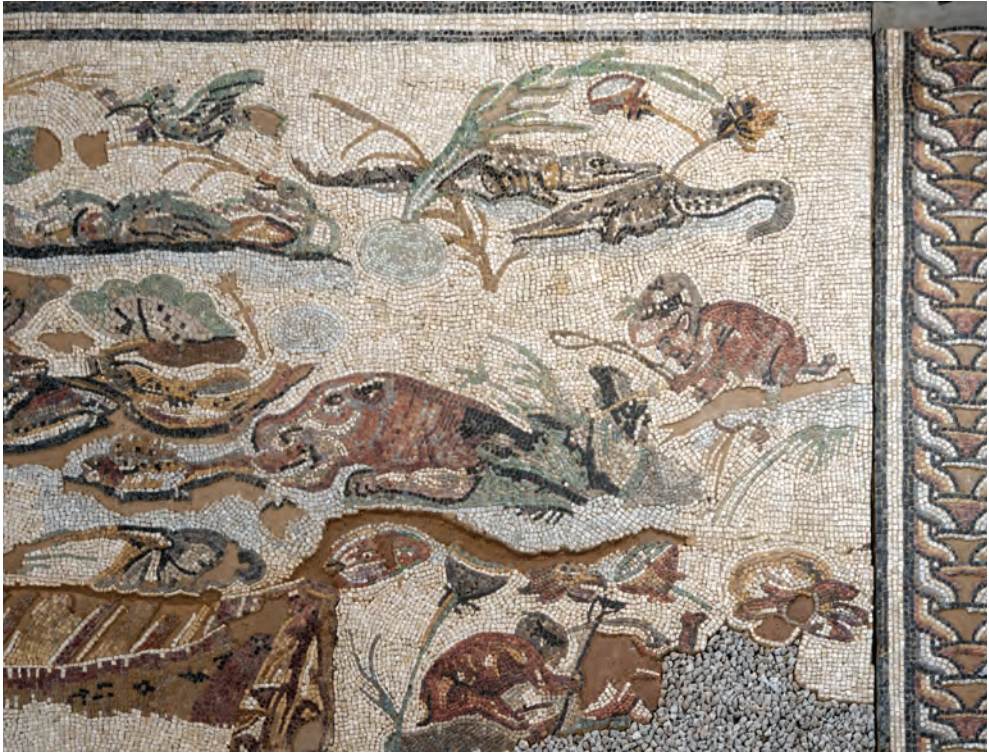
Fig. 6. Alexandrie, Musée gréco-romain : Pavement nilotique de Thmouis, angle droit du pavement (en cours de restauration) (cliché : A. Pelle, Archives CEAlex)

- Les tesselles ont été déplacées, l'image est brouillée, mais les tesselles sont en nombre suffisant et, à partir du cliché, il est possible de les réagencer pour restituer l'image initiale (exemples : la danseuse Fig. 3 et 4 ; le pêcheur, les tiges des fleurs Fig. 6).
- Les tesselles ont été déplacées, on ne voit à partir du cliché initial, mais les tesselles qui subsistent sont en nombre insuffisant : on réagence les tesselles

disponibles qui se sont détachées au cours de la suppression du ciment, et on laisse en lacune la partie dont les tesselles manquent (exemples : la partie supérieure de la corolle de profil du nelumbo de l'angle gauche ; dans l'angle droit, la bande de terre herbeuse sous le pêcheur ; pour d'autres plantes, on a pu restituer la file de contour, et laisser le centre en lacune, Fig. 6). A/ un élément de la composition a disparu, dans une zone qui est désormais détruite (ex : du « monstre » qui surgit de l'eau pour attraper le pêcheur, il ne reste plus qu'une portion de la tête, le reste est en lacune, Fig.

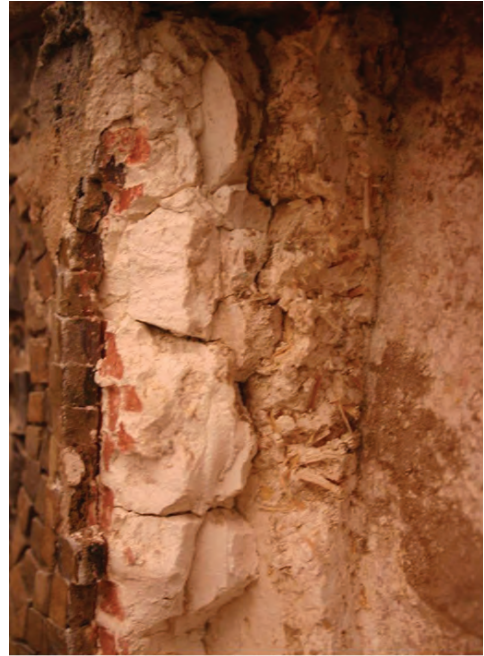
Fig. 3 Mosaic Stratigraphy (photo: M. Jbaee 2008, by permission of DGAM, Syria)

lime mortar mixed with powdered limestone and a large quantity of hay. The second layer, 2 cm thick, was then applied. It was composed of lime mortar mixed with powdered limestone but free of hay. This formed the ground for the artist or the mosaic worker onto which he first drew the subject with natural colours, the sinopia, and then placed the tesserae over these colours (Fig. 3).

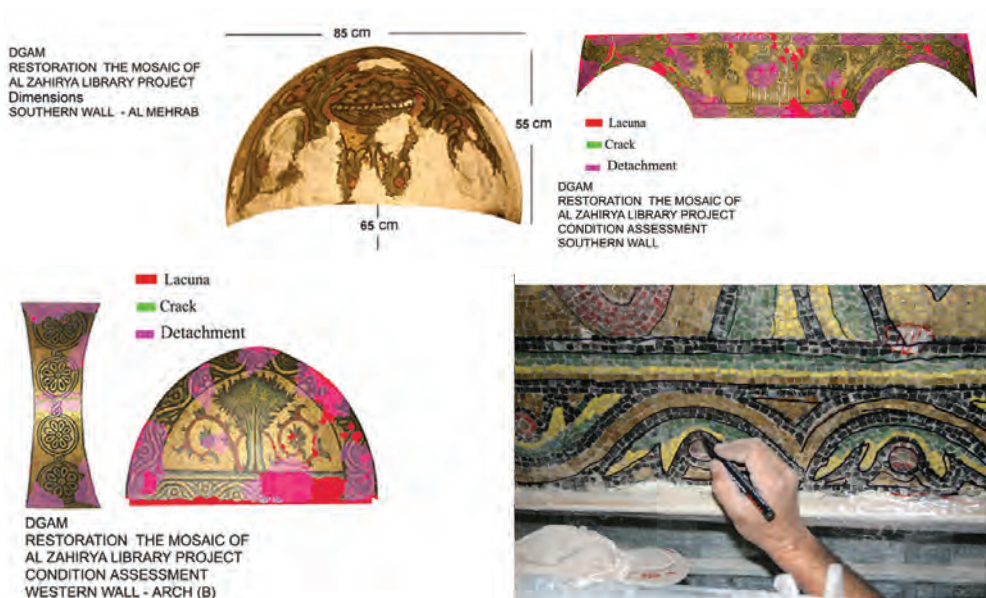
Fig. 6. Documentation (photos and drawings: M. Jbaee 2008, by permission of DGAM, Syria)

- Documenting the condition assessment (Fig. 6) as follows:
 - Photography of the entire mosaic, problems and particular details
 - Defining problems on the plans and on the photographs taken previously
 - Drawing the entire mosaic on nylon at a scale of 1:1.

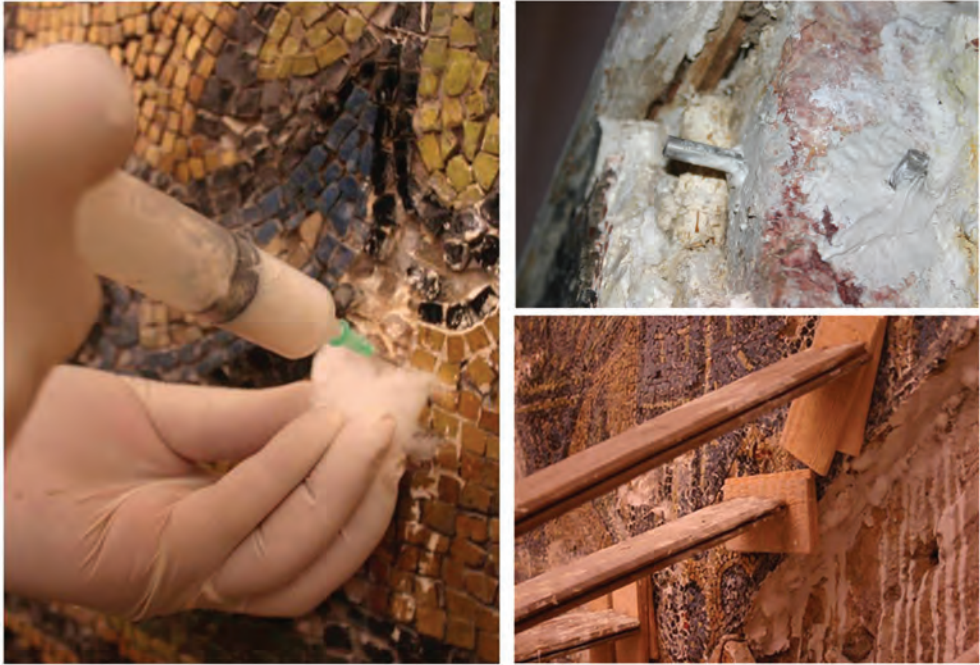
Fig. 7. Interventions-consolidation (photo: M. Jbaee 2008, by permission of DGAM, Syria)

- Simple cleaning of the surface of the mosaic, in order to remove dust and dirt, then consolidating all the detached parts by injecting mortar and acrylic resin between the tesserae, and the deeper layers (Fig. 7). In places with a high risk of collapse, we used wedges

of stainless steel to re-fix the layers of the mosaic to the wall, and these operations were accompanied with wooden support pieces pressed onto the detached parts of the mosaic in order to prevent bulging.

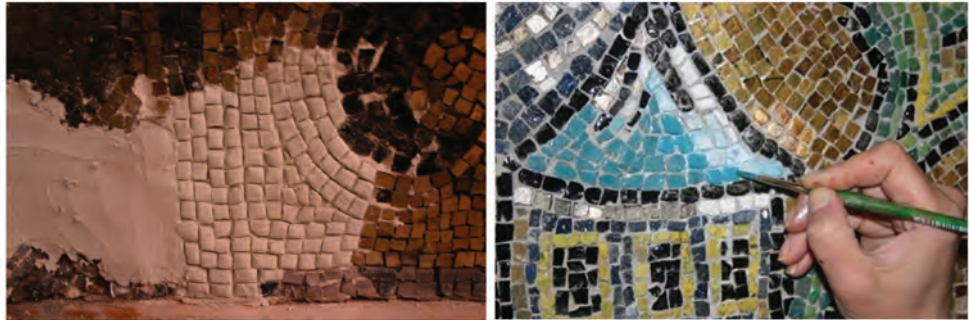
Fig. 9. Interventions-refilling of the lacunae and colouring (photo: M. Jbaee 2008, by permission of DGAM, Syria)

- Refilling the lacunae by using the previously fallen cubes, or by using mortar, as a replacement of the missing cubes, in order to create new cubes from mortar to be placed in the lacunae, and then coloured in suitable and harmonious colours, in the final phase (Fig. 9).

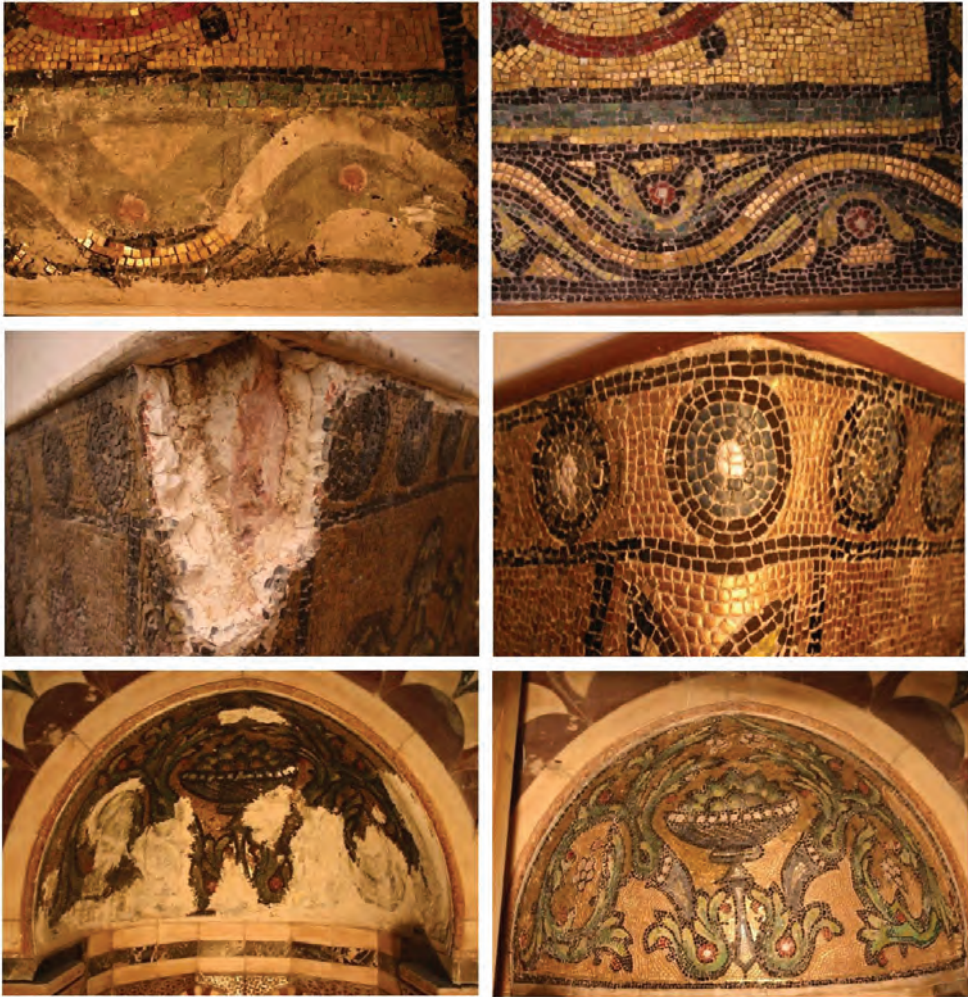
Fig. 11. Comparison-before and after (photo: M. Jbaee 2008, by permission of DGAM, Syria)

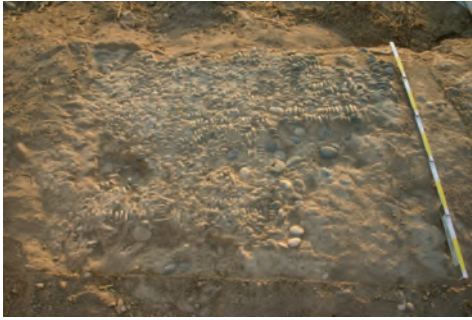
Fig. 2. The mosaic as excavated

This mosaic, dated to the 9th-8th century BC is very interesting because it is composed of black and white pebbles (Fig. 2). These are of oval form and 8-13cm long. They are fixed with a natural mud mixture to create different geometric shapes (concentric circles within the squares of a chequerboard). The surviving section that was detached measures approximately 1 m².

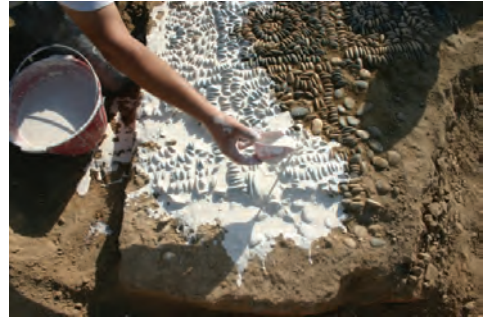
Fig. 3. Making the plaster mould

This kind of mosaic, because of the size and weight of the pebbles and gravel-bearing nature of the soil, requires a different method of detachment from the traditional one. A wooden box, 30 cm high, was designed, around the panel in order to make a mould of plaster (Fig. 3 and 4). Then the traditional way of detaching mosaics was applied: the edges and bottom of the panel were liberated, the surface was

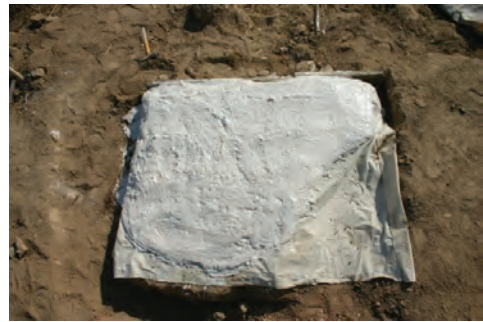
Fig. 4. The mosaic in the mould

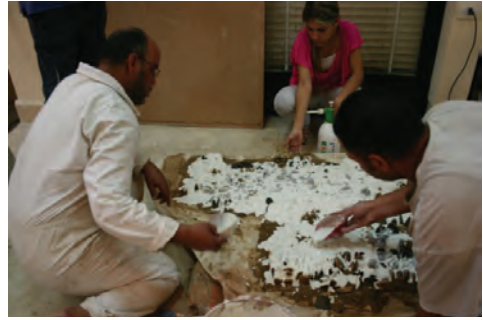
Fig. 8. New backing with hydraulic mortar

- A layer of soil was removed from the back, bearing layer, to a depth of 6 cm (Fig. 7) and replaced by new mortar (hydraulic lime, Primal, sand free of salt, crushed brick and water) (Fig. 8).
- The restoration work required a support plate, and for this reason we have been working on a support – under experi-

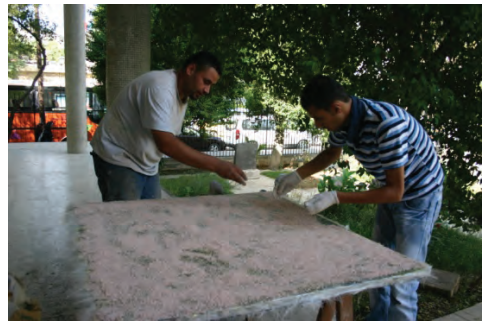
Fig. 9. Roughing the surface of the support

- The support that carries the mosaic consists of sheets of aluminium and foam

material (Fig. 9). After treatment, the panel was fixed on the board (Fig. 10) with a layer of fiberglass, resin and soft

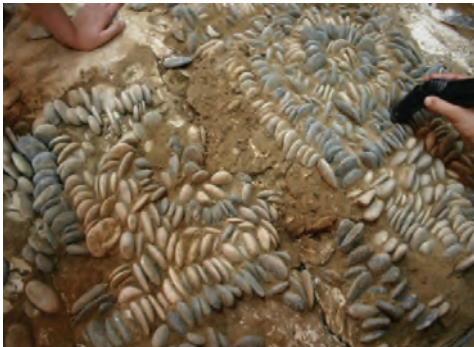
Fig. 7. Cleaning the soil from the back

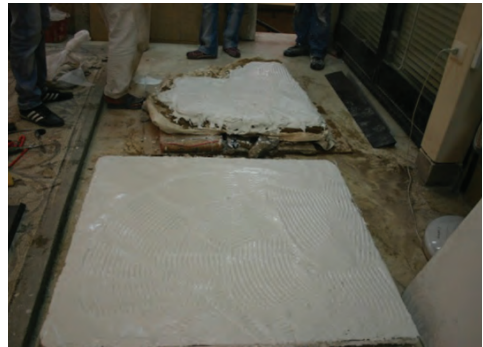
Fig. 10. Putting the mortar on the board and panel

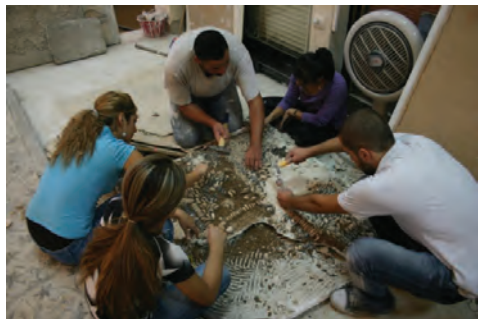
Fig. 11. Cleaning the gypsum from the surface

- The dry plaster was cleaned (Fig. 11) with plastic brushes and an air compressor in order to remove the remnants of soil, and a layer of mortar and gravel was added. Some missing parts were remade (Fig. 12 and 13). Finally a protective layer of beeswax was added. After the addition of a metal frame, the mosaic was placed in the Ancient Near East Department of Aleppo Museum (Fig. 14).

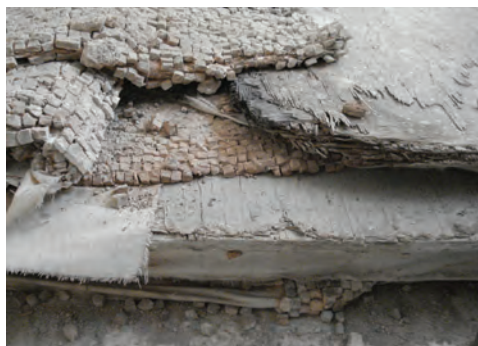
Fig. 2. Lifted mosaics piled in storage without any protective padding

often without any separation padding between the boards (Fig. 2). The most usual padding used between mosaic panels for transfer or storage was cushioning polyester foam, which often deteriorates and stains the mosaic surface.

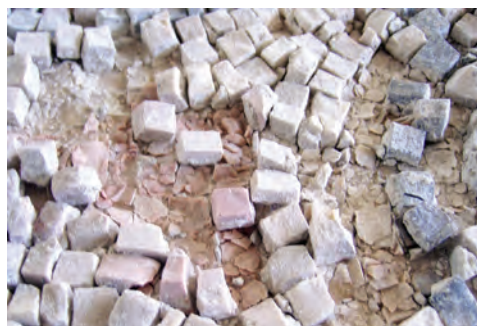
Fig. 3. Remains of tesserae, which have been broken and lost due to the pounding of the *tesselatum*

- a. Mechanical damage from pounding has caused severe cracking of the tesserae, loss of their edges, or their total loss. In several areas the tesserae are cracked or completely broken and in many cases only a thin flake or small fragments from the surface remain attached to the facing cloth. The main body of the tesserae is either sitting loose above these fragments or has been completely lost (Fig. 3).

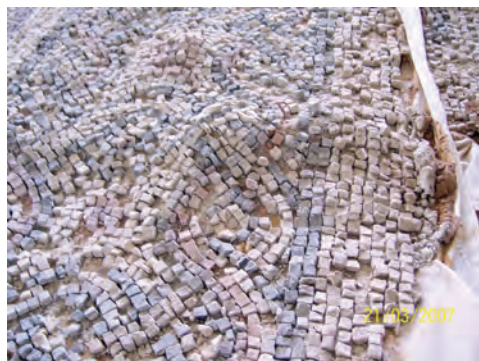
Fig. 4. Several tesserae lying loose and displaced on the rear of the mosaic

- b. A large number of loose tesserae are found on the back surface of the mosaics as a result of inappropriate packing and transfer of the lifted mosaics. The condition is usually worse in mosaics that have been stored in rolls, as additional stresses are imposed which cause the loosening and disorder of the *tesselatum* (Fig. 4).

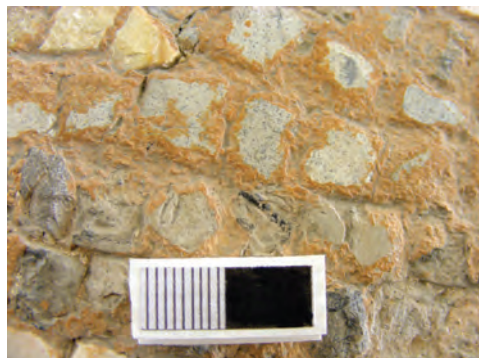
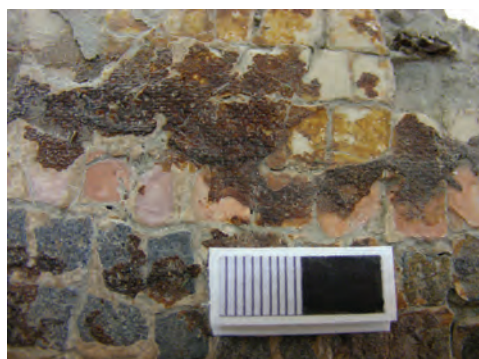
Fig. 5. Remains of rubber glue covering most of mosaic surface

Fig. 6. Deteriorated remains of rubber glue

- c. Deteriorated rubber glue remains have caused discoloration of the mosaic surface, which is affecting the legibility of the mosaic and creates aesthetic problems (Fig. 5 and 6).
- d. The strong adherence of the glue and the difficulty in the removal of the facing cloth has often caused loss of tesserae edges and corners, loss of flakes or scales from the surface and loss of the original mortar between the tesserae (Fig. 7). The result is a mosaic surface with rounded and cracked tesserae (Fig. 8).

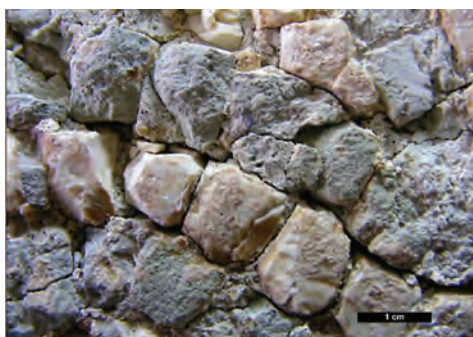
Fig. 8. Rounded and cracked tesserae after the loss of edges and corners

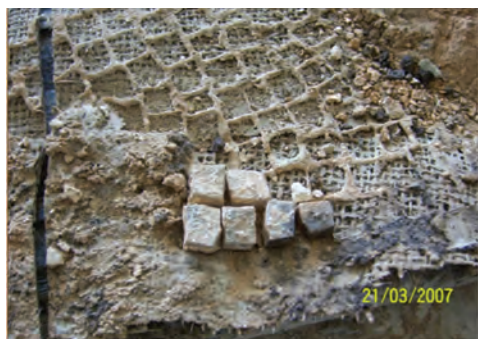
Fig. 9. Inappropriate facing fabrics, i.e. burlap, do not adhere well to the *tessellatum*

- e. Rubber glue has deteriorated and has lost its adhesive properties. As a result, the tesserae have become loose and in most cases they have been lost. Their imprints and flakes of the stone surface still remain on the facing cloth.
- f. Tesserae loss, due to the use of inappropriate coarse facing cloths has been identified in several cases (Fig. 9).

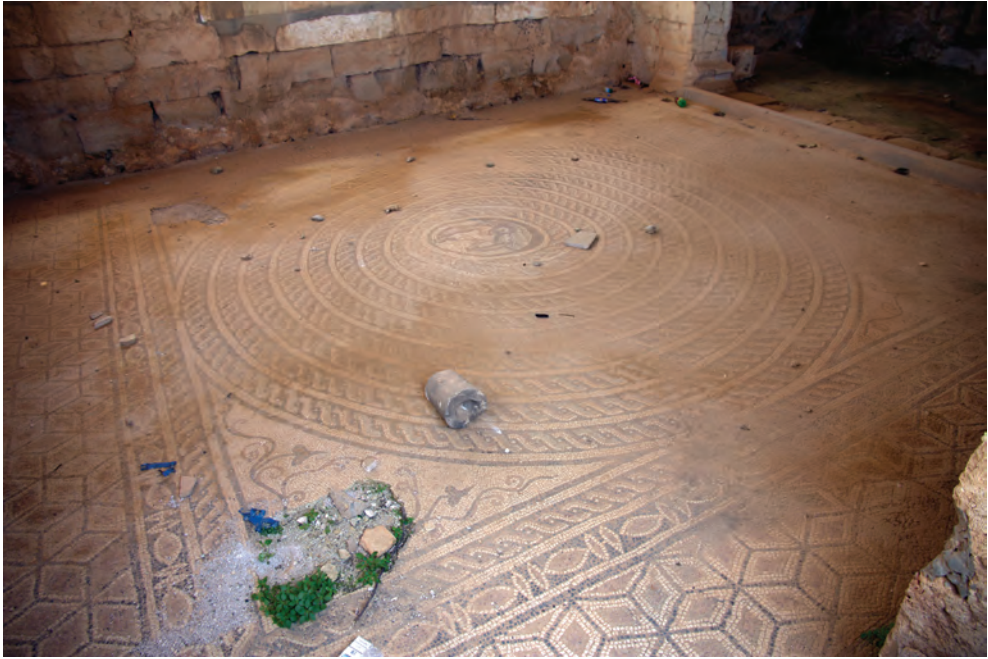
Fig. 1. Overview of the Seasons mosaic within its cover building, House of Jason Magnus, Cyrene (photo: W.T. Wootton)

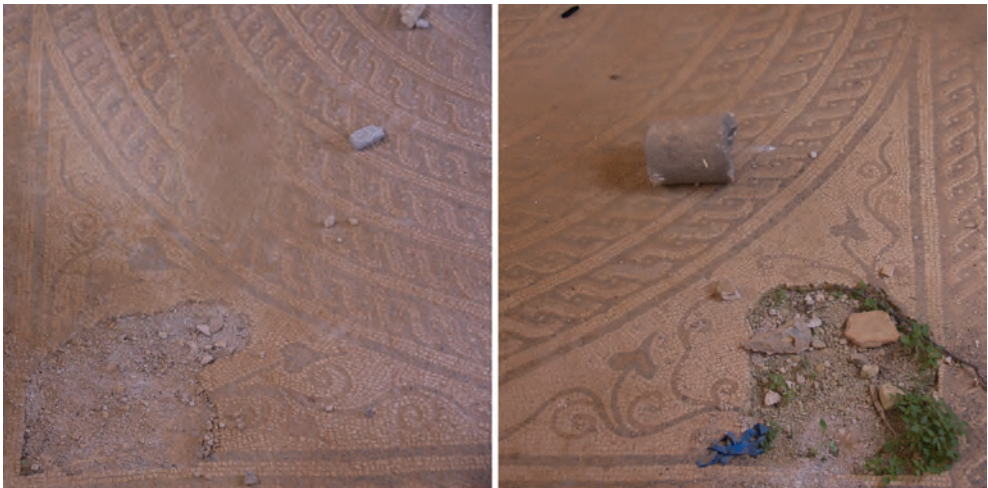
Fig. 2. Details of the removed spandrels, Spring to the left and Winter to the right, the Seasons mosaic, House of Jason Magnus, Cyrene (photo: W.T. Wootton)
