MANAGING ARCHAEOLOGICAL SITES WITH MOSAICS: FROM REAL PROBLEMS TO PRACTICAL SOLUTIONS

THE 11TH CONFERENCE OF THE INTERNATIONAL COMMITTEE
FOR THE CONSERVATION OF MOSAICS, MEKNES, OCTOBER 24-27 2011

edited by
Demetrios Michaelides and Anne-Marie Guimier-Sorbets

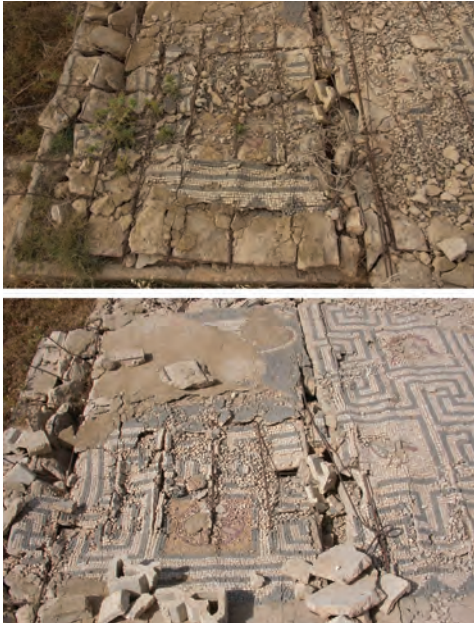
Fig. 4. Mosaic 16, below in 2005 and above in 2012, Sidi Khrebish, Benghazi (photo: W.T. Wootton)

ted pavements, one *emblema* and one *opus sectile* floor were uncovered (Michaelides 1988), some of which were then lifted by the Libyan authorities, re-laid onto concrete reinforced with iron, and moved together to form a new suite of pavements. Two mosaics found at the entrance to the Turkish cemetery in 1965 had already been lifted by the Department of Antiquities prior to these excavations (Lloyd 1985, 11). Comparison to the published excavation photographs shows the rate of deterioration, while photographs taken in 2005 and 2012 indicate its acceleration in some cases. Compare for example Fig. 4 and 5 to Michaelides 1998, no. 16, fig. 39-45, col. pl. II-III, and no. 25, fig. 62, 75-87, 89, col. pl. IX-XV.

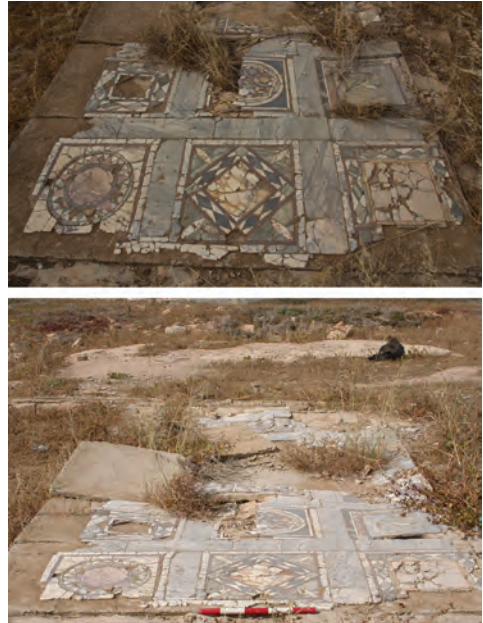
Fig. 5. Pavement 25, below in 2005 and above in 2012, Sidi Khrebish, Benghazi (photo: W.T. Wootton)

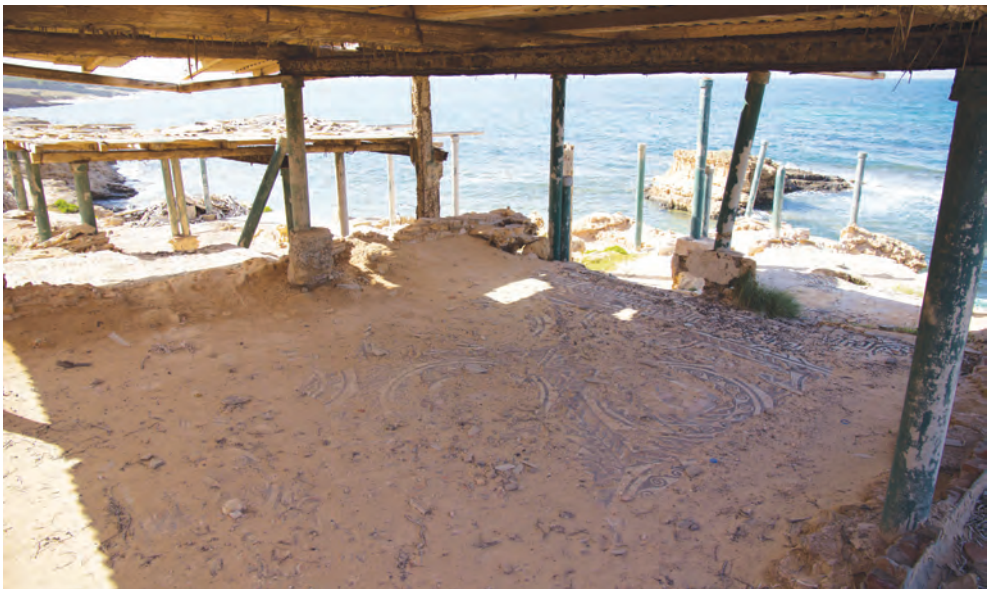
Fig. 6. View of the covered mosaics at the Villa of the Nereids at Tajourah (photo: W.T. Wootton)

The severity of the situation at many Libyan sites – the Villa of the Nereids at Tajourah is particularly critical (Fig. 6) – demands swift and decisive action (Di Vita 1966; Mattingly 1995, 141 (“Taggiura”); Kenrick 2009, 142). Any remedial work, however, should be part of a wider programme of condition assessment so that the Department can make informed decisions about the allocation of funds at local, regional and national levels based on an understanding of the scale of the problem. This will not only require time and specialist knowledge but also innovative solutions; John Stewart’s proposal to train site managers and archaeologists to undertake rapid surveys, for example, could be usefully tested (see Stewart 2017). During this process appropriate long-term preventive measures should also be identified. An initial survey of lifted mosaics in Libya was completed in association with Mosaikon before the conference was held (Antomachi and Abend 2017, report on the project although without the Liby-
