WHAT COMES TO MIND WHEN YOU HEAR MOSAIC? CONSERVING MOSAICS FROM ANCIENT TO MODERN

PROCEEDINGS OF THE 13TH CONFERENCE OF THE INTERNATIONAL COMMITTEE
FOR THE CONSERVATION OF MOSAICS, BARCELONA 15-20 OCTOBER 2017

What comes to mind when you hear mosaic? Conserving mosaics from ancient to modern
The 13th conference of the International Committee for the Conservation of Mosaics
Barcelona 15-20 October 2017

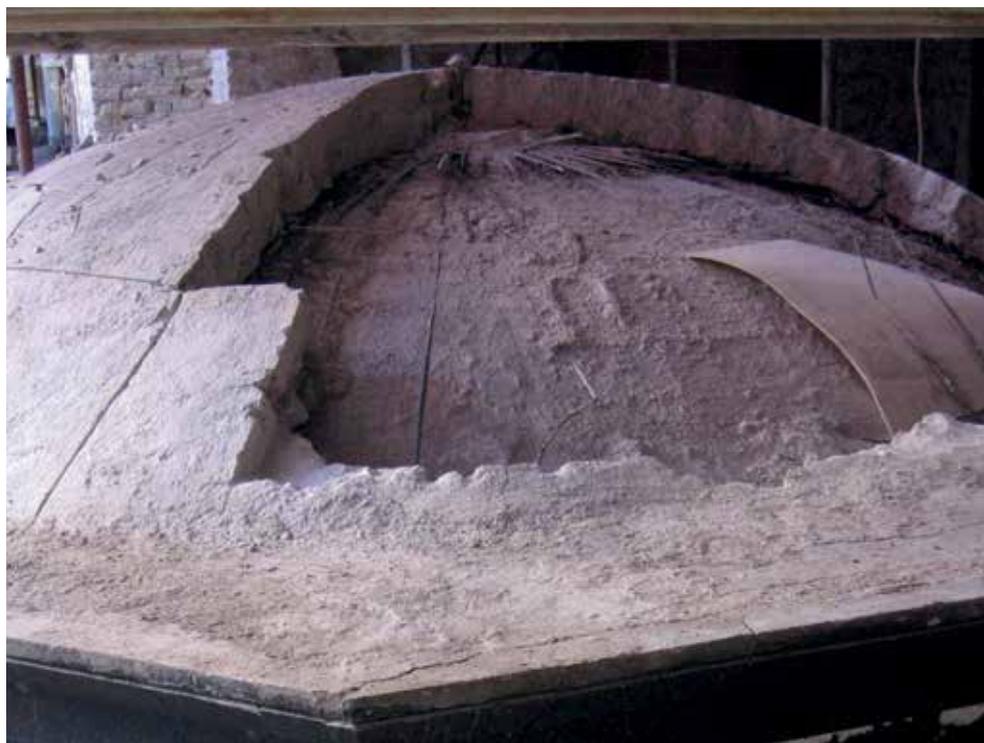
Fig. 5. Ziller-Loverdos mansion, vault mosaic, severe damage of mosaic substrates (photo Hellenic Ministry of Culture and Sports)

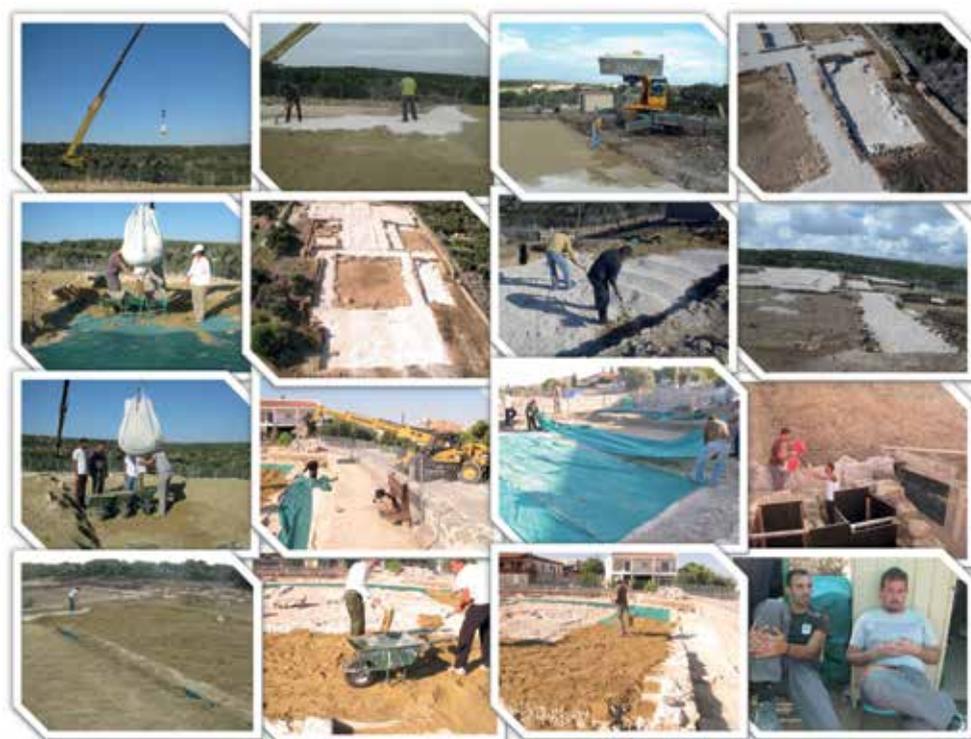
Fig. 8. Reburial methods and techniques (Department of Antiquities of Cyprus)

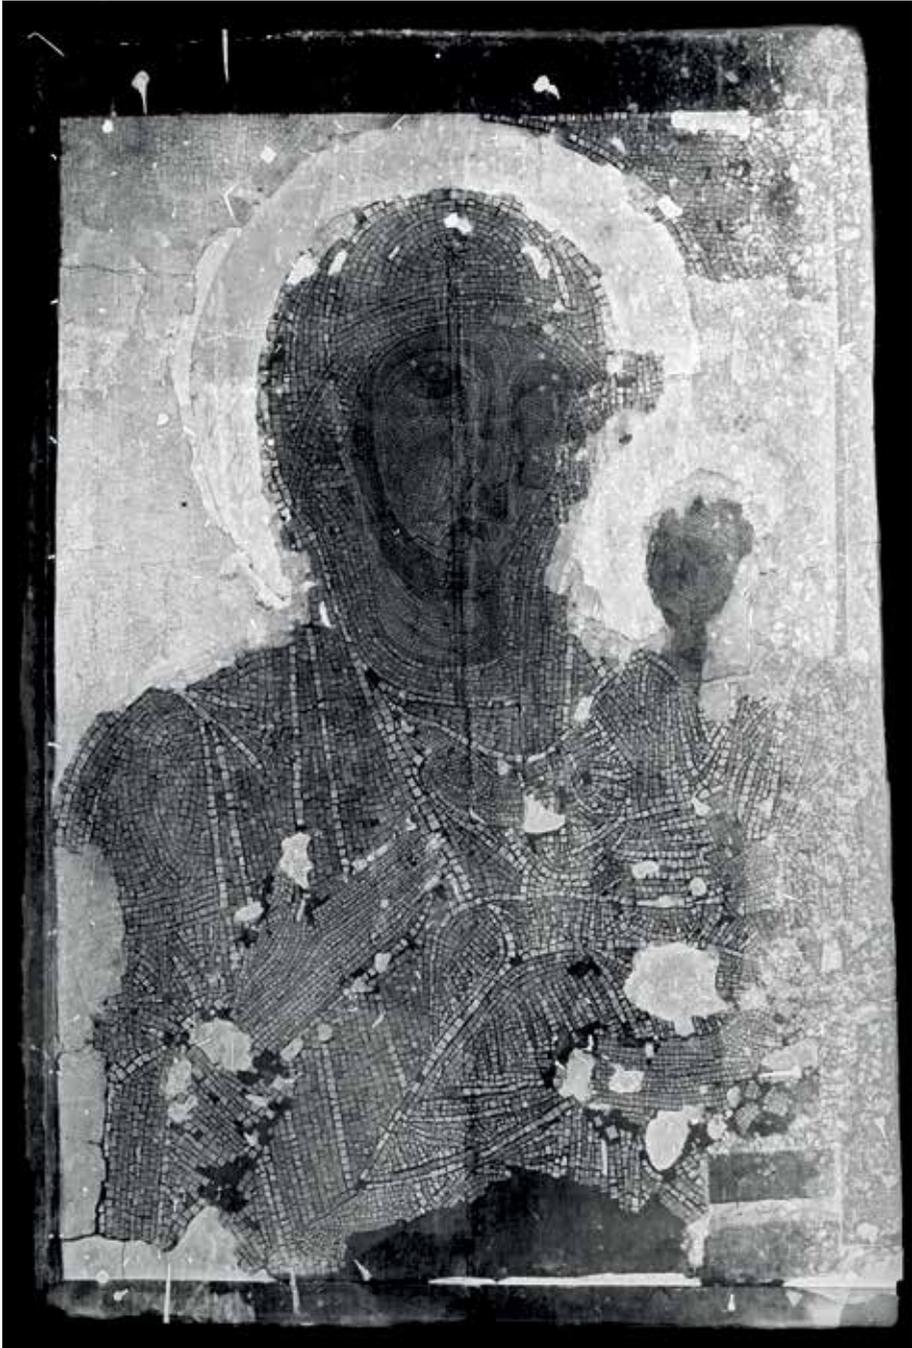
Fig. 6. X-Ray image of the icon, 15 sections merged and enhanced in Photoshop, Energy 55-60kV, Tube Current 0,2-0,63mA, Exposure Time: 20sec-3mins

In April 2015, the icon was transferred to the Balikli Greek Hospital to be examined with radiographic techniques. The resulting X-ray image of the icon comprises of fifteen digital radiographs, which were provided in DICOM format, 17.5 MB each, and viewed in Canon CXDI Light Viewer Version 1.0.0.06. A low tube voltage setting of 60 kV and 3 mA tube current was recommended to the operator, based on the published examples of the British Museum Mexican masks, which consist of similar materials (Lang *et al.* 2005: 41). After a series of tests the operation conditions were adjusted: the energy ranged from 55 to 60 kV, the X-ray tube current from 0,2 to 0,63 mA, and the exposure time from 20 secs to 3 mins. Exposure time was significantly lower at

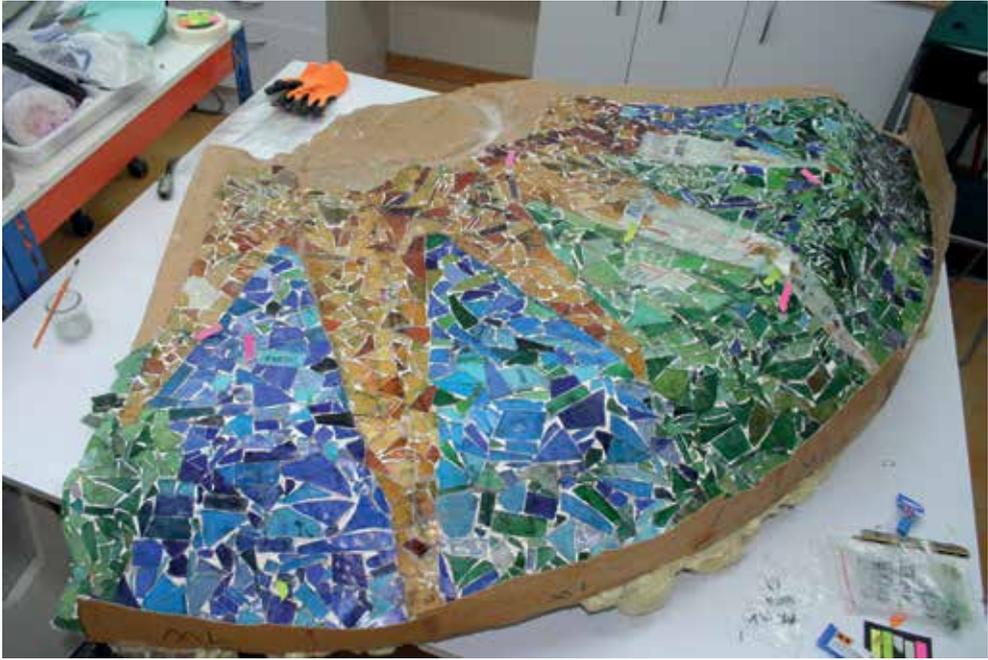
Fig. 8. Preparation of sections for reinstallation in the mould (photo Gamarra & Garcia)

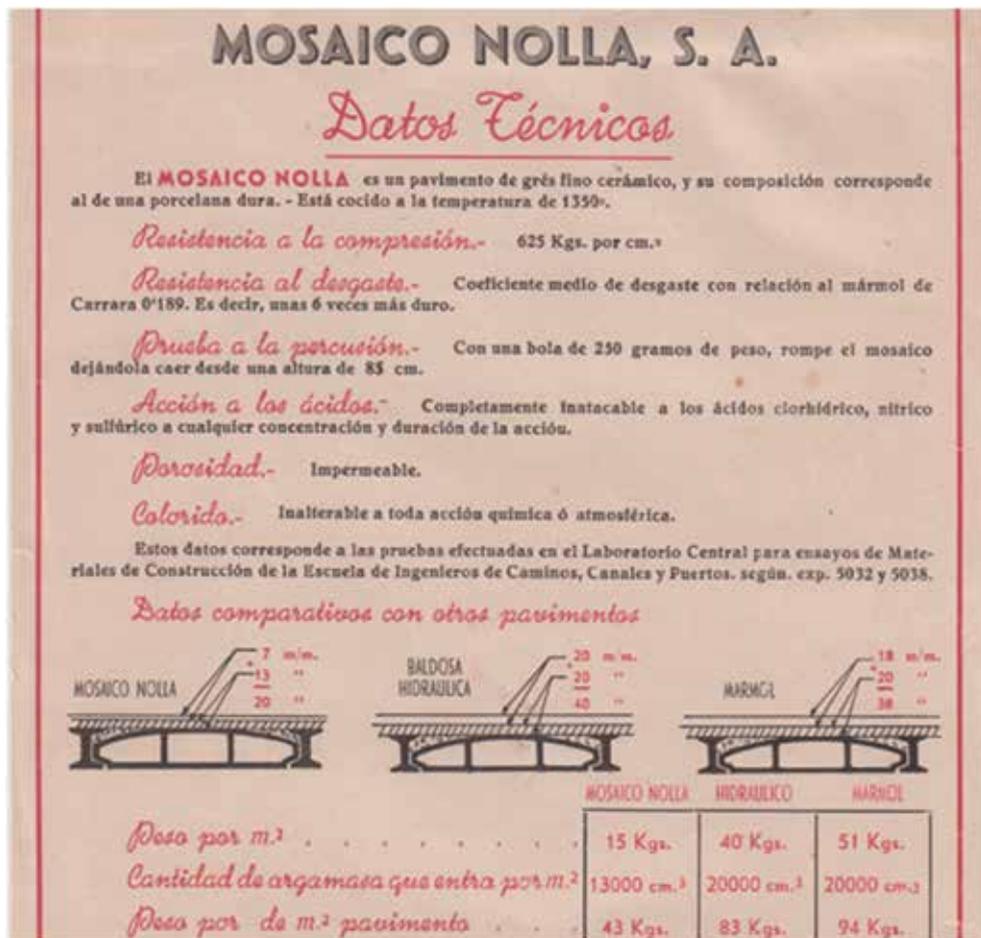
Fig. 6. Physical characteristics of Nolla tile, described in a factory catalogue (CIDCeN)

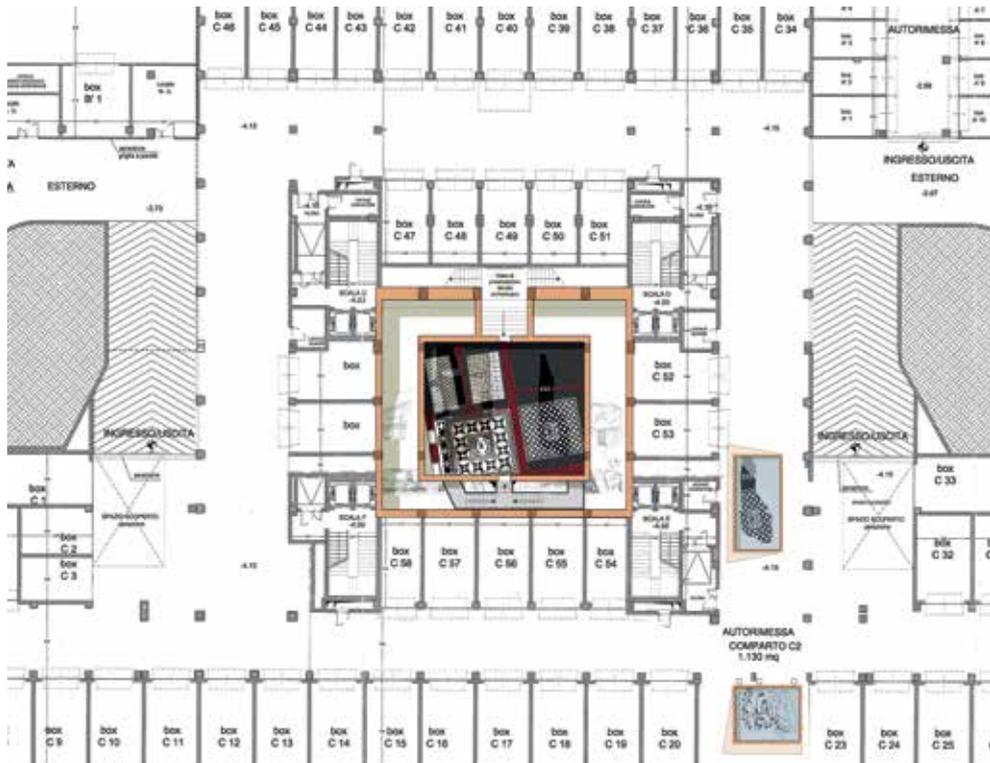
Fig. 5. Plan of the first version of the 'archaeological box' (processed drawing Stefano Borghini)

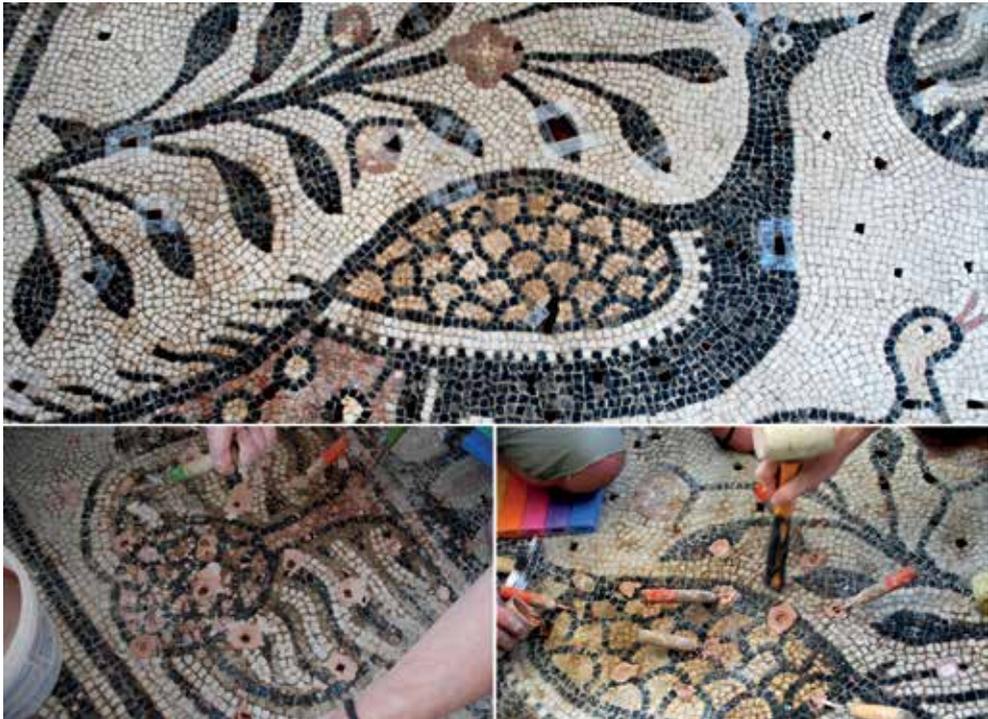
Fig. 9. Consolidation of baptistery mosaic by injection of mortar (photos M. Tutkovski)

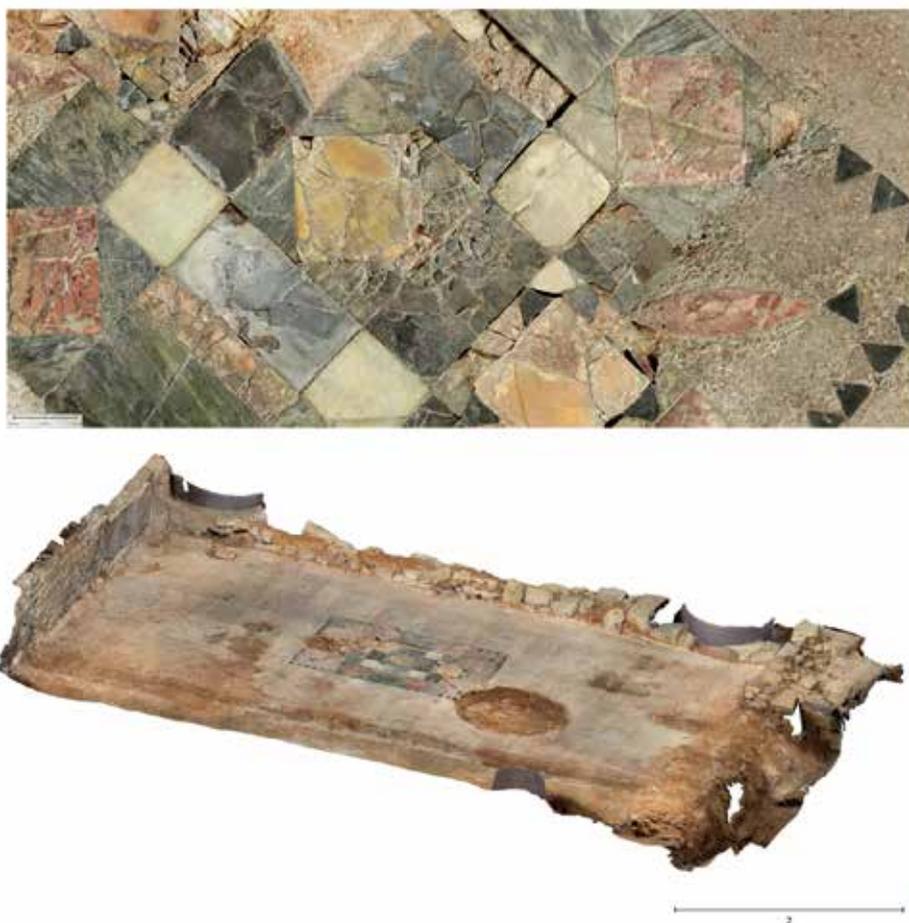
Fig. 3. Top: orthomosaic with 0.0003m GSD; Bottom: textured 3D model (photo by authors)
