WORCESTER COLLEGE CHAPEL, OXFORD MOSAIC PAVEMENT DESIGNED BY WILLIAM BURGESS

T
W
O
M
O
S
A
I
C
S
F
R
O
M
E
N
G
L
A
N
D

HORNIMAN MUSEUM FACADE, LONDON HUMANITY IN THE HOUSE OF CIRCUMSTANCE A MOSAIC MURAL BY ROBERT ANNING BELL

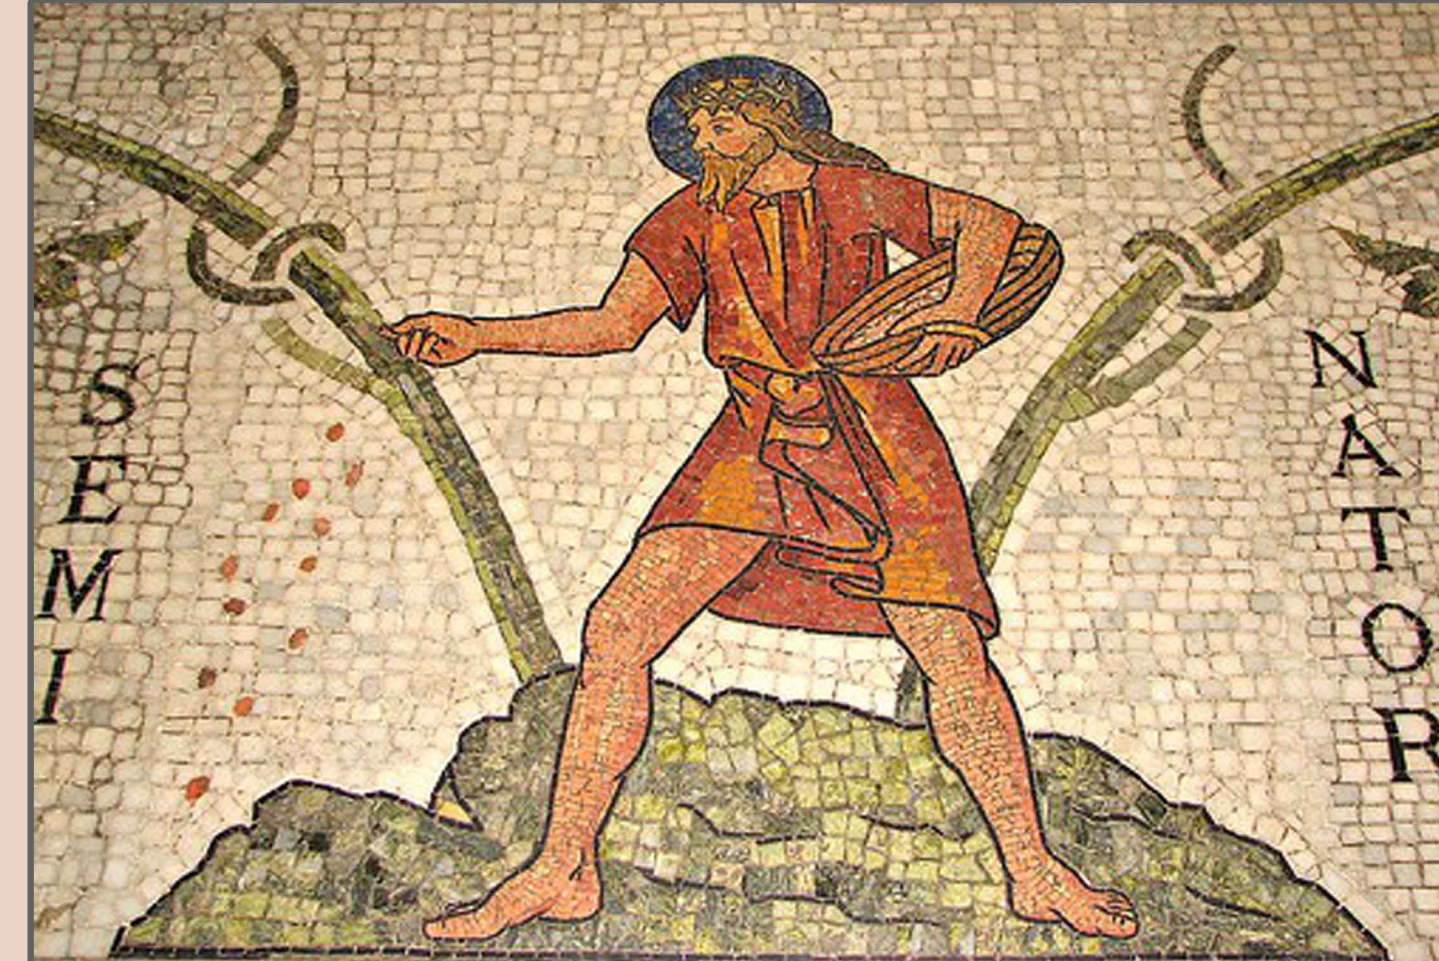
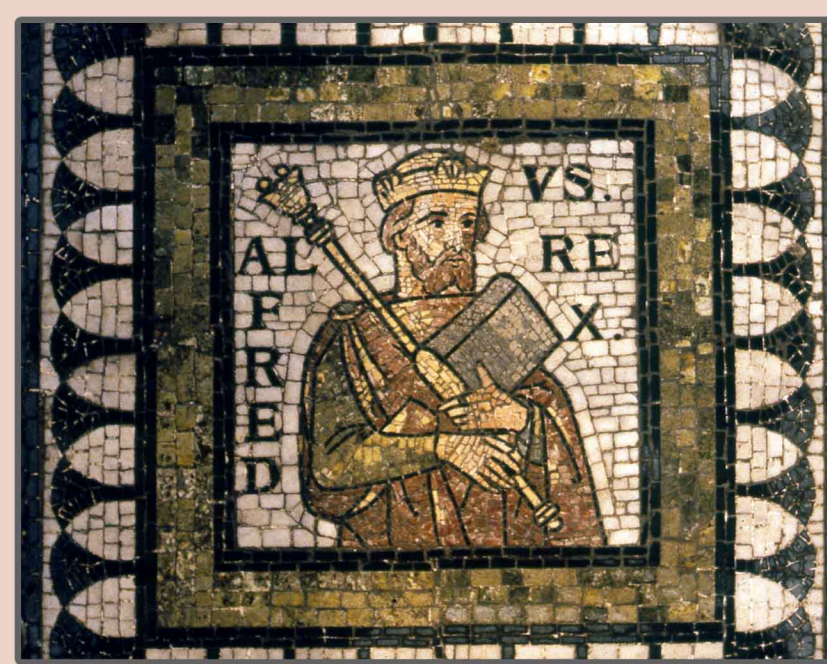
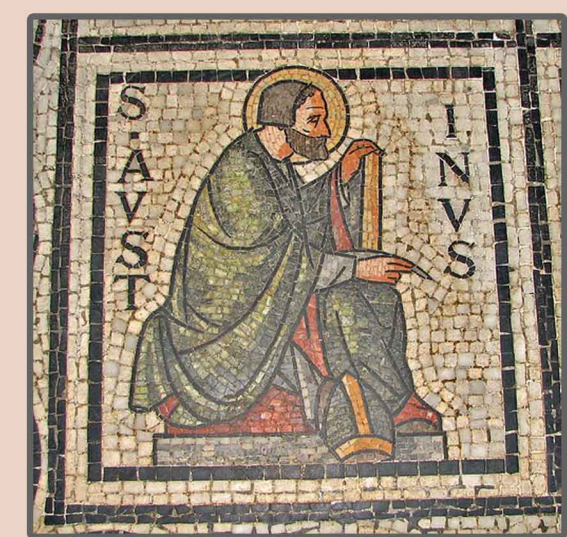
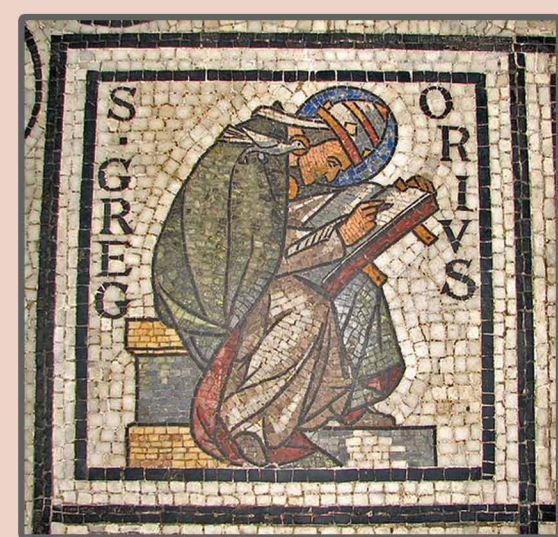
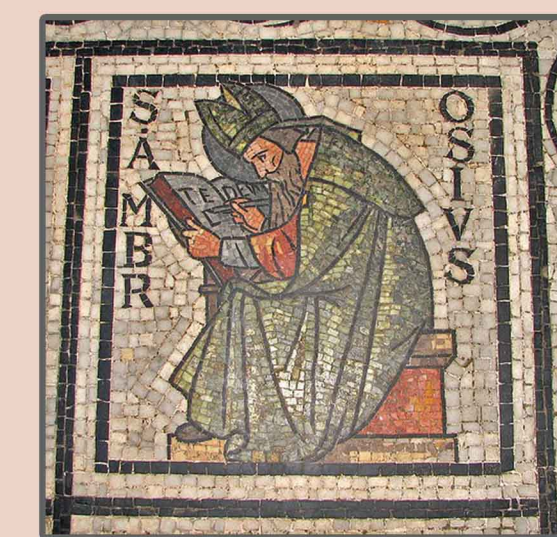
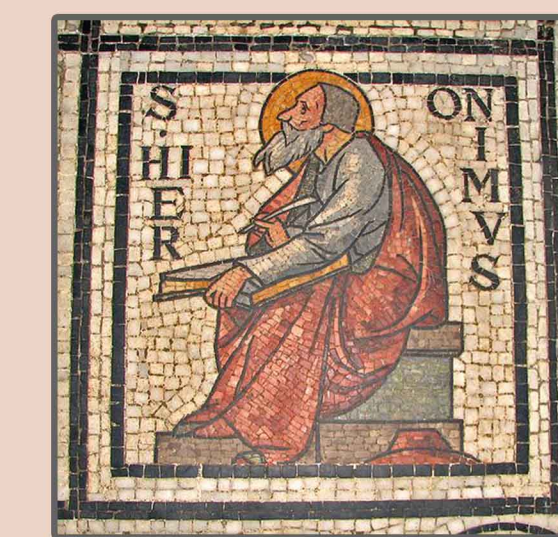
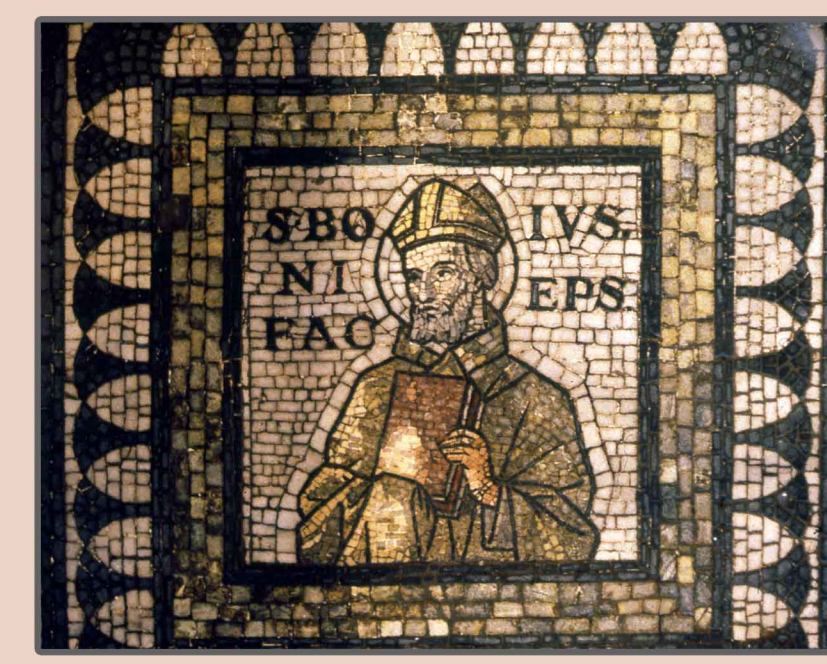
THE CONDITION OF THE PAVEMENT IN 1981:

THE FIRST SECTION OF THE FLOOR, BY THE ENTRANCE SHOWED THE HEAVIEST WEAR, WITH SECTIONS BREAKING AWAY INTO LACUNAE WHICH HAD BEEN REPAIRED IN THE PAST. THE MOST WORKING PROBLEM WAS THAT THE TWELVE EMBLEMA DESIGNED TO HAVE BEEN MADE INTO PRE-FABRICATED PANELS WHICH HAD SETTLED AT DIFFERENT ANGLES TO THE GEOMETRIC INFILL WHICH APPEARED TO HAVE BEEN INSTALLED USING THE "REVERSE" METHOD. ALSO, DAMP WAS RISING AND WEAKENING THE MORTAR, UNDER THE GUILLOCHE AND GEOMETRIC AREAS. THE OTHER TWO PANELS WERE IN A MUCH BETTER CONDITION AND SEEMED TO SHOW THAT THEY WERE FIXED BY THE "REVERSE" METHOD ONLY.

AS THE CHAPEL WAS IN CONTINUOUS USE AND BECAUSE OF THE CLEAR DETERIORATION OVER TIME, IT WAS DECIDED TO LIFT THE WESTERN PANEL AND RELAY INTO A LIME-BASED HOMOGENEOUS MORTAR, ONTO A NEW BASE; THE BASE WAS CONSTRUCTED OF 100MM OF STAINLESS STEEL REINFORCED CONCRETE SCREED LAID ONTO A DAMP-PROOF MEMBRANE.

FIRST THE FLOOR WAS CLEANED THOROUGHLY AND THEN A HEXAGONAL WEAVE COTTON MESH WAS GLUED TO THE SURFACE USING A SPECIAL PVA ADHESIVE WHICH WOULD RE-EMULSIFY AND SOFTEN EASILY WHEN WATER IS APPLIED DURING THE RELAYING PROCESS.

A REGISTRATION GRID WAS SET OUT ON SEASONED WOODEN BATTENING, (THE SAME BATTENING TO BE REASSEMBLED FOR THE RELAY TO MINIMISE ERROR), AND TRANSFERRED TO THE DRIED SCRIM BEFORE LIFTING. A DRAWING IS MADE AND RECORD PHOTOGRAPHS ARE TAKEN BEFORE AND AFTER "SCRIMMING."

THE MOSAIC WAS THEN LIFTED IN SECTIONS, INDIVIDUALLY MARKED AND PLOTTED ONTO THE MASTER PLAN. IT WAS CONFIRMED THAT THE EMBLEMA WERE MOUNTED ON PANELS OF BOTH SLATE AND LIMESTONE.

CONSOLIDATION WORK AND A SUB-FLOOR WAS INSTALLED READY FOR THE RELAY. THE MIX USED FOR THE RECEIVING BED WAS COMPRISED OF LIME, WHITE CEMENT, PORTLAND CEMENT AND SHARP WASHED SAND IN THE FOLLOWING PROPORTIONS: 4:1:1:1. THE GROUT WAS MIXED IN THE RATIO OF 4:1:1 WITH NO SAND ADDED. THE COST OF THE WORK WAS ABOUT £20,000.

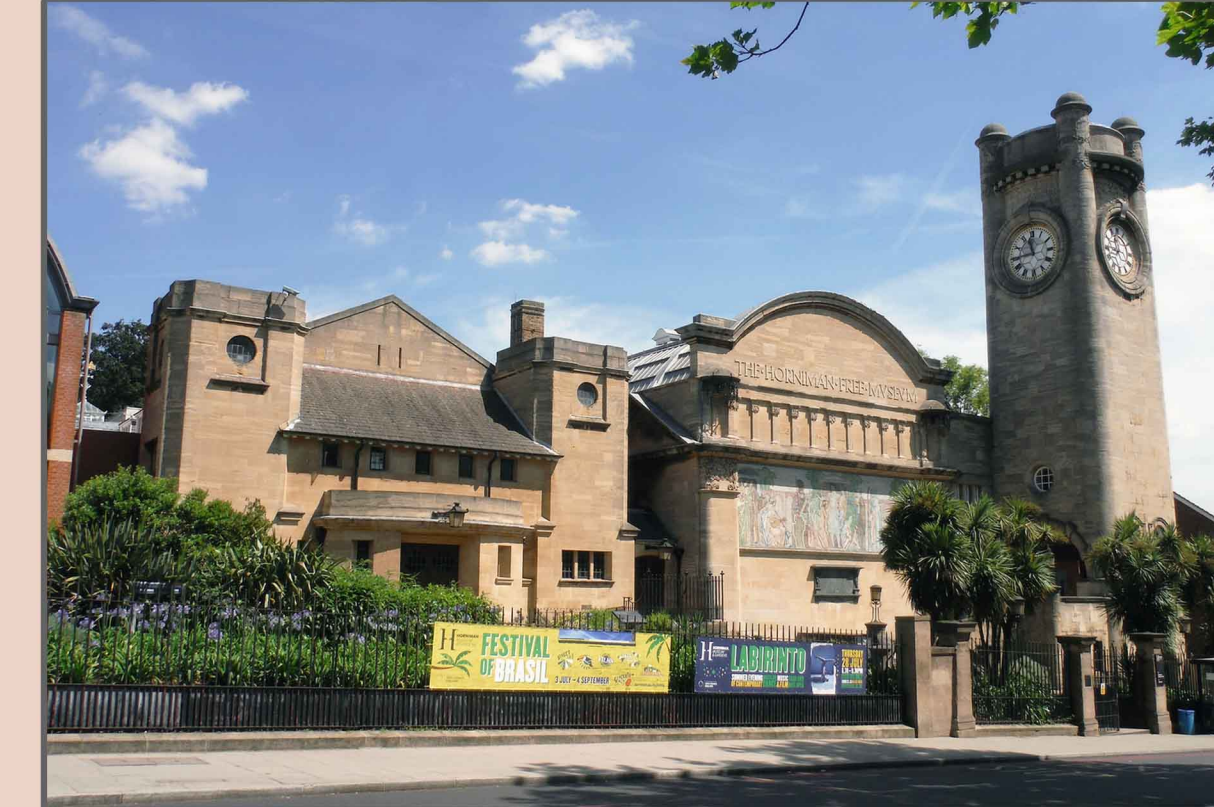
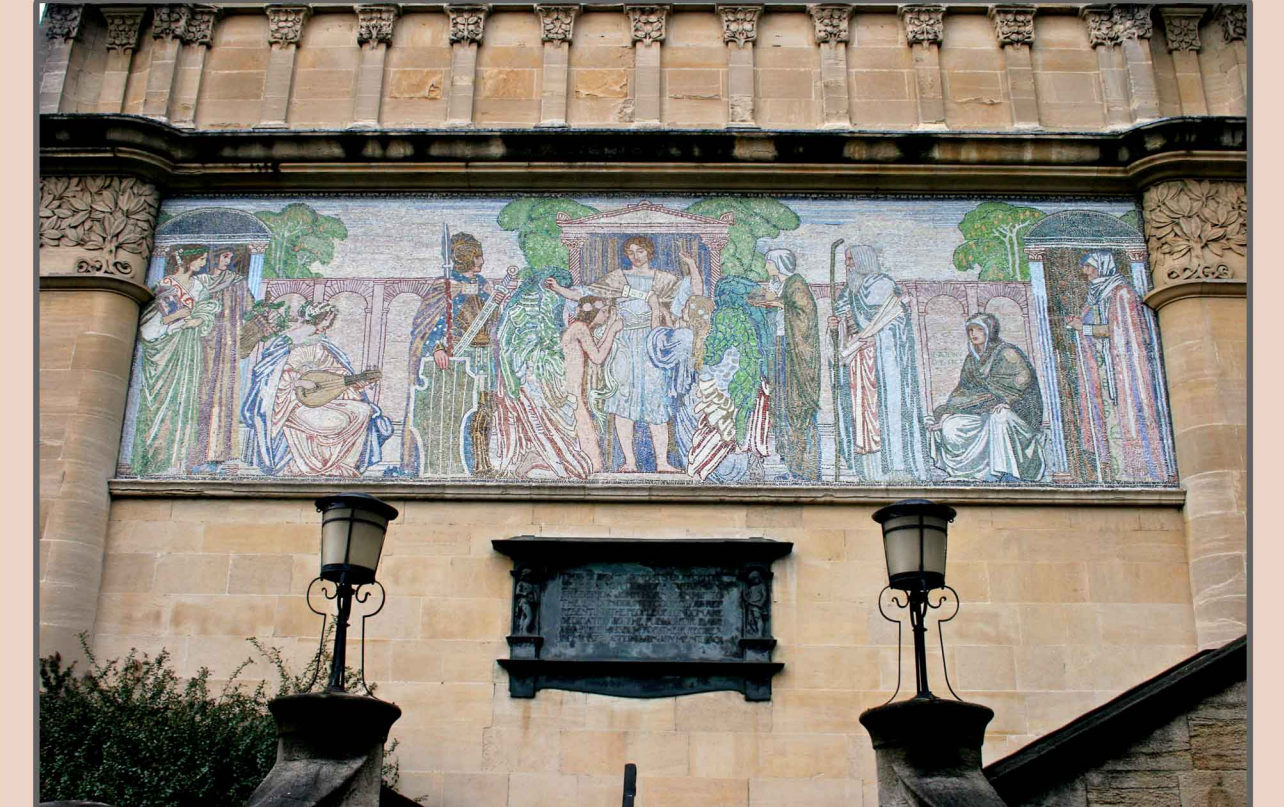
THE CONDITION OF THE MURAL IN 1984:

ORIGINALLY THE TESSERAE HAD BEEN FIXED BY PRESSING THEM INTO A MIX CONTAINING LIME AND BOILED LINSEED OIL; THE OIL WAS IN A HIGH PROPORTION, PERHAPS WITH THE INTENTION OF INCREASING WATER RESISTANCE IN DEFENCE OF ITS EXPOSED EXTERIOR SITING.

UNFORTUNATELY, AS THE MUSEUM BUILDING IS MADE OF POROUS STONE, AND MORE PROBABLY OWING TO PERIODS OF ILL-MAINTAINED DRAINAGE, WATER, BUILT UP BEHIND THE PUTTY/OIL MIX AND WAS PREVENTED FROM DISSIPATING BY THE OIL CONTENT. THIS MEANT THAT IN PERIODS OF FREEZING WEATHER, OWING TO ICE CRYSTAL EXPANSION, THE BEDDING BECAME DETACHED FROM THE BUILDING IN PARTS, LOOSENING TESSERAE, AND THREATENING TO FALL IN LARGER SHEETS WITH PUTTY ATTACHED.

PRIOR TO THE 1984 INSPECTION, MANY REPAIRS HAD BEEN CARRIED OUT BY THIRD PARTIES, SOME OF WHICH WERE QUITE LARGE. THESE REPAIRS IN CEMENT BASED MIXES ACTED IN TWO WAYS:

A) THE REPAIRS ANCHORED PARTS OF THE MOSAIC, WHICH HAD PREVIOUSLY MOVED THROUGH EXPANSION AND CONTRACTION EVENLY WHEN OF ONE BEDDING, CAUSING TEARS AND RUPTURES TO THE MOSAIC BORDERING THE REPAIRS BY OWING TO THE ABSORPTION OF OIL FROM THE LIME PUTTY; THE REPAIRS HAD FAILED TO ADHERE TO THE RENDER BEHIND, AND WERE HANGING ONTO ENLARGING BLISTERS OF THE ALREADY FAILING ORIGINAL MOSAIC.

IT WAS CLEAR THAT THE ORIGINAL BEDDING HAD FAILED AND THAT REPAIRS ONLY EXACERBATED THE CONDITION AFTER TIME. IT WAS DETERMINED THAT THE BEST COURSE WAS TO TAKE DOWN THE MOSAIC AND RE-FIX INTO A LIME-BASED HOMOGENEOUS MORTAR. THE ORIGINAL RENDER SHOULD BE TAKEN DOWN AND REPLACED WITH A STAINLESS STEEL REINFORCED RENDER, FIXED TO THE BUILDING BY MECHANICAL MEANS. AN EXPANSION JOINT RAN AROUND THE PERIMETER, TO CARRY TO THE FACE.

THE PROPORTIONS OF THE MIX FOR THE SECONDARY RENDER TO RECEIVE THE TESSERAE WERE 2:1:9 IN LIME, PORTLAND CEMENT, AND SHARP WASHED SAND. THE PROPORTIONS FOR THE GROUT WERE 2:1:2 IN LIME, WHITE CEMENT AND SILVER SAND. THE SILVER SAND WAS USED TO STIFFEN THE GROUT AS THE JOINTS BETWEEN THE TESSERAE WERE WIDE.

THE MOSAIC WAS THOROUGHLY CLEANED AND A HEXAGONAL WEAVE COTTON SCRIM WAS ADHERED TO THE SURFACE UTILISING A SPECIAL PVA EMULSION; THEN A REGISTRATION GRID WAS PLACED OVER THE SURFACE. RECORD PHOTOGRAPHS WERE TAKEN BEFORE AND AFTER THE "SCRIMMING."

THE MOSAIC WAS THEN TAKEN DOWN IN MANAGEABLE SECTIONS WHICH WERE RECORDED TO A KEY-PLAN. AFTERWARDS THE BACKS OF THE TESSERAE WERE CLEANED AND TREATED TO REMOVE OIL RESIDUE AND THUS PROMOTE GOOD ADHESION FOR THE RE-FIX.

MATCHING REPLACEMENT TESSERAE WERE SOURCED FROM DONA OF MURANO; THESE WERE A REASONABLE MATCH FOR COLOUR, BUT THE TEXTURE ON CLOSER INSPECTION WAS DIFFERENT TO THE ENGLISH SMALLS. THIS DIFFERENCE WAS THOUGHT DESIRABLE SO THAT THE RESTORED AREAS COULD BE CLEARLY IDENTIFIED. THE AREAS OF PREVIOUS RESTORATION WERE ALSO MATCHED SIMILARLY.
