CENTRAL INSTITUTE FOR CONSERVATION IN BELGRADE

Conservation of mosaic from the archaeological site **NEBESKE STOLLCE** Serbia

Milena Jovanović, Maja Franković, Duško Jovanović

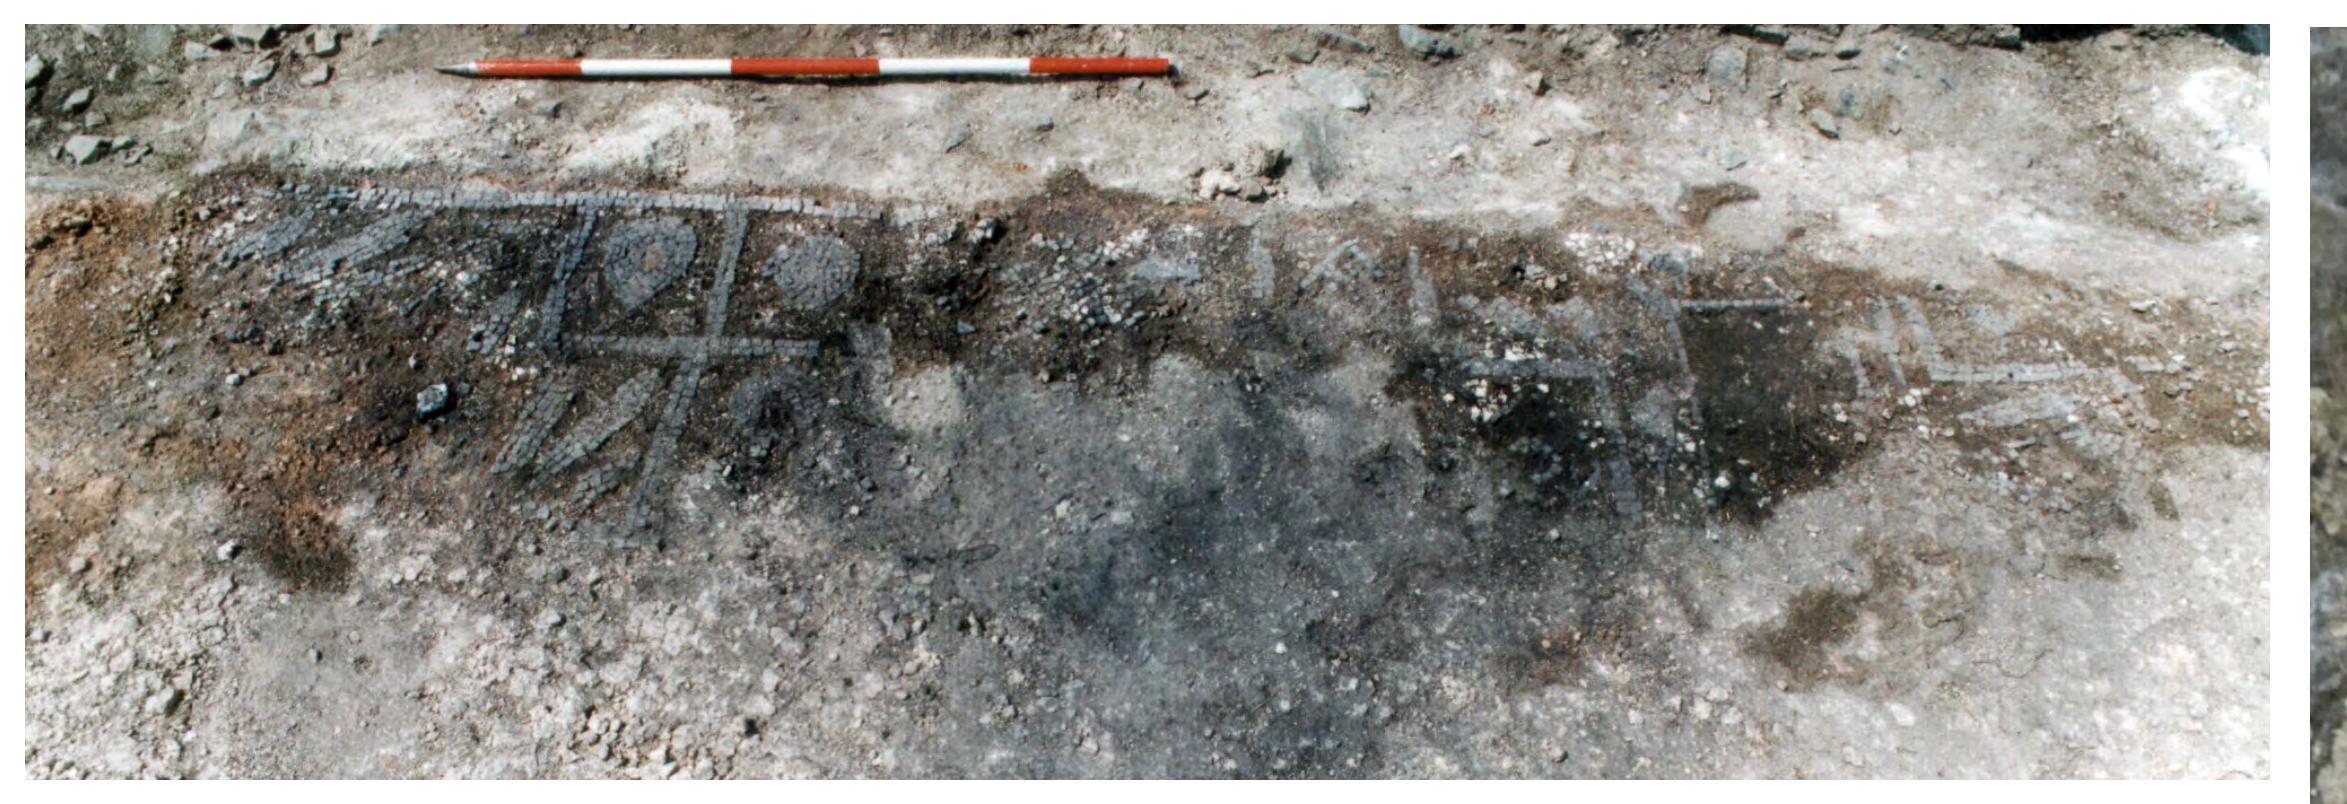
NEW SUPPORT

New support consisted of an intermediate layer of light lime-casein mortar containing perlite and expanded clay, reinforced with fiber-glass. Once placed on new support facing was removed and fragments were glued to honeycomb aluminium panels

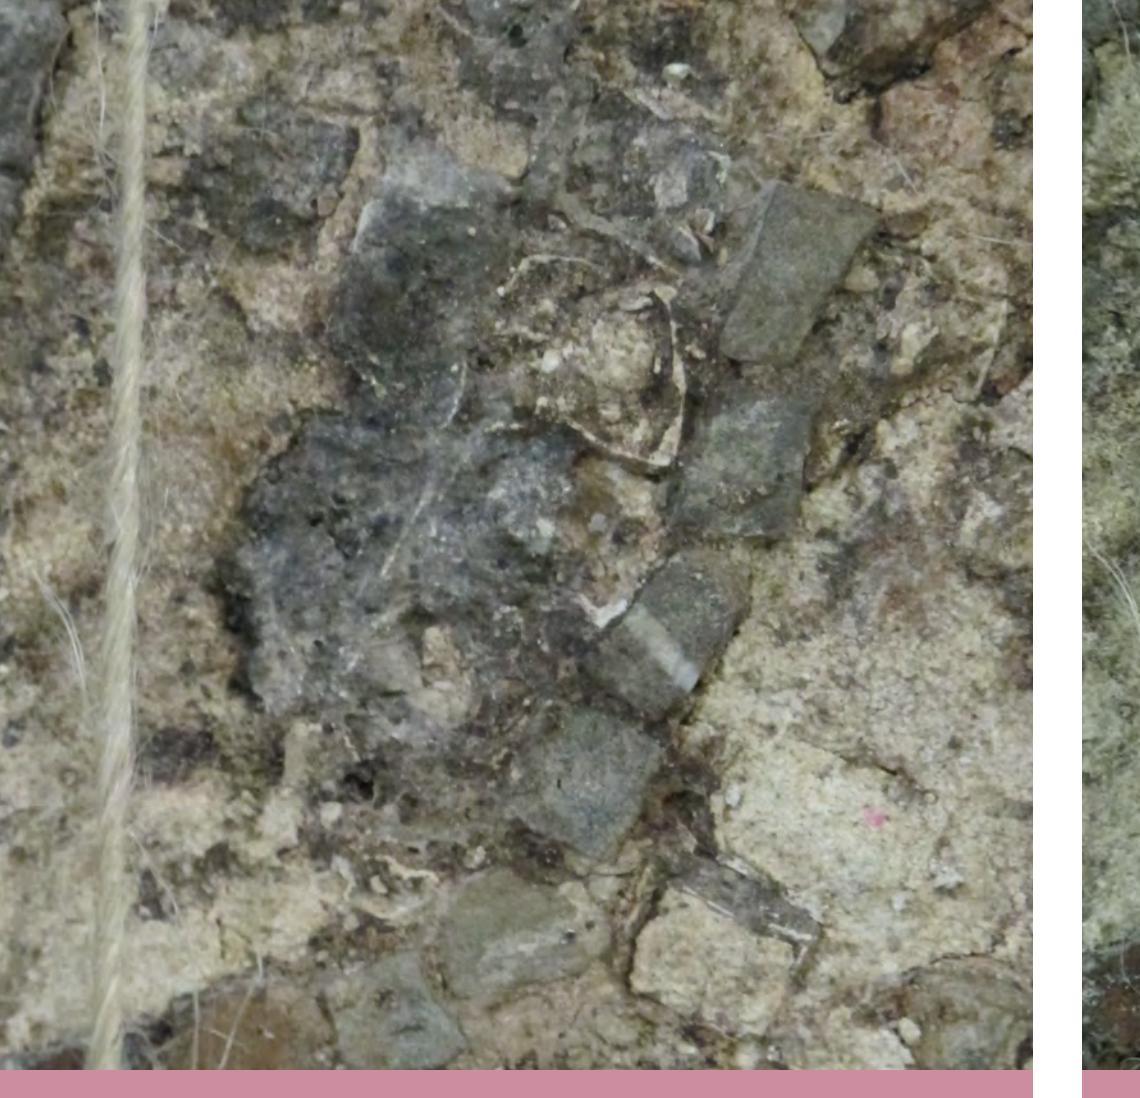
Before laser cleaning treatment

Because of the fragility of white tesserae, cleaning had to be done with minimum contact, so laser and steamcleaning were combined.

The laser employed was a Q-switched Nd:YAG laser, Thunder art.The infrared wavelength (1064 nm) at 330 mJ was used for the general cleaning of tessellatum, while the same wavelength at 275 mJ was used for terracotta tesserae. Thicker soil deposits were first moistened and then cleaned at 380 mJ. The tar deposits from burning as well as some layers of soil and glue mixture were successfully cleaned. Underneath some of these layers the degraded white tesserae were found.Additional rinsing of dirt was done with steamcleaner and fine brush. Detachments were stabilized by injecting colloidal acrilic dispersion (Primal WS 24), while remains of white tesserae were consolidated with nanolime (CaLo-Sil E25).

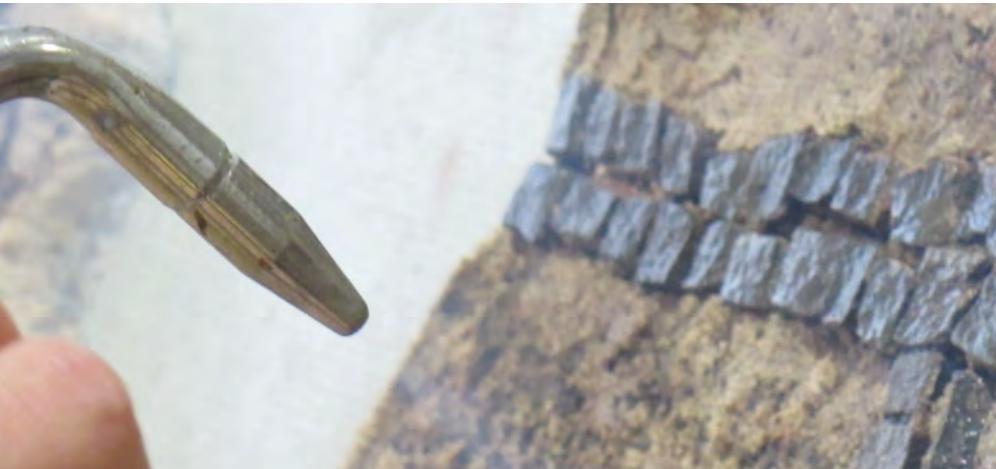
After laser cleaning treatment

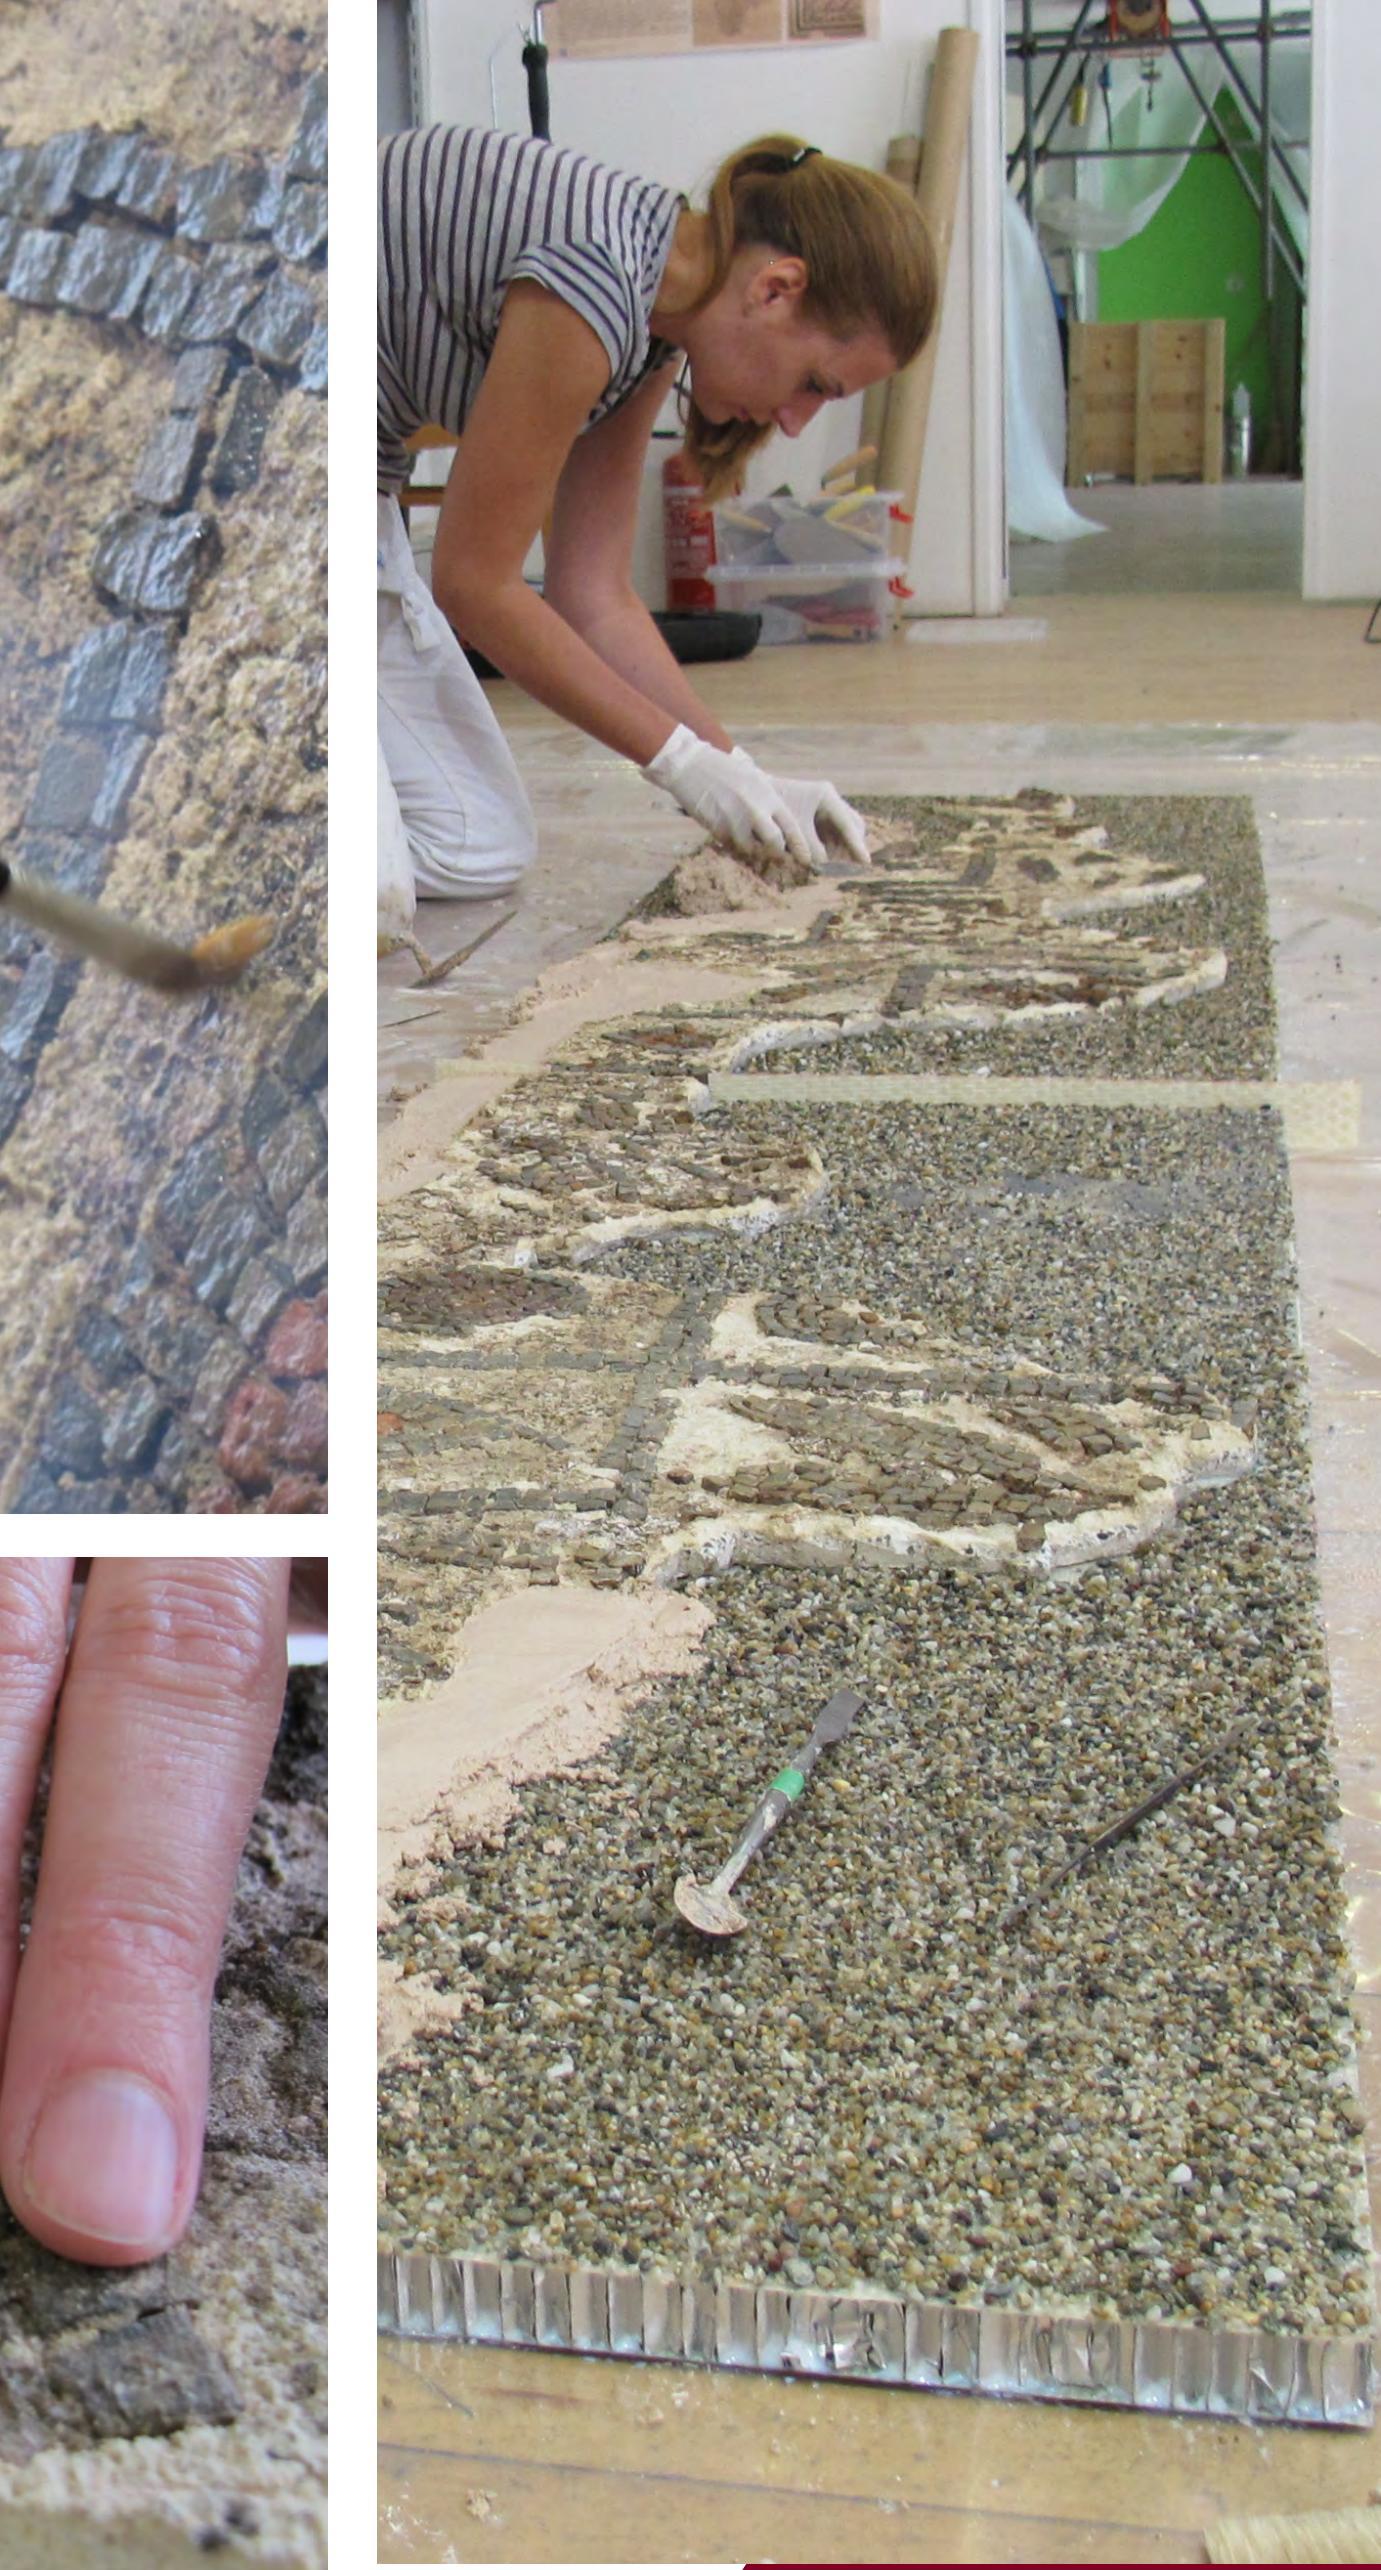
CONDITION

Mosaic was badly damaged; surface was covered with traces of soot, tesselatum was disturbed with many lacunae and loose tesserae. White tesserae were especially affected by fireand wet burial conditions – only thin shells were preserved filled with lime mixed with dirt.

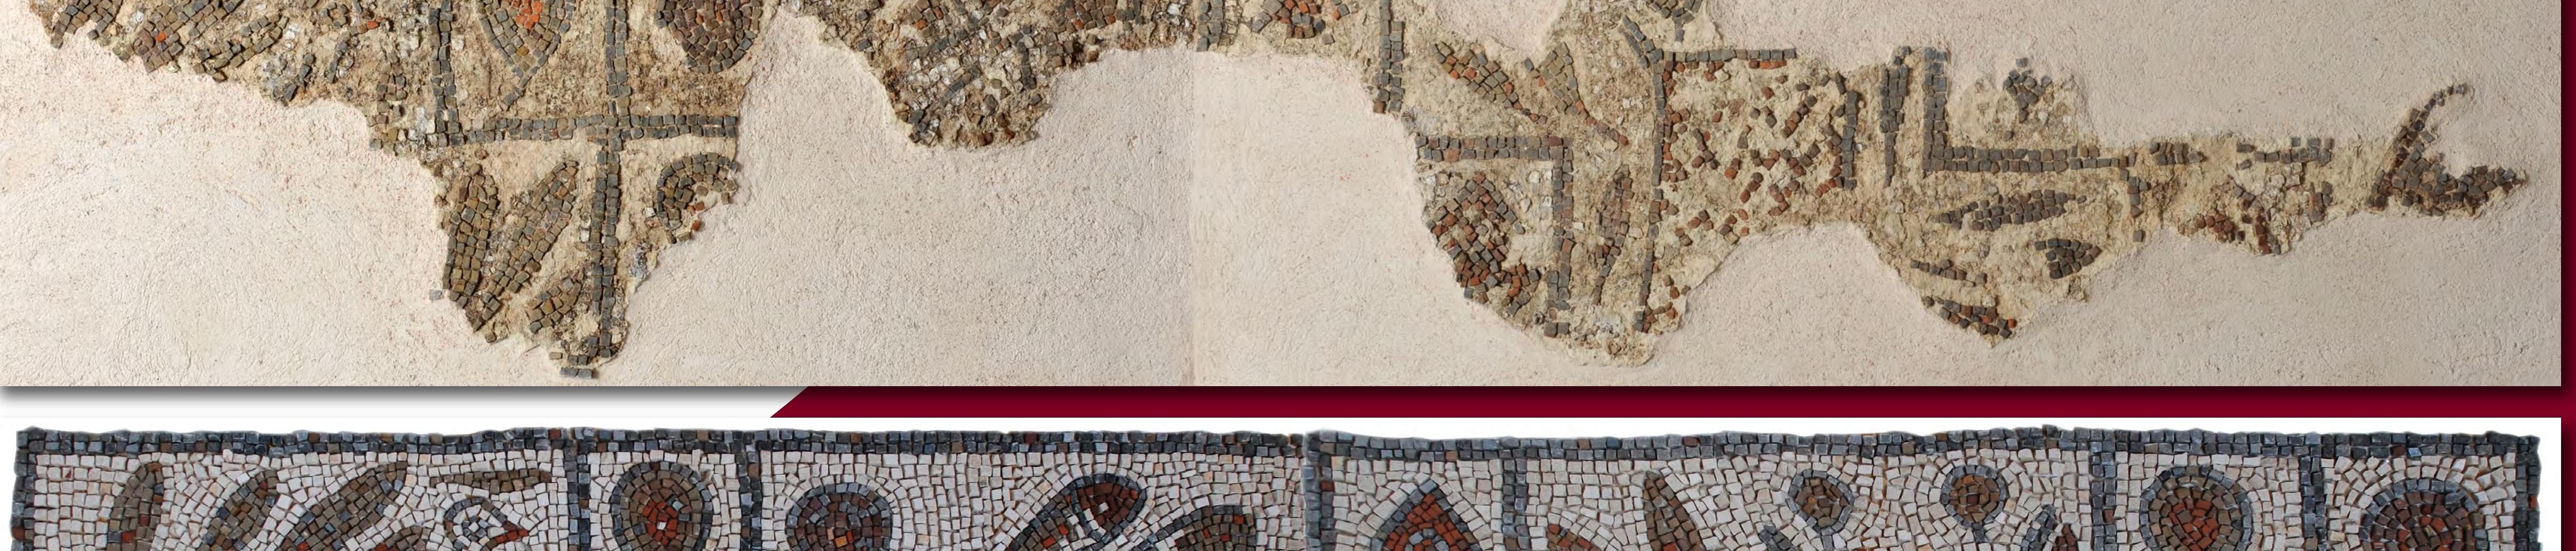
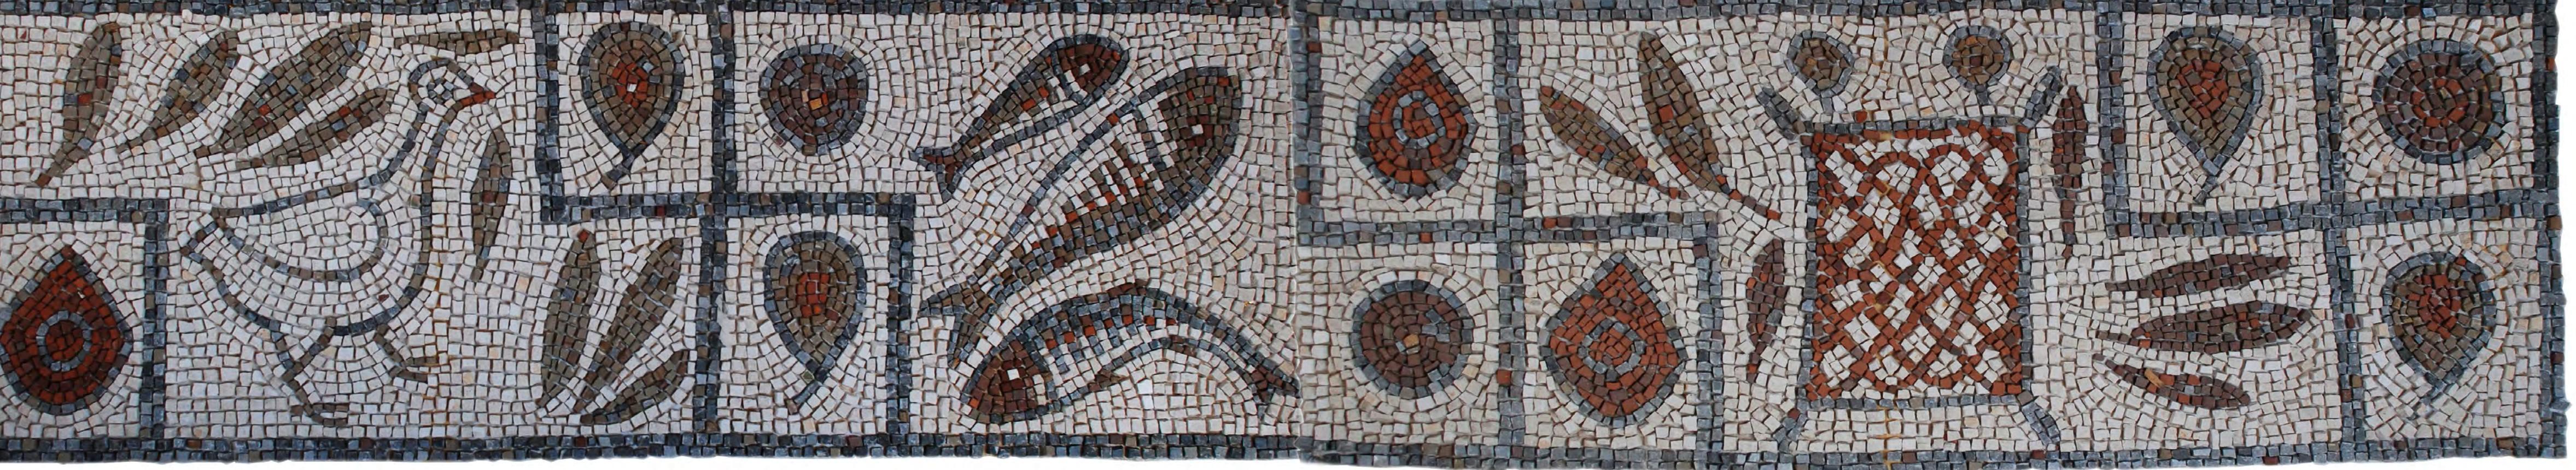
RECONSTRUCTION

Reconstructed mosaic copy was made by restorer Duško Jovanović to enable understanding mosaic decoration that was highly disrupted by mosaic decay.
